June 20, 2025  
File No. 01204123.42, Task 10

Subject: May 2025 Monthly Report for Modified Stipulated Order for Abatement (Case No. 6177-4), Chiquita Canyon Landfill (Facility ID 119219), Castaic, California

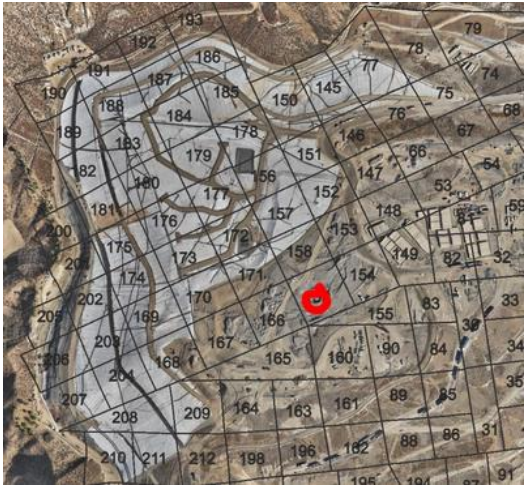
159

Using the attached image, annotate all areas where inspectors identified a fissure or tension crack.

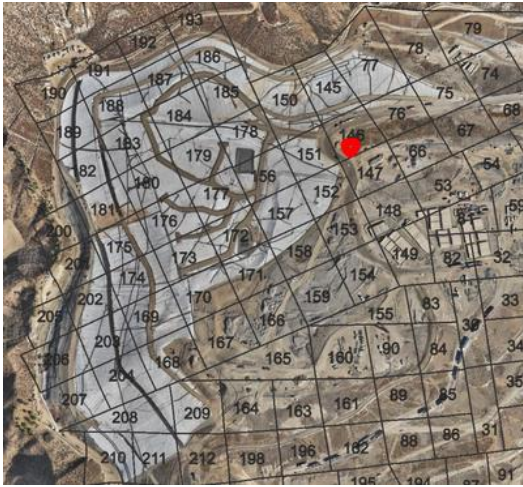
146

Using the attached image, annotate all areas where inspectors identified a fissure or tension crack.

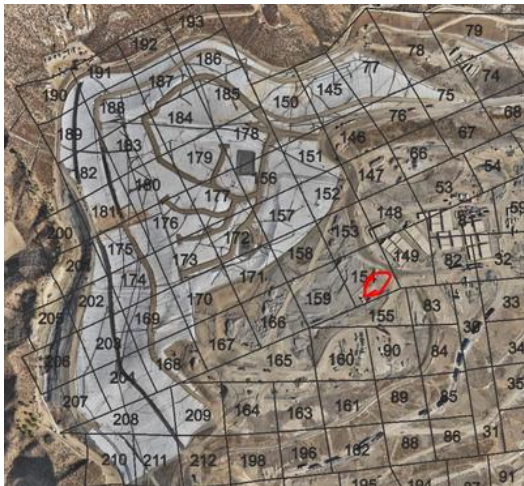
154

Using the attached image, annotate all areas where inspectors identified a fissure or tension crack.

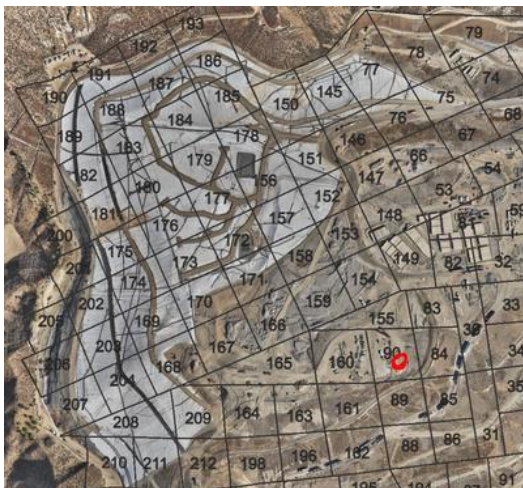
90

**Using the attached image, annotate all areas where inspectors identified a fissure or tension crack.**

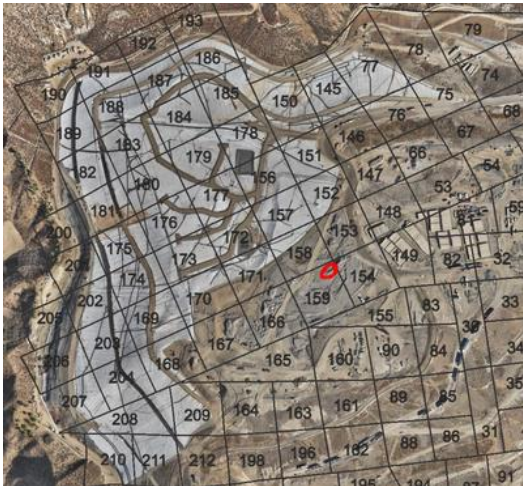
159

Using the attached image, annotate all areas where inspectors identified a fissure or tension crack.

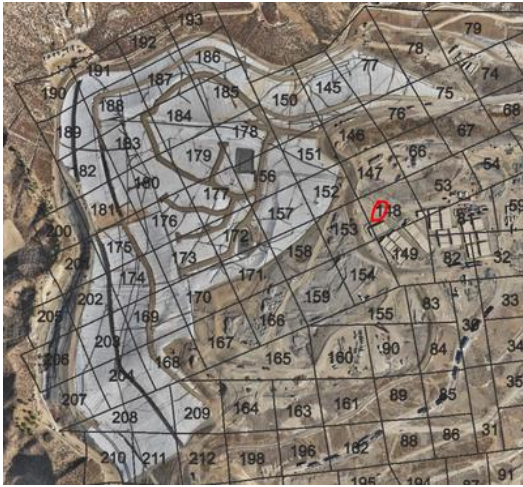
Grid Location 148

Using the attached image, annotate all areas where inspectors identified a fissure or tension crack.

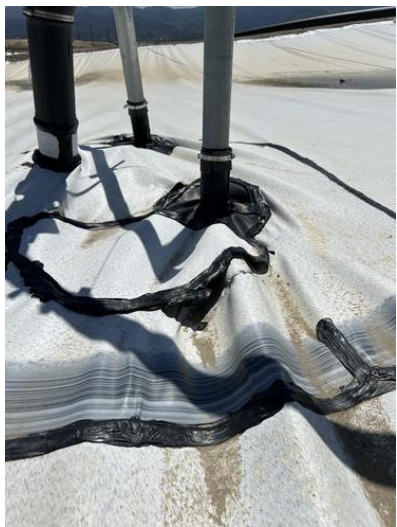
Photo 1

Found 2:07 pm on 4/28/25

A weld came free and needs to be patched/extrusion welded.

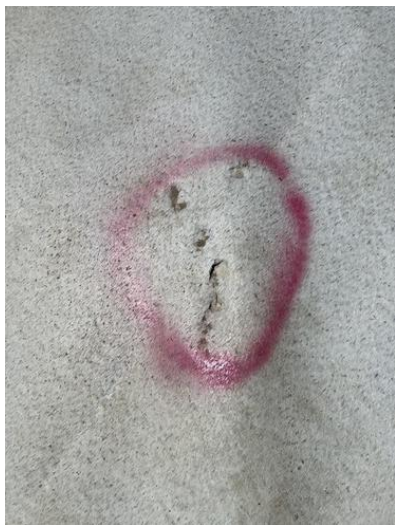
Photo 4

Found 4/28/25 at 2:17pm. Grid 185

Puncture in cover needs to be extrusion welded.

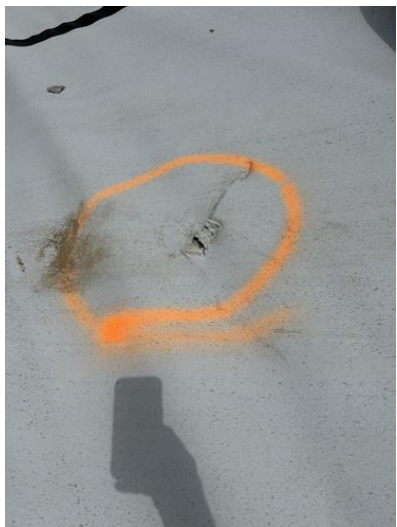
Photo 1

Found 5/5/25 1:09pm Grid 201

Puncture in cover needs to be extrusion welded.

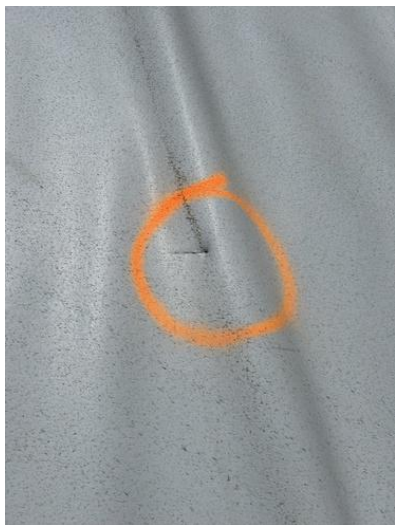
Photo 4

Found 5/5/25 1:15pm Grid 201

Puncture in cover needs to be extrusion welded.

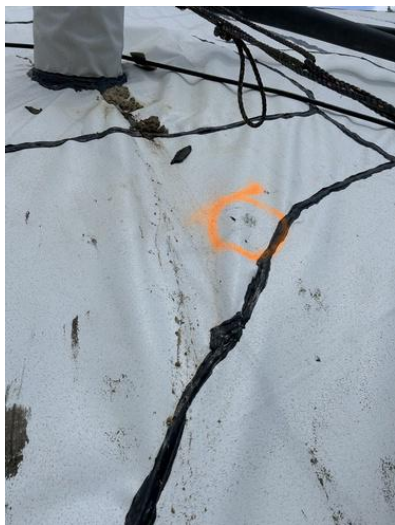
Photo 7

Found 5/5/25 1:20pm Grid 201

**Notate what the issue is and what needs to be repaired** Puncture in cover needs to be extrusion welded.

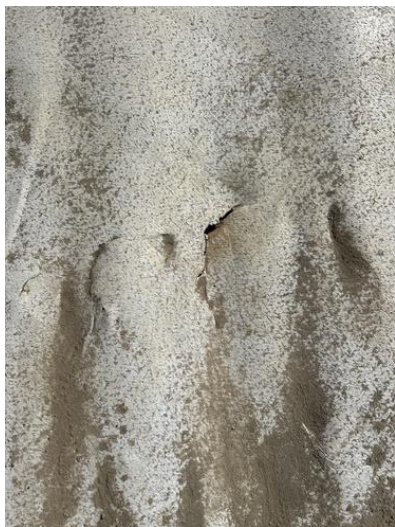
Photo 1

Found 5/19 at 9:29 am in grid 78.

Tear in cover, needs to be patched/extrusion welded.

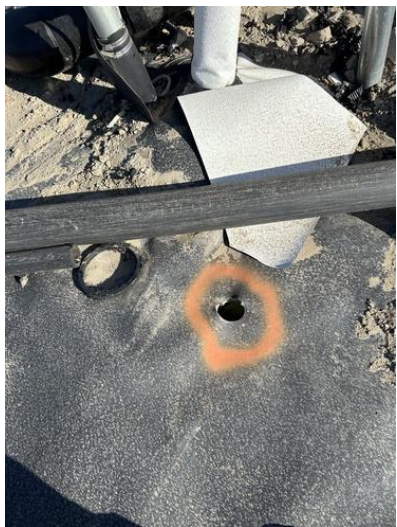
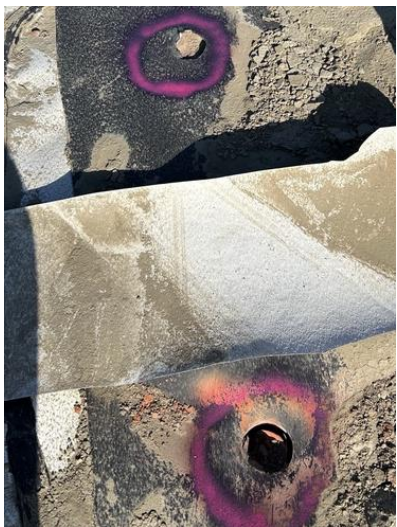
Found on 5/20/25 at 7:45am. Grid 75/76

3 holes from posts that were moved need to be patched and extrusion welded.

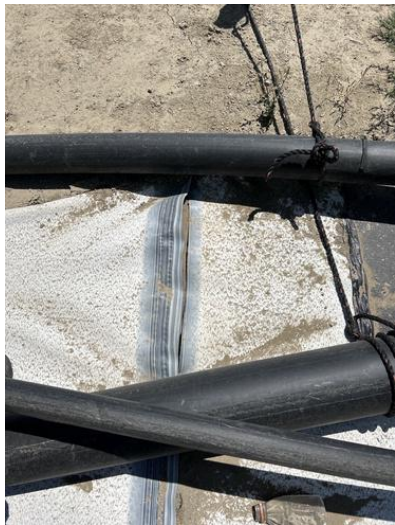
Found 1:28pm on 5/27/25. Grid 146
