**CHIQUITA CANYON**  
*A Waste Connections Company*

**Re: Chiquita Canyon, LLC's Weekly Report on the Documentation and  
Tracking of Cover Issues and Monthly Summary**

# 4050 - Chiquita Reaction Area Tracking of Fissures and Tension Cracks

**JUNE 2025 FISSURE AND TENSION CRACK MONITORING SUMMARY**

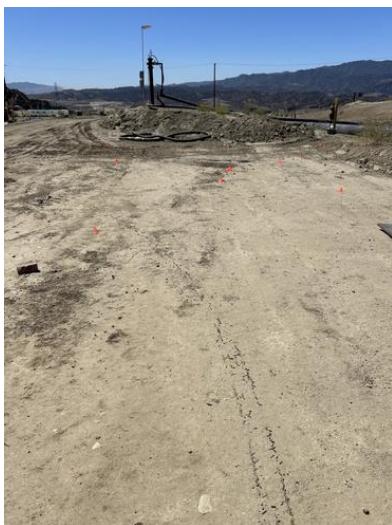
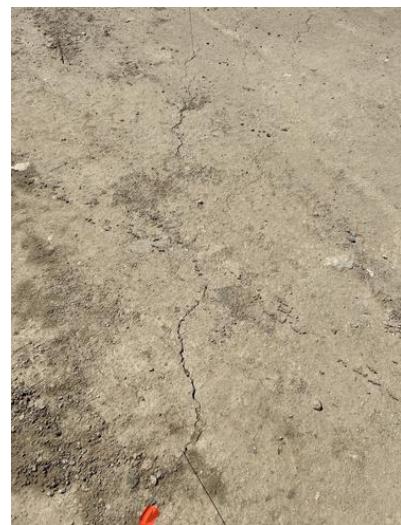
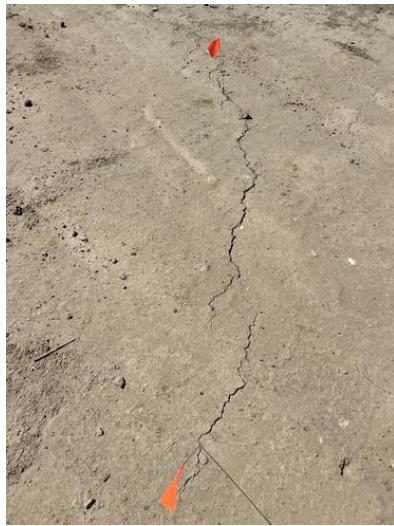
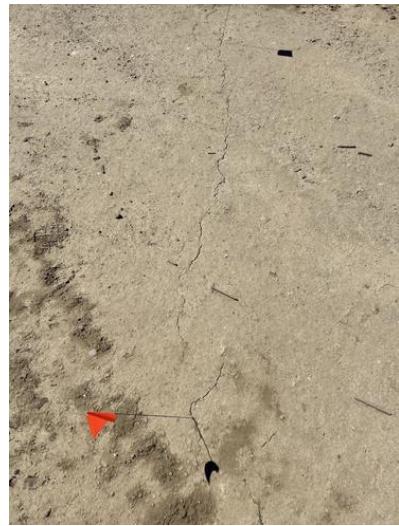
**Grid Location**

149

20ft x 30ft

Small 0.5-2" in width

Extra small <0.5" in height

N to S

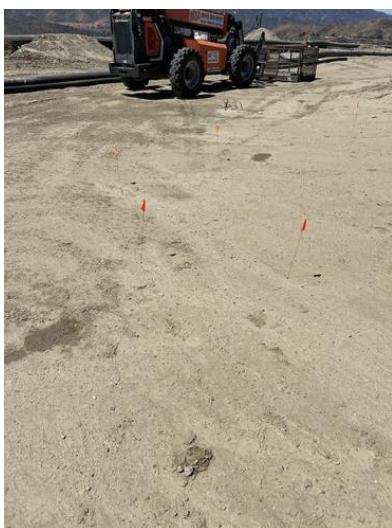
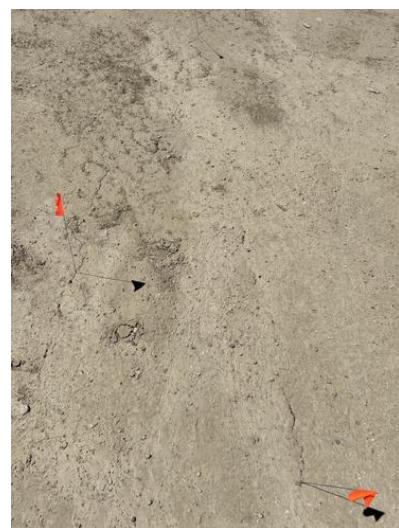
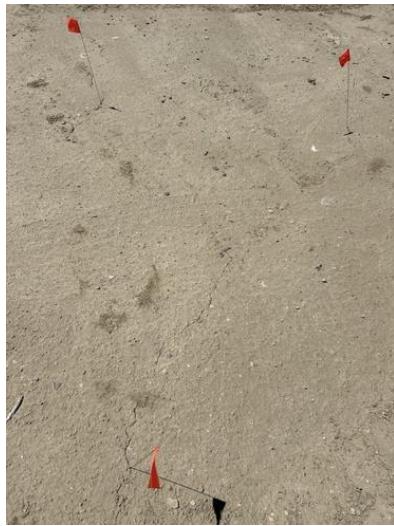
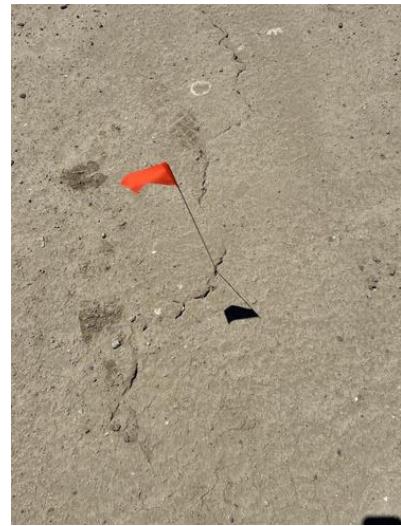
**Grid Location**

160

18ft x 32ft

Small 0.5-2" in width

Extra small <0.5" in height

N to S

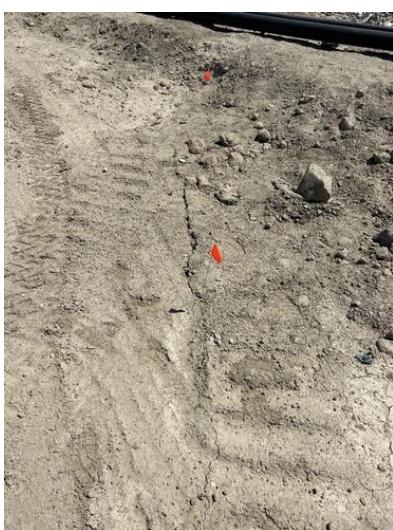
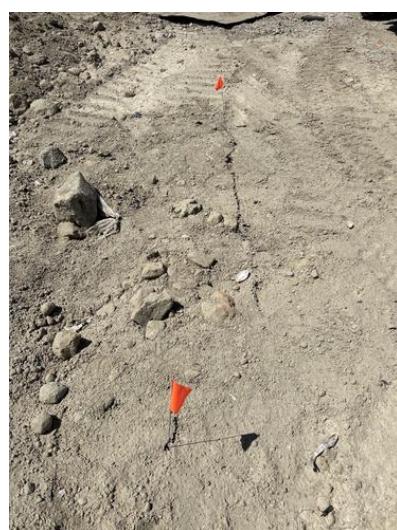
**Grid Location**

154

7ft

Horizontal Offset (width)	Small 0.5-2" in width
Vertical Offset (height)	Extra small <0.5" in height
Orientation (direction)	NE to SW

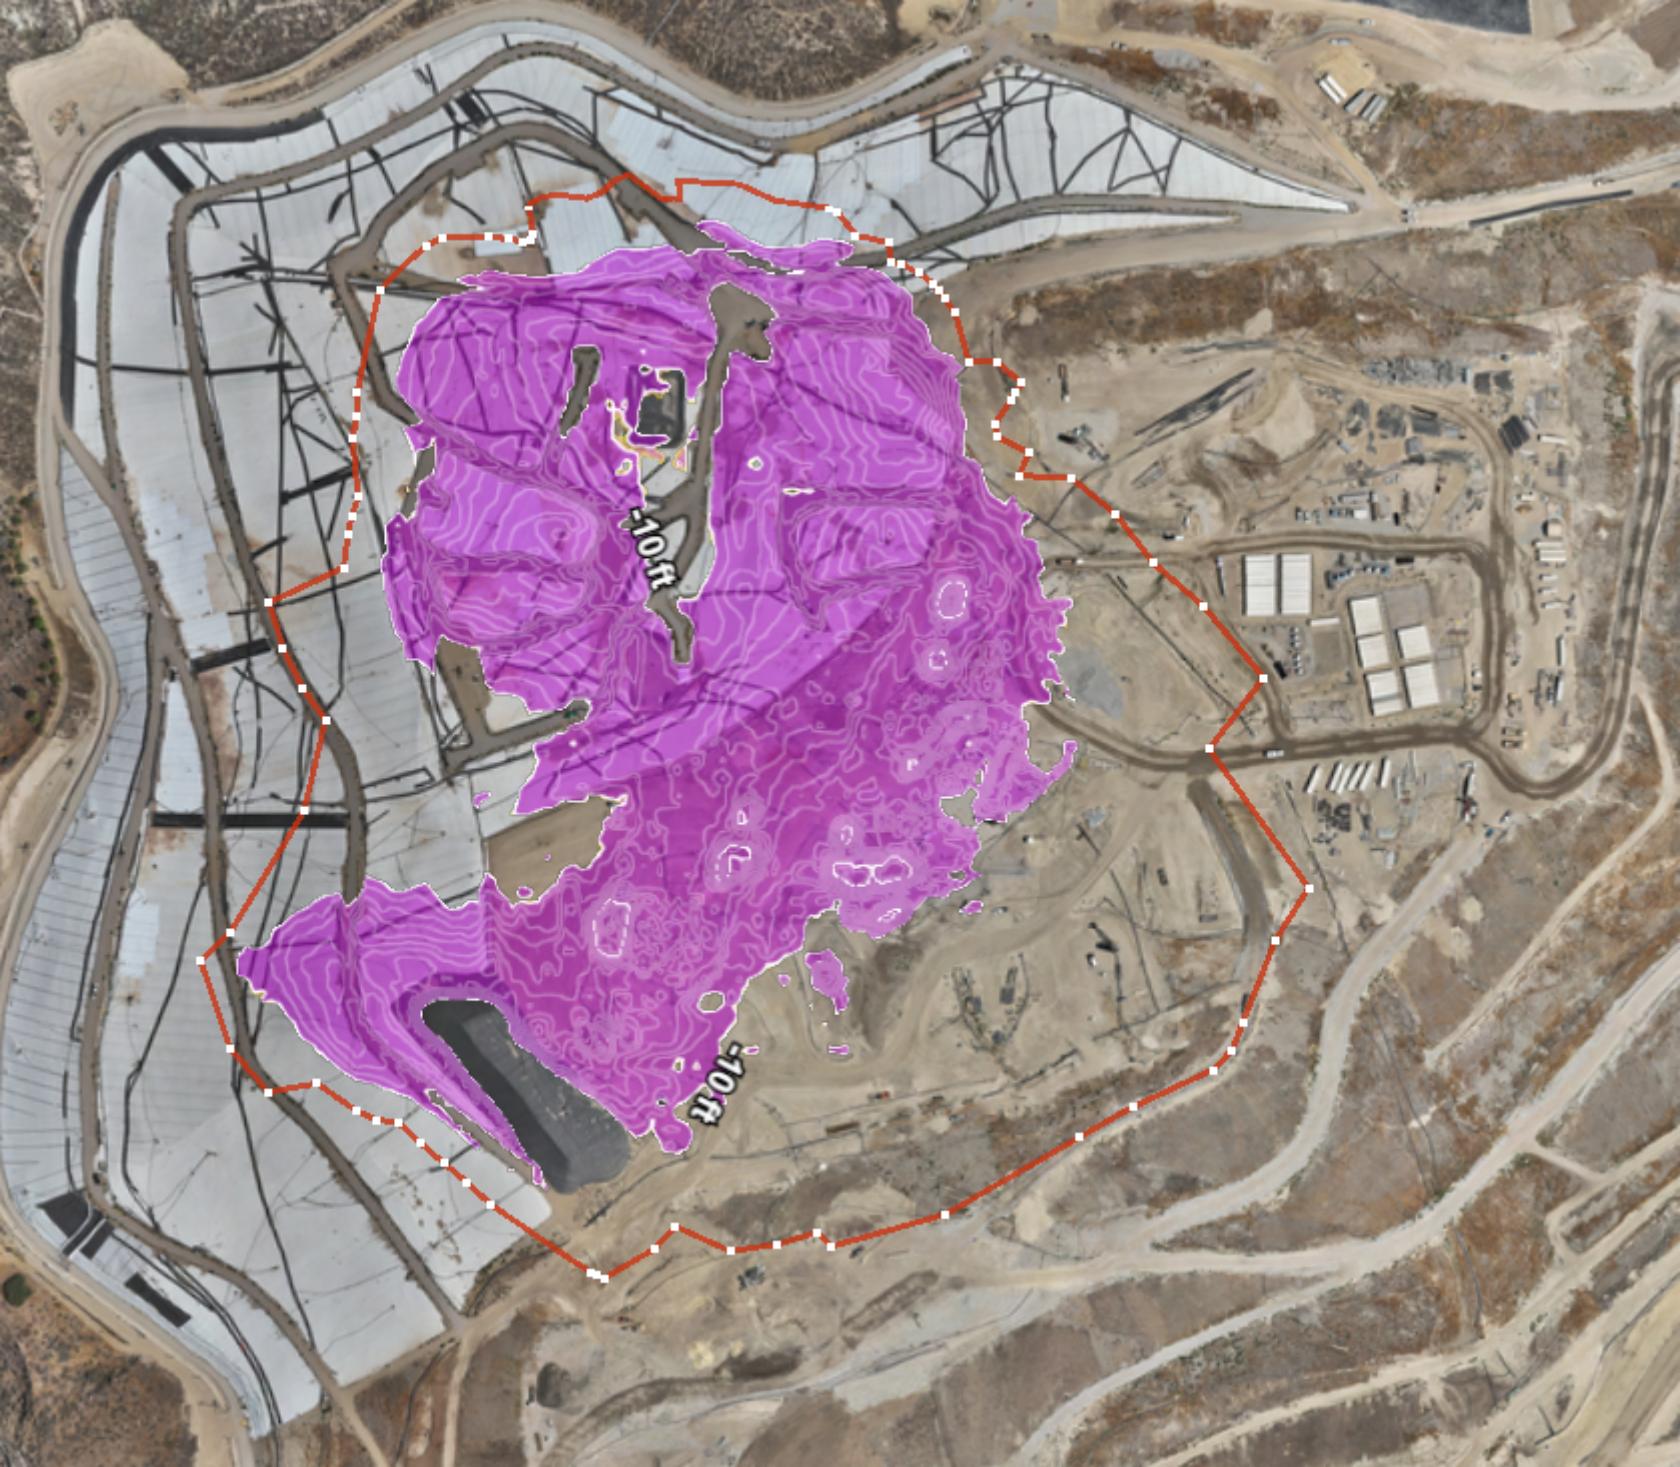
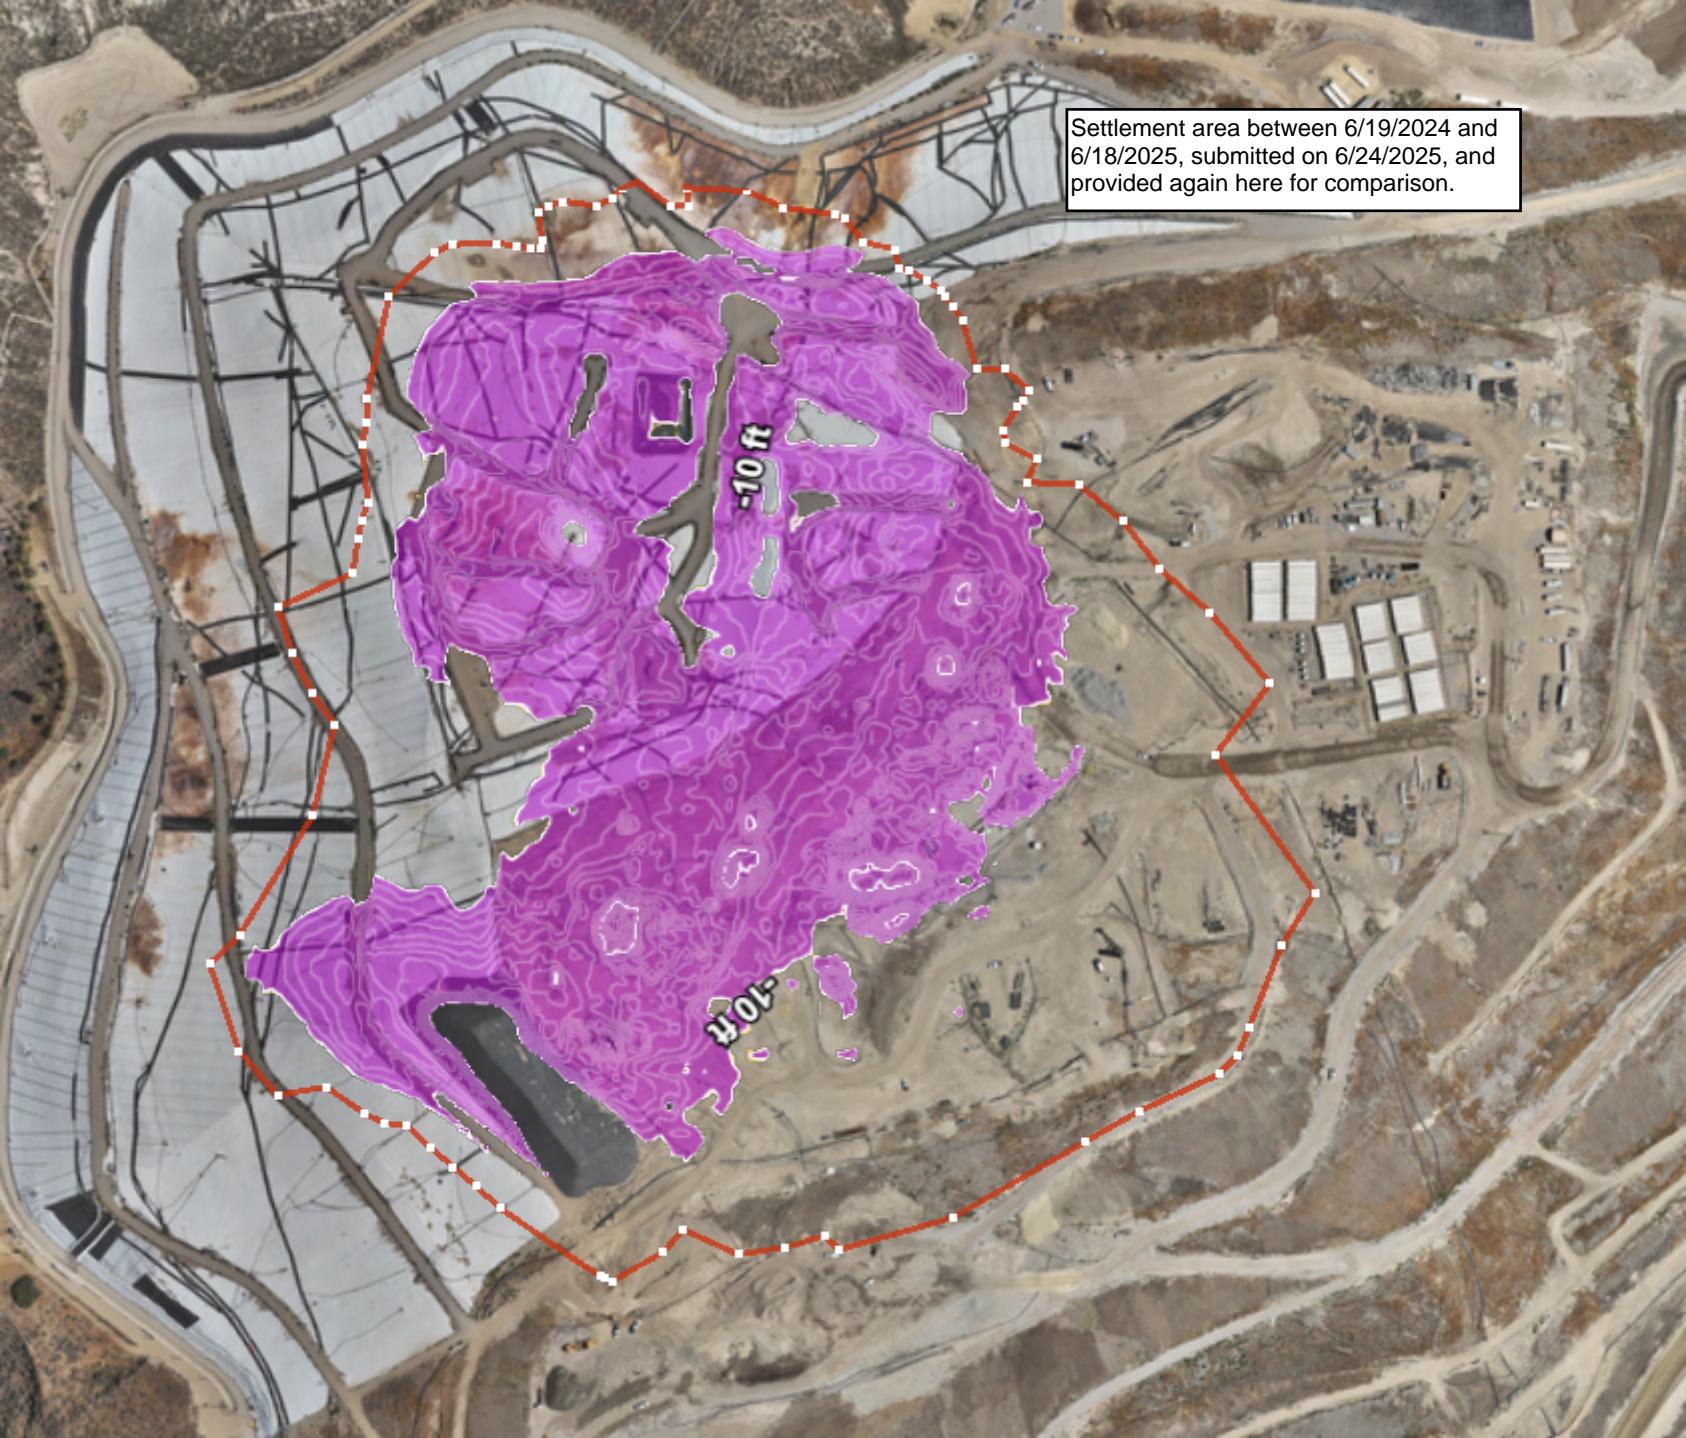
Settlement area between 6/19/2024 and 6/18/2025, submitted on 6/24/2025, and provided again here for comparison.

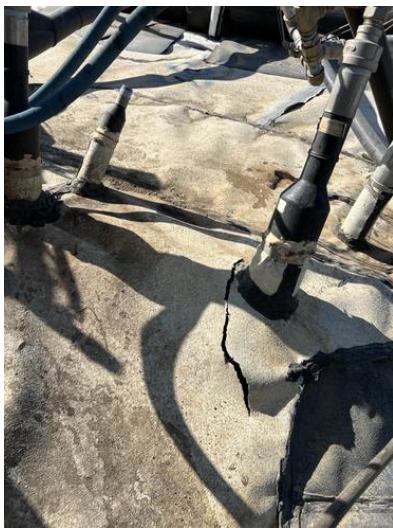
Photo 1

Found 8:33am in grid 77

12" tear in liner needs to be extrusion welded.
