Below is Chiquita's weekly update on the status of the installation of the EVOH 60-mil geomembrane cover at the Chiquita Canyon Landfill, in accordance with Mitigation Measure 4.1 of the LEA's Compliance Order issued May 1, 2025.

CHIQUITA CANYON LANDFILL

Project Name: Chiquita Canyon Cell 8 Tank Farm		Project No. RM22.1077	Daily Field Report Sequence Number: 059	
Location of Work: Santa Clarita, CA	Client Waste Connections	Date: July 21, 2025	Day of The Week: Monday	
General Contractor: Sukut Construction, Inc.	Liner Contractor: D&E Construction	Project Manager: Rick Mitchell		
General Foreman: Matt Rodarte	Liner Superintendent: Dennis Kennedy	GLA CQA Officer: Tom Runyan		
Source and Description of Fill Material: Imported Gravel	Weather: Overcast to Sunny: 60°F to 93°F Wind: Calm to 9mph	CQA Technician: Magno Jara		
Equipment utilized: Water Truck, Cat 834 RTD, Cat D3 Dozer, Cat D5 LGP Dozer, Smooth Drum Roller.

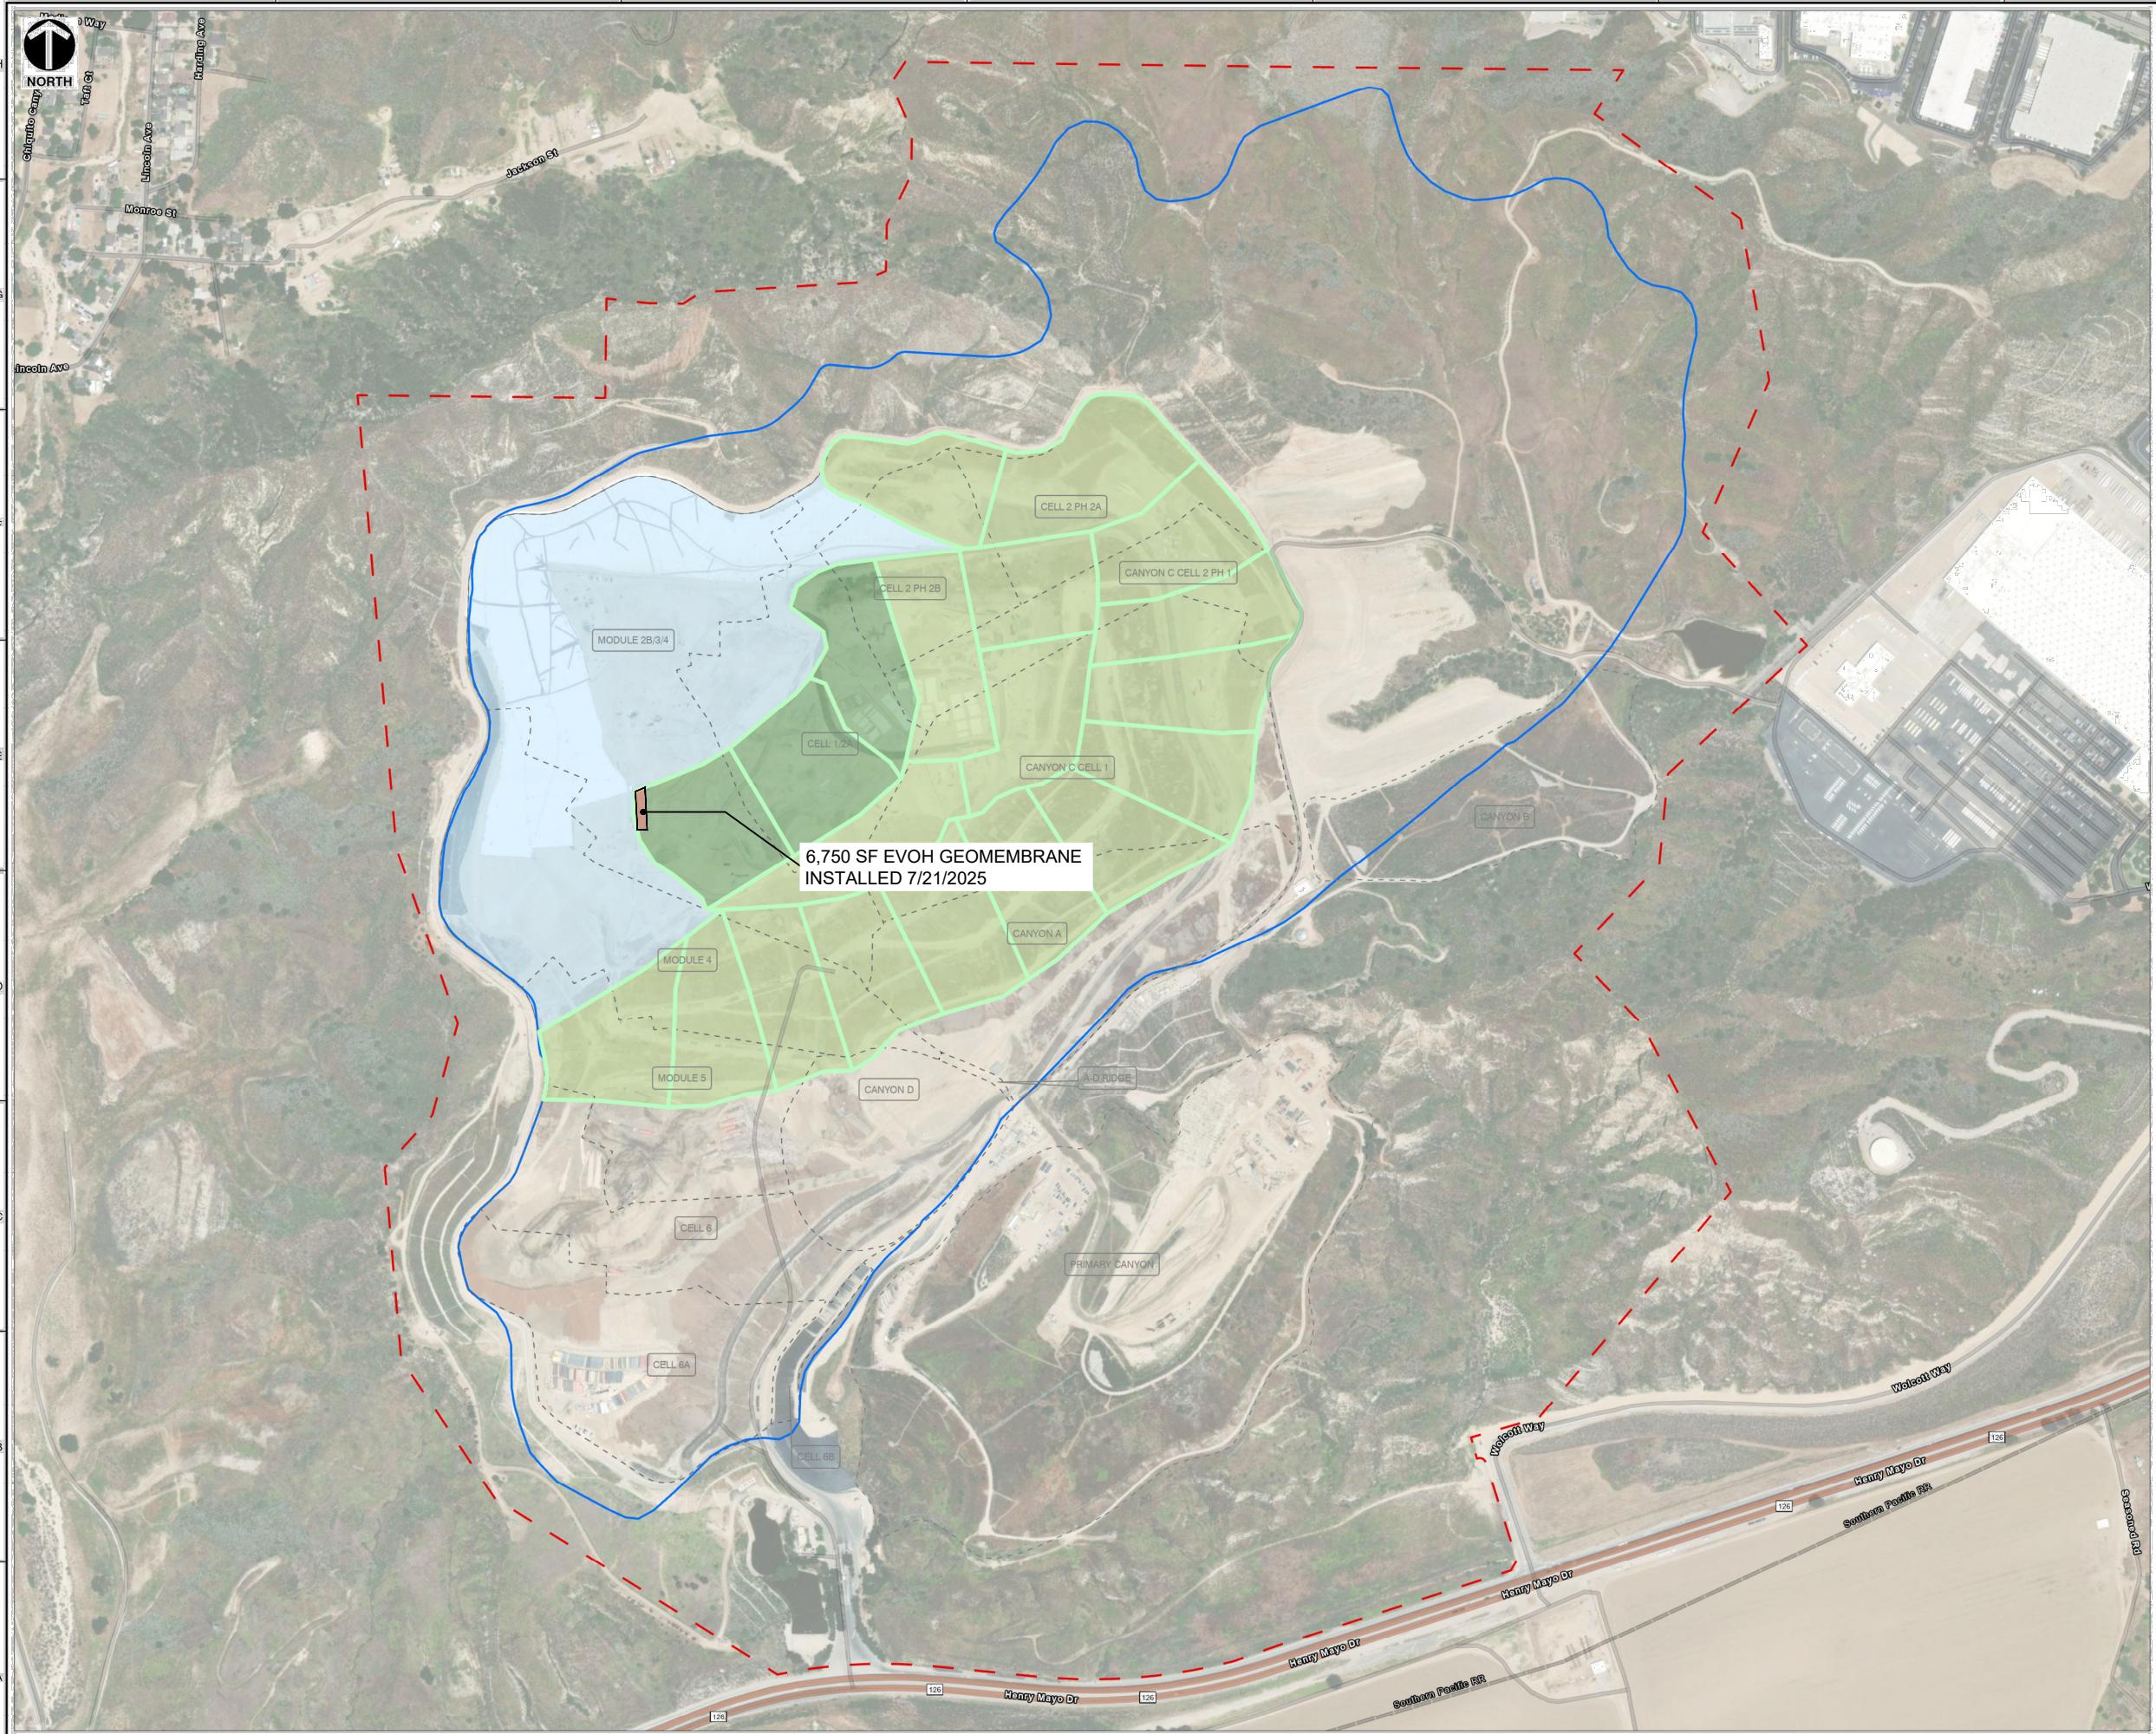
SITE MAP

The attached site map shows the approximate extent of the geomembrane cover installed as of Friday, August 8, 2025, as well as the geomembrane coverage area described in the draft workplan for extension of the geomembrane cover dated May 16, 2025, and submitted to the LEA and DTSC. Note that Chiquita is preparing a response to the agencies' correspondence regarding the scope of the planned extension area. Also attached to this submission are the July 2025 monthly isopach map and a figure identifying wells showing signs of reaction as of June 2025. Due to technical limitations, we are unable to create one figure including all of this data.

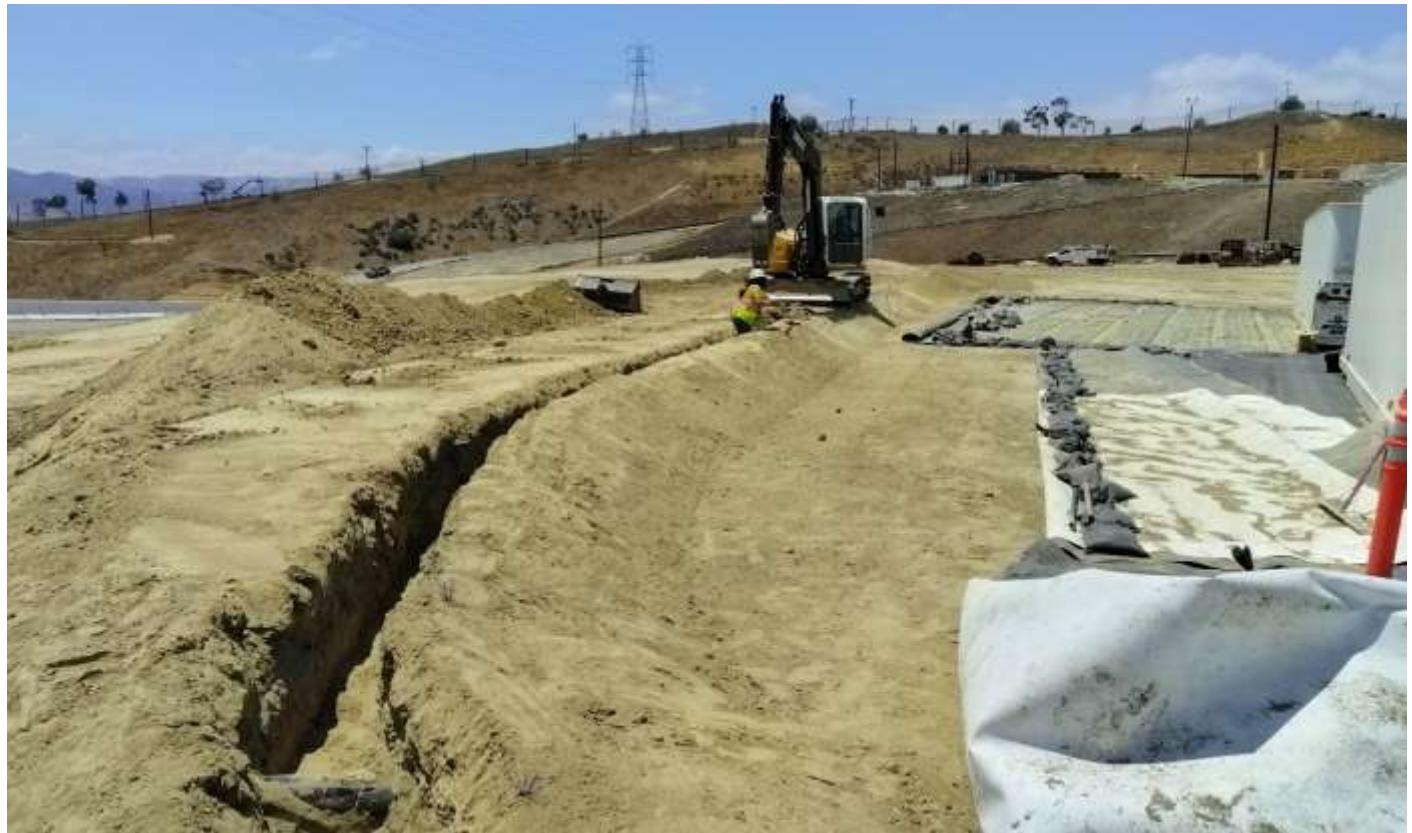
*Picture 1: Anchor trench construction (Pad #1).*

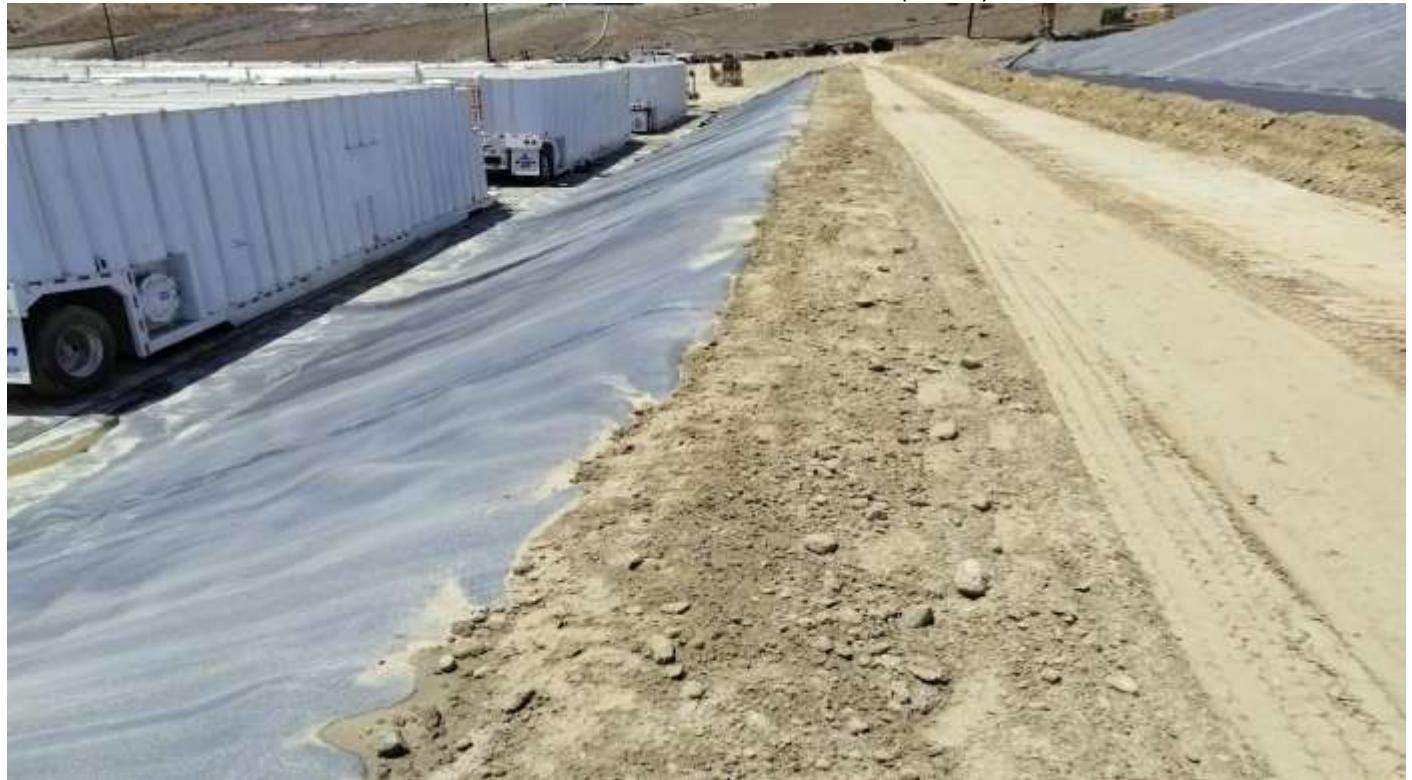
*Picture 2: Pad 1 East Slope Backfill*

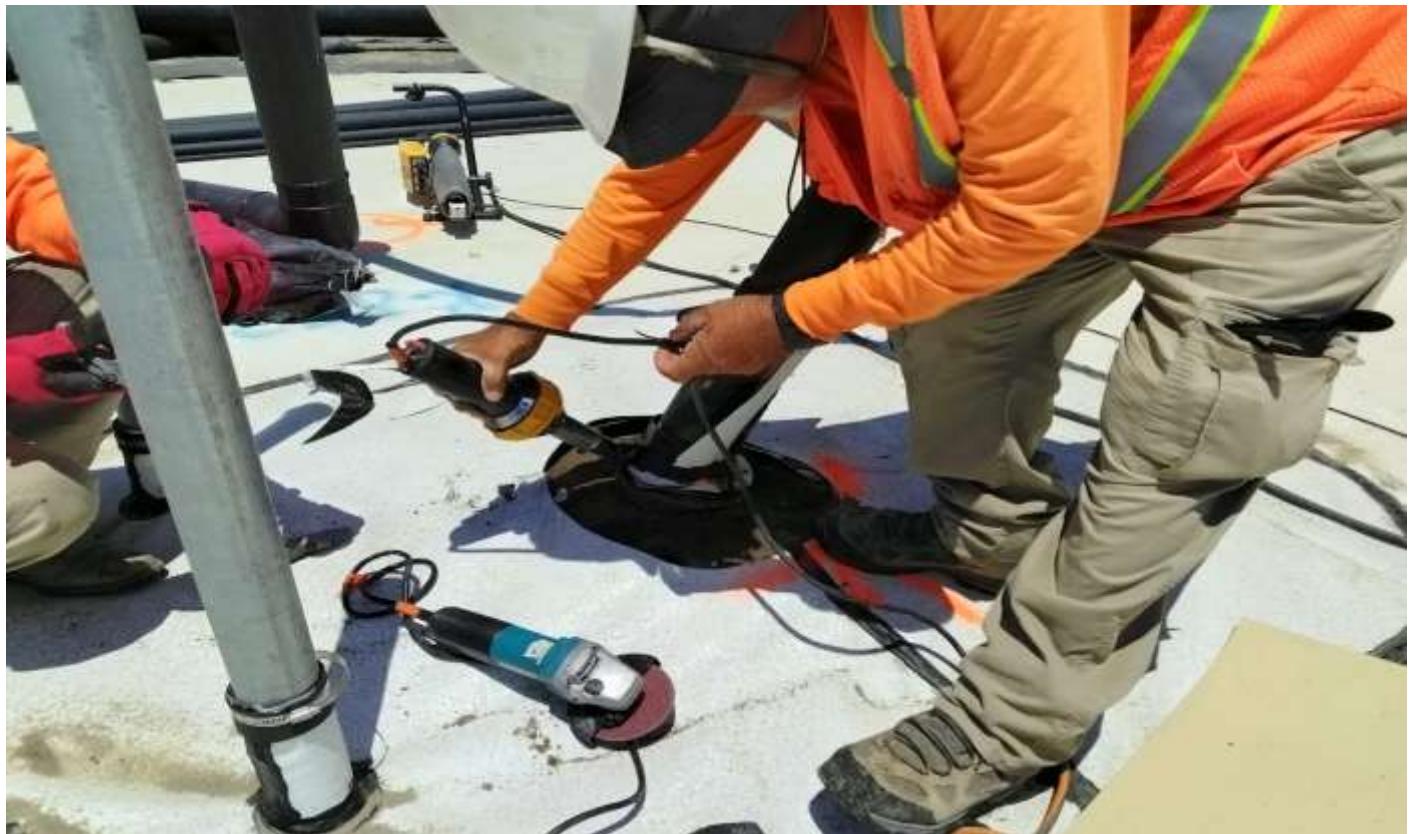
Picture 3: Fabricated Pipe Boots (Top deck)
