CHIQUITA CANYON
A Waste Connections Company

**Re: Chiquita Canyon, LLC's Weekly Report on the Documentation and
Tracking of Cover Issues, Monthly Summary and Monthly Isopach Map**

4050 - Chiquita Reaction Area Tracking of Fissures and Tension Cracks

**AUGUST 2025 FISSURE AND TENSION CRACK MONITORING SUMMARY
CHIQUITA CANYON LANDFILL
CASTAIC, CALIFORNIA**

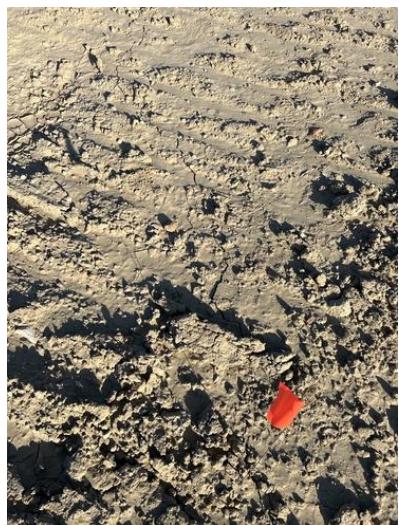
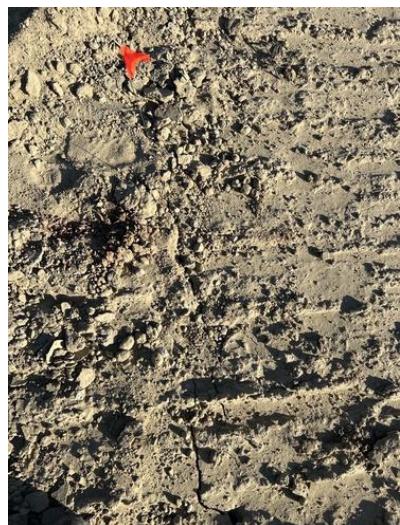
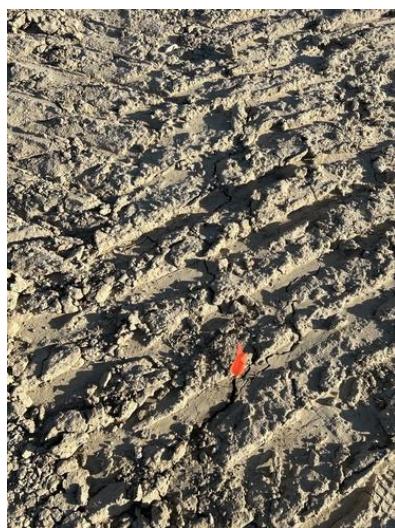
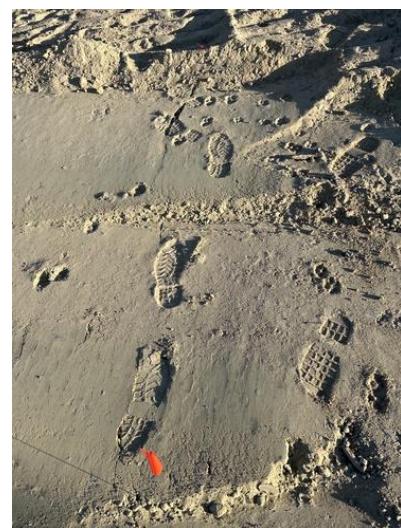
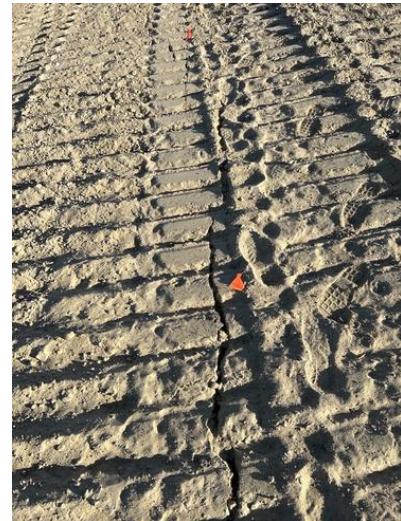
Grid Location

147

155ft x 5ft

Not continuous crack over 50ft.

Small 0.5-2" in width

Small 0.5-2" in height

NW to SE

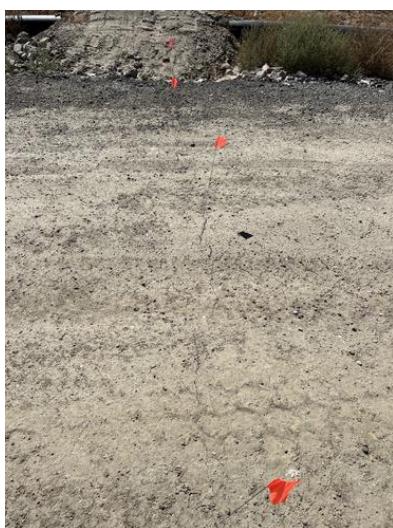
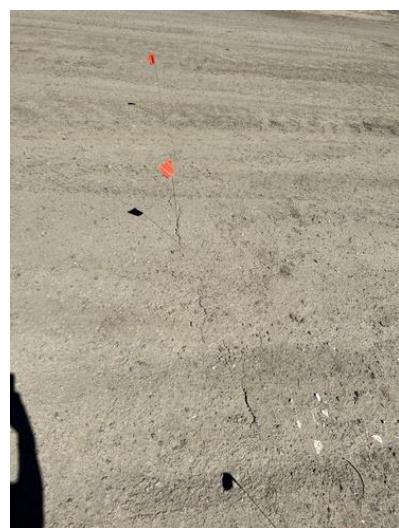
146

7ft

Horizontal Offset (width)	Extra Small <0.5 in width
Vertical Offset (height)	Extra small <0.5" in height
Orientation (direction)	N to S

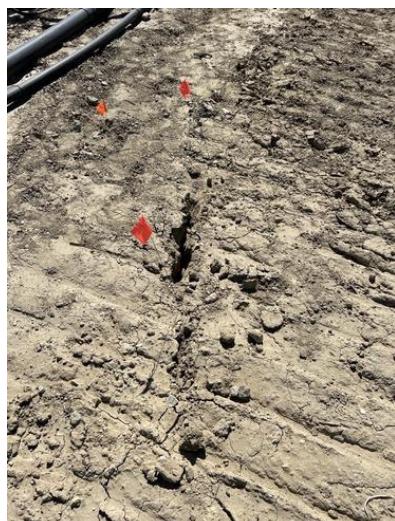
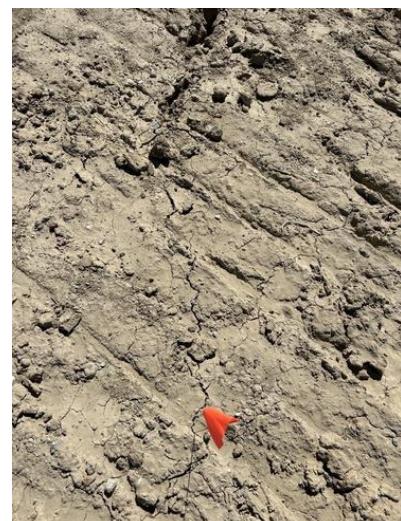
147

5ft

Medium 2-4" in width

Extra small <0.5" in height

NW to SE

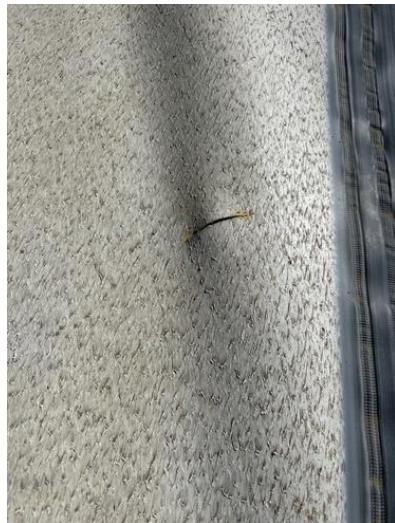
Photo 1

Grid 169

Small tear in liner. Needs to be extrusion welded

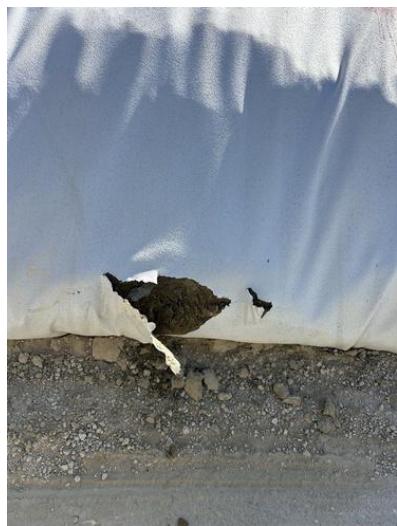
Photo 1

Grid 200

Liner torn open. Needs to be patched
