**Re: Chiquita Canyon, LLC's Weekly Leachate Inspection Report for Stipulated Order for Abatement (Case No. 6177-4), Condition 27(c)**

Attachment: Leachate Inspection Logs from February 3 – February 9, 2025

# 4050 - Chiquita Leachate Seep/Pooling Inspection

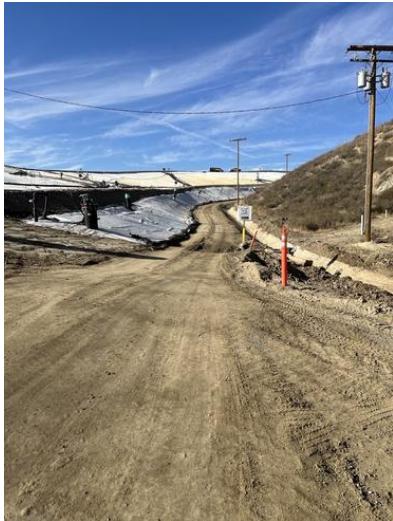
Photo 1

North side perimeter road

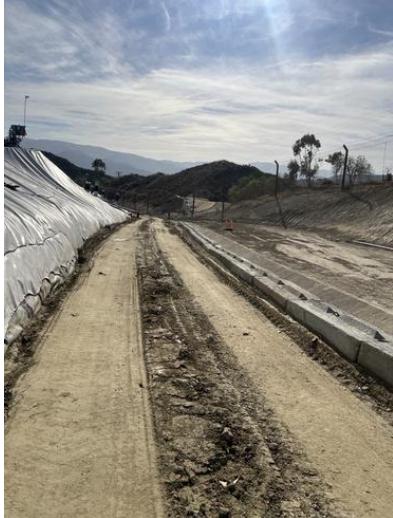
Photo 1

West side perimeter road

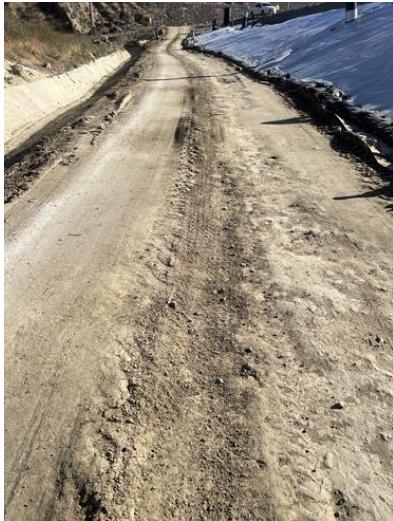
Photo 1

North side perimeter road

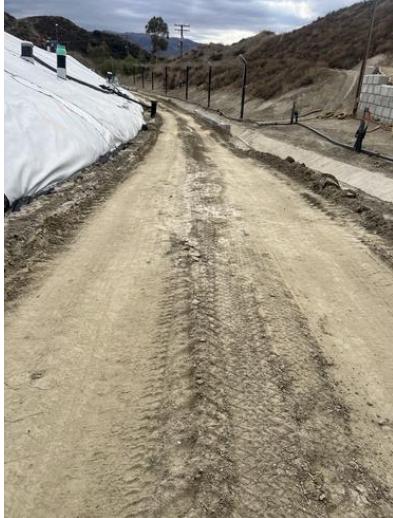
Photo 1

West side perimeter road

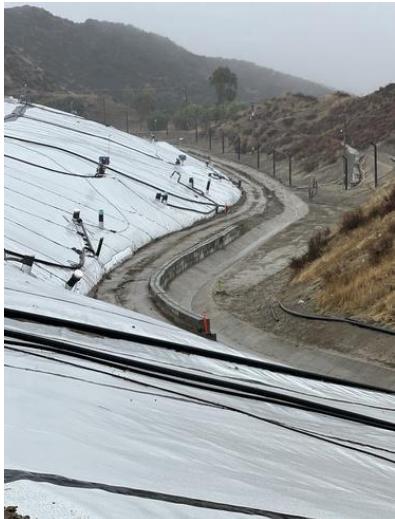
Photo 1

West side perimeter road

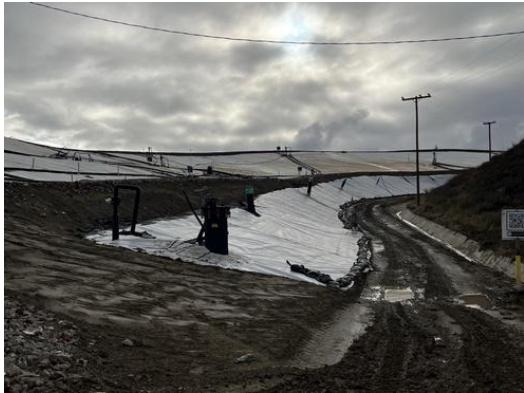
Photo 1

North side perimeter road

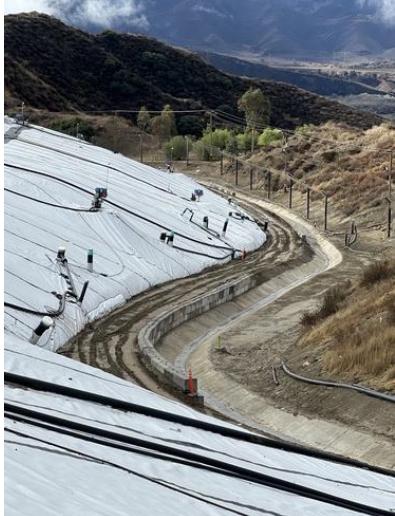
Photo 1

West side perimeter road

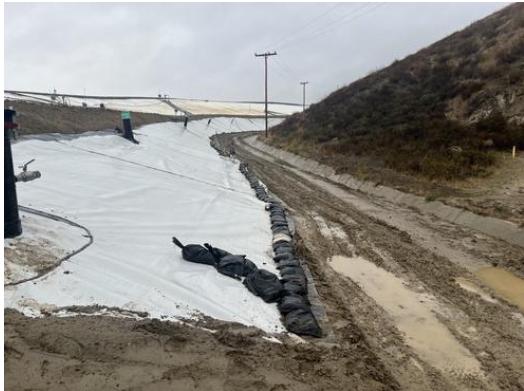
Photo 1

North side perimeter road

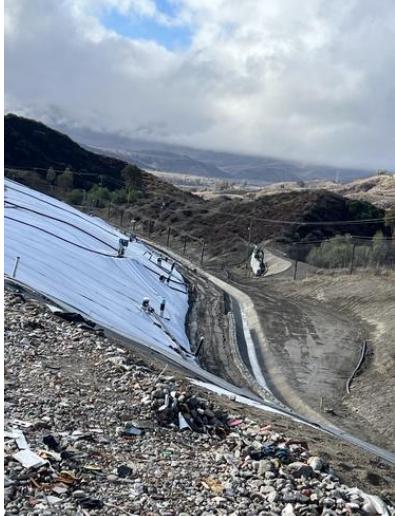
Photo 1

West side perimeter road

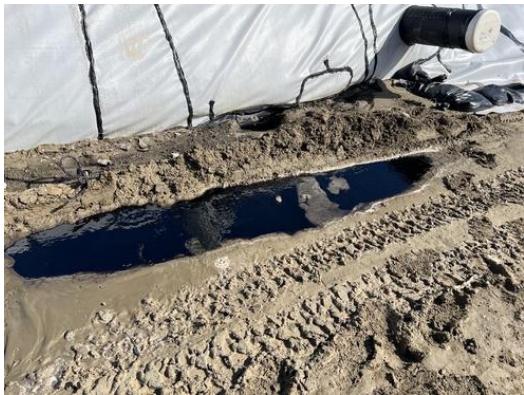
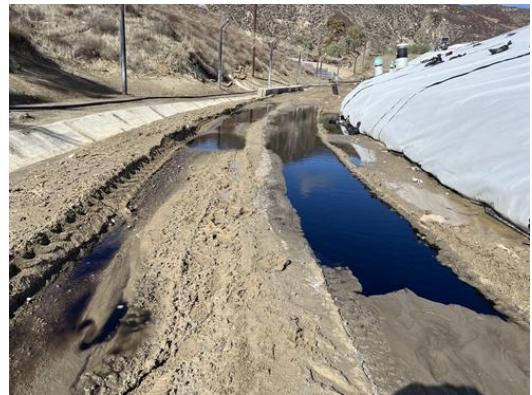
207

3 hours

51-80 gallons

500 sq ft

### 3 - Moderate Odor

### Standing free liquid

Standing liquid vacuumed. Seam was temporarily sealed. Permanent repair was completed on 2/10/25

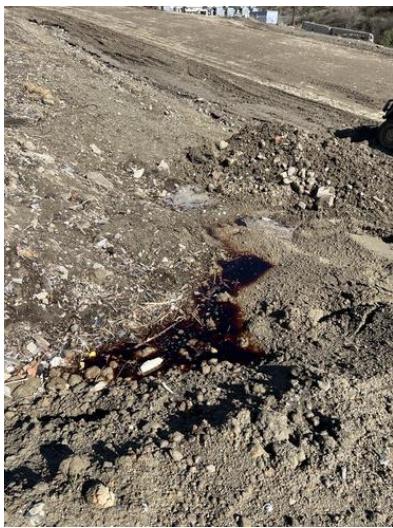
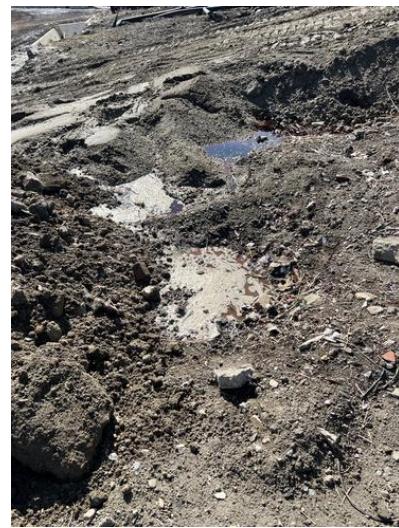
52

21-50 gallons

100sq ft

### 1 - Very Light Odor Detected

### Standing free liquid

Fresh dirt added and compacted to seal seep.

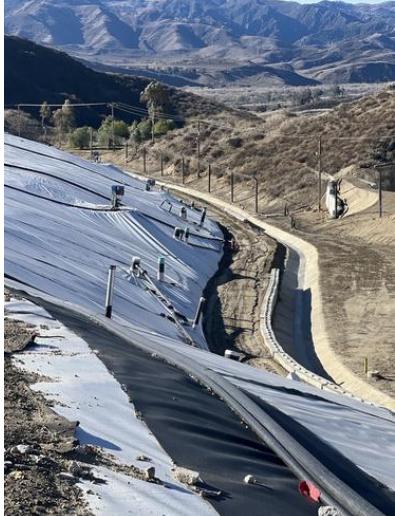
Photo 1

West side perimeter road. Seeps from previous day were not observed at this time

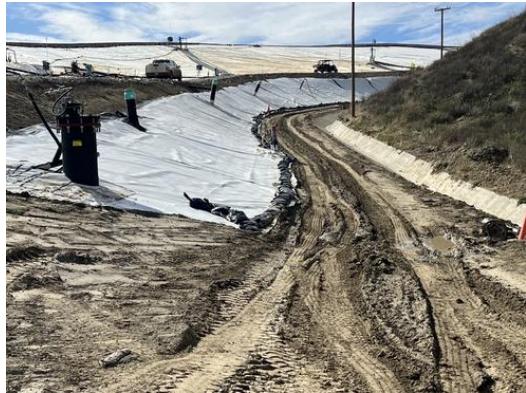
Photo 1

North side perimeter road

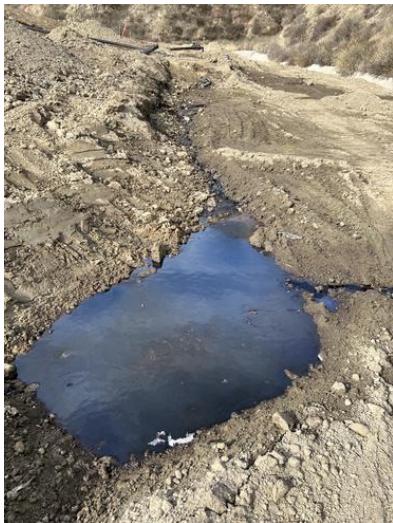
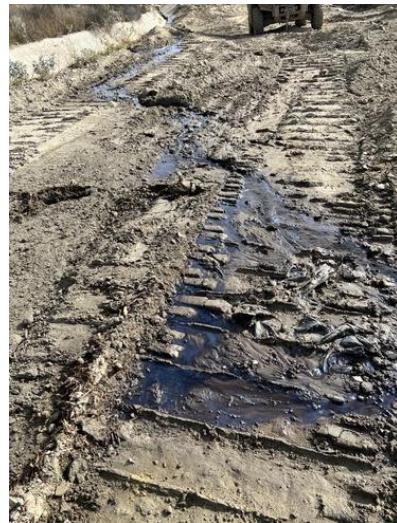
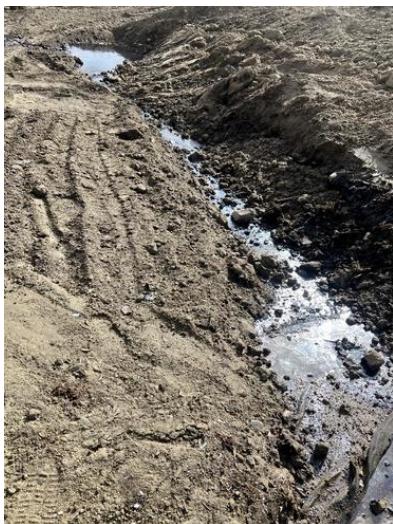
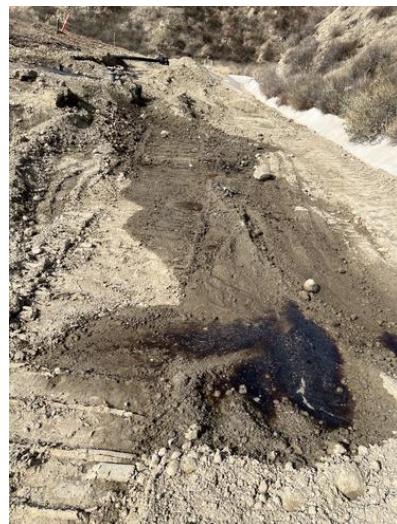
78

6 hours

21-50 gallons

120 sq ft

1 - Very Light Odor Detected

Standing free liquid

Clean dirt was added and a berm was created to contain seep also a check dam was constructed across the channel to stop it from going to the basin. Water channel was pressure washed on 2/11/25.

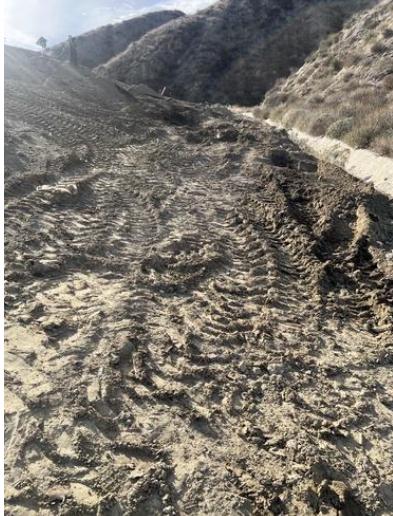
Photo 1

North side perimeter road. Seep from the morning was not observed at this time
