CHIQUITA CANYON
A Waste Connections Company

Re: Chiquita Canyon, LLC's Weekly Report on the Documentation and Tracking of Cover Issues

Attachment: February 3, 2025 Weekly Cover Issues Report

**JANUARY 2025 FISSURE AND TENSION CRACK MONITORING SUMMARY
CHIQUITA CANYON LANDFILL
CASTAIC, CALIFORNIA**

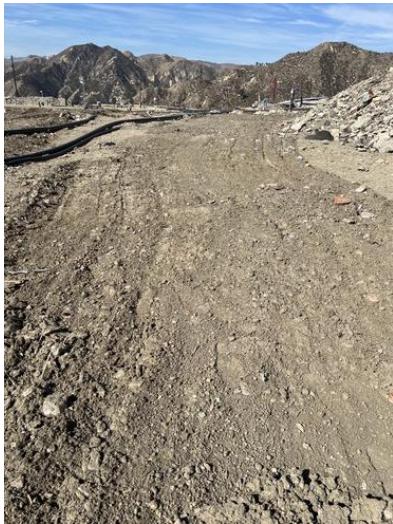
Grid 159

No

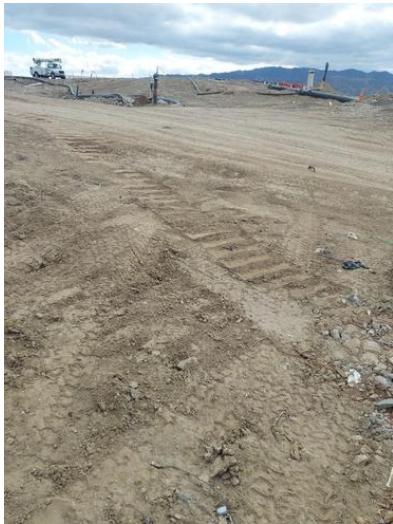
Grid 147

No

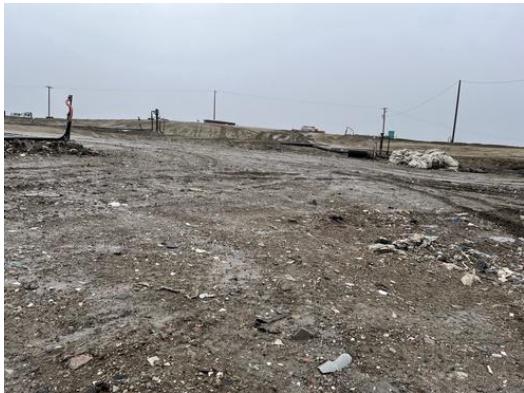
Grid 167

No

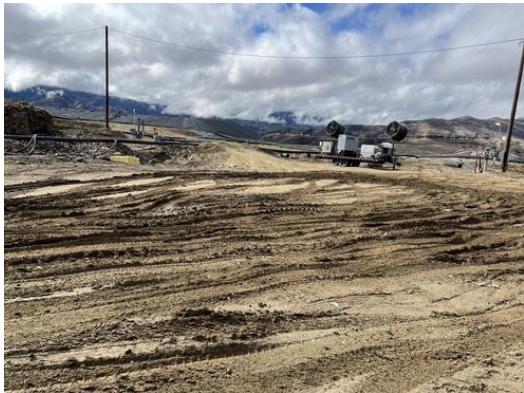
Grid 170

No

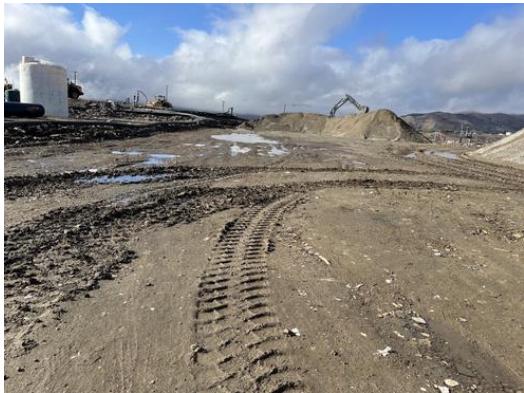
Grid 153

No

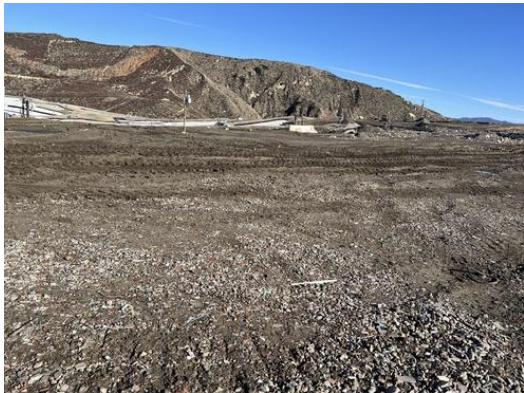
Grid 159

No

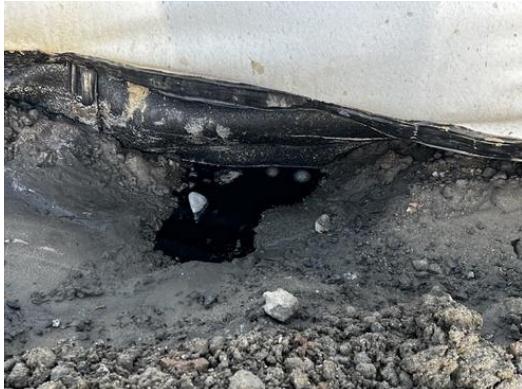
Photo 1

Near the west side perimeter road, the seam between the 30mm and 60mm liners separated and needed to be re-sealed together.

Seam was temporarily sealed. Permanent repairs were conducted when weather conditions improved from the recent rain. Liners were sealed together on 2/10/25.

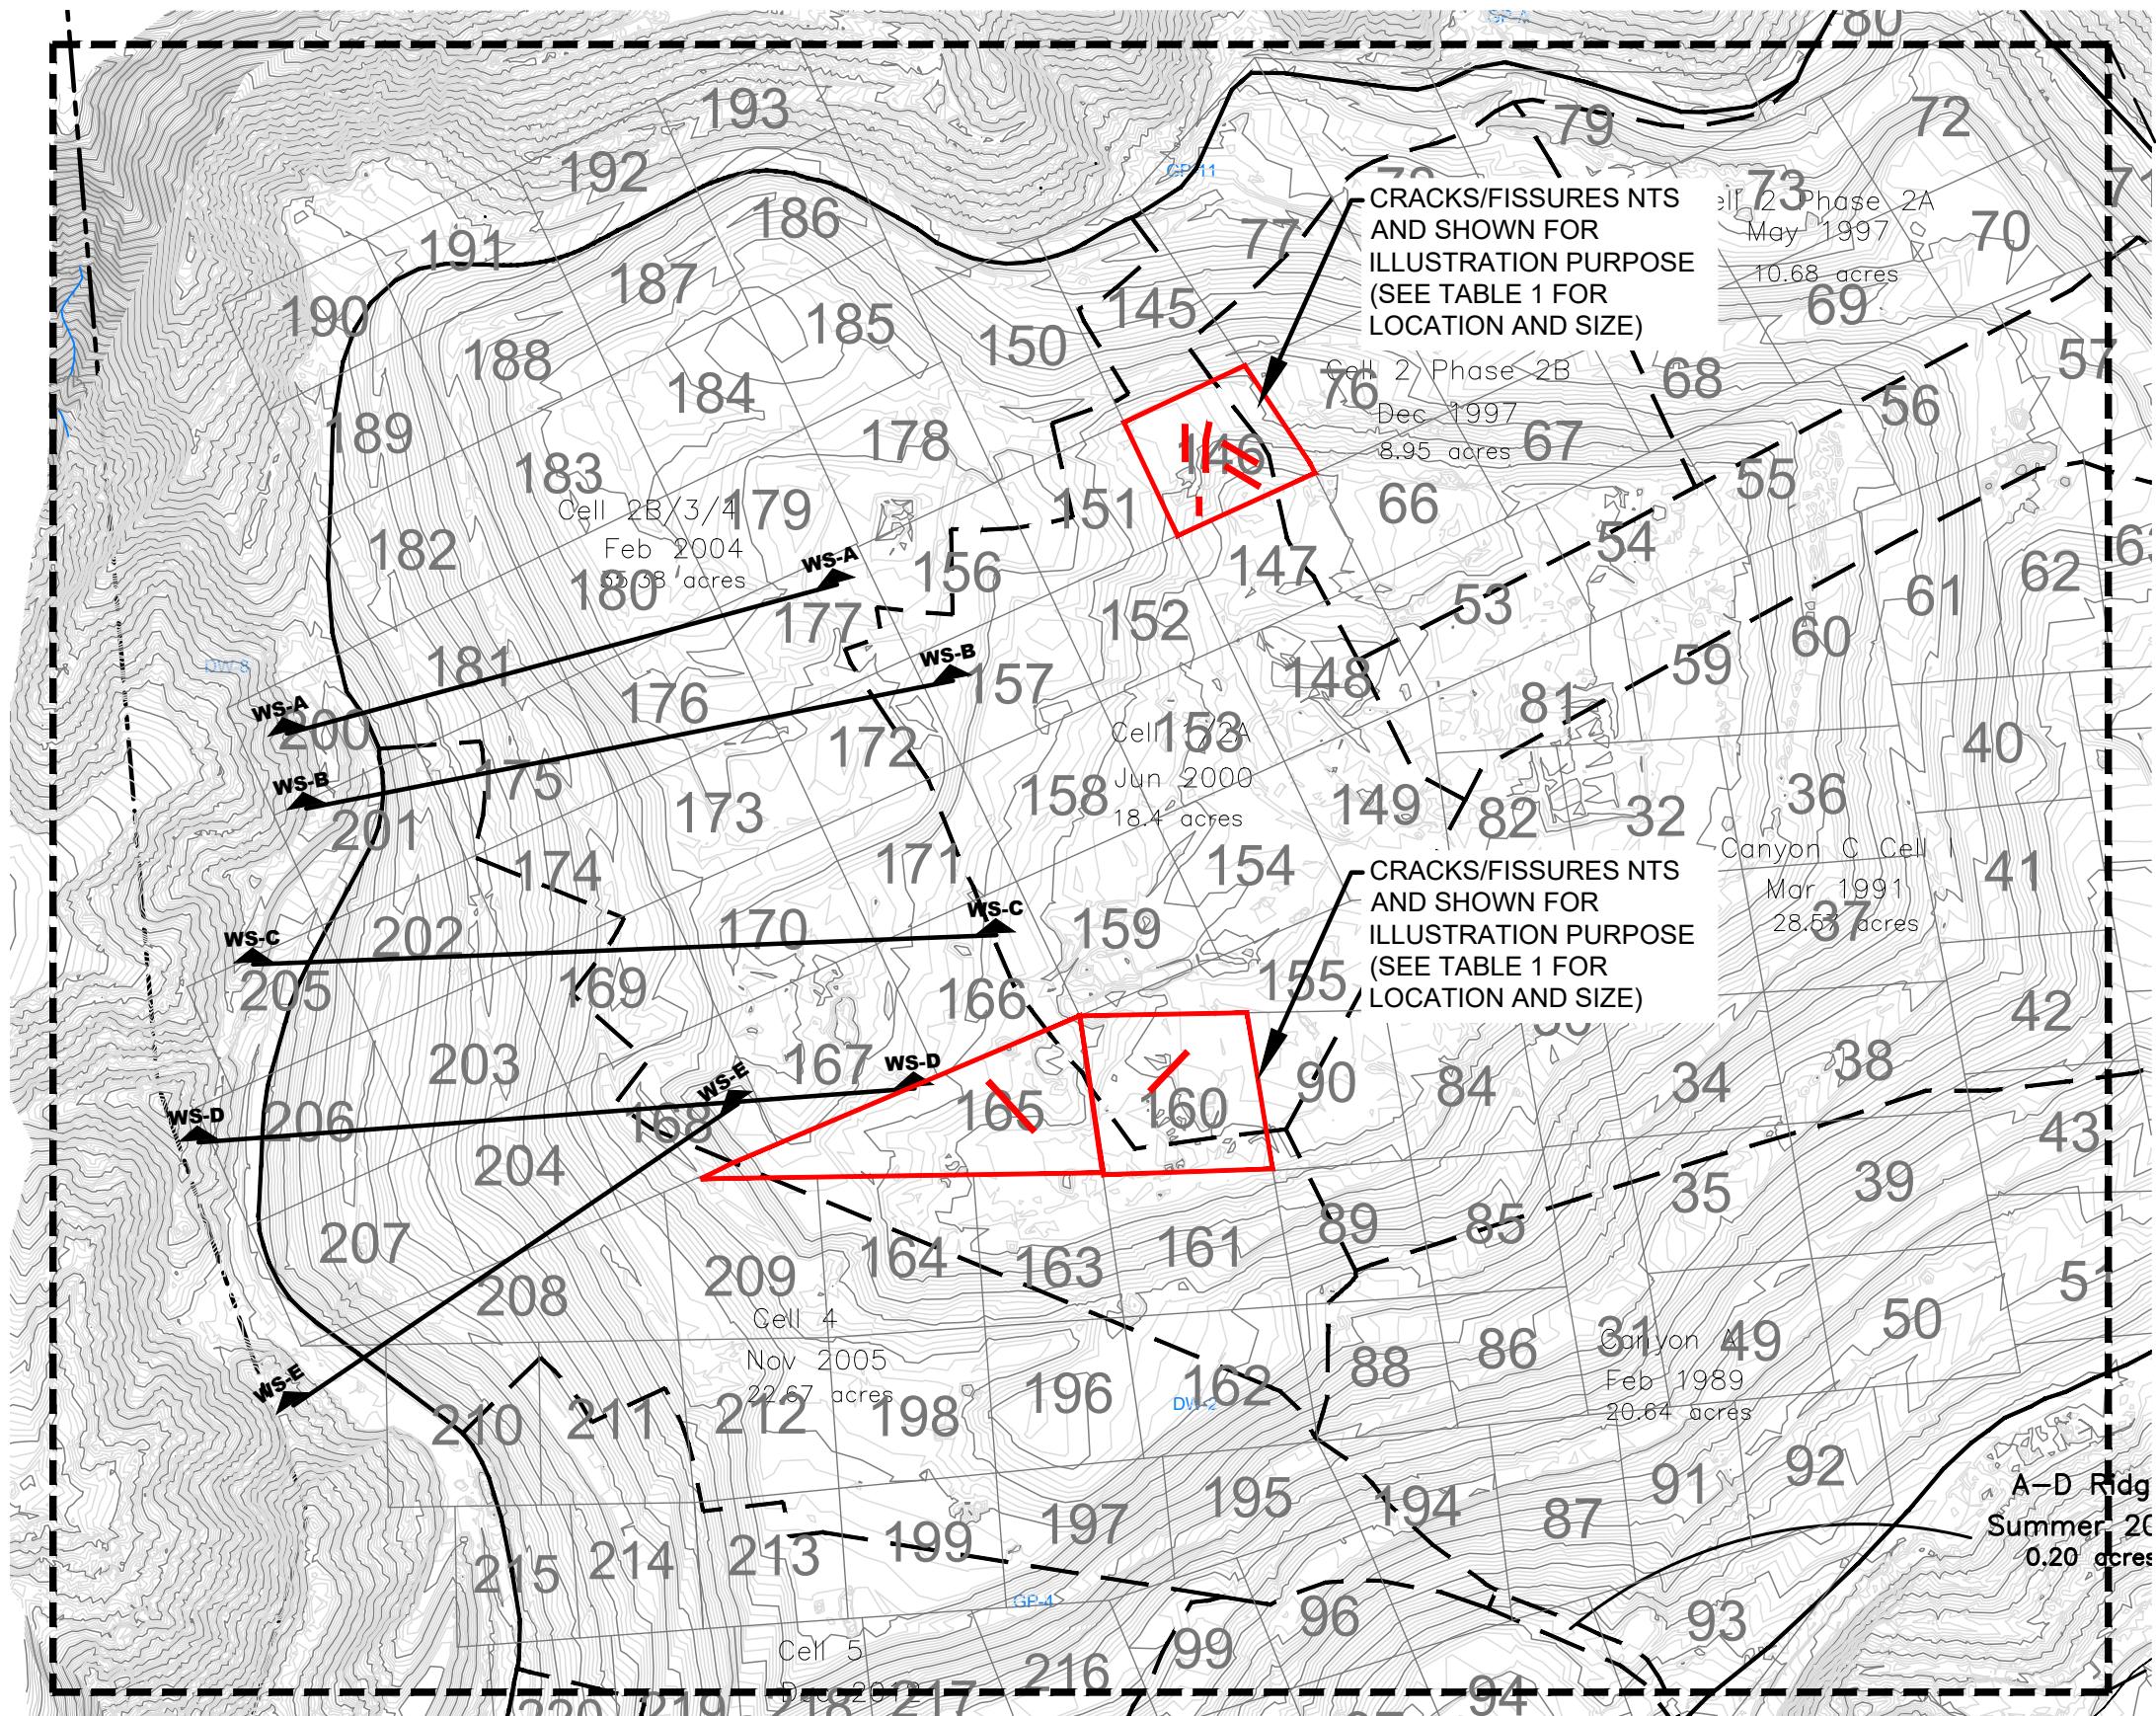
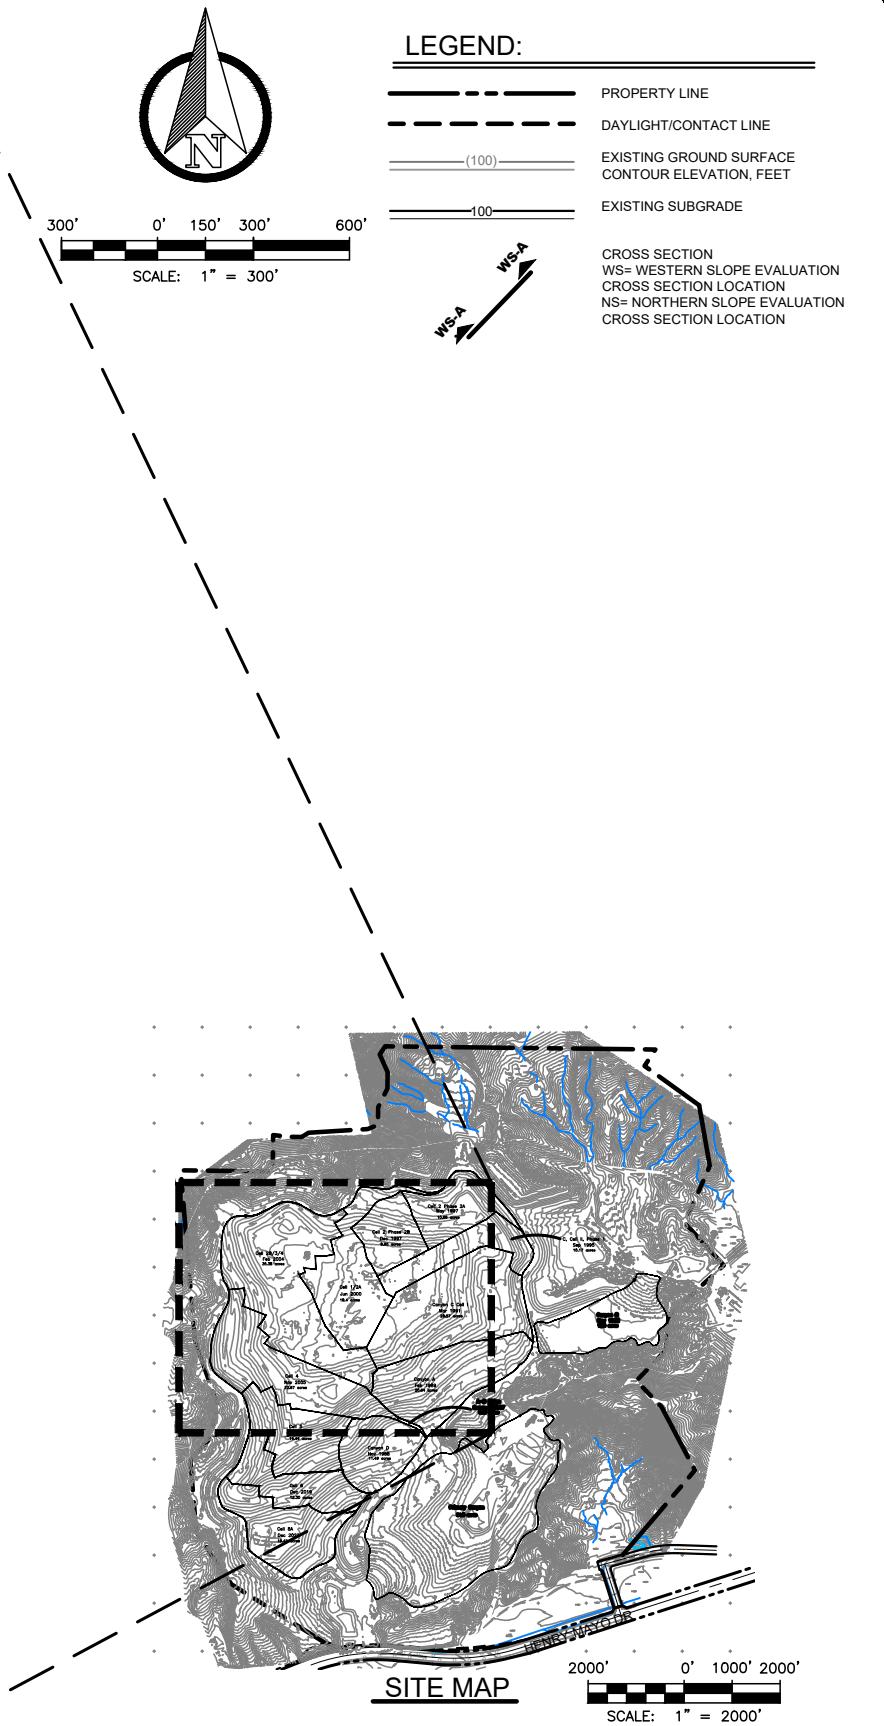
FIG NO.
01
PROJECT NO.
RM22.1077

All the cracks were repaired by placing soil and track-walking over the crack. The locations of the grids and the relative orientations of the cracks identified above are shown in Figure 1. The grid locations of these cracks on the top deck of the landfill and the orientations of the cracks indicate they were likely associated with settlement and not with slope instability.

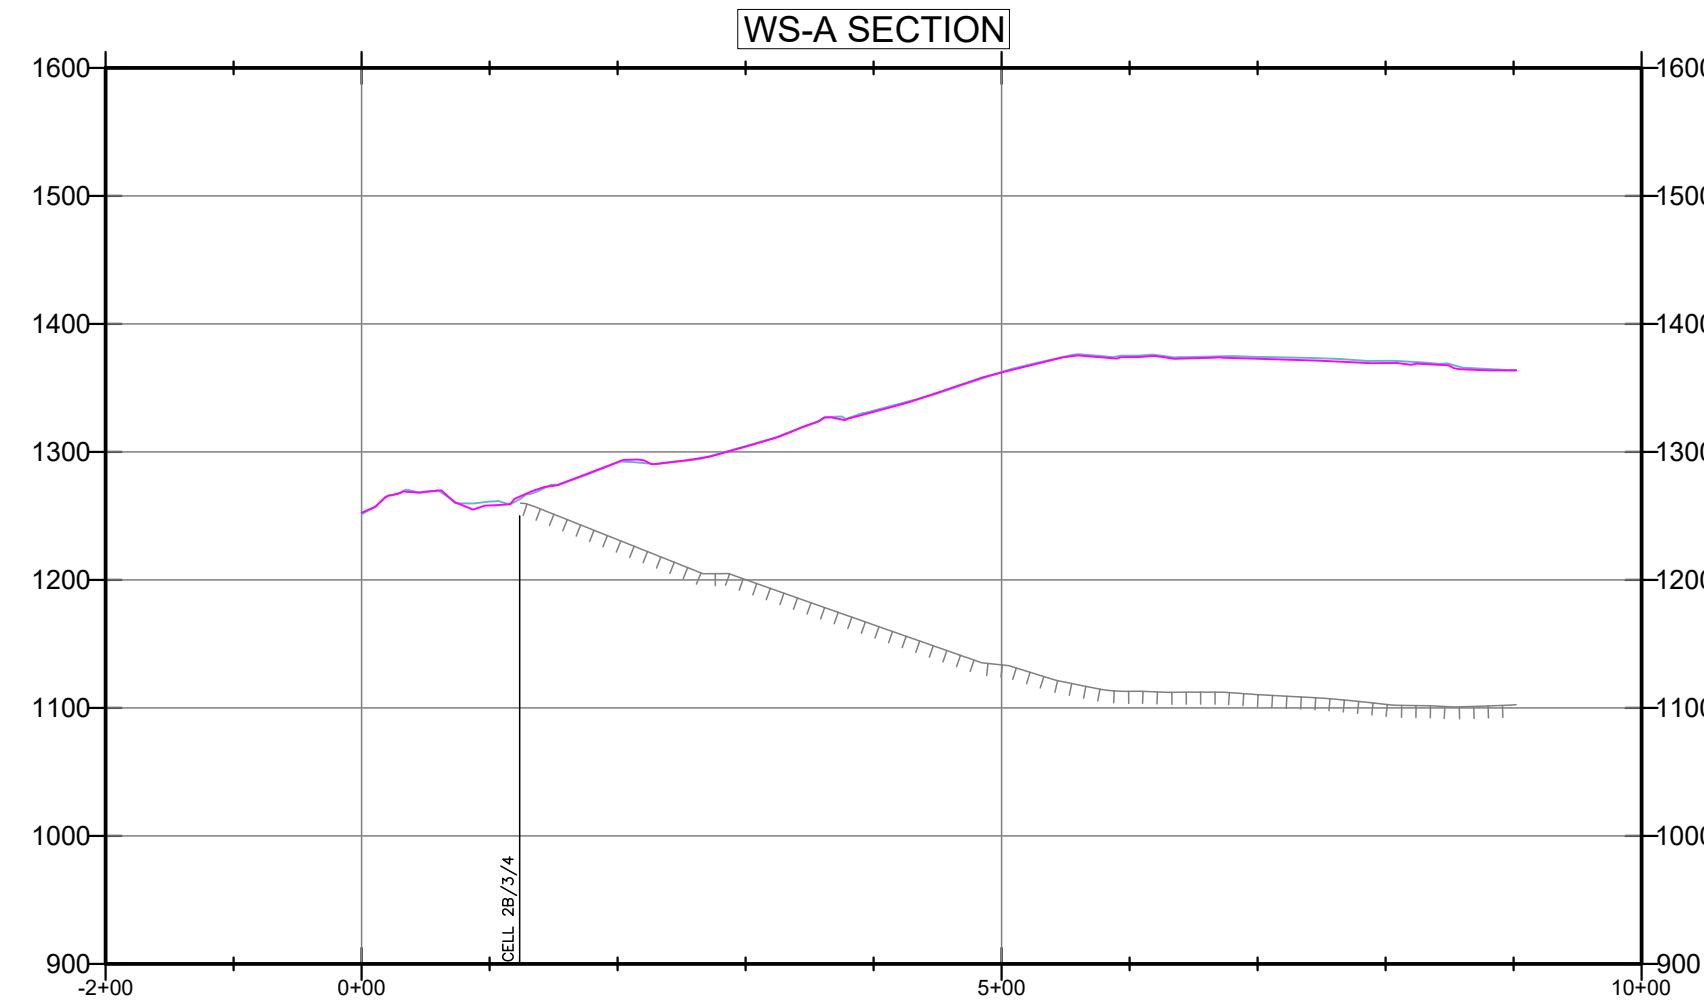
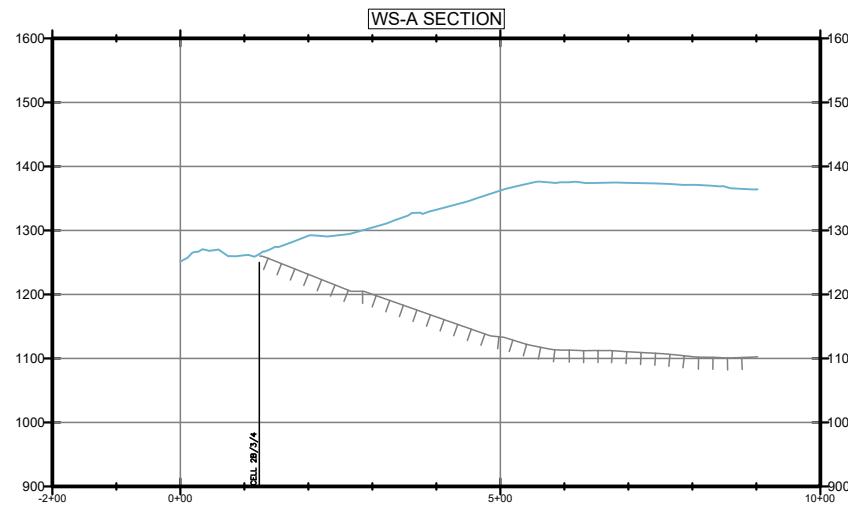
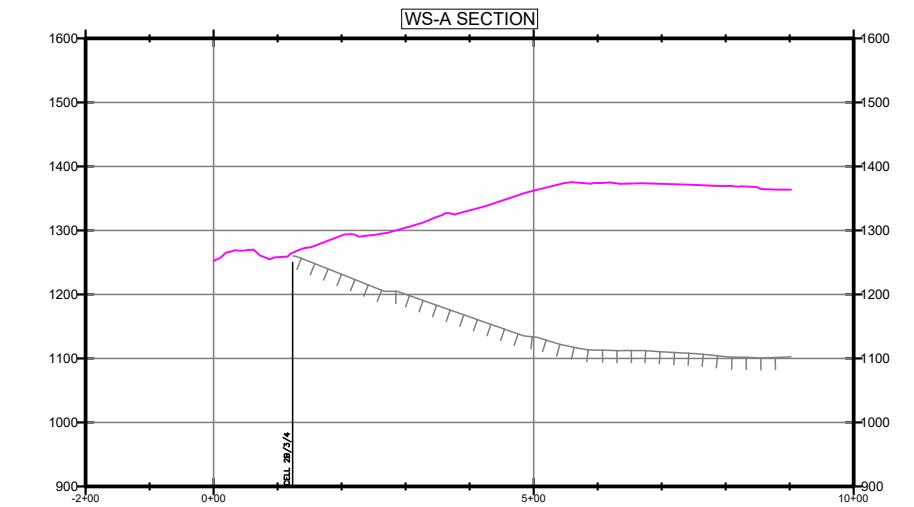
FIGURE 2A

Cross sections that compare December 26, 2024 and January 29, 2025 topography are shown in Figures 2A through 2E. The locations of the cross sections are shown in Figure 1. The sections show no significant differences in slope between the December 2024 and January 2025 profiles, and no evidence of deformation indicative of instability, which is
