Re: Chiquita Canyon, LLC's Weekly Leachate Inspection Report for Stipulated Order for Abatement (Case No. 6177-4), Condition 27(c)

Attachment: Leachate Inspection Logs from February 10 – February 16, 2025

4050 - Chiquita Leachate Seep/Pooling Inspection

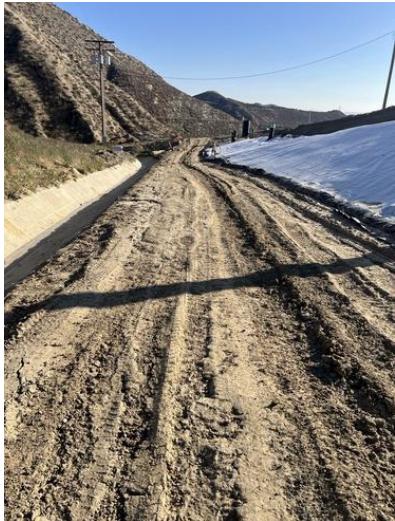
Photo 1

No

North side perimeter road

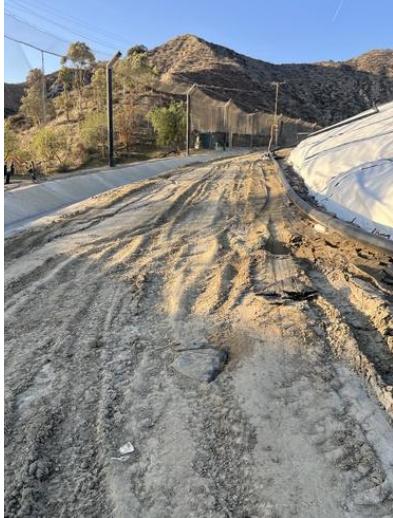
Photo 1

No

West side perimeter road

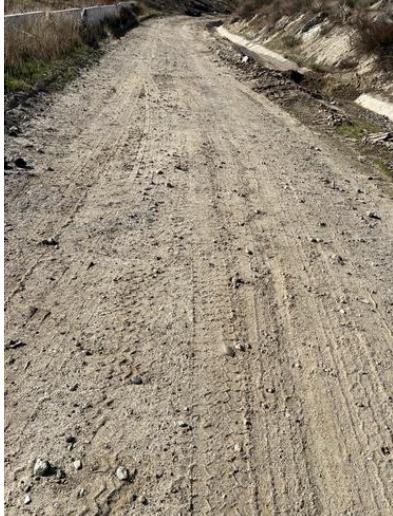
Photo 1

No

North side perimeter road

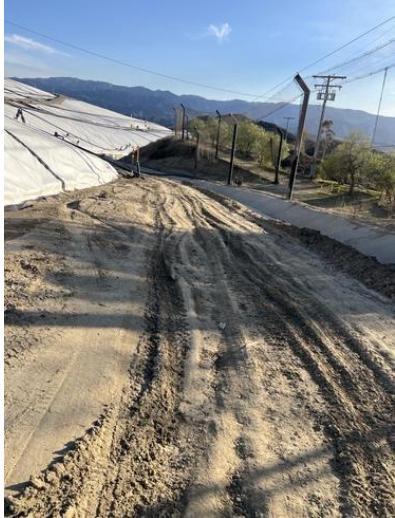
Photo 1

No

West side perimeter road

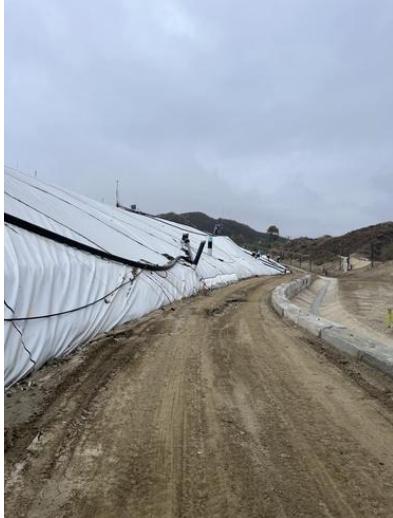
Photo 1

No

West side perimeter road

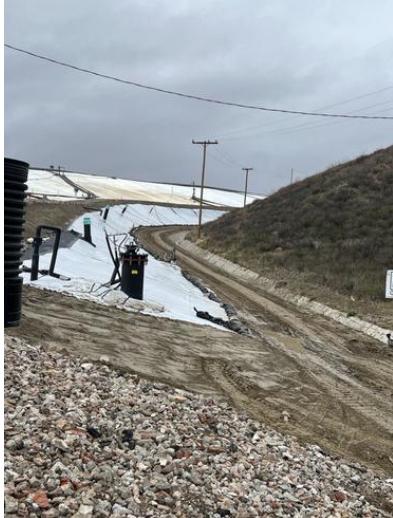
Photo 1

No

North side perimeter road

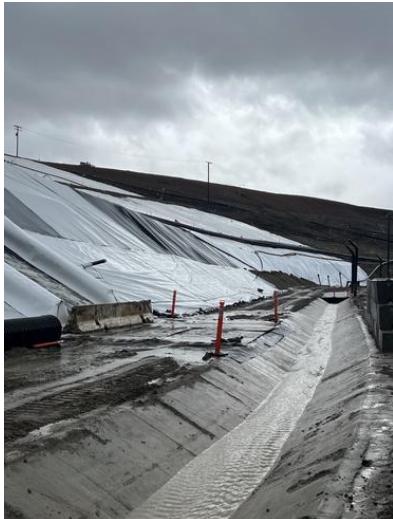
Photo 1

No

West side perimeter road

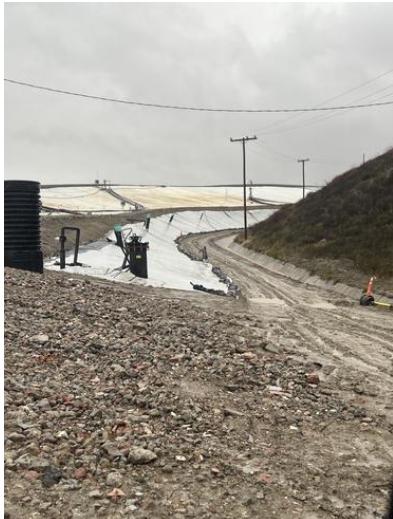
Photo 1

No

North side perimeter road

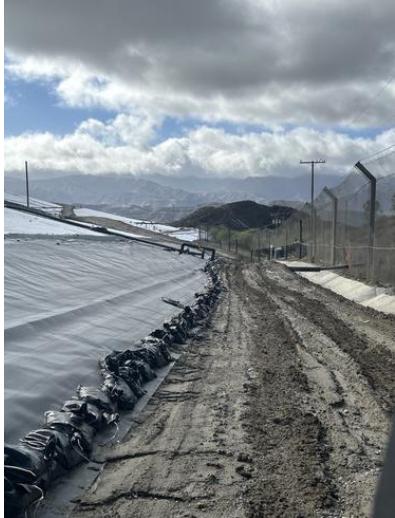
Photo 1

No

West side perimeter road

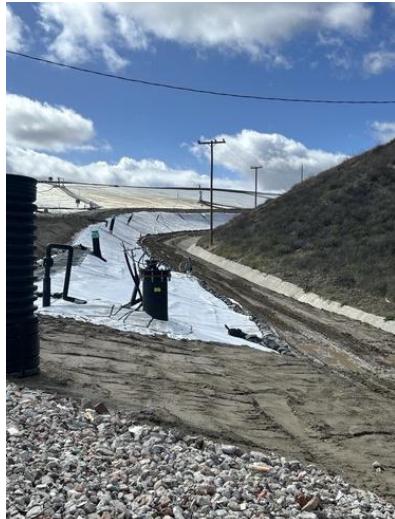
Photo 1

No

North side perimeter road

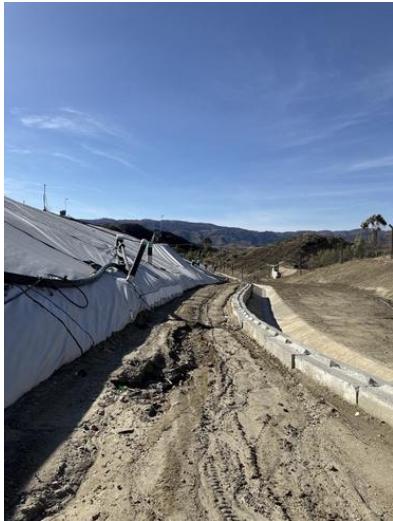
Photo 1

No

West side perimeter road

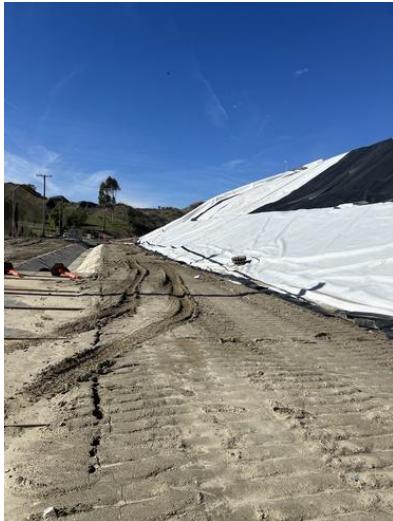
Photo 1

No

West side perimeter road

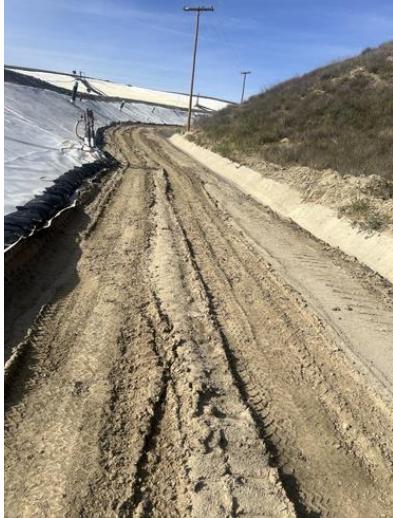
Photo 1

No

North side perimeter road

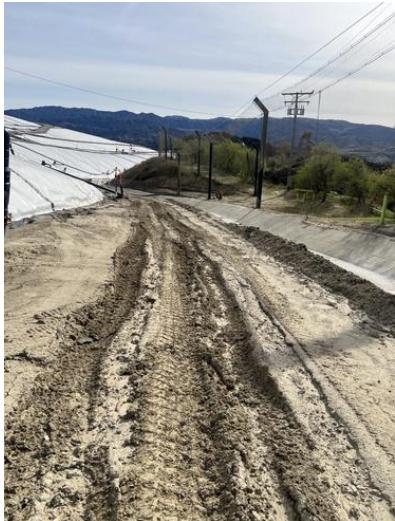
Photo 1

No

West side perimeter road
