# CHIQUITA CANYON

**Re: Chiquita Canyon, LLC's Weekly Report on the Documentation and Tracking of Cover Issues**

Attachment: February 10, 2025 Weekly Cover Issues Report

# 4050 - Chiquita Reaction Area Tracking of Fissures and Tension Cracks

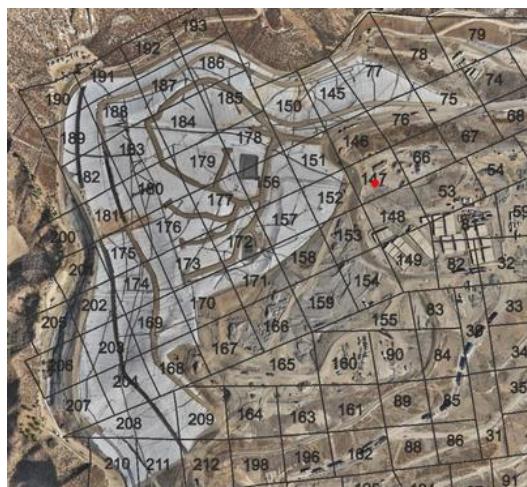
147

**Using the attached image, annotate all areas where inspectors identified a fissure or tension crack.**

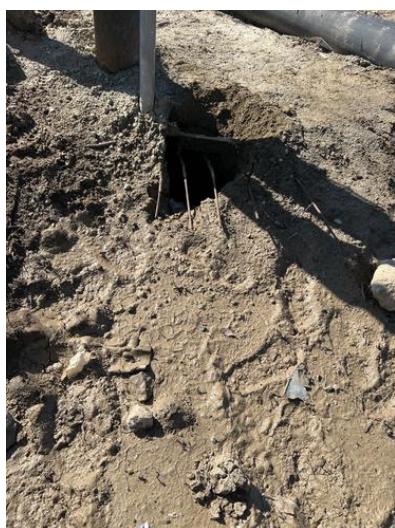
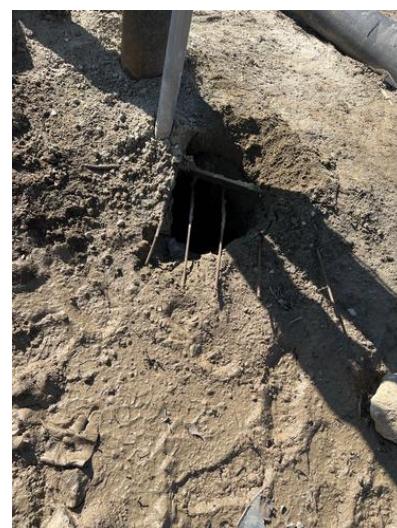
3 ft

Horizontal Offset (width)	Large >4" in width
Vertical Offset (height)	Extra small <0.5" in height
Orientation (direction)	N to S

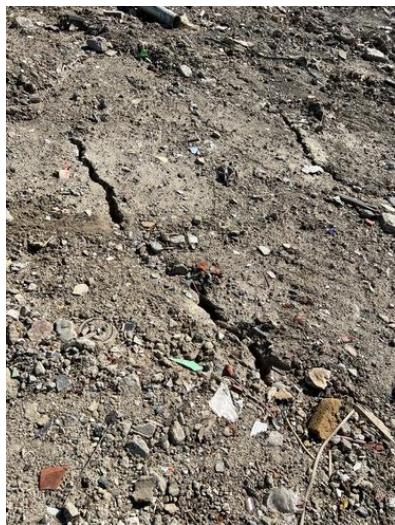
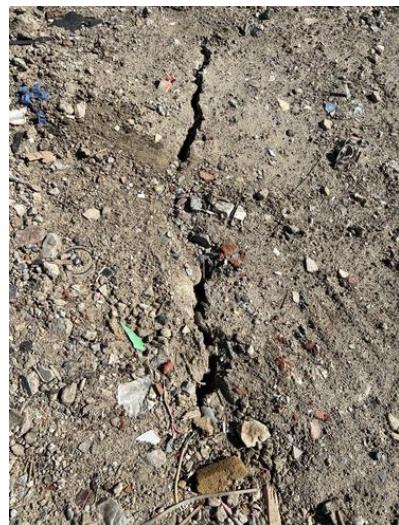
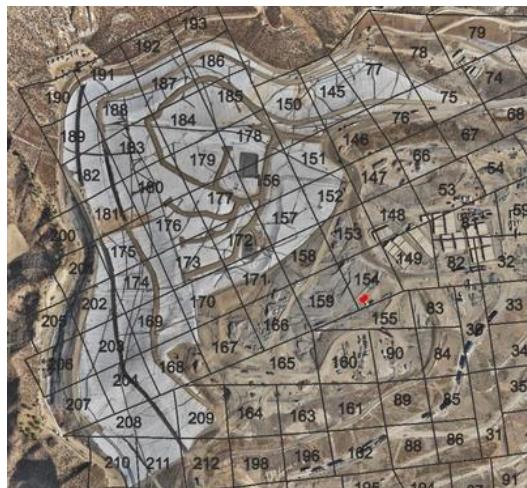
154

10ft x 7ft

Small 0.5-2" in width

Extra small <0.5" in height

NE to SW

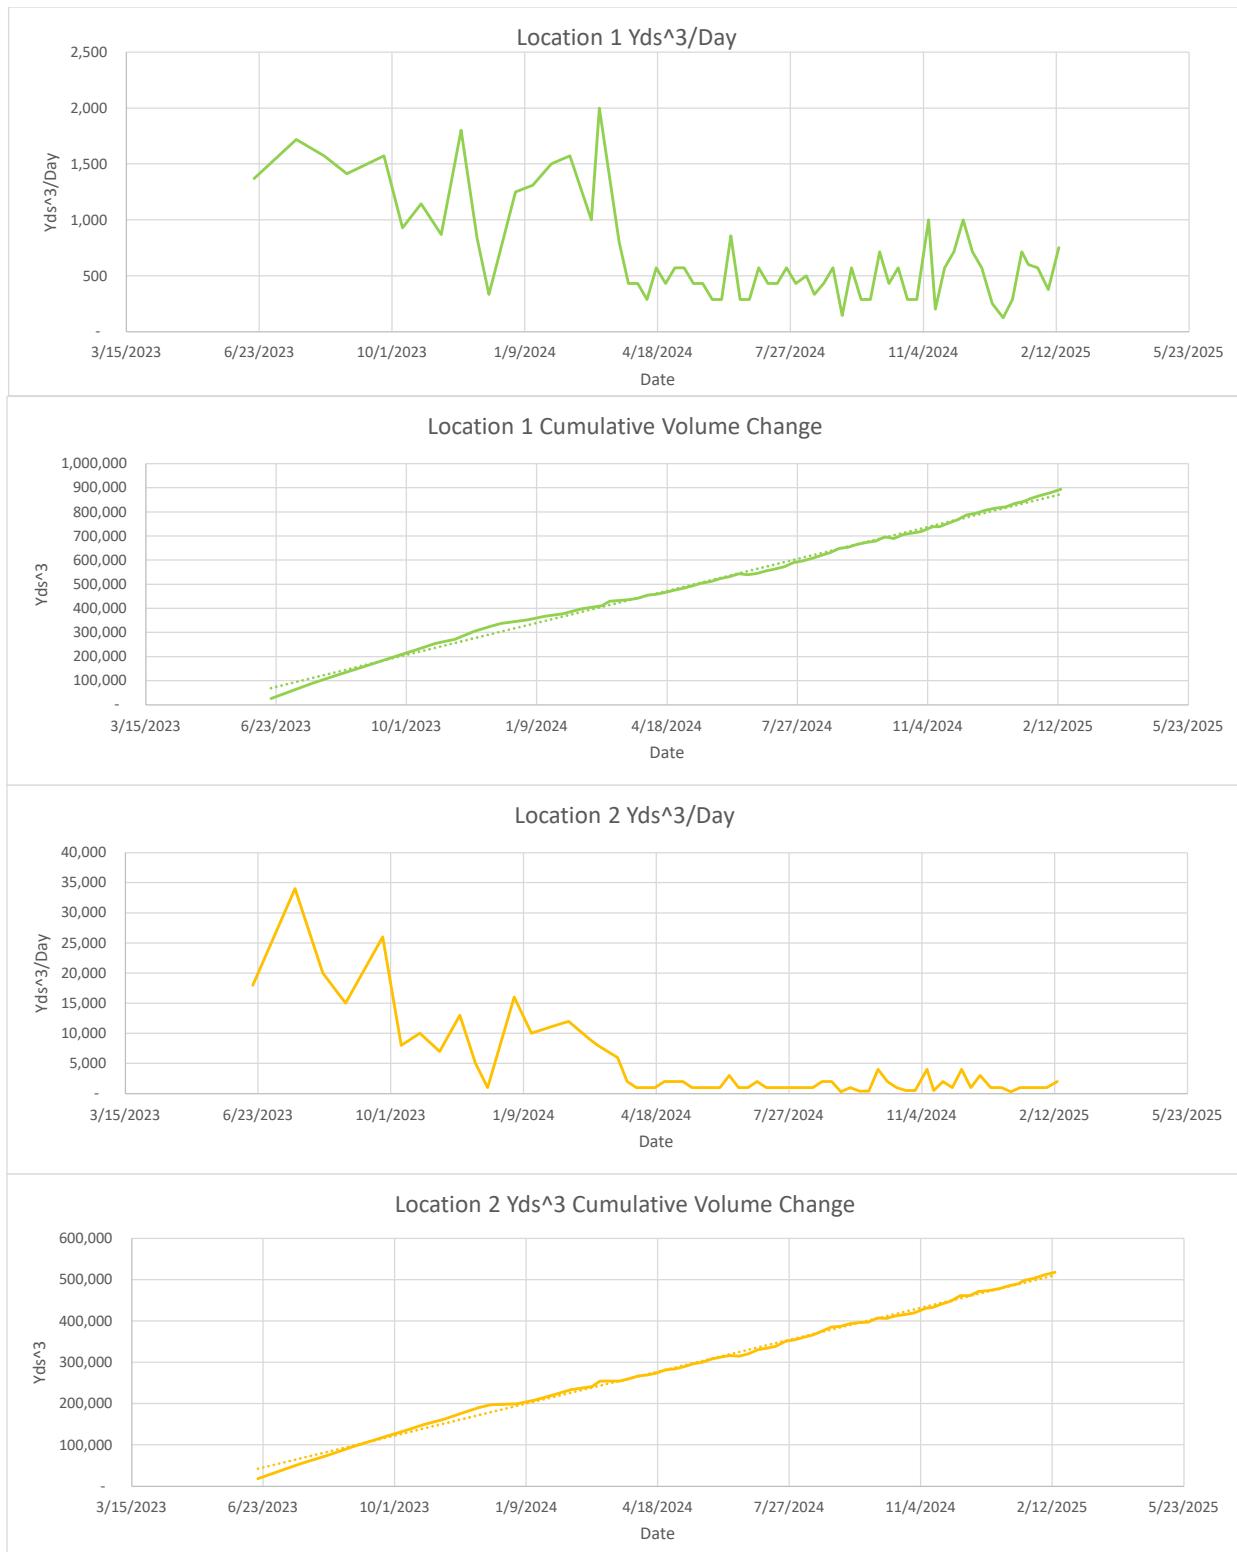
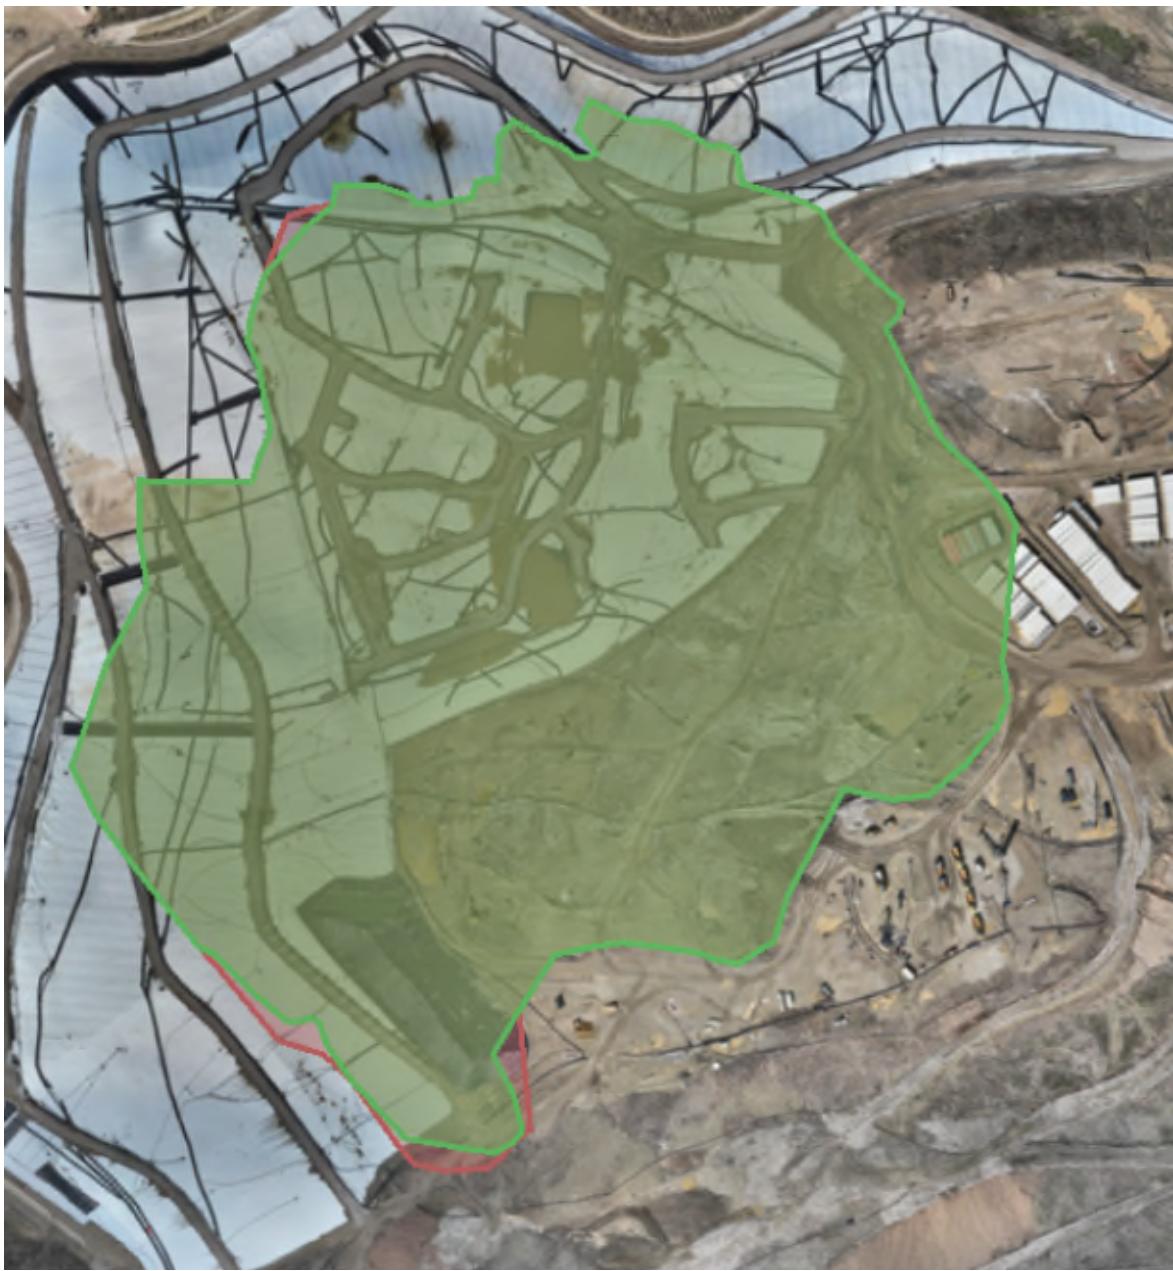
- The charts on the following page show the settlement in cubic yards measured at a fixed location.
- The map shows the settlement area growth between 1/29/25 (in green) and 2/14/25 (in red). These polygons show the areas that have settled more than 5 feet since 5/31/23; however, as the span of time between the start date of 5/31/23 and new survey dates increases, the accuracy of this map as an indicator of settlement attributed to the reaction will diminish.

- Waste fill occurred near the measurement areas in May 2023. Some of the early settlement is likely due to the initial waste settlement of a new fill.

- The major depression in the top deck was excluded because the soil fills used to prevent ponding would skew the settlement trends due to those areas showing up as fill instead of settlement.
