CHIQUITA CANYON
A Waste Connections Company

Re: Chiquita Canyon, LLC's Weekly Report on the Documentation and Tracking of Cover Issues

Attachment: February 17, 2025 Weekly Cover Issues Report
cc: Mark Como, Department of Public Health
Eric Morofuji, Department of Public Health

4050 - Chiquita Reaction Area Tracking of Fissures and Tension Cracks

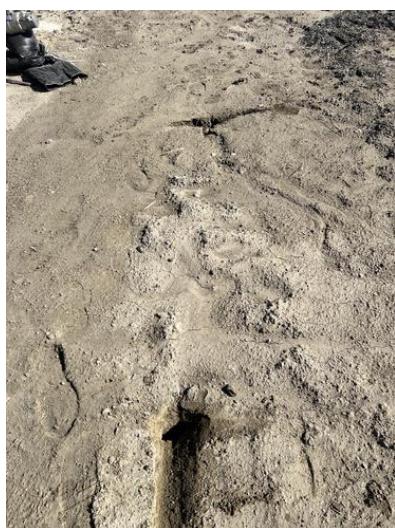
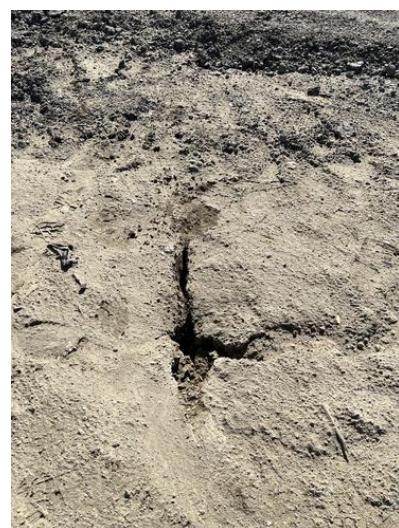
146

7ft x 3 ft

Horizontal Offset (width)	Medium 2-4" in width
Vertical Offset (height)	Extra small <0.5" in height
Orientation (direction)	NW to SE

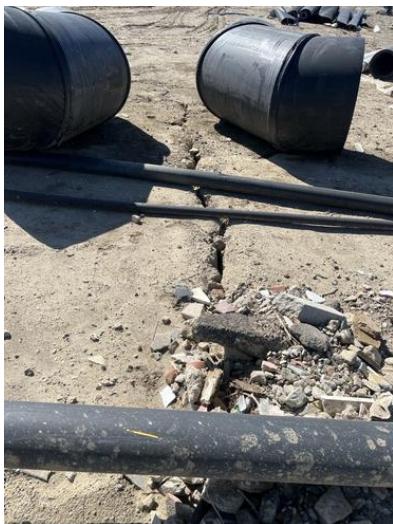
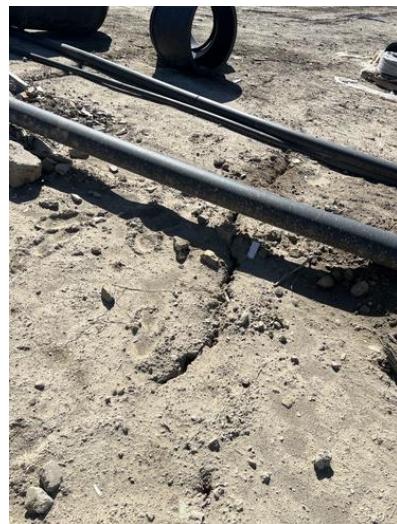
154

15ft x 8 ft

Medium 2-4" in width

Extra small <0.5" in height

N to S

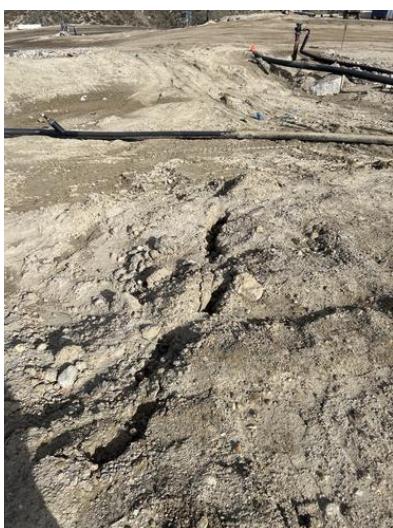
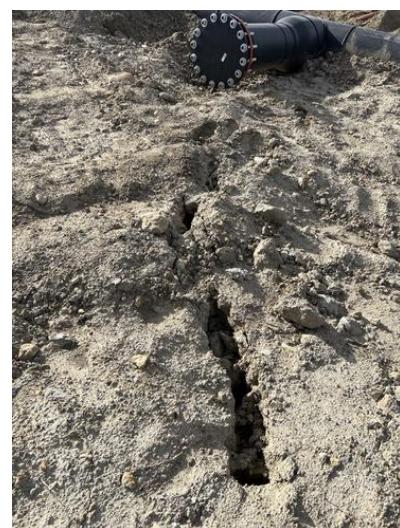
148

7ft

Horizontal Offset (width)	Large >4" in width
Vertical Offset (height)	Extra small <0.5" in height
Orientation (direction)	N to S

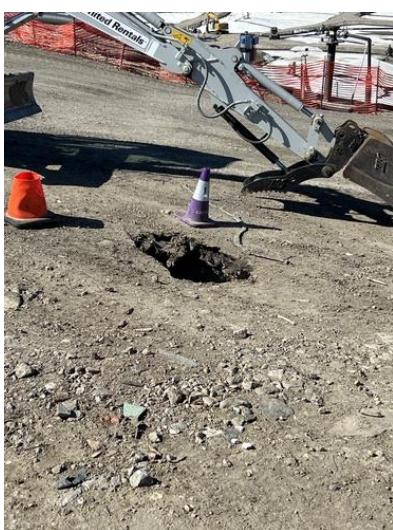
147

2ft

Horizontal Offset (width)	Large >4" in width
Vertical Offset (height)	Extra small <0.5" in height
Orientation (direction)	N to S

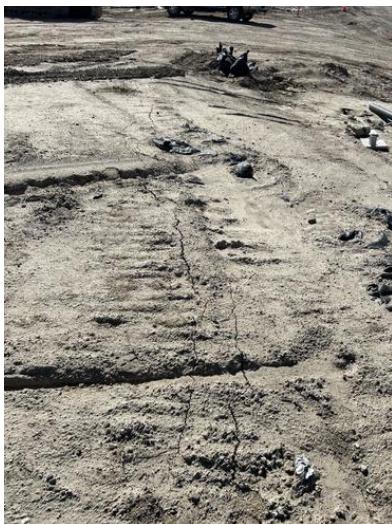
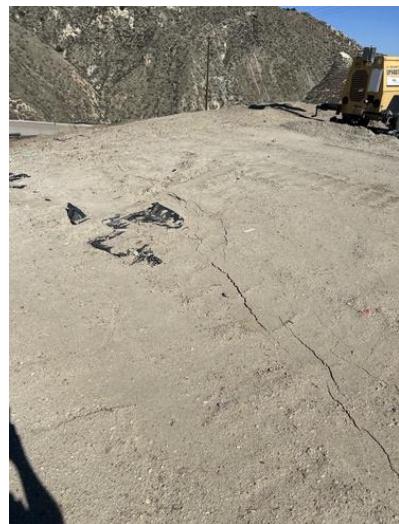
146

15ft

Extra Small <0.5 in width

Extra small <0.5" in height

N to S

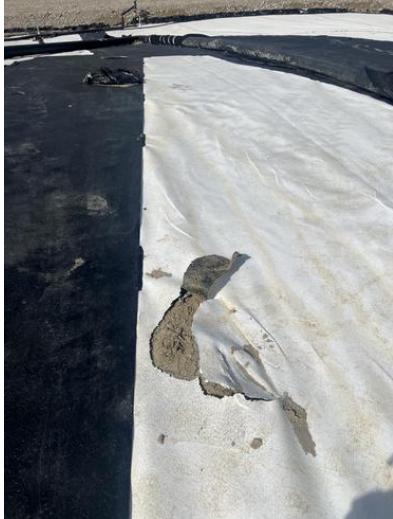
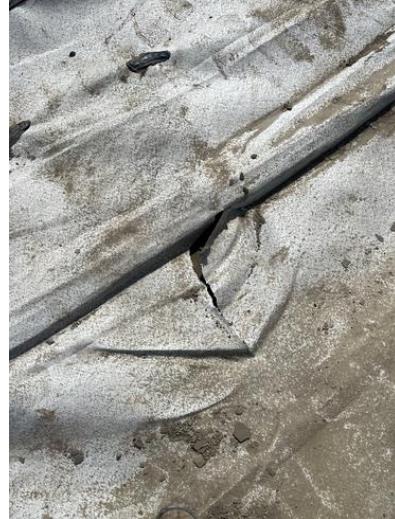
Liner torn in two locations. Tears need to be patched and extrusion welded.

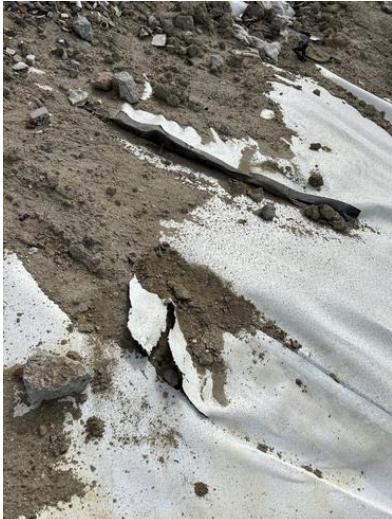
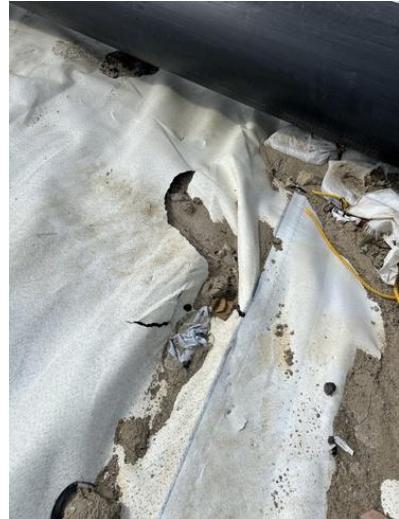
There are five tears in the same general area on the liner. The tears need to be patched and extrusion welded.
