CHIQUITA CANYON
A Waste Connections Company

Re: Chiquita Canyon, LLC's Weekly Report on the Documentation and Tracking of Cover Issues

Attachment: February 24, 2025 Weekly Cover Issues Report

4050 - Chiquita Reaction Area Tracking of Fissures and Tension Cracks

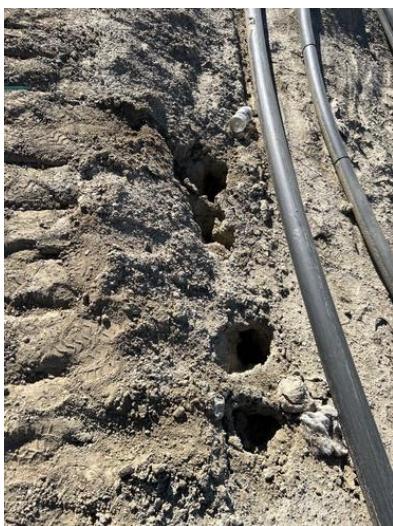
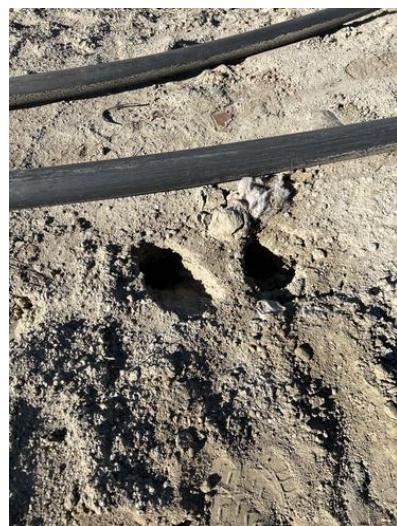
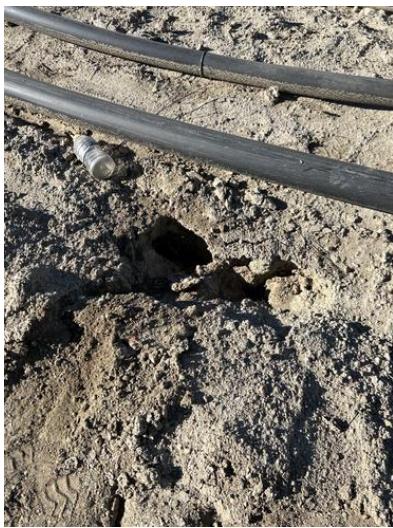
Grid Location

146

Length of crack (ft) or area containing multiple cracks (ft x ft)

1ft x 4ft

Horizontal Offset (width)

Large >4" in width

Vertical Offset (height)

Small 0.5-2" in height

Orientation (direction)

NW to SE

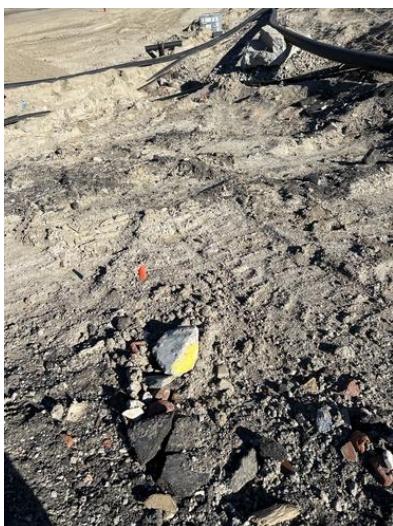
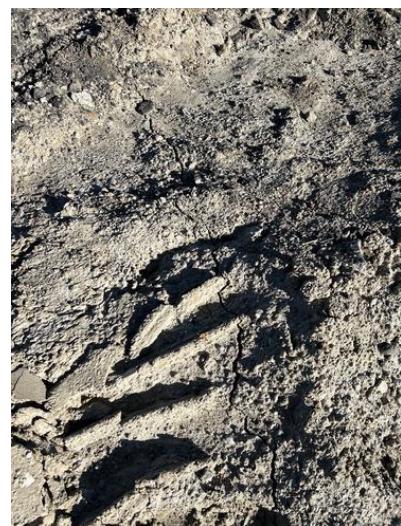
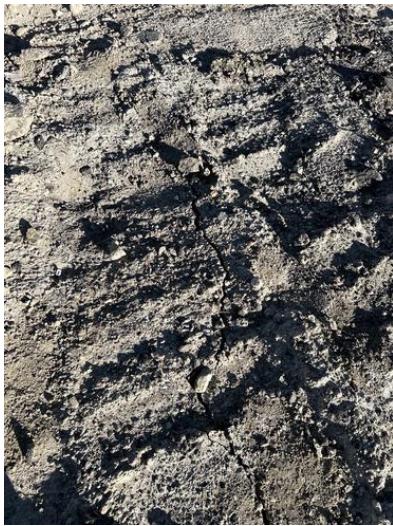
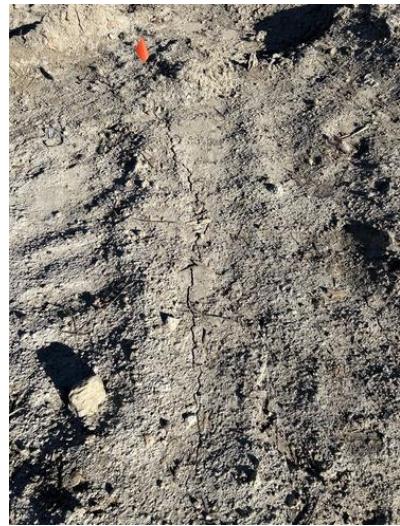
Grid Location

146

Length of crack (ft) or area containing multiple cracks (ft x ft)

20ft x 35ft

Horizontal Offset (width)

Small 0.5-2" in width

Vertical Offset (height)

Extra small <0.5" in height

Orientation (direction)

NW to SE

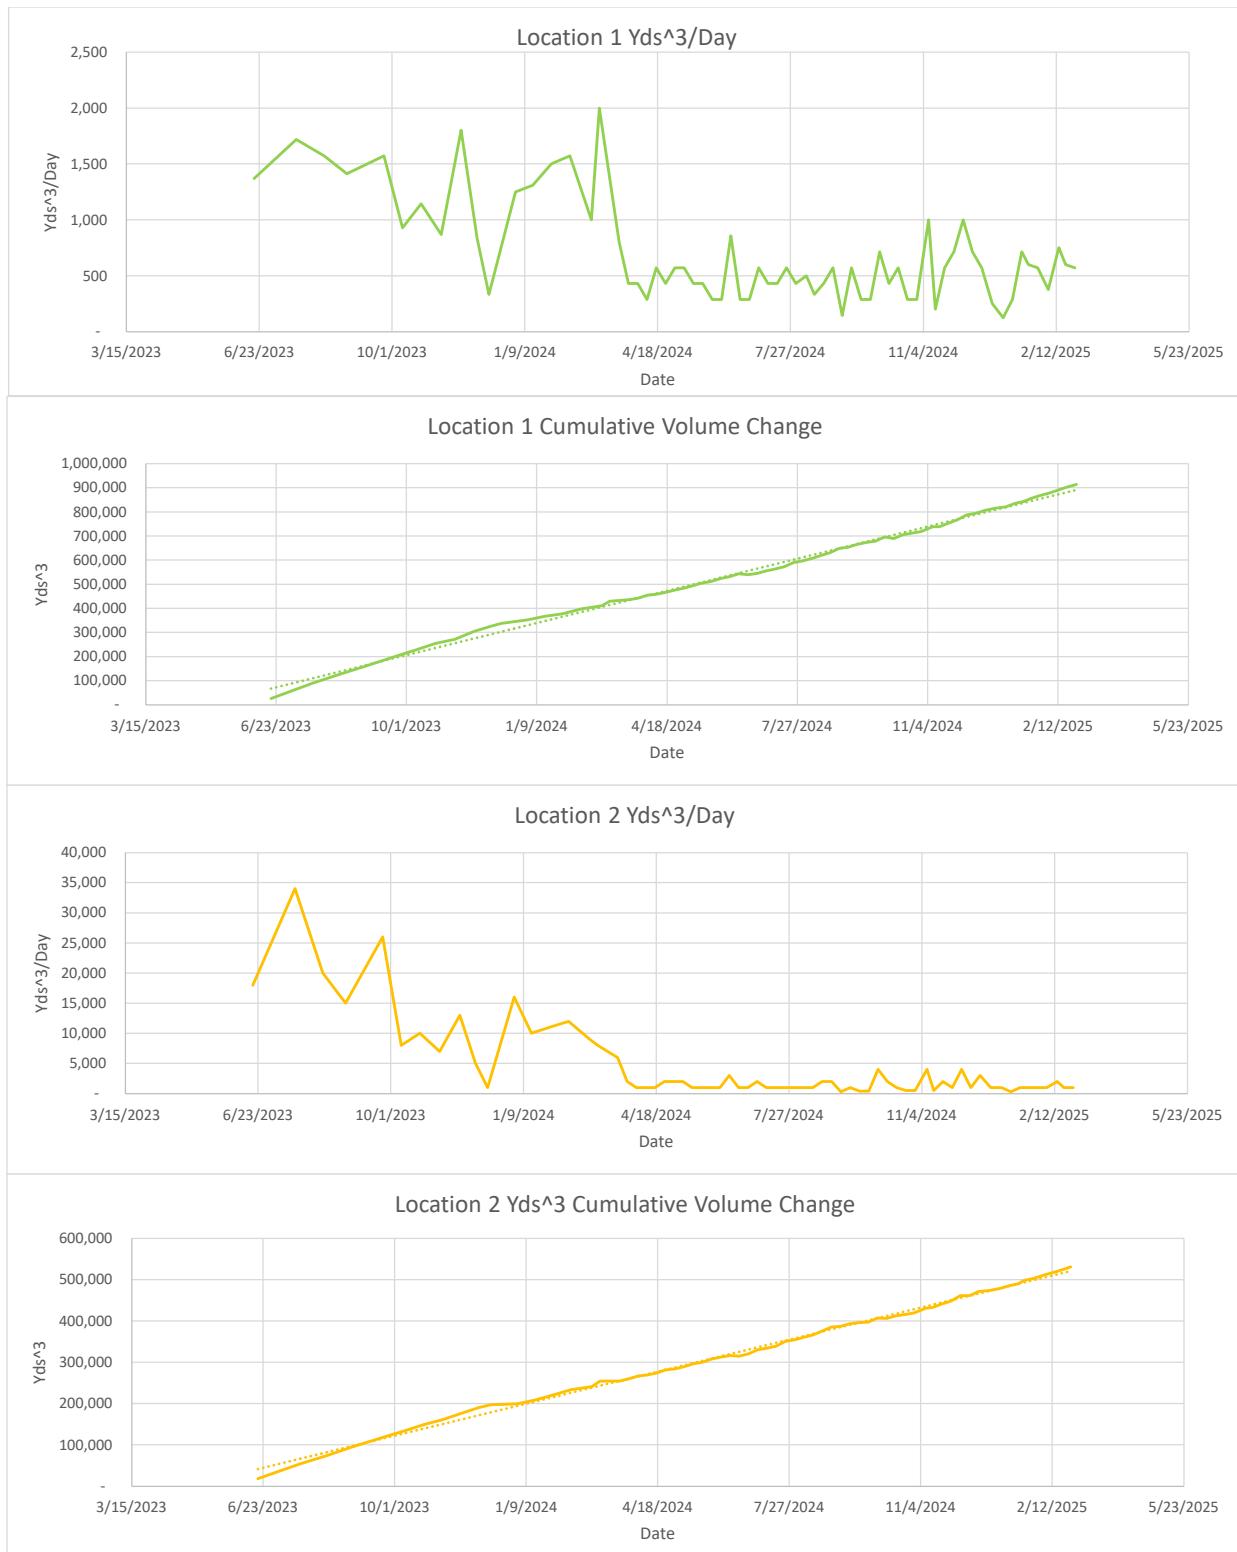
- The charts on the following page show the settlement in cubic yards measured at a fixed location.
- The map shows the settlement area growth between 2/14/25 (in green) and 2/26/25 (in red). These polygons show the areas that have settled more than 5 feet since 5/31/23; however, as the span of time between the start date of 5/31/23 and new survey dates increases, the accuracy of this map as an indicator of settlement attributed to the reaction will diminish.

- Waste fill occurred near the measurement areas in May 2023. Some of the early settlement is likely due to the initial waste settlement of a new fill.

- The major depression in the top deck was excluded because the soil fills used to prevent ponding would skew the settlement trends due to those areas showing up as fill instead of settlement.

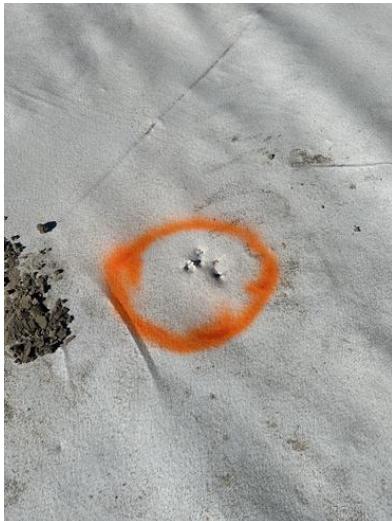
Photo 1

Two small holes side by side in grid 156 that will need to be extrusion welded.
