March 10, 2025

**FEBRUARY 2025 FISSURE AND TENSION CRACK MONITORING SUMMARY
CHIQUITA CANYON LANDFILL
CASTAIC, CALIFORNIA**

This monthly summary report was prepared by Geo-Logic Associates, Inc. (GLA) to summarize the monitoring and tracking of fissures and tension cracks that was performed at the Chiquita Canyon Landfill (Landfill) between February 1 and February 28, 2025. This summary was prepared in accordance with Chiquita Canyon, LLC's (Chiquita) April 16, 2024 Second Revised Written Plan (Second Revised Written Plan) to document and track cover issues and is associated with Milestone 2B of the Local Enforcement Agency's (LEA) June 6, 2024 Compliance Order, formerly referred to as Mitigation Measure #2B. The conclusions in this summary are based on GLA's review and evaluation of Chiquita's daily Reaction Area Tracking of Fissures and Tension Cracks data sheets that document and track cover issues, and on information from Chiquita's drone aerial surveys.

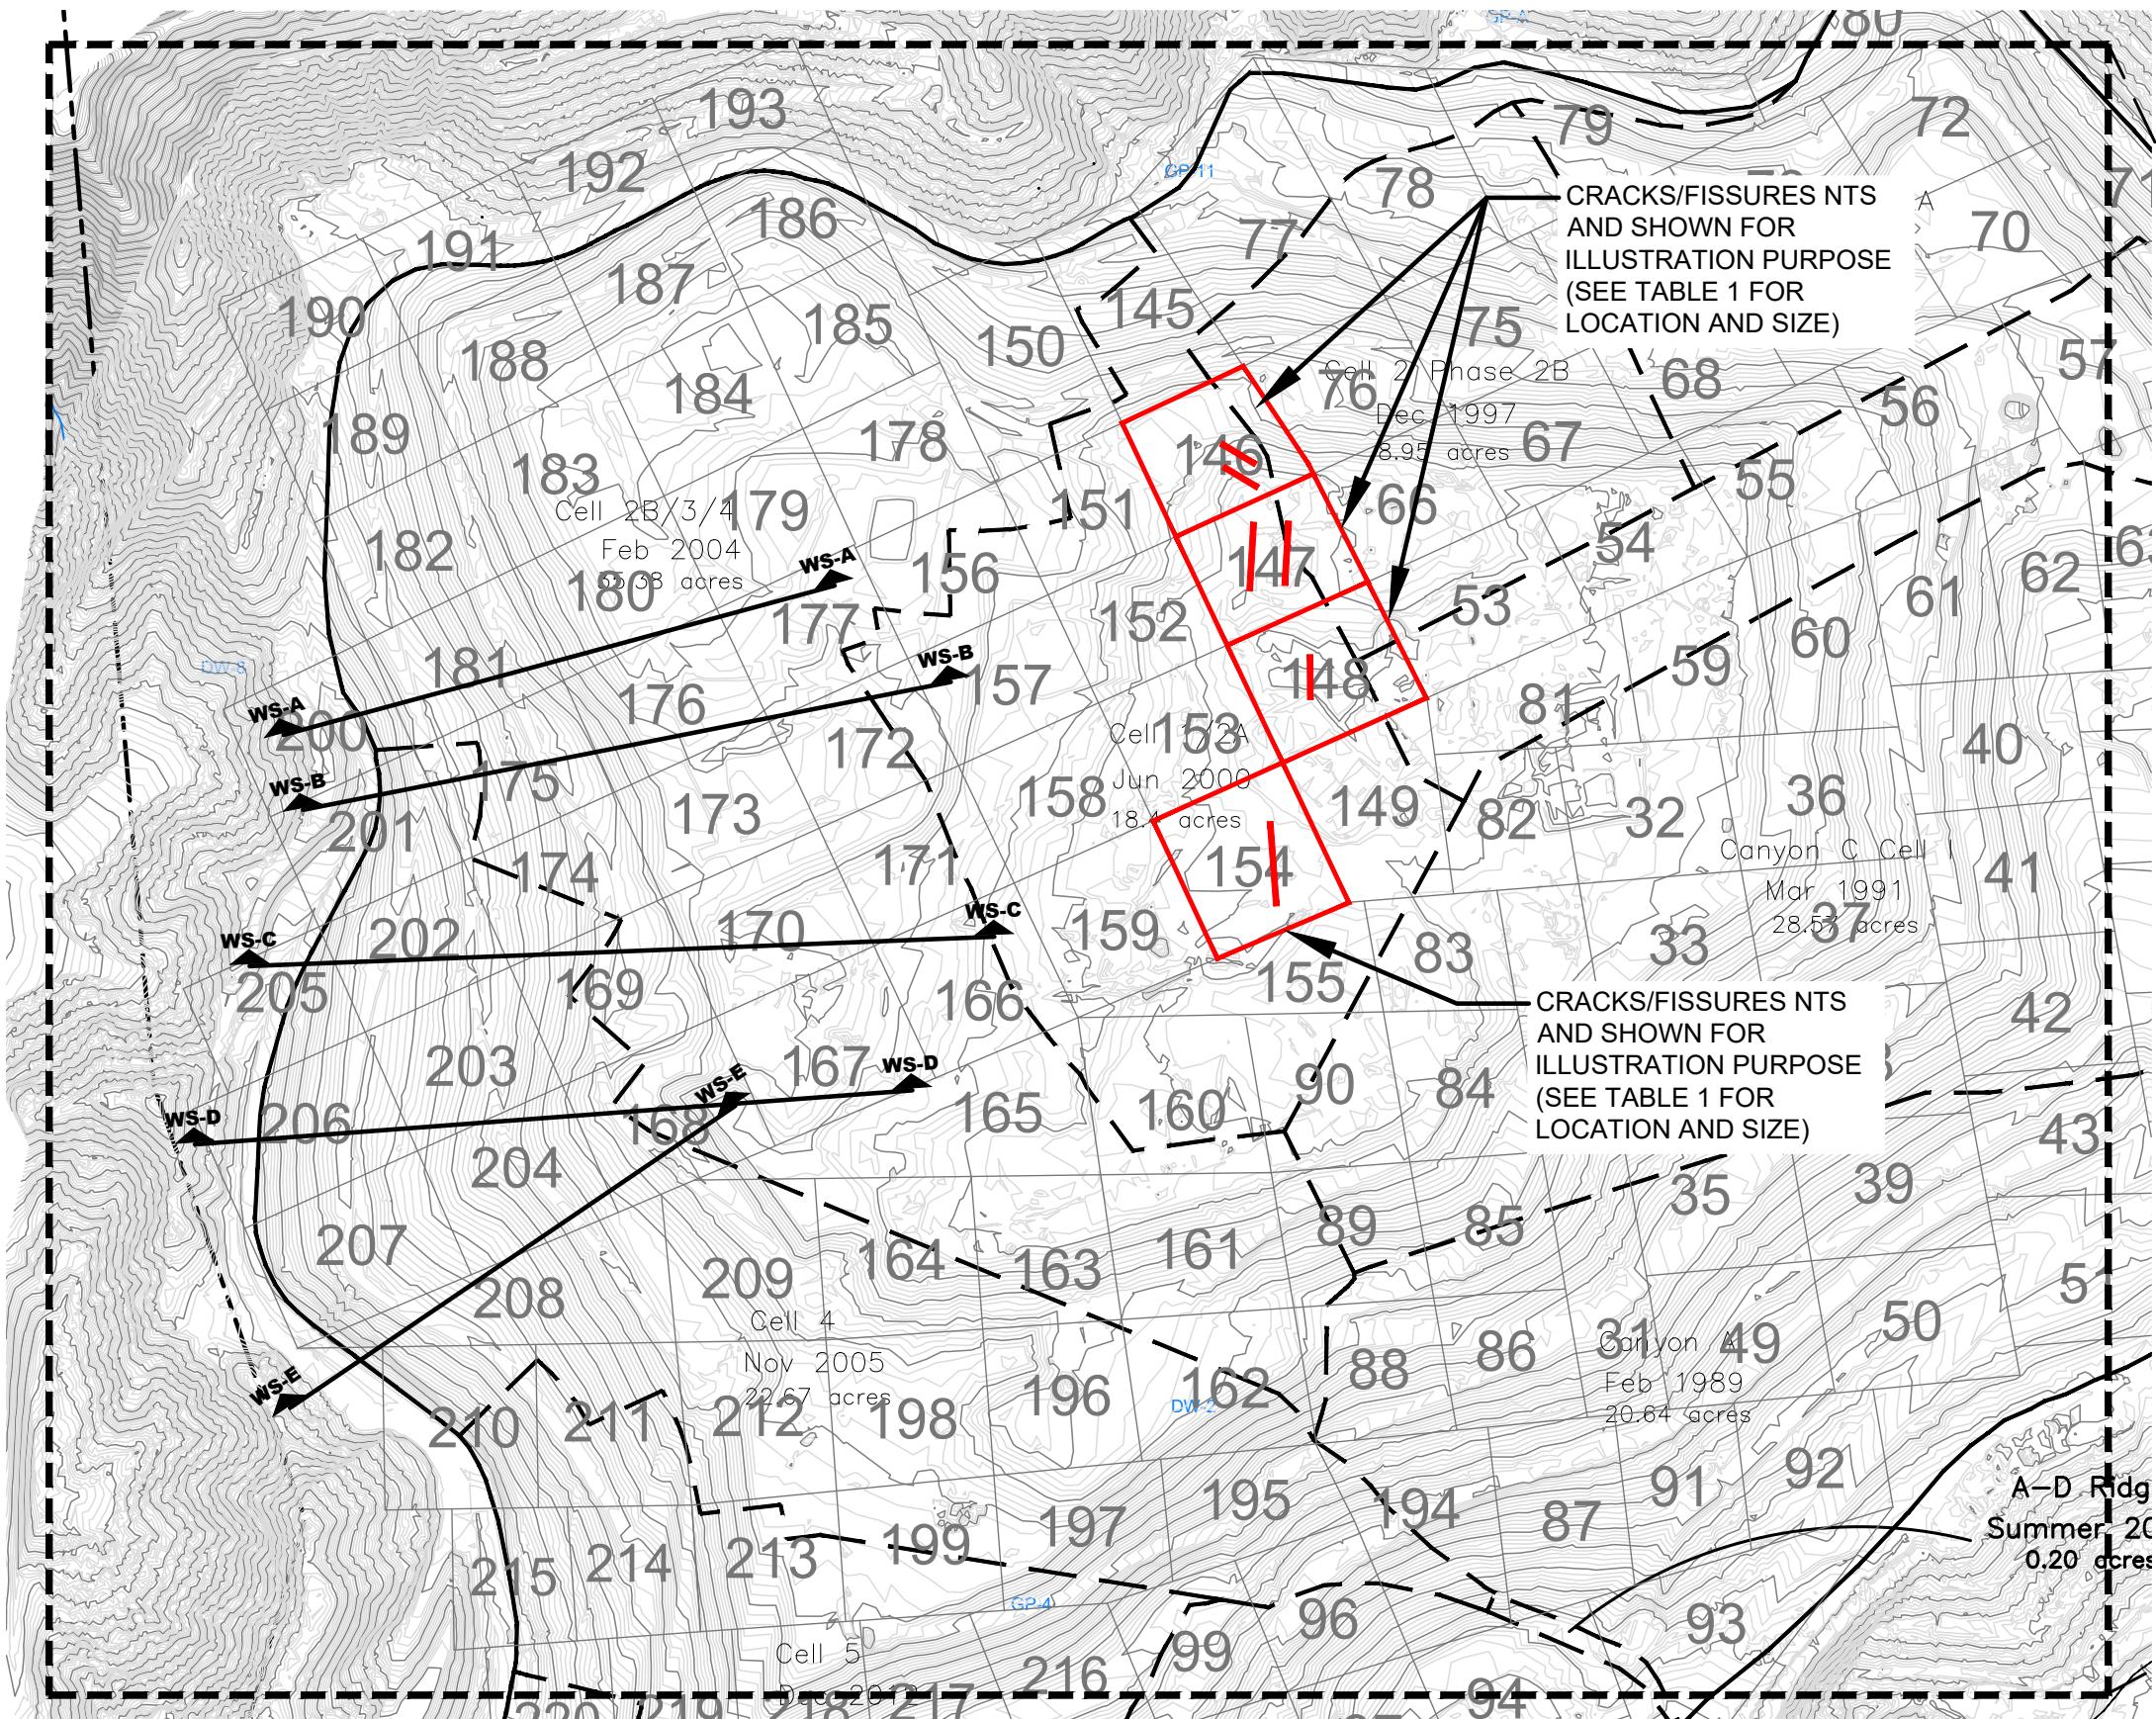
FIG NO.
01

All of these cracks were repaired by placing soil and track-walking over the crack. The locations of the grids and the relative orientations of the cracks identified above are shown in Figure 1. The grid locations of these cracks on the top deck of the landfill and the orientations of the cracks indicate they were likely associated with settlement and not with slope instability.

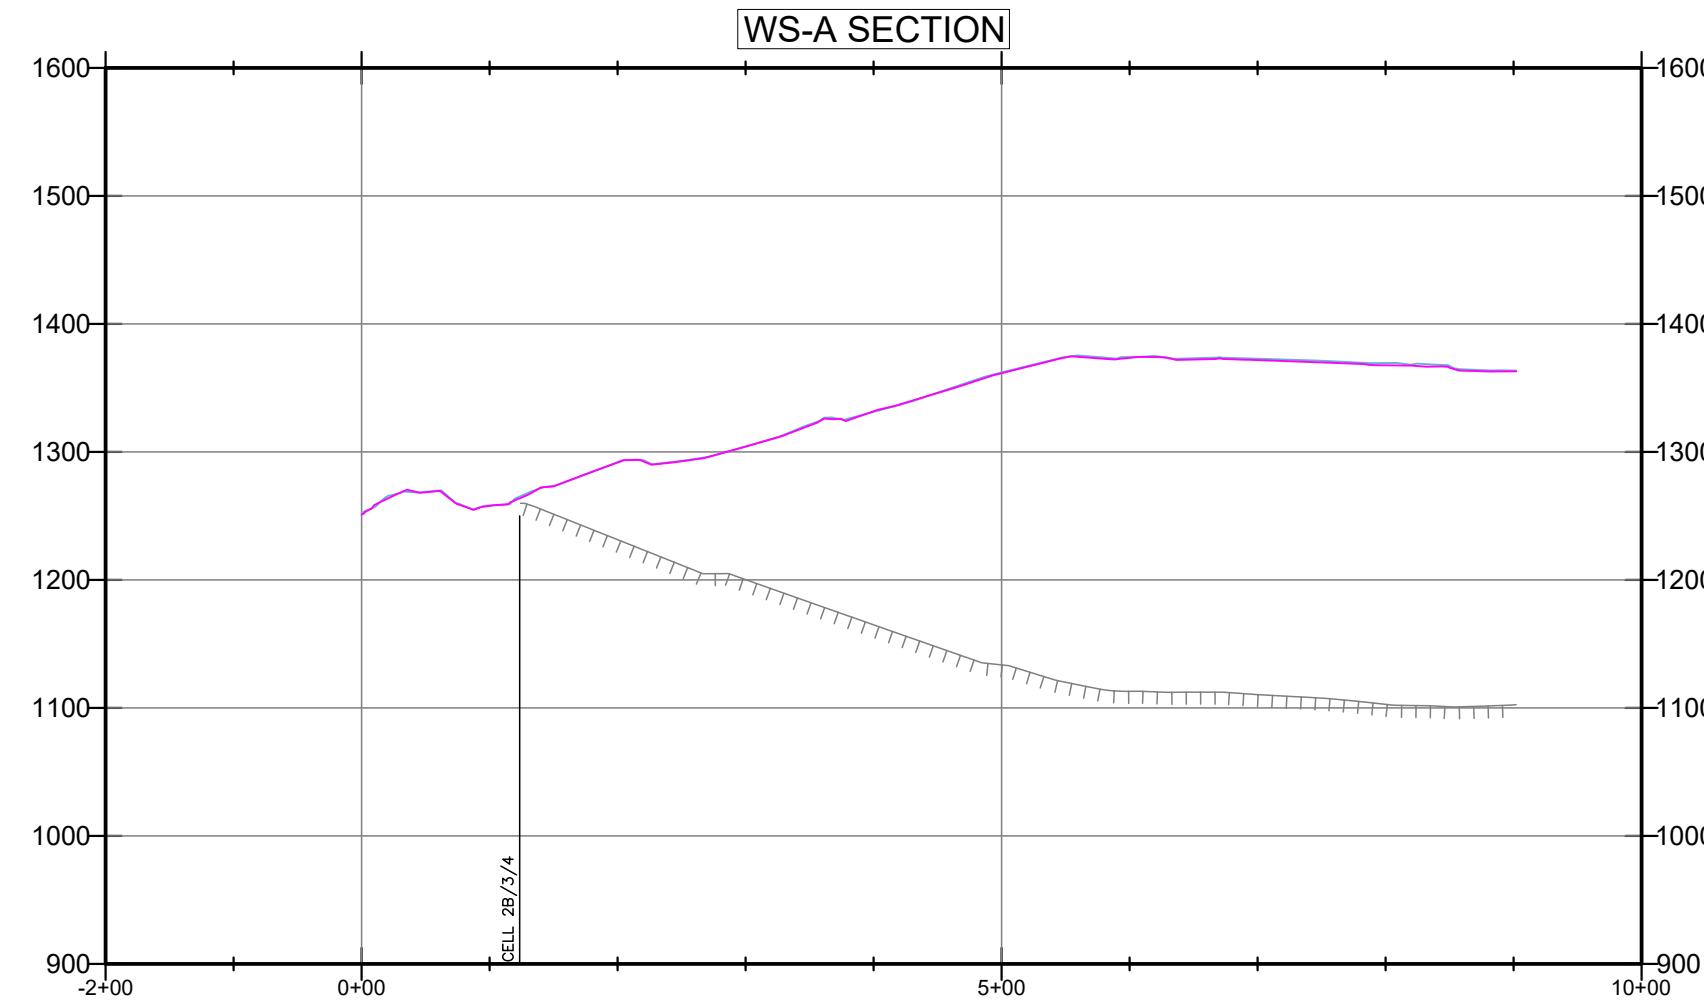
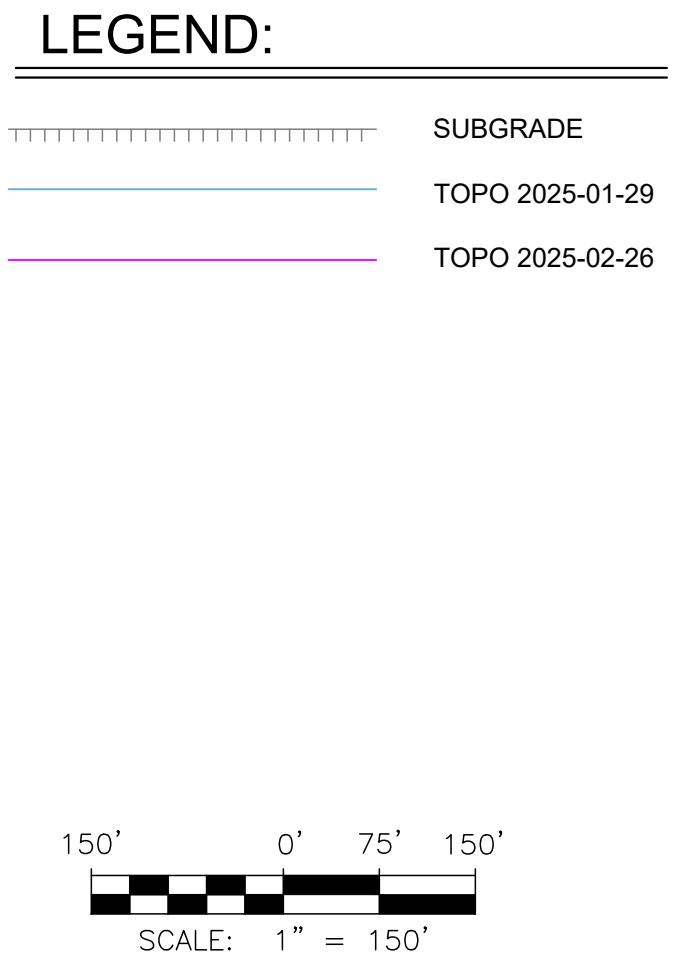
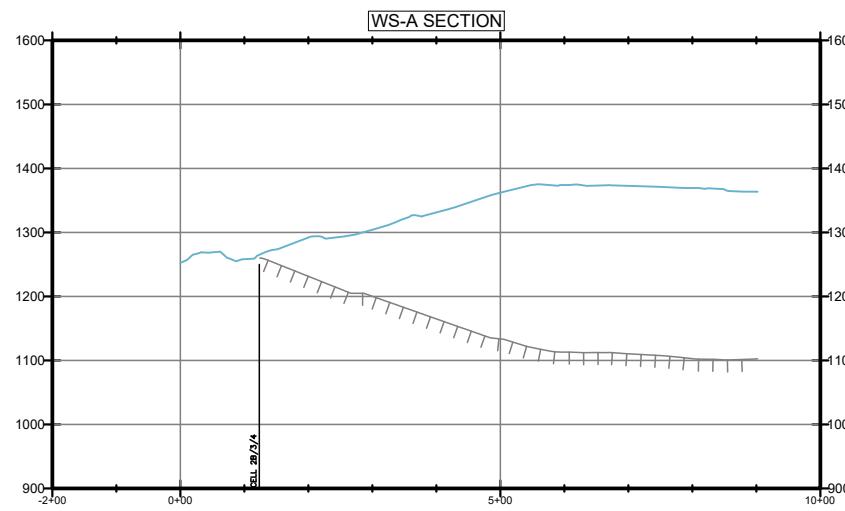
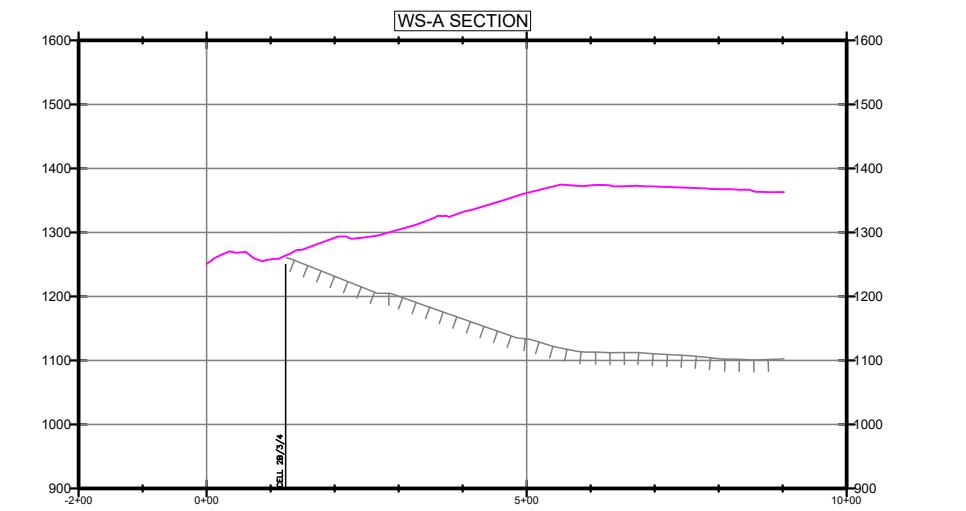
FIGURE 2A
WESTERN SLOPE CROSS SECTION A
FEBRUARY 2025 MONITORING SUMMARY
CHIQUITA CANYON LANDFILL
COUNTY OF LOS ANGELES, CA

Cross sections that compare January 29, 2025 and February 26, 2025 topography are shown in Figures 2A through 2E. The locations of the cross sections are shown in Figure 1. The sections show no significant differences in slope between the January 2025 and February 2025 profiles, and no evidence of deformation indicative of instability, which is consistent with the daily site observations described above and the information summarized in Tables 1 and 2.
