CHIQUITA CANYON

Re: Chiquita Canyon, LLC's Weekly Report on the Documentation and Tracking of Cover Issues and Monthly Summary

Attachment: March 3, 2025 Weekly Cover Issues Report and Monthly Summary

4050 - Chiquita Reaction Area Tracking of Fissures and Tension Cracks

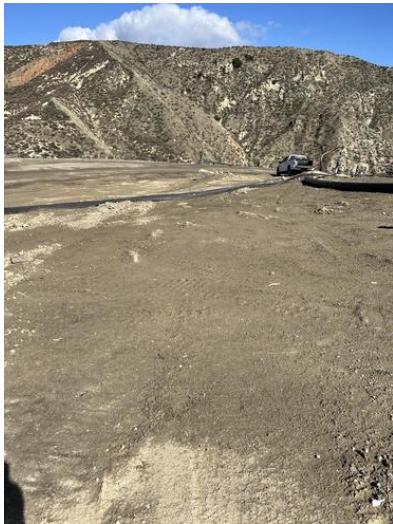
Grid 146

No

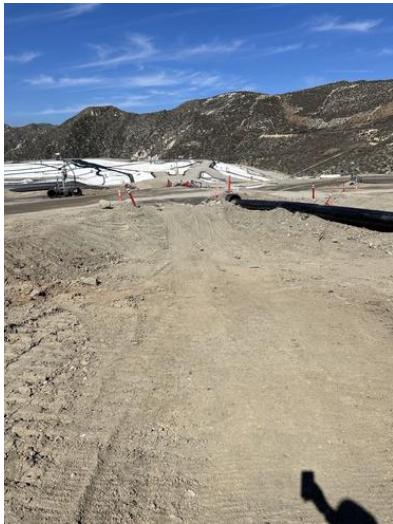
Grid 147

No

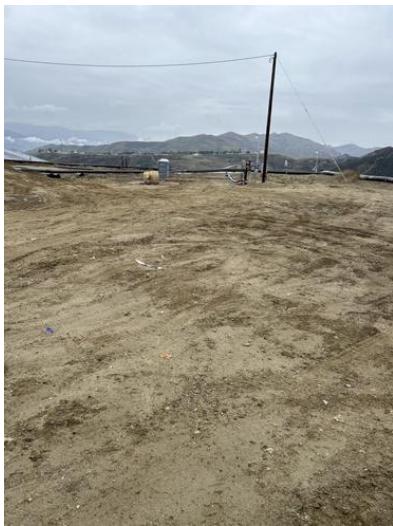
Grid 170

No

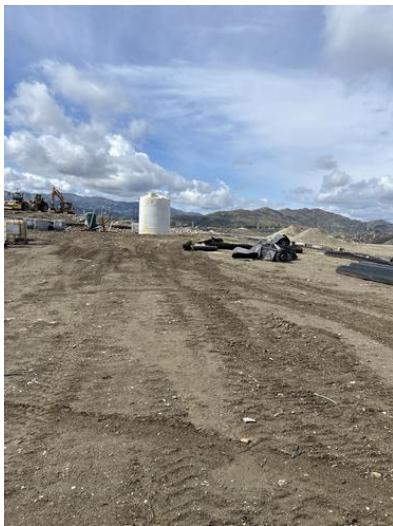
Grid 154

No

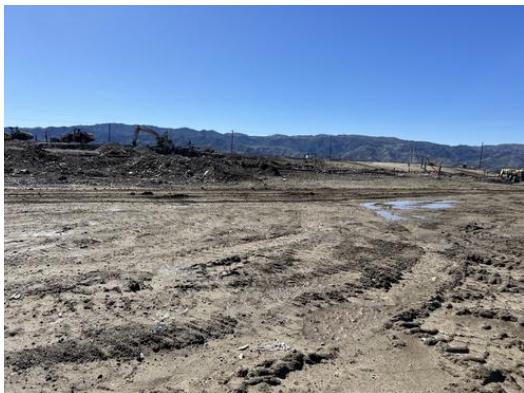
Grid 153

No

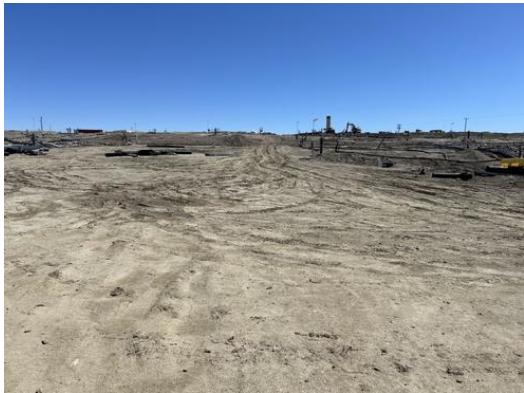
Grid 170

No

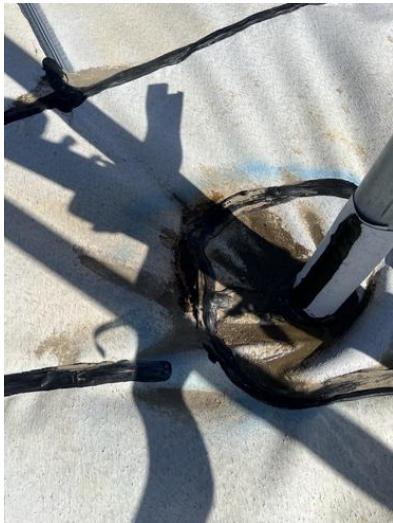
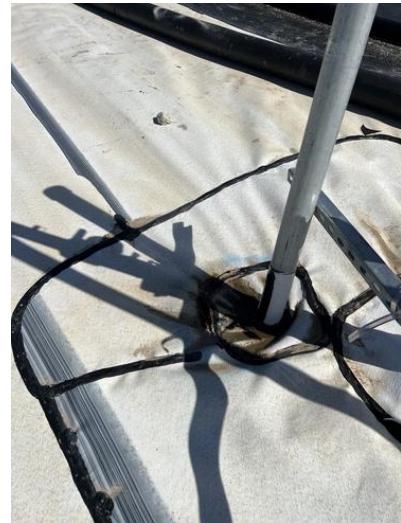
4 inch tear in liner in grid 185.
Needs to be patched and
extrusion welded.
