CHIQUITA CANYON
A Waste Connections Company

Re: Chiquita Canyon, LLC's Weekly Report on the Documentation and Tracking of Cover Issues

Attachment: March 10, 2025 Weekly Cover Issues Report

4050 - Chiquita Reaction Area Tracking of Fissures and Tension Cracks

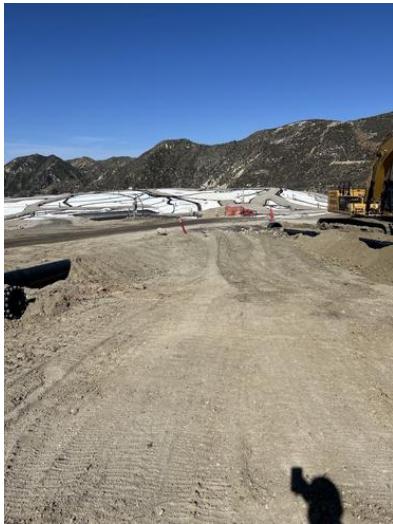
Photo 1

Fissure or Tension Crack Found?

No

Grid 147

Are there any indications of slope stability concerns?

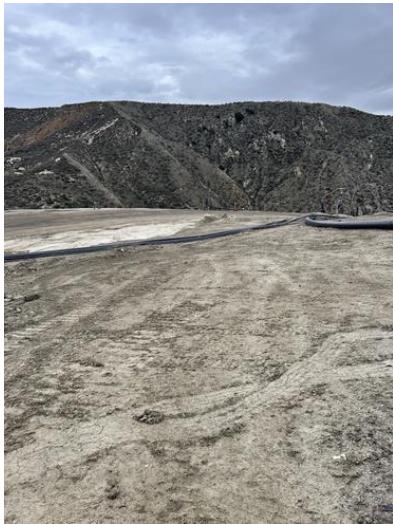
Photo 1

Fissure or Tension Crack Found?

No

Grid 146

Are there any indications of slope stability concerns?

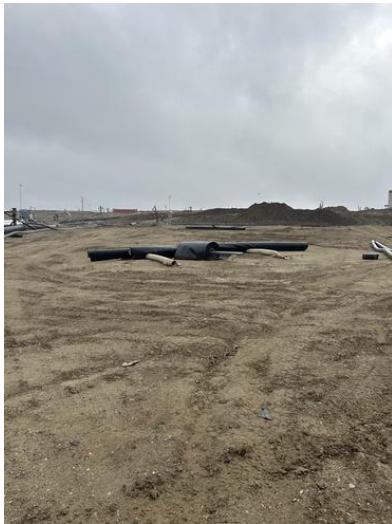
Photo 1

Fissure or Tension Crack Found?

No

Grid 170/171

Are there any indications of slope stability concerns?

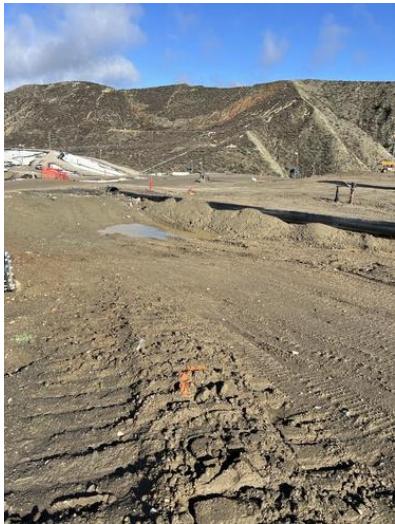
Photo 1

Fissure or Tension Crack Found?

No

Grid 147

Are there any indications of slope stability concerns?

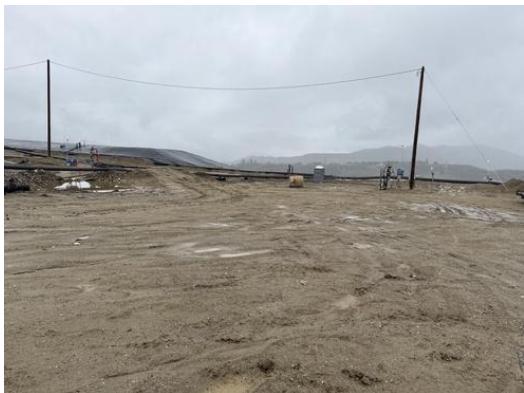
Photo 1

Fissure or Tension Crack Found?

No

Grid 170

Are there any indications of slope stability concerns?

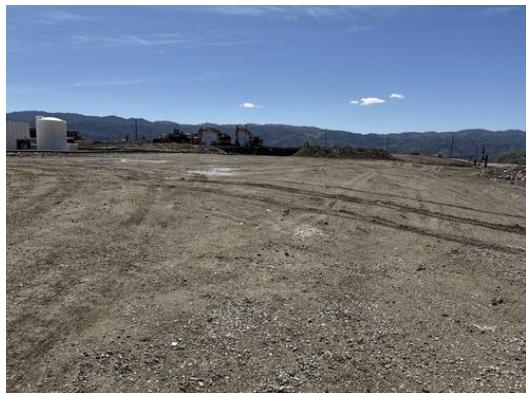
Photo 1

Fissure or Tension Crack Found?

No

Grid 153

Are there any indications of slope stability concerns?

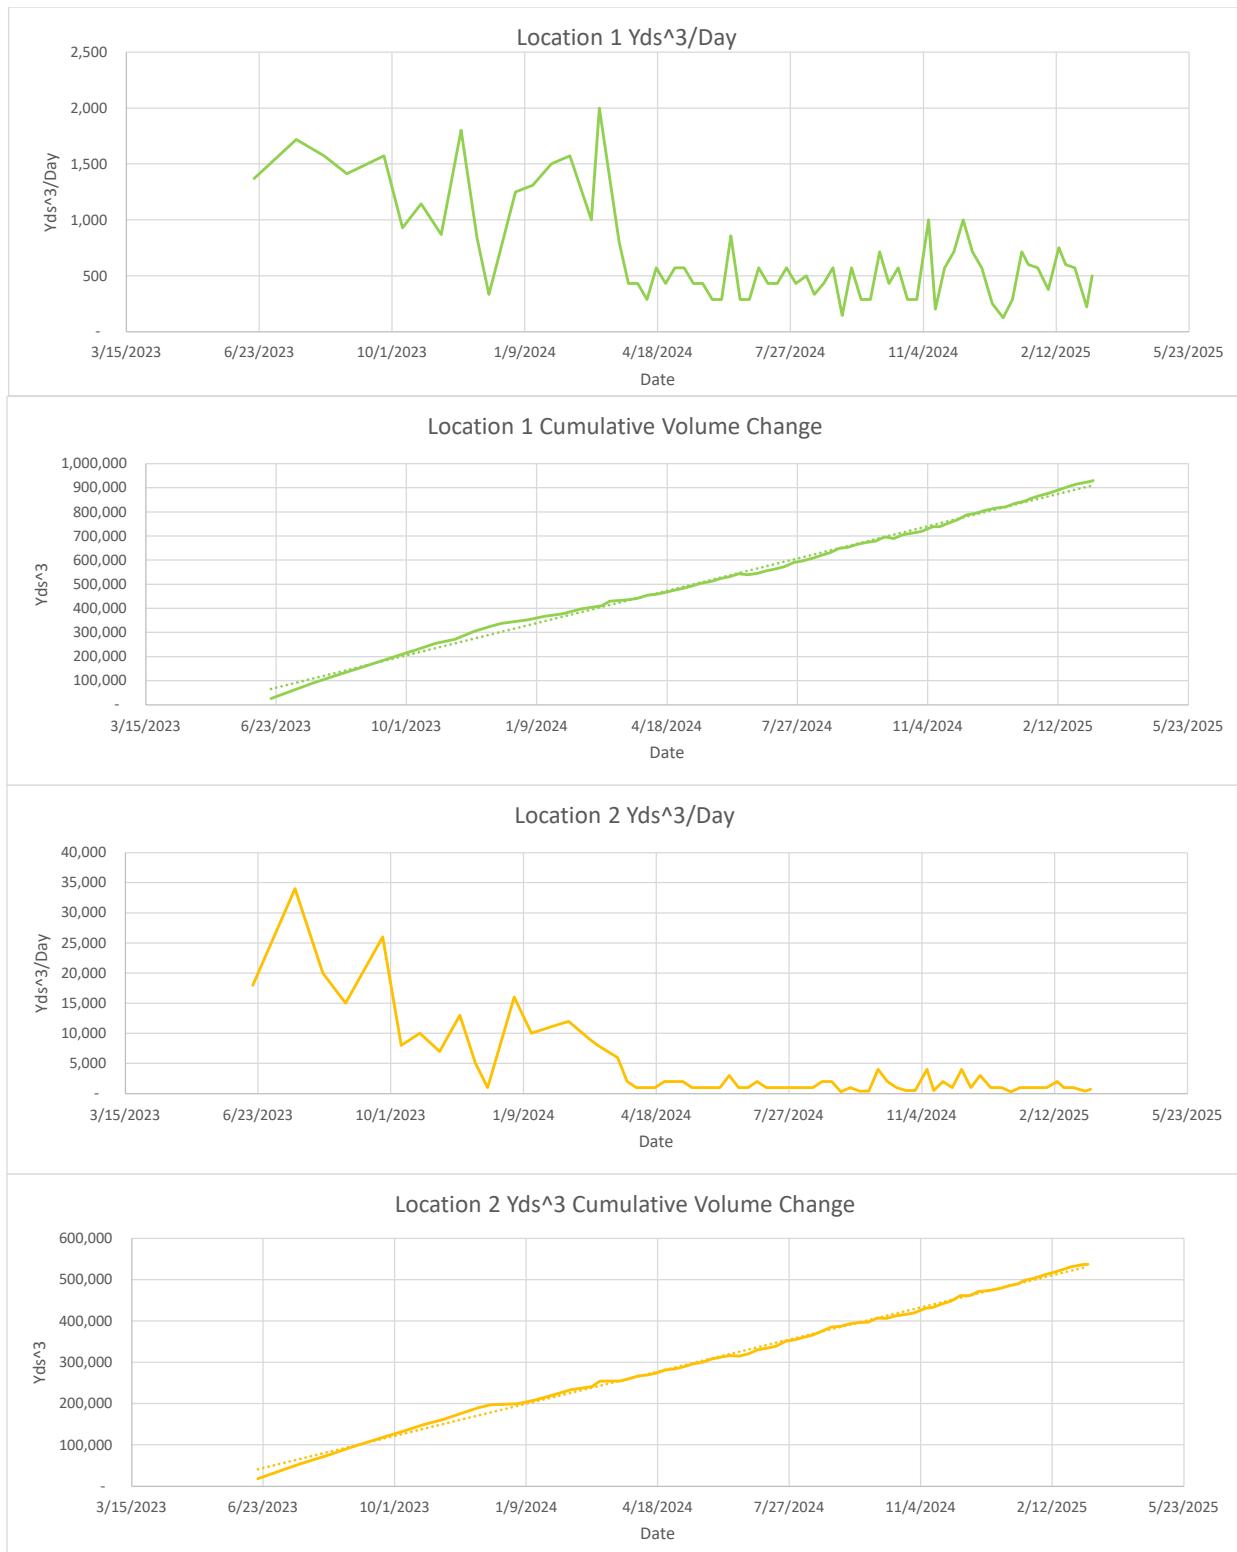
- The charts on the following page show the settlement in cubic yards measured at a fixed location.
- The map shows the settlement area growth between 2/26/25 (in green) and 3/11/25 (in red). These polygons show the areas that have settled more than 5 feet since 5/31/23; however, as the span of time between the start date of 5/31/23 and new survey dates increases, the accuracy of this map as an indicator of settlement attributed to the reaction will diminish.

- Waste fill occurred near the measurement areas in May 2023. Some of the early settlement is likely due to the initial waste settlement of a new fill.

- The major depression in the top deck was excluded because the soil fills used to prevent ponding would skew the settlement trends due to those areas showing up as fill instead of settlement.

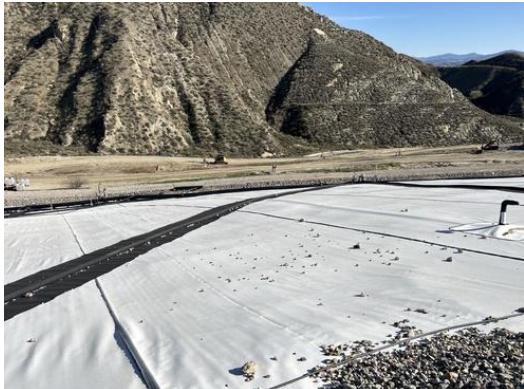
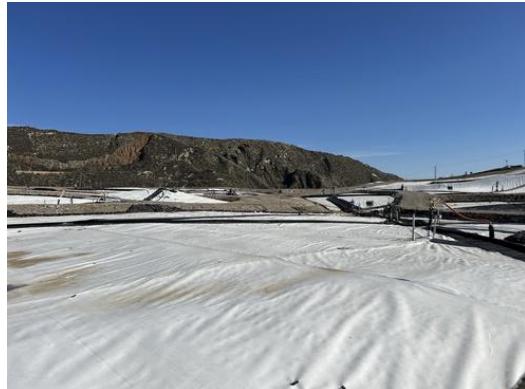
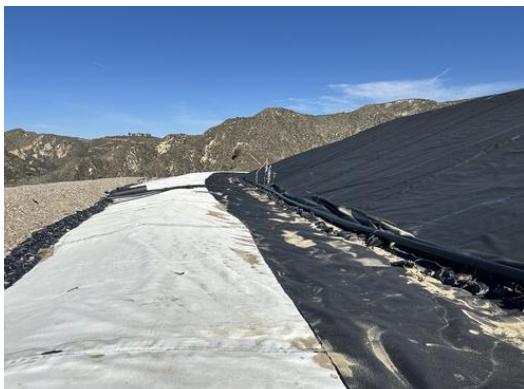
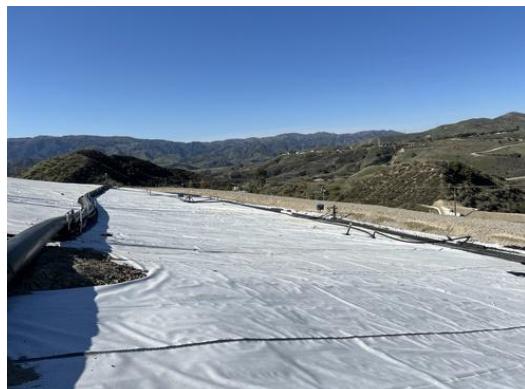
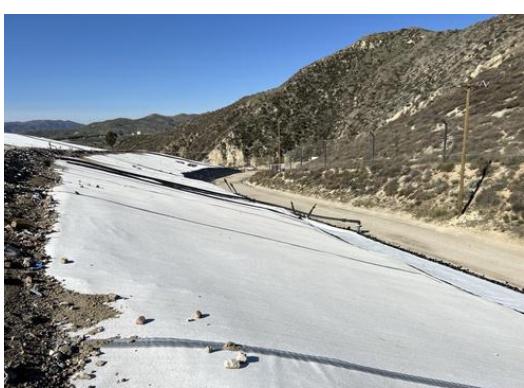
Are there any issues with the geosynthetic cover?

No

Are there any anomalous (unusual or unexpected) areas of cover damage or deformation that may indicate underlying instability?

Are there any signs of a downslope tension crack at the top of the slope or bulging at or near the toe of the slope?

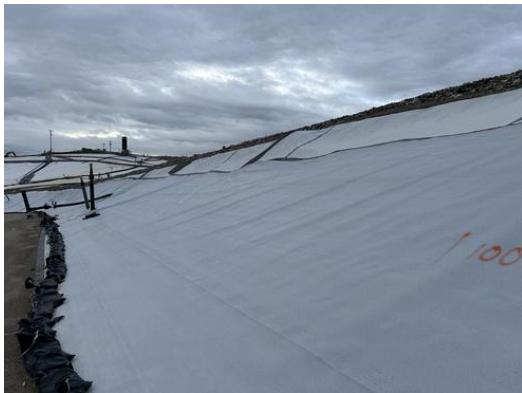
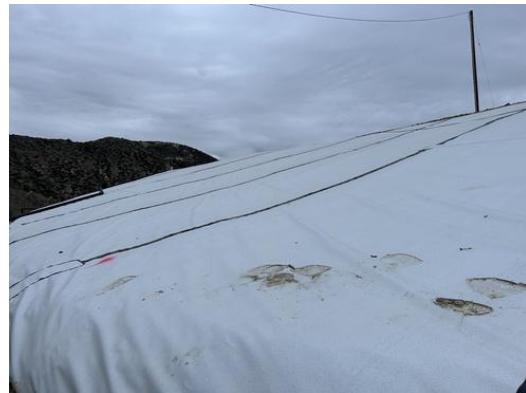
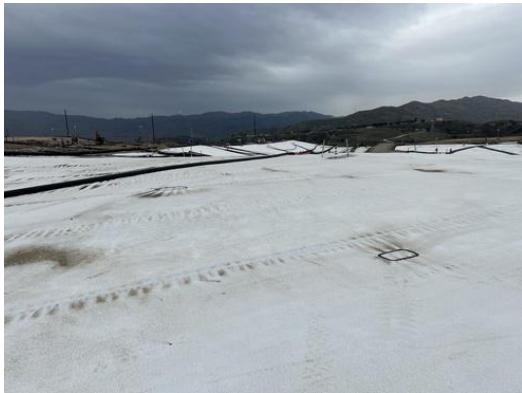
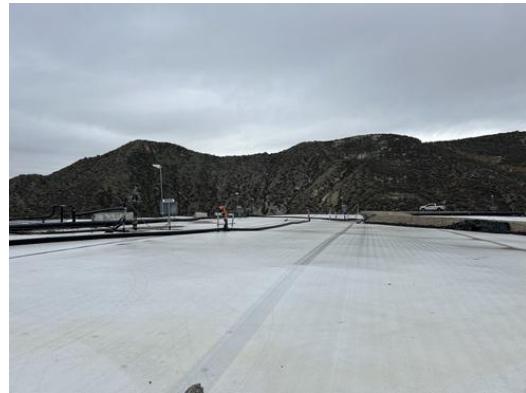
Are there any issues with the geosynthetic cover?

No

Are there any anomalous (unusual or unexpected) areas of cover damage or deformation that may indicate underlying instability?

Are there any signs of a downslope tension crack at the top of the slope or bulging at or near the toe of the slope?

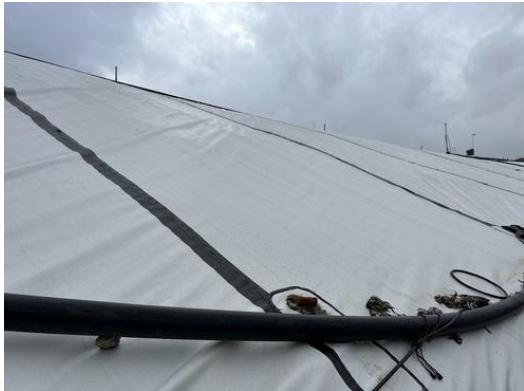
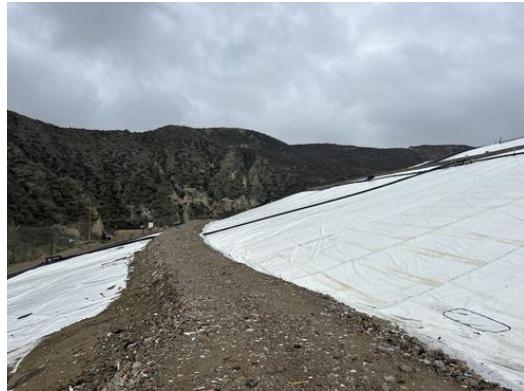
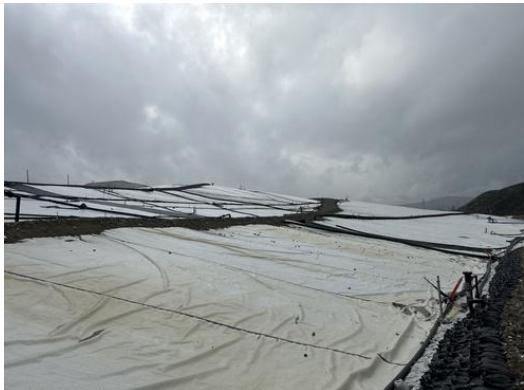
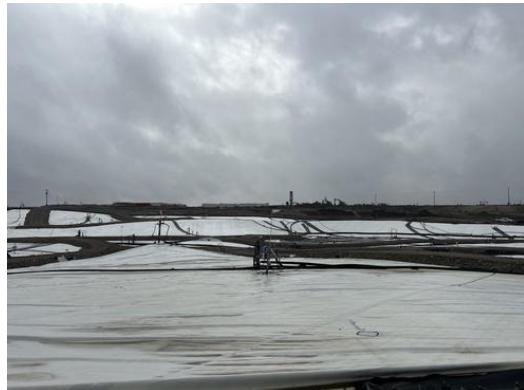
Are there any issues with the geosynthetic cover?

No

Are there any anomalous (unusual or unexpected) areas of cover damage or deformation that may indicate underlying instability?

Are there any signs of a downslope tension crack at the top of the slope or bulging at or near the toe of the slope?

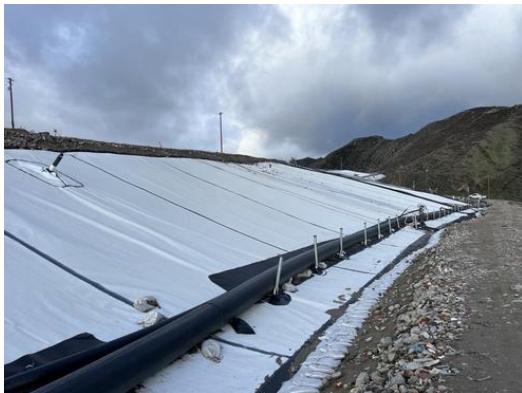
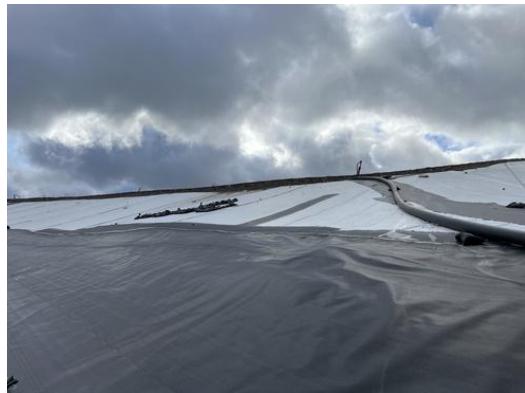
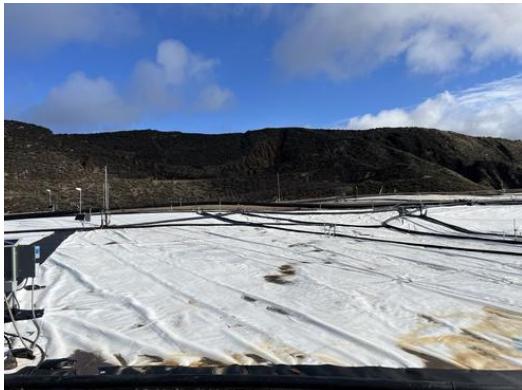
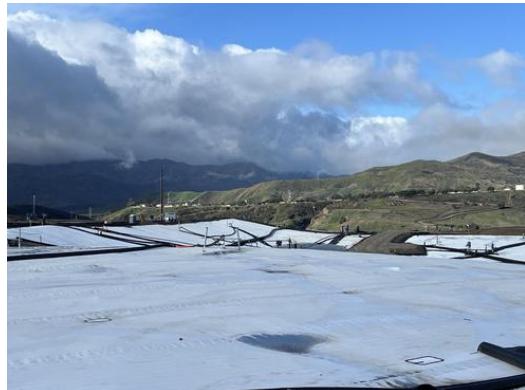
Are there any issues with the geosynthetic cover?

No

Are there any anomalous (unusual or unexpected) areas of cover damage or deformation that may indicate underlying instability?

Are there any signs of a downslope tension crack at the top of the slope or bulging at or near the toe of the slope?

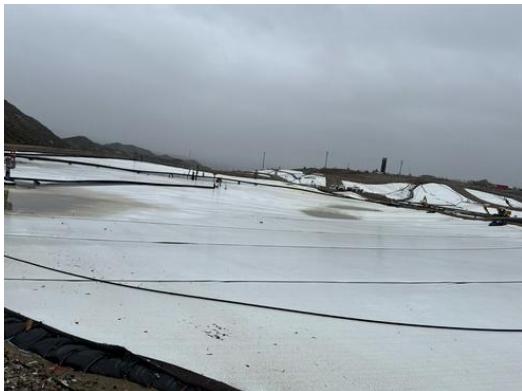
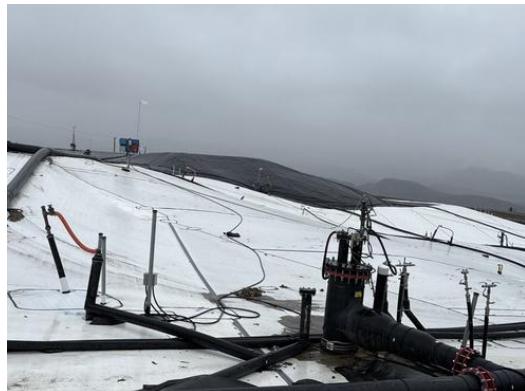
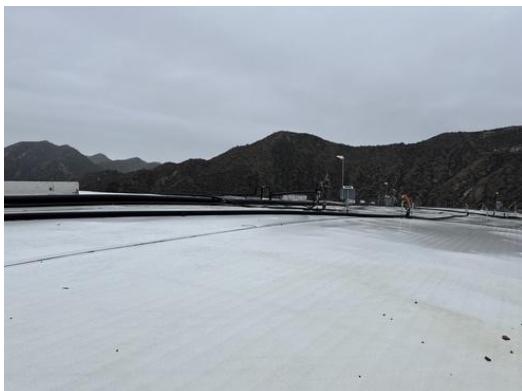
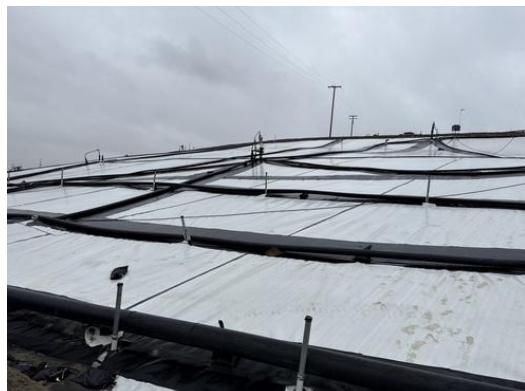
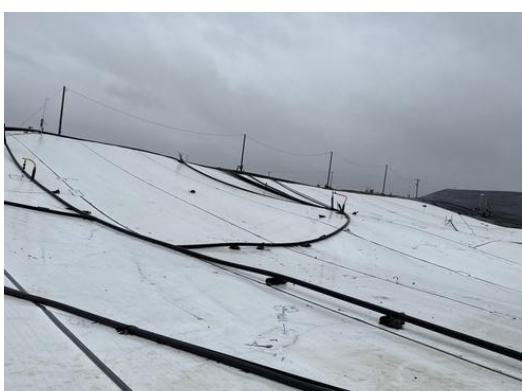
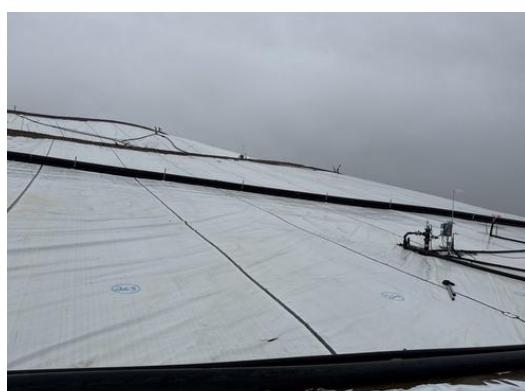
Are there any issues with the geosynthetic cover?

No

Are there any anomalous (unusual or unexpected) areas of cover damage or deformation that may indicate underlying instability?

Are there any signs of a downslope tension crack at the top of the slope or bulging at or near the toe of the slope?

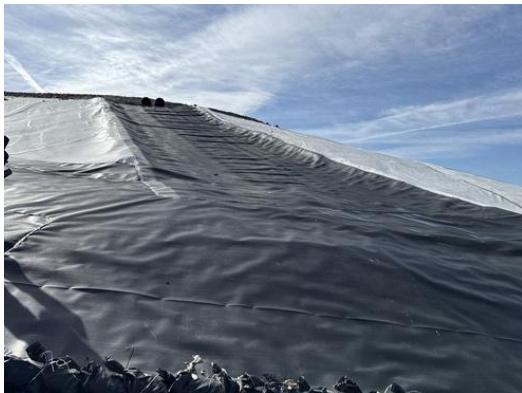
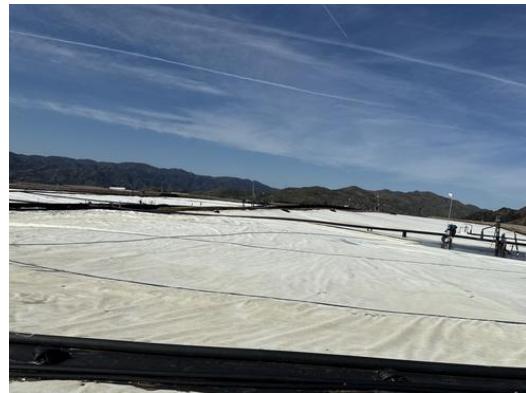
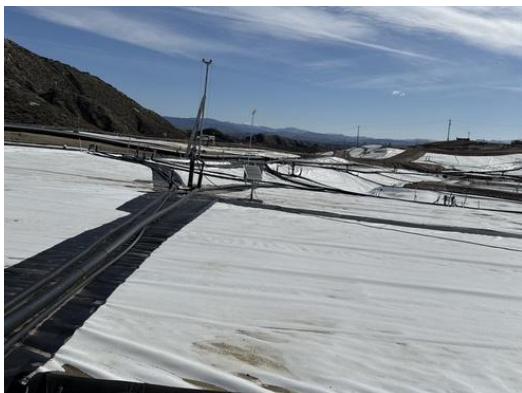
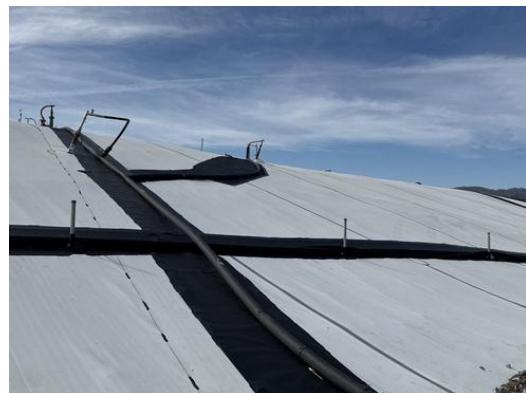
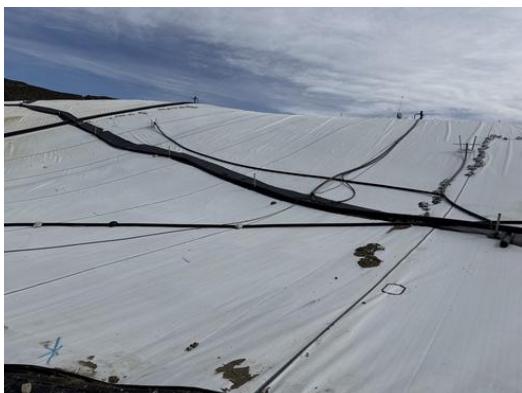
Are there any issues with the geosynthetic cover?

No

Are there any anomalous (unusual or unexpected) areas of cover damage or deformation that may indicate underlying instability?

Are there any signs of a downslope tension crack at the top of the slope or bulging at or near the toe of the slope?
