**CHIQUITA CANYON**  
*A Waste Connections Company*

**Re: Chiquita Canyon, LLC's Weekly Report on the Documentation and Tracking of Cover Issues**

Attachment: March 17, 2025 Weekly Cover Issues Report

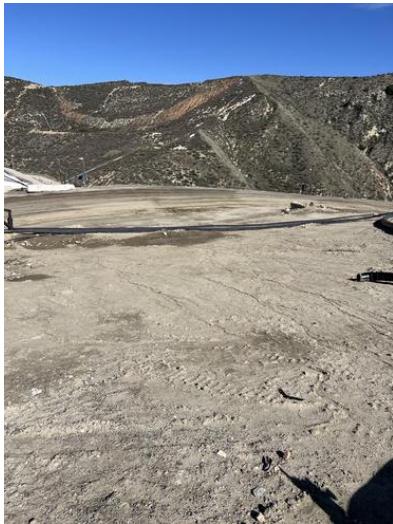
Grid 146

No

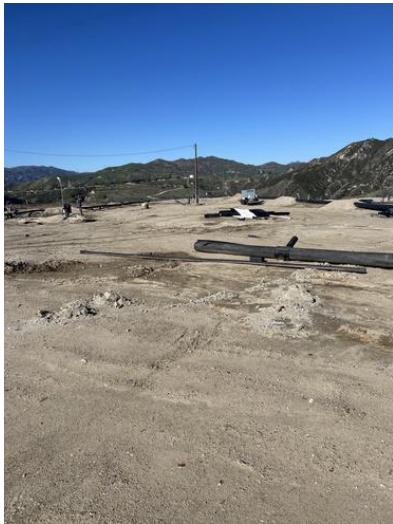
Grid 171/170

No

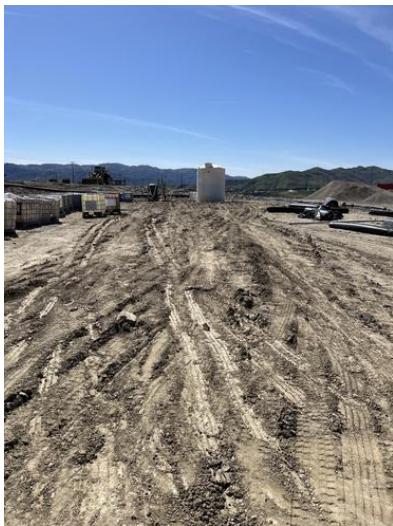
Grid 154.

No

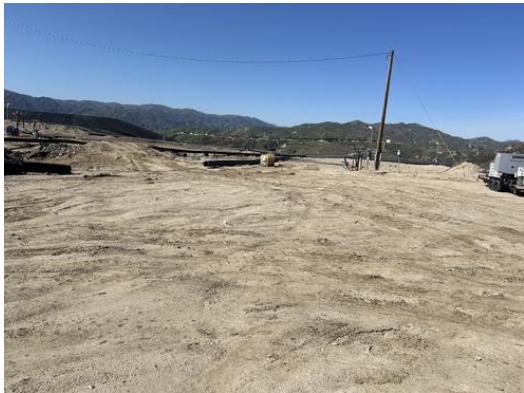
Grid 170

No

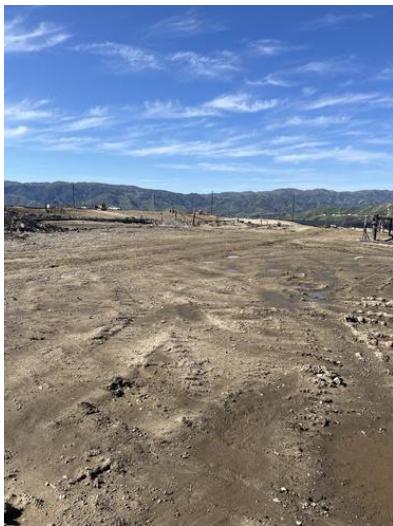
Grid 153

No

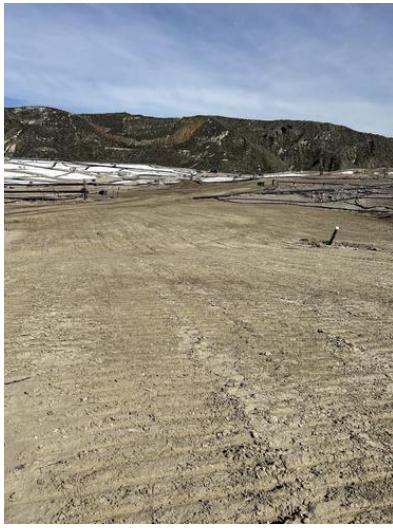
Grid 165

No

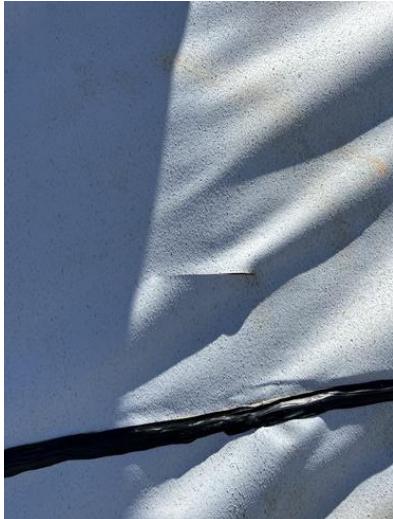
Photo 1

4 inch cut in the liner in grid 205.  
Needs to be patched and  
extrusion welded.

Cut in liner was sealed with flex tape upon finding the tear at 10:20 am on 3/17/25. The tear was patched and extrusion welded at 12:02 PM on 3/17/25.

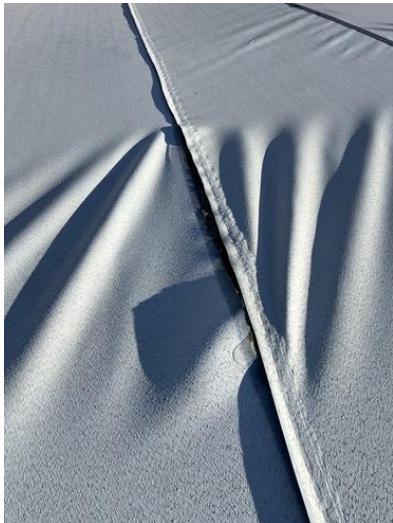
Photo 1

4 ft separation at a seam in grid 145, needs to be patched and extrusion welded

Liner was patched and extrusion welded.
