CHIQUITA CANYON

Re: Chiquita Canyon, LLC's Weekly Report on the Documentation and Tracking of Cover Issues

4050 - Chiquita Reaction Area Tracking of Fissures and Tension Cracks

4050 - Geosynthetic Cover Inspection

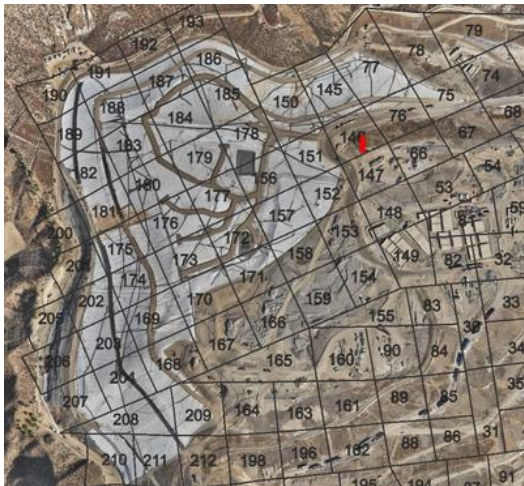
Fissure or Tension Crack Found?

Yes

146

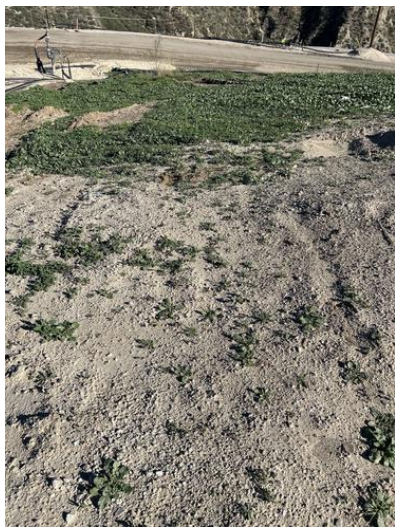
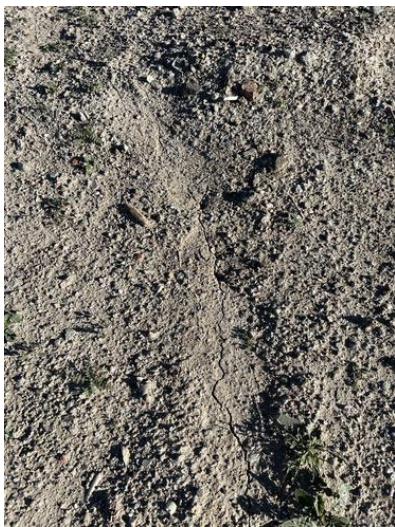
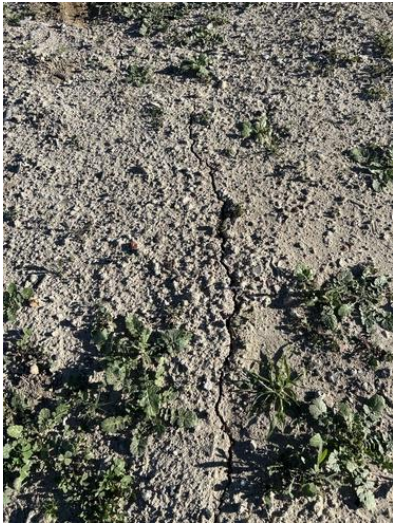
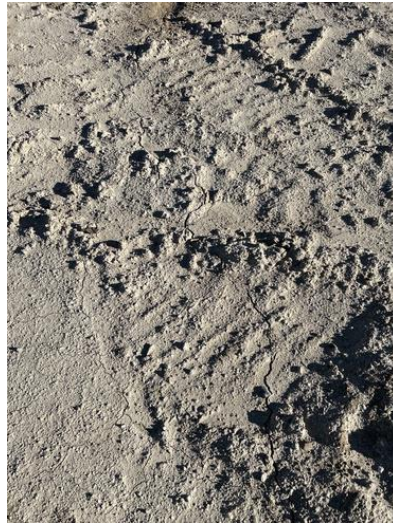
10ft x 25ft

Extra Small <0.5 in width

Extra small <0.5" in height

N to S

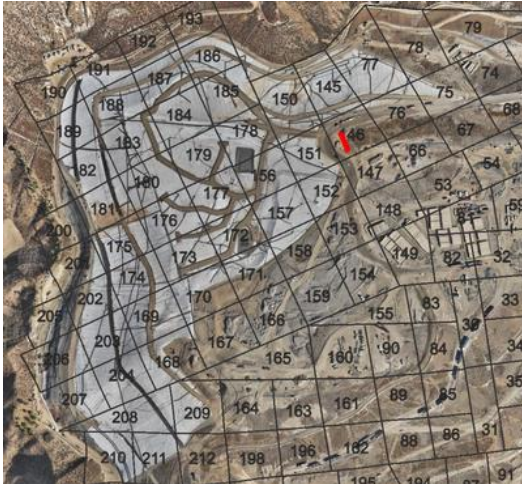
Fissure or Tension Crack Found?

Yes

146

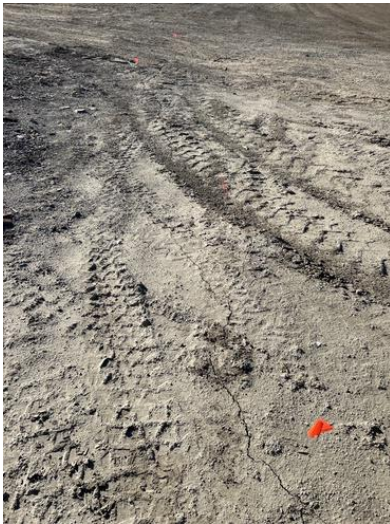
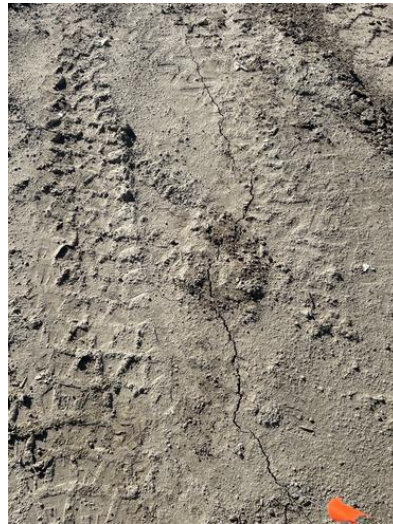
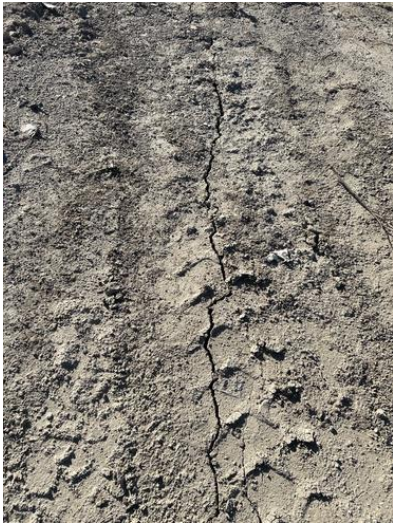
Length of crack (ft) or area containing multiple cracks (ft x ft) 35 ft

Horizontal Offset (width) Small 0.5-2" in width

Vertical Offset (height) Extra small <0.5" in height

Orientation (direction) N to S

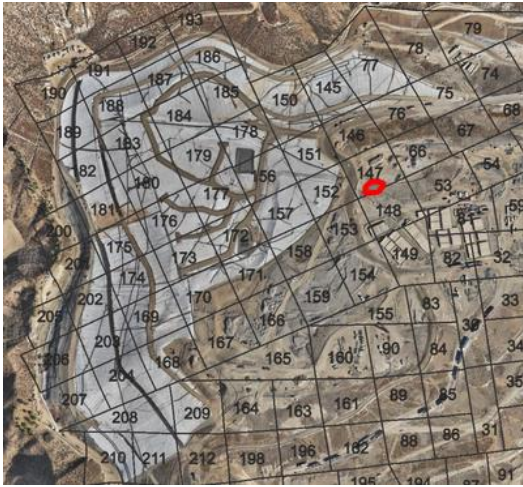
Fissure or Tension Crack Found?

Yes

147

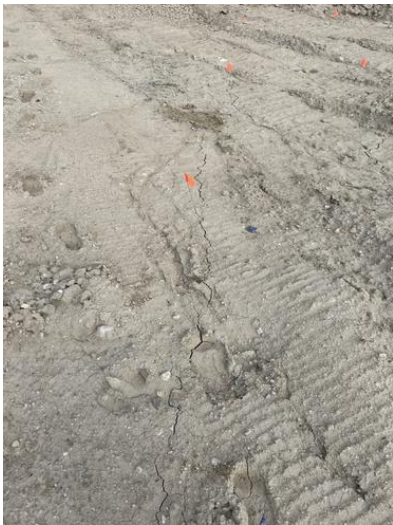
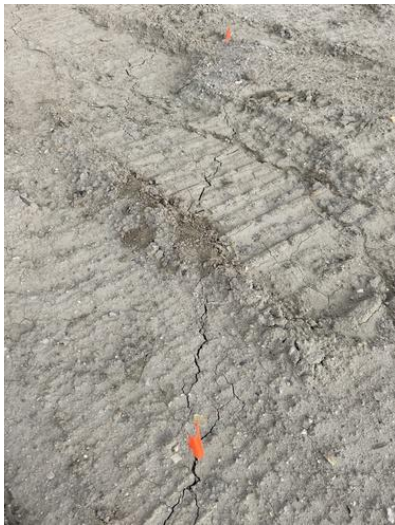
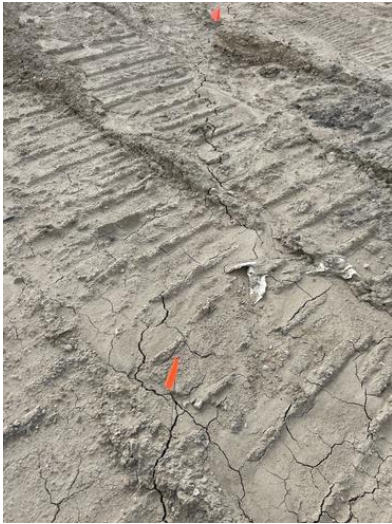
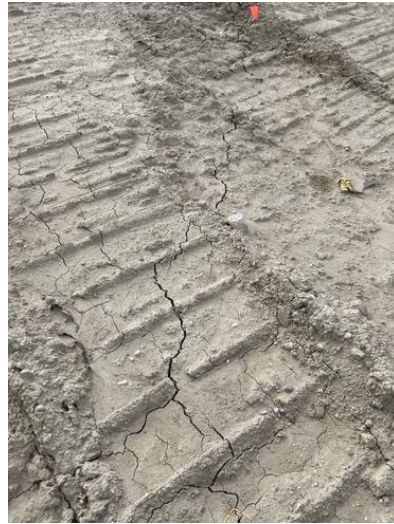
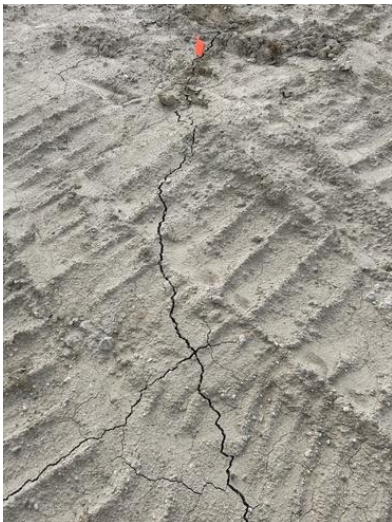
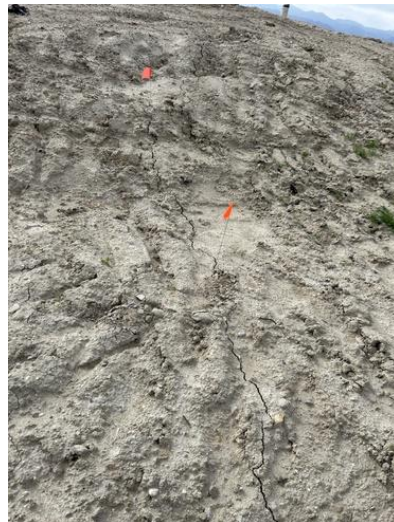
30ft x 30ft area

Extra Small <0.5 in width

Extra small <0.5" in height

NW to SE

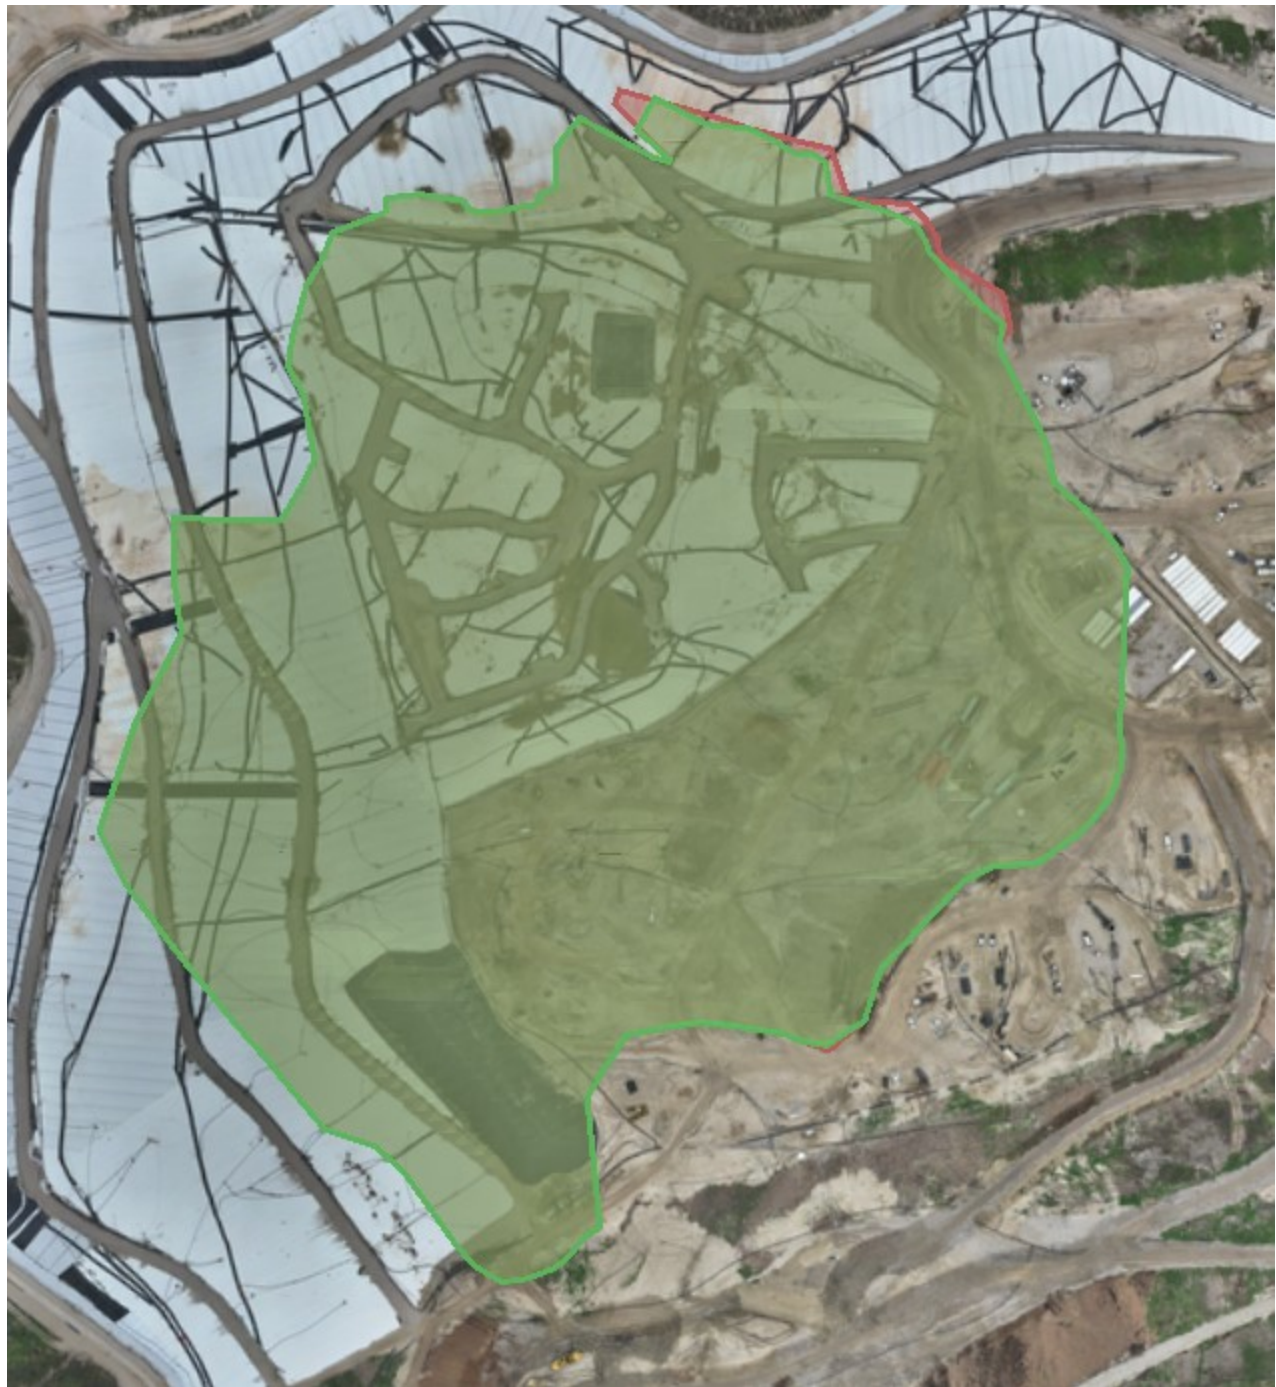
- The charts on the following page show the settlement in cubic yards measured at a fixed location.
- The map shows the settlement area growth between 3/11/25 (in green) and 3/26/25 (in red). These polygons show the areas that have settled more than 5 feet since 5/31/23; however, as the span of time between the start date of 5/31/23 and new survey dates increases, the accuracy of this map as an indicator of settlement attributed to the reaction will diminish.

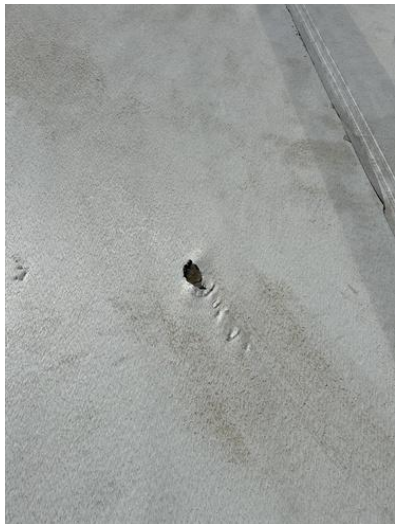
Photo 1

2" x 3" tear in liner in Grid 180 found at 10:05 am. Needs to be patched and extrusion welded.

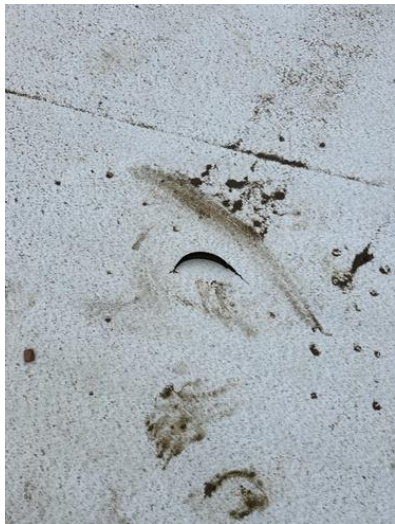
Photo 1

5 inch tear in the liner in grid 188 found at 10:25am. Needs to be patched and extrusion welded.

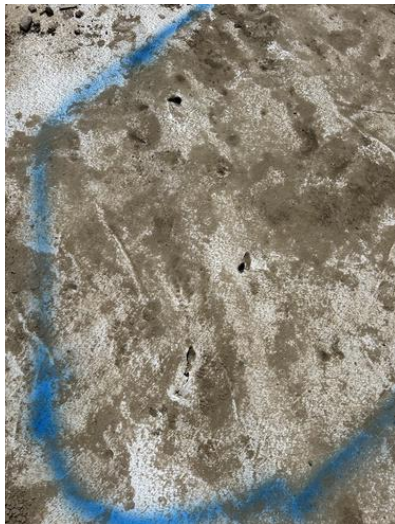
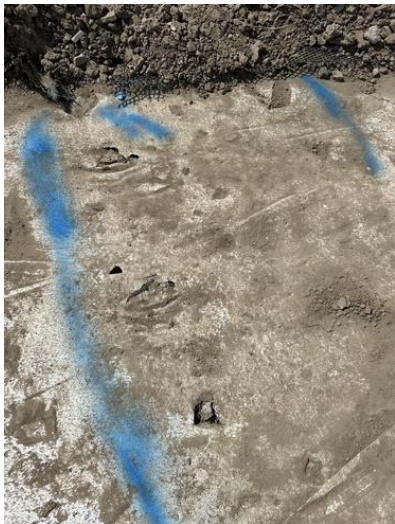
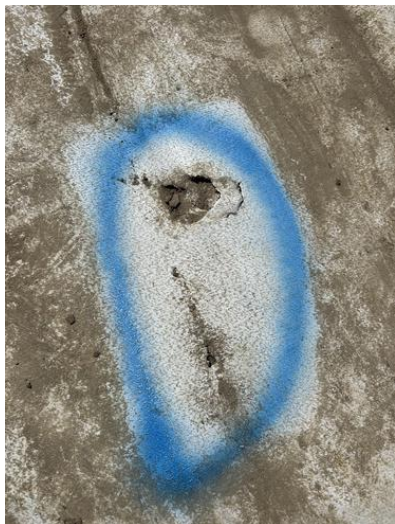
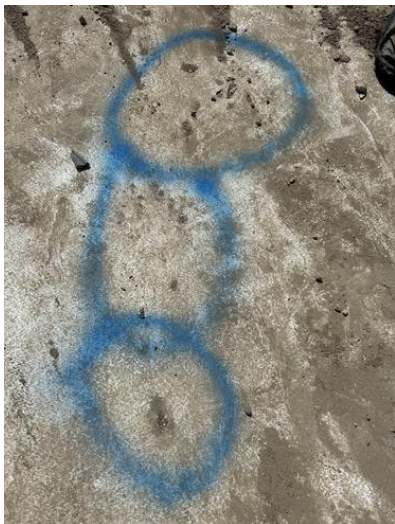
Multiple small tears in liner from vehicle in grid 156. Patch and extrusion welding needed
