**Re: Chiquita Canyon, LLC's Weekly Report on the Documentation and  
Tracking of Cover Issues and Monthly Summary**

# 4050 - Chiquita Reaction Area Tracking of Fissures and Tension Cracks

# 4050 - Geosynthetic Cover Inspection

**MARCH 2025 FISSURE AND TENSION CRACK MONITORING SUMMARY  
CHIQUITA CANYON LANDFILL  
CASTAIC, CALIFORNIA**

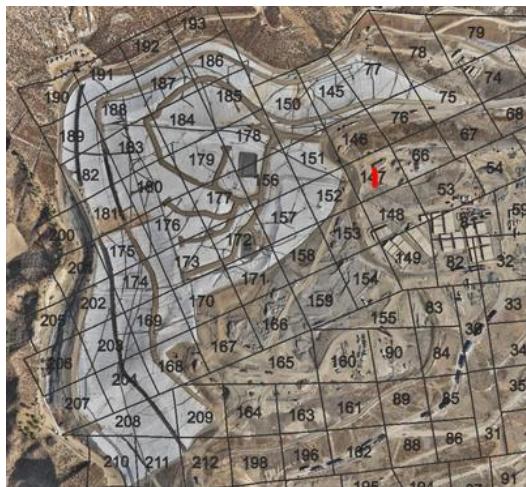
**Using the attached image, annotate all areas where inspectors identified a fissure or tension crack.**

147

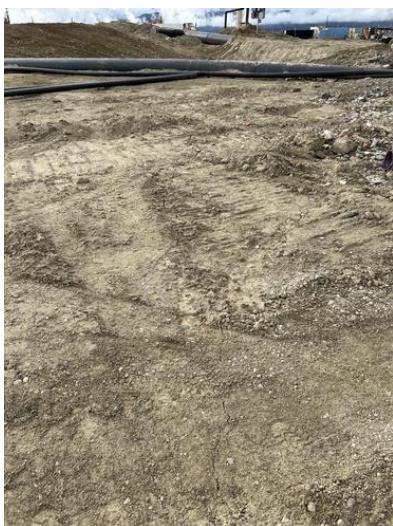
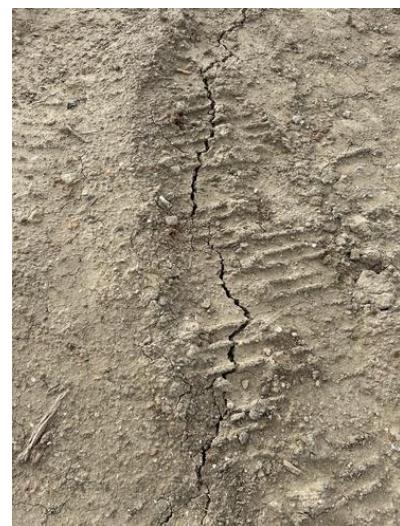
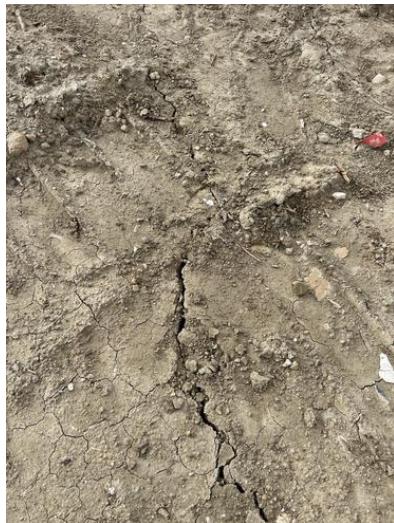
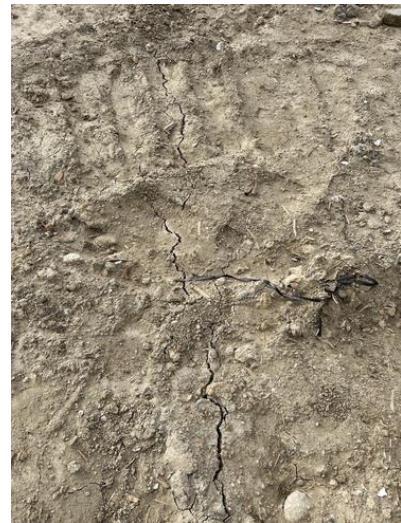
**Grid Location**

6ft x 35ft

Small 0.5-2" in width

Extra small <0.5" in height

NW to SE

The two “small” and two “extra small” cracks that were observed were repaired by placing soil and track-walking over the crack. The grid locations of these cracks on the top deck of the landfill and the orientations of the cracks indicate they were likely associated with settlement and not with slope instability.

Cracks were track walked.

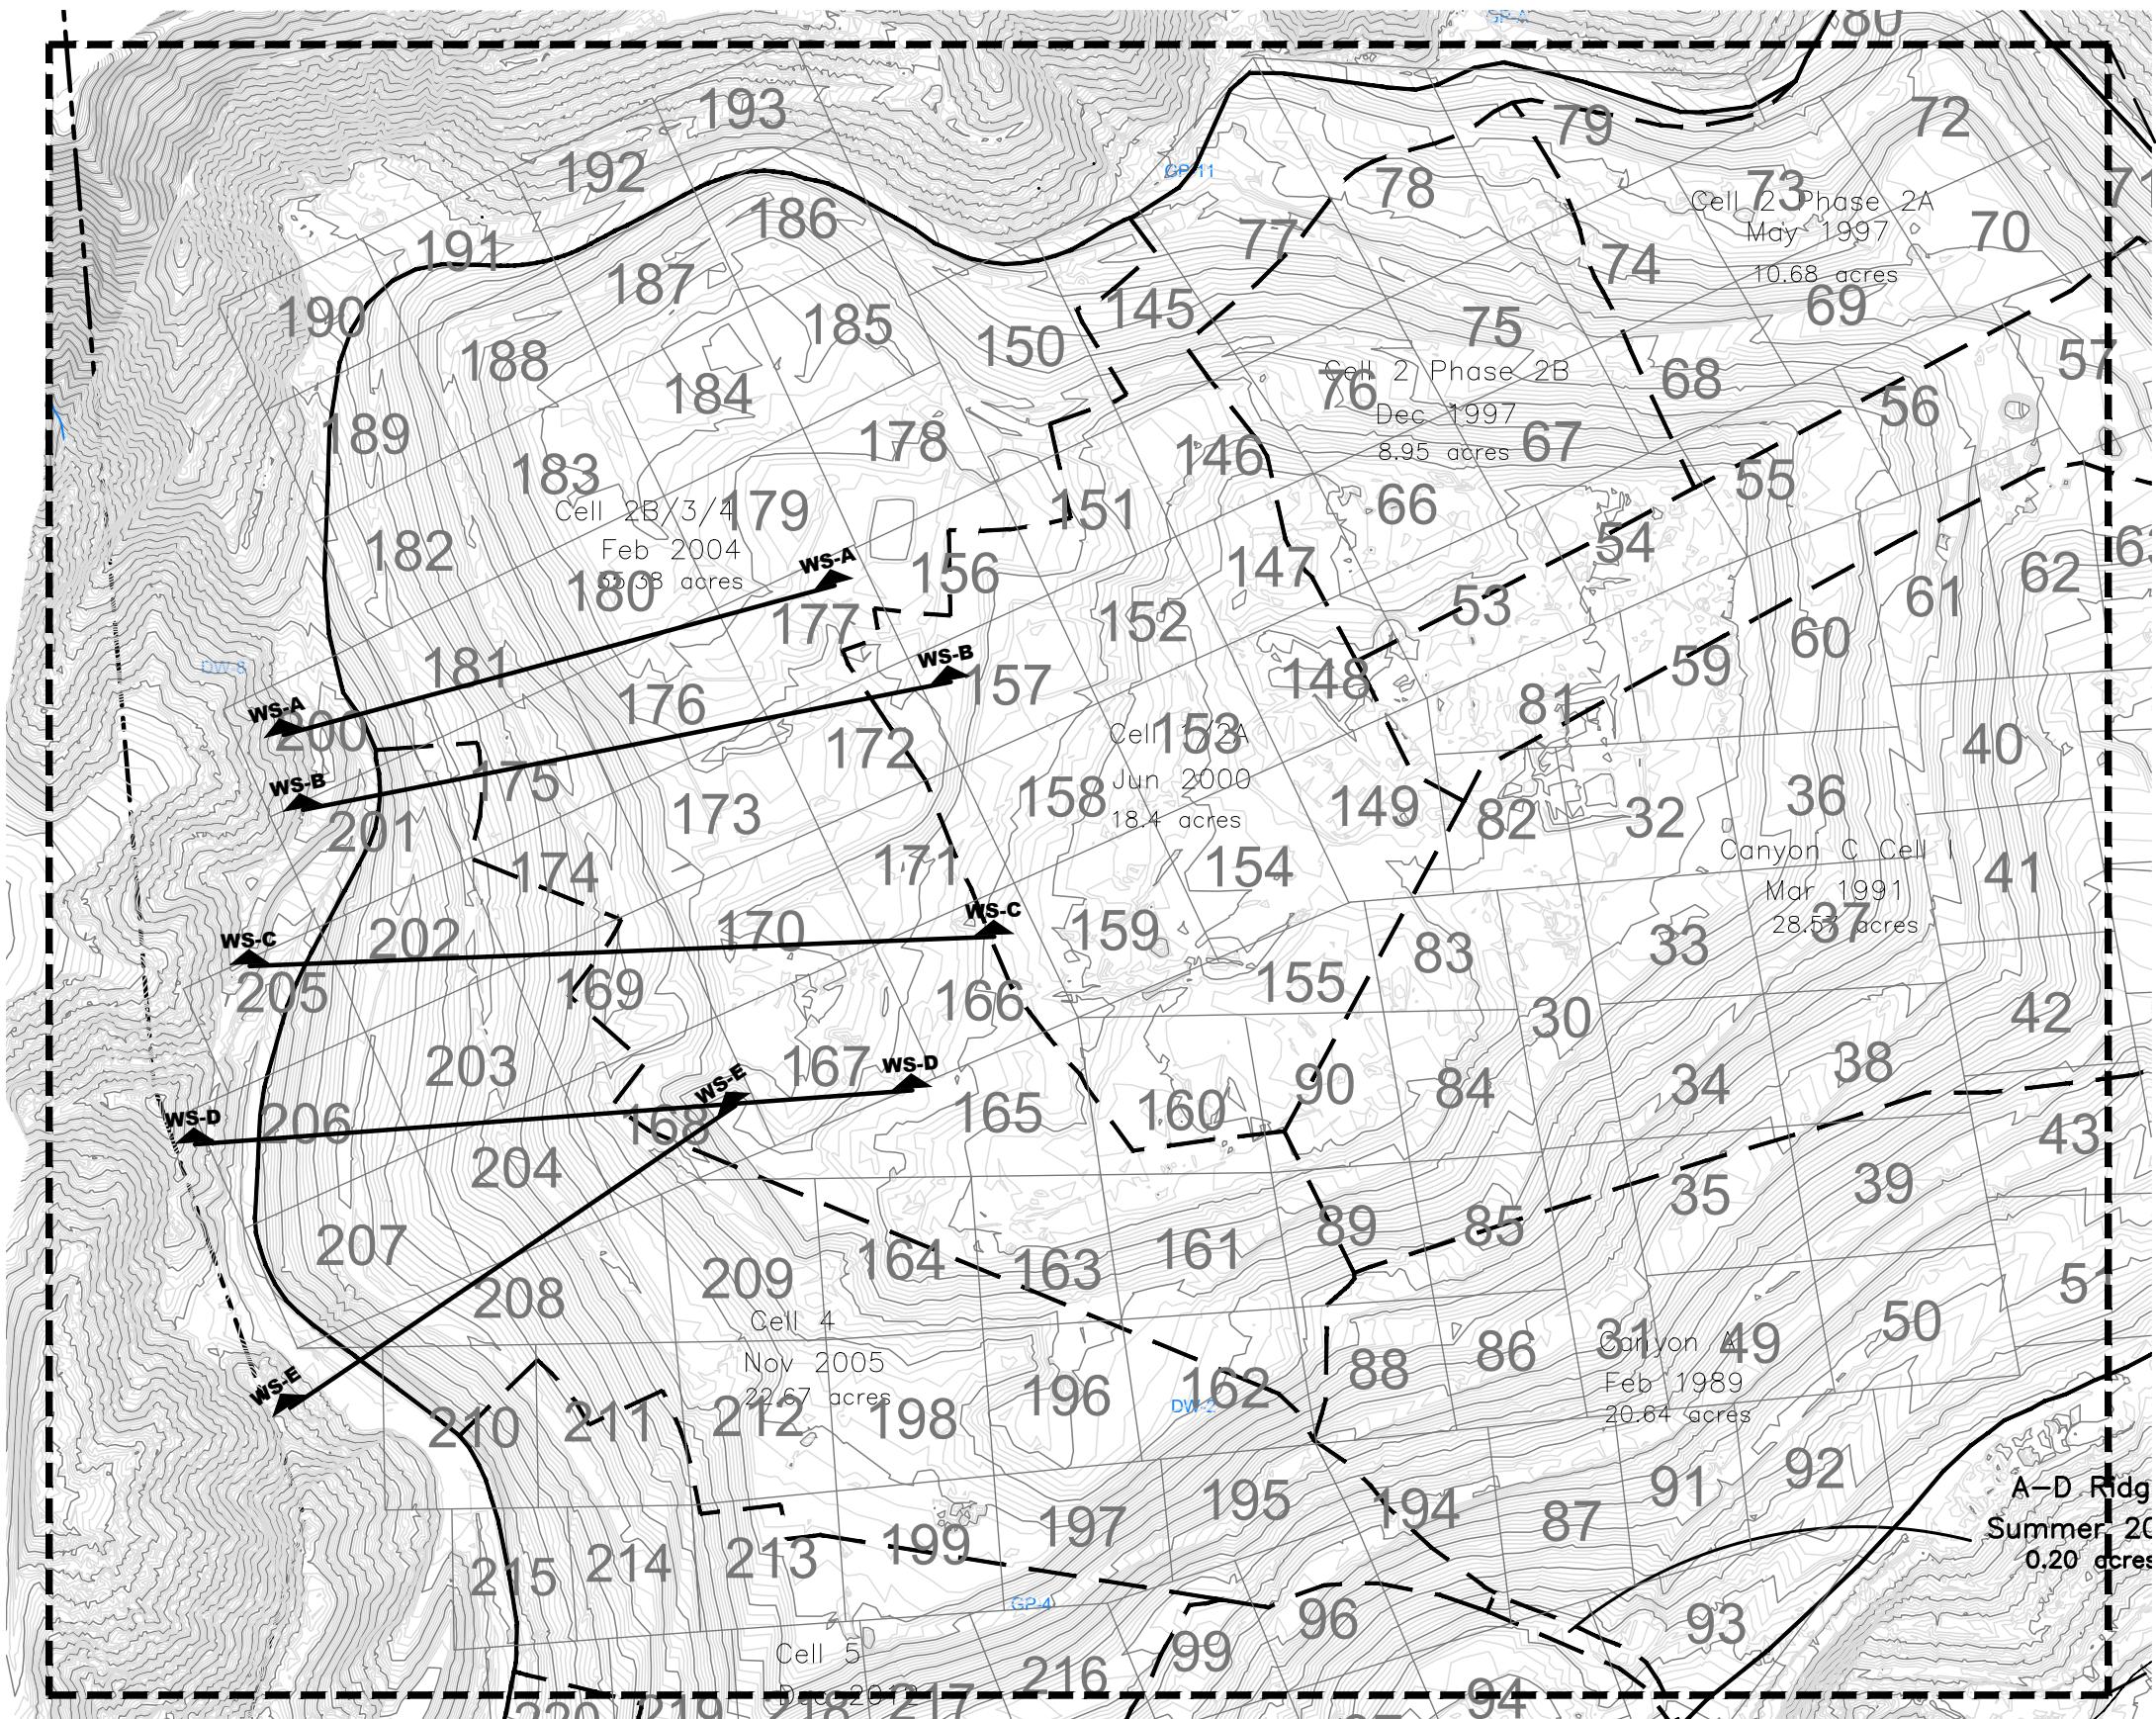
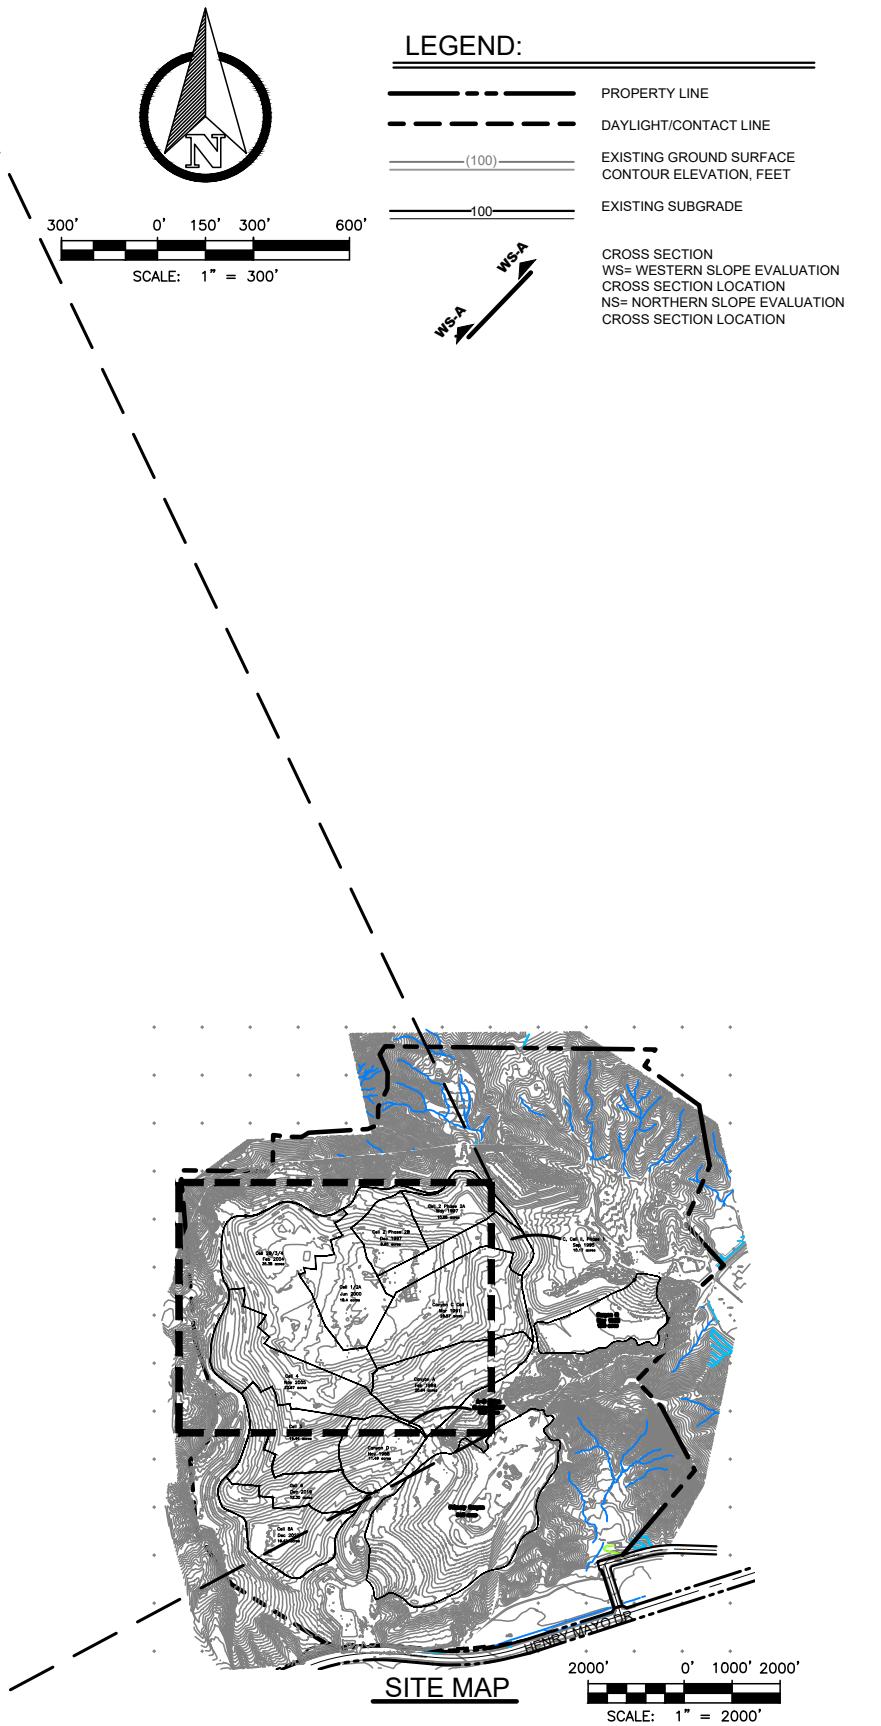
FIG NO.  
01

fissures with “medium” or “large” horizontal offset were observed in March. The locations of the grids are shown in Figure 1. This figure does not show any cracks or fissures because no cracks meeting the definition of “significant” or having a “medium” or “large” horizontal offset were observed in March.

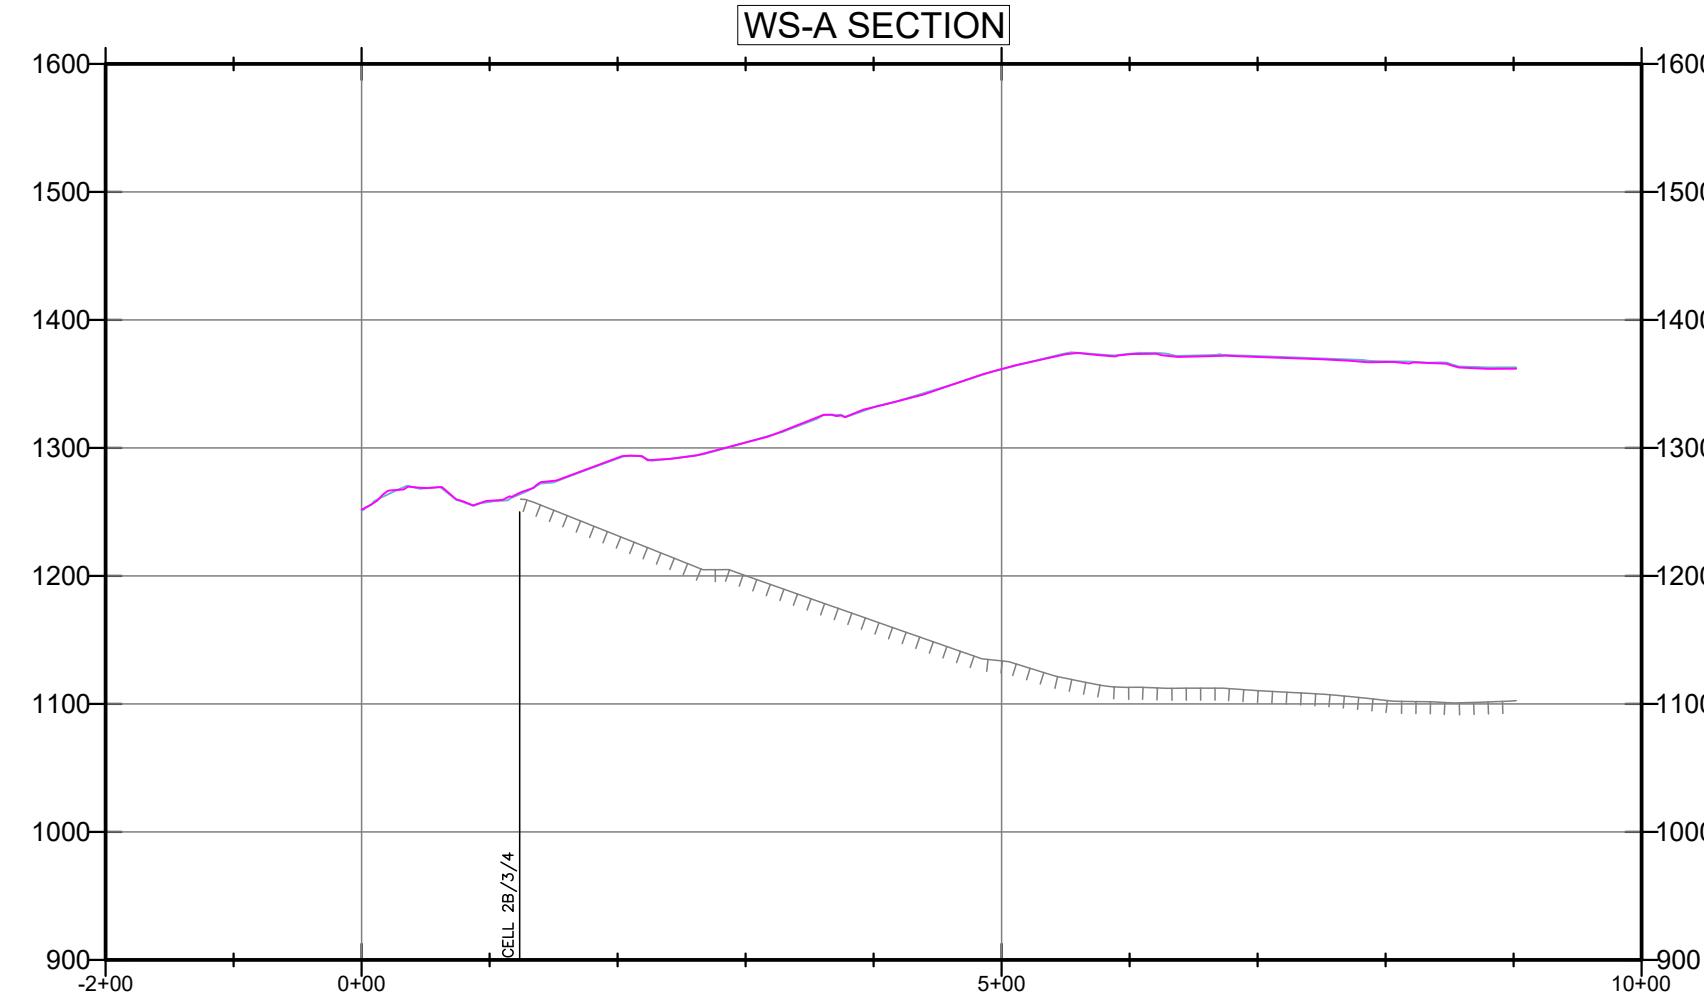
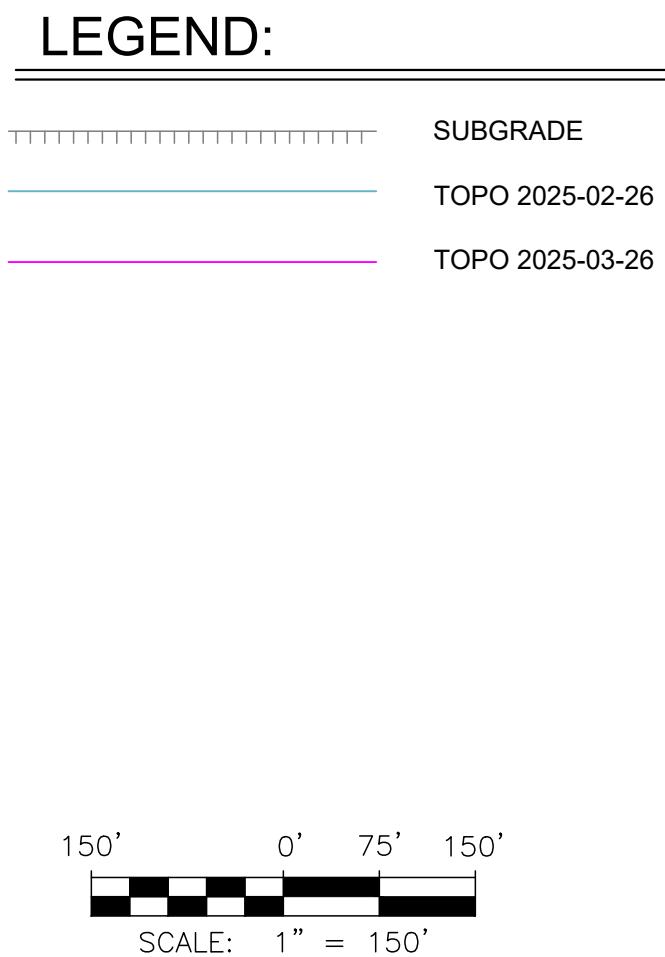
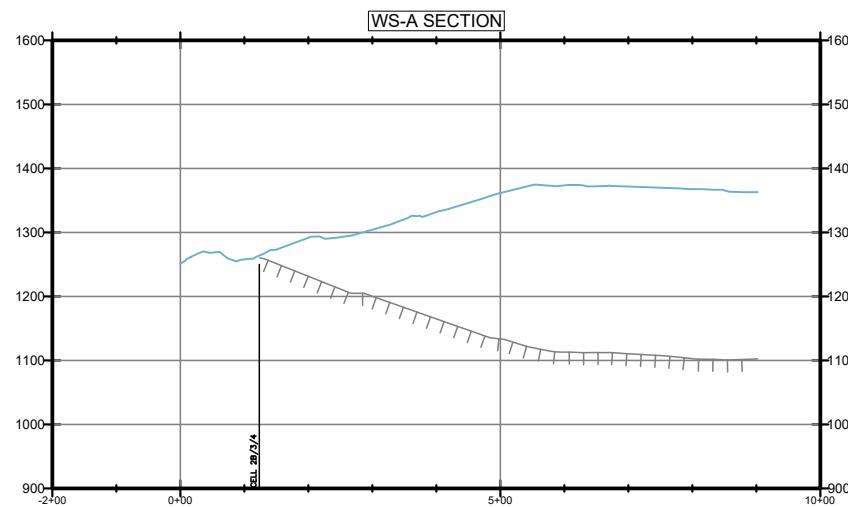
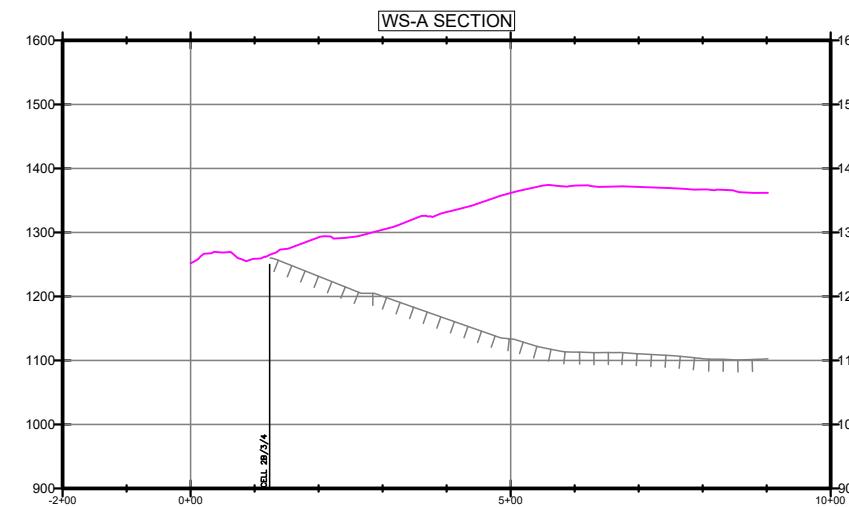
## FIGURE 2A

Cross sections that compare February 26, 2025 and March 26, 2025 topography are shown in Figures 2A through 2E. The locations of the cross sections are shown in Figure 1. The sections show no significant differences in slope between the February 2025 and March 2025 profiles, and no evidence of deformation indicative of instability, which is consistent with the daily site observations described above and the information summarized in Tables 1 and 2.
