**CHIQUITA CANYON**  
*A Waste Connections Company*

**Re: Chiquita Canyon, LLC's Weekly Report on the Documentation and Tracking of Cover Issues**

# 4050 - Chiquita Reaction Area Tracking of Fissures and Tension Cracks

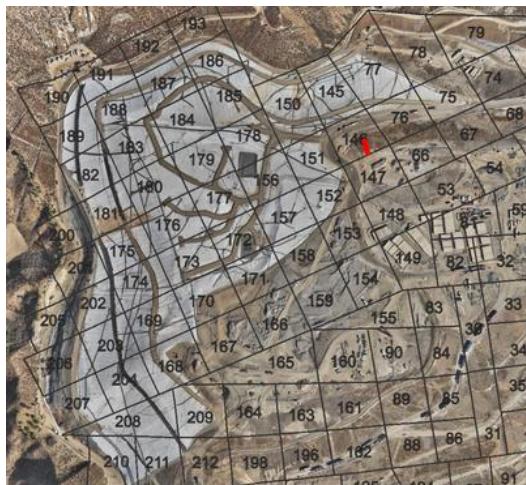
146

Yes

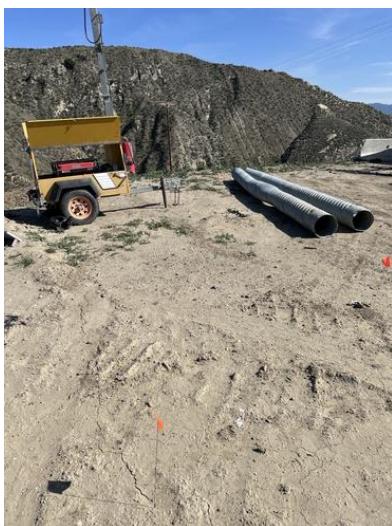
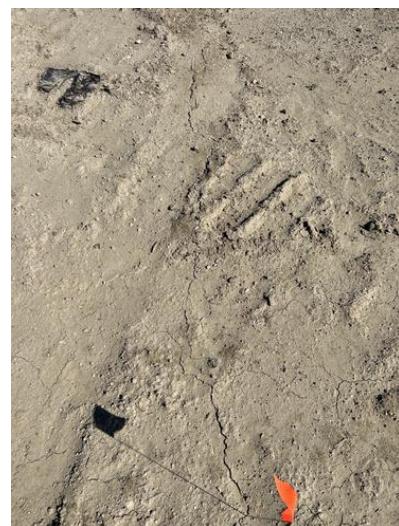
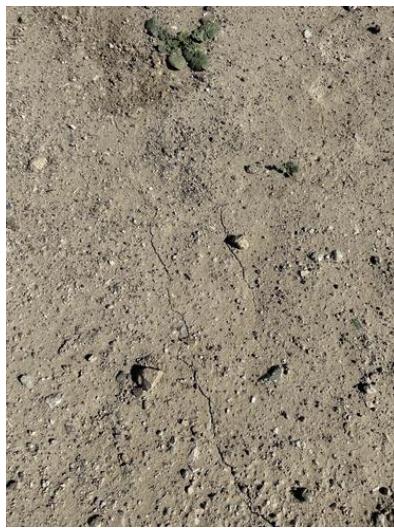
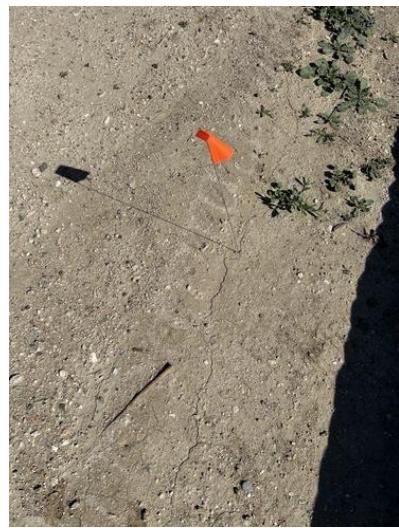
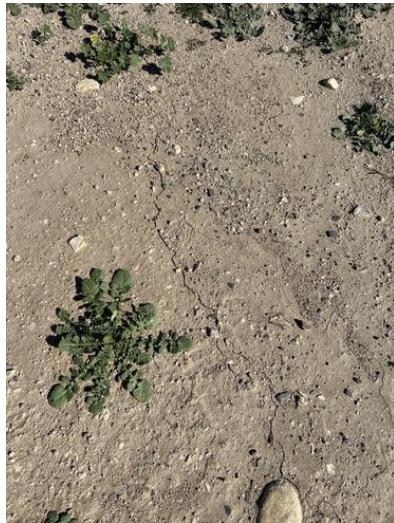
15ft x 30ft

Extra Small <0.5 in width

Extra small <0.5" in height

NW to SE

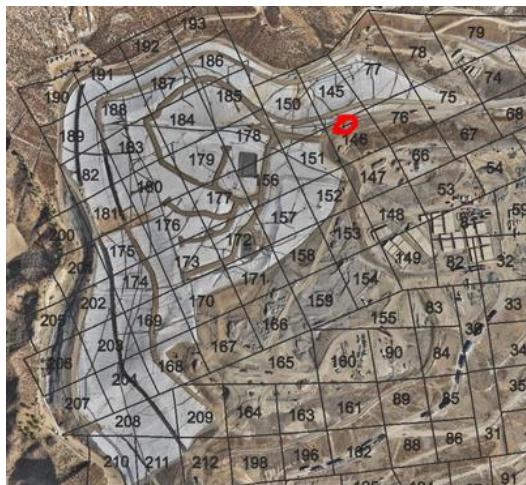
146

Yes

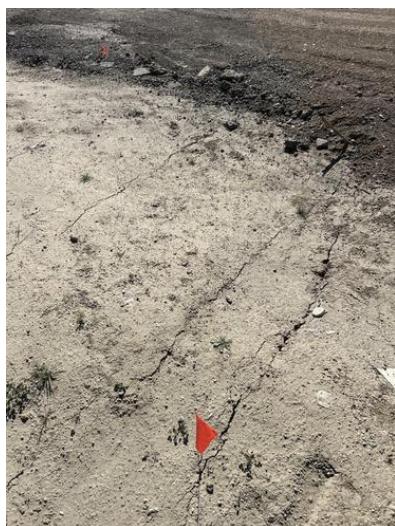
Photo 1

6ft x6ft area

Horizontal Offset (width)	Extra Small <0.5 in width
Vertical Offset (height)	Extra small <0.5" in height
Orientation (direction)	N to S

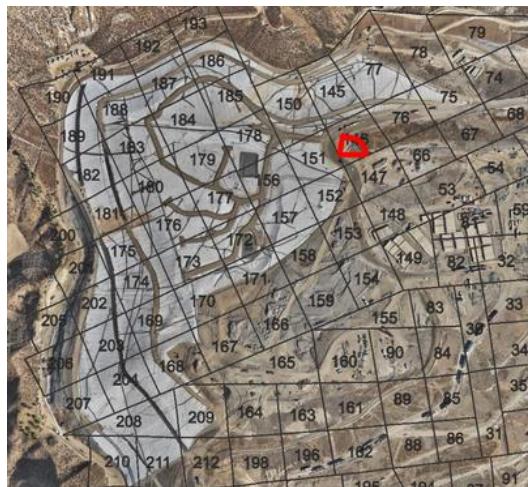
146

Fissure or Tension Crack Found?	Yes
---------------------------------	-----

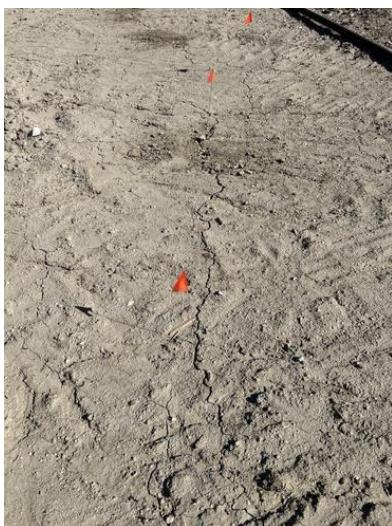
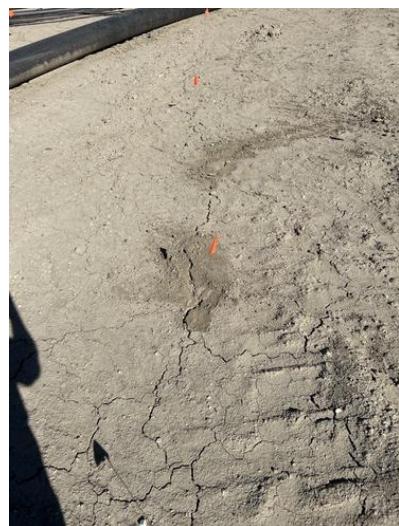
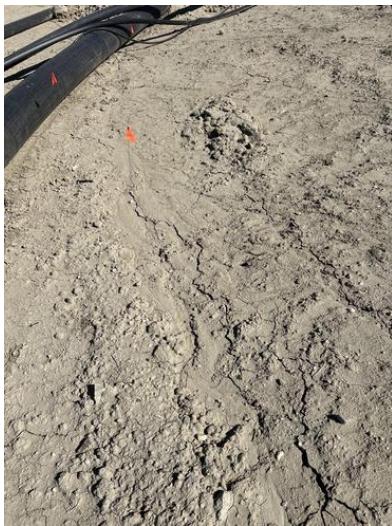
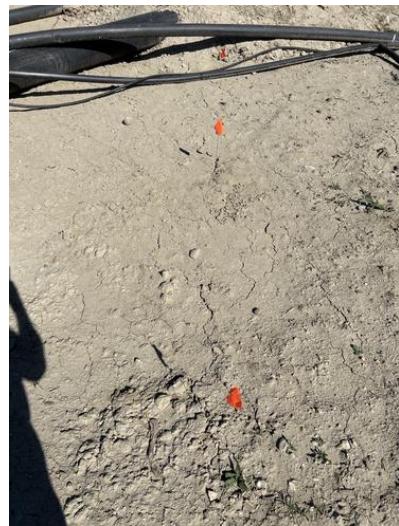
25ft x 25ft area

Extra Small <0.5 in width

Extra small <0.5" in height

N to S

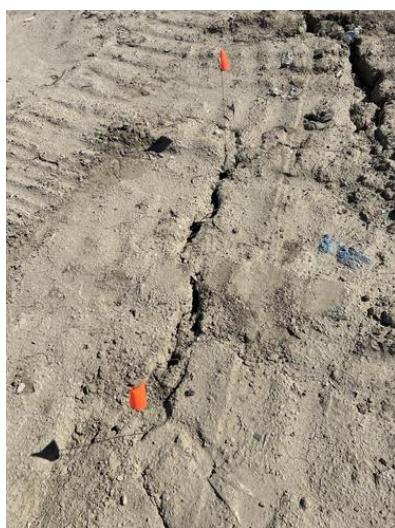
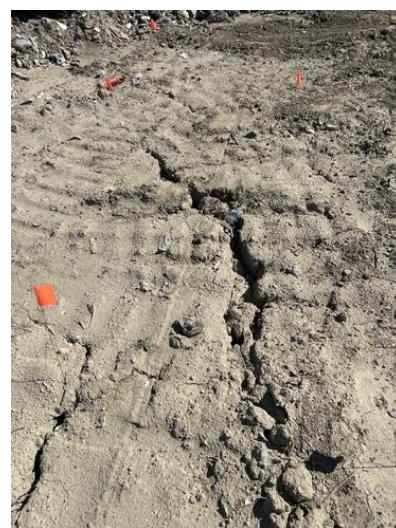
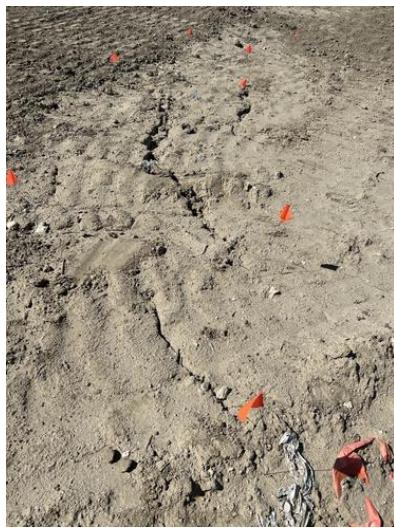
4ft x10ft area

Medium 2-4" in width

Extra small <0.5" in height

E to W

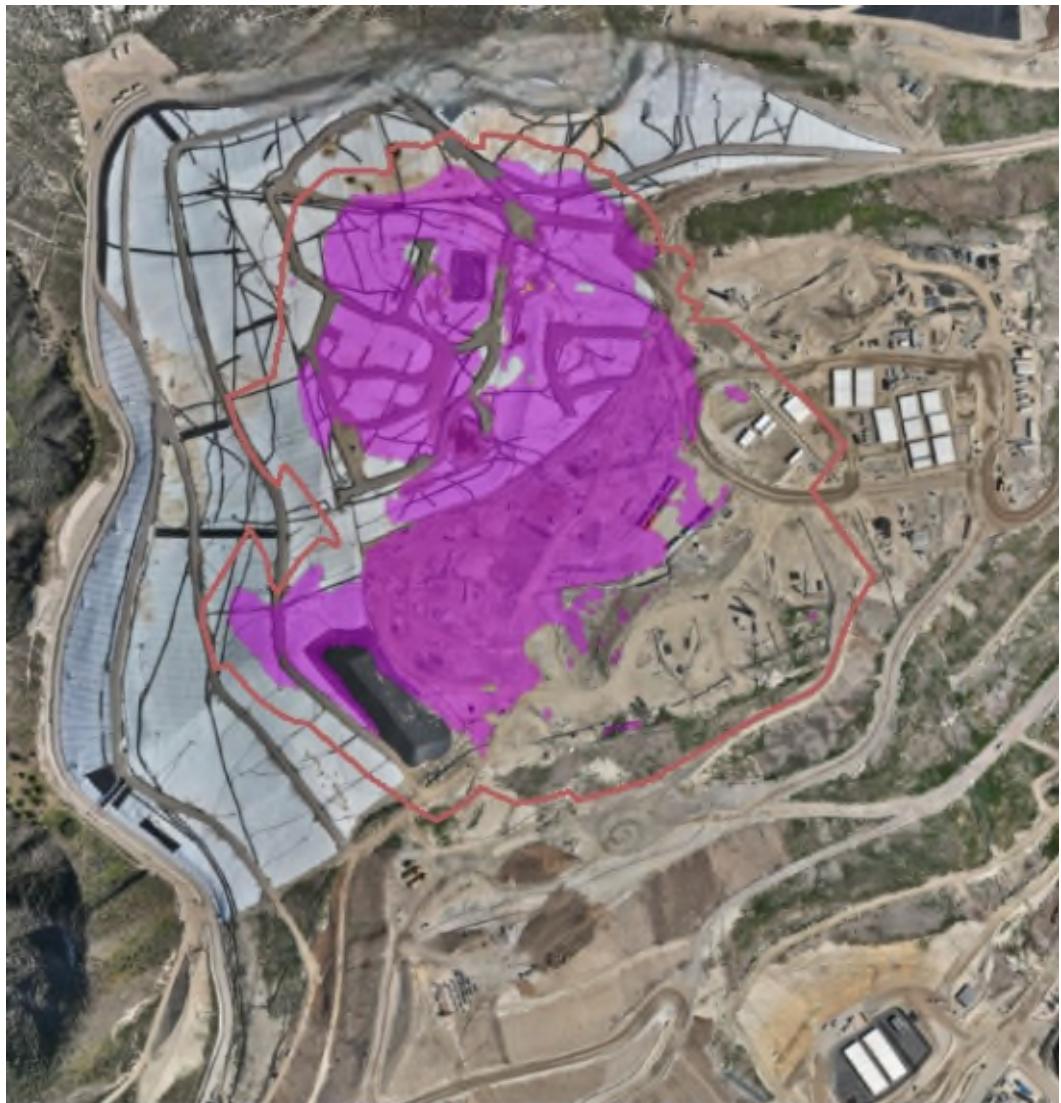
- The charts on the following page show the settlement in cubic yards measured at a fixed location.
- The map shows the area between 4/10/2024 and 4/9/2025 where the grades have changed more than 10 feet. A typical MSW strain rate is 3% per year - for a landfill with a 300-foot waste column, this would be 9 feet per year.

- During normal site operations before site closure, large stockpiles of rock materials were maintained, and sometimes moved as other operations necessitated. The areas used for these material stockpiles were south and east of the lined area. There is not a way to differentiate between settlement and stockpile movements.

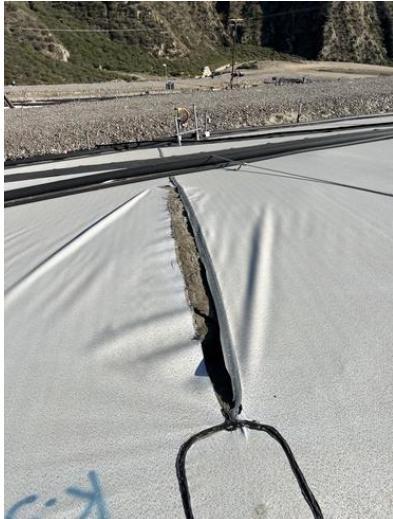
Photo 1

15 ft tear/separation in liner at seam in Grid 145. Need to be patched and extrusion welded.

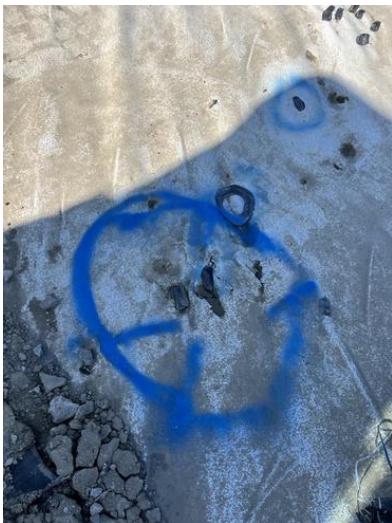
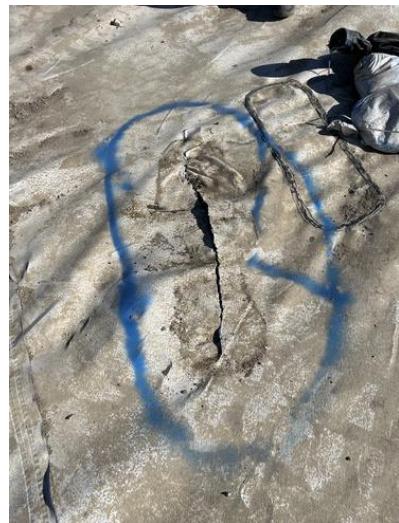
Two tears near each other in grid 178 need to be patched and extrusion welded.
