**CHIQUITA CANYON**  
*A Waste Connections Company*

**Re: Chiquita Canyon, LLC's Weekly Report on the Documentation and Tracking of Cover Issues**

Attachment: April 14, 2025 Weekly Cover Issues Report

# **Fissures and Tension Cracks**

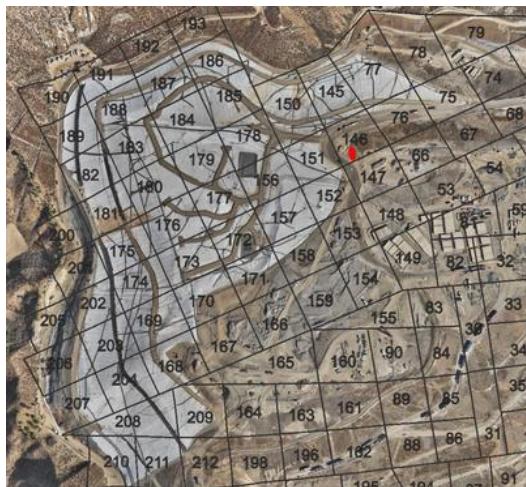
146

**Using the attached image, annotate all areas where inspectors identified a fissure or tension crack.**

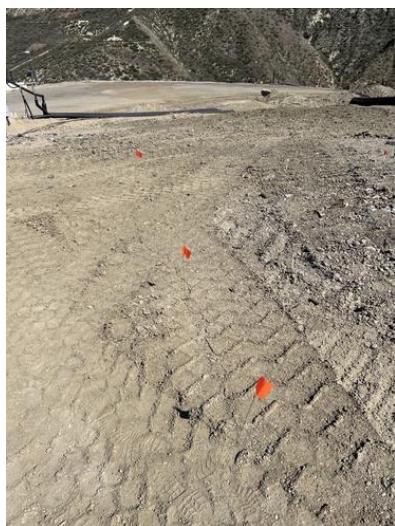
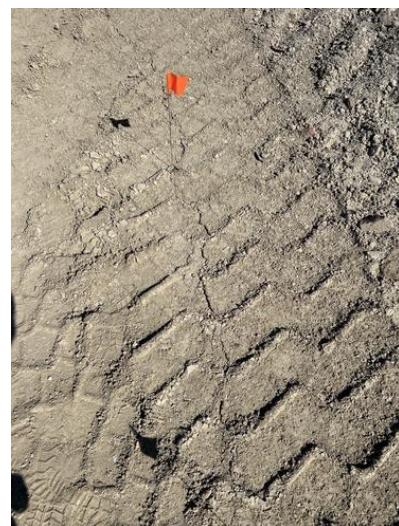
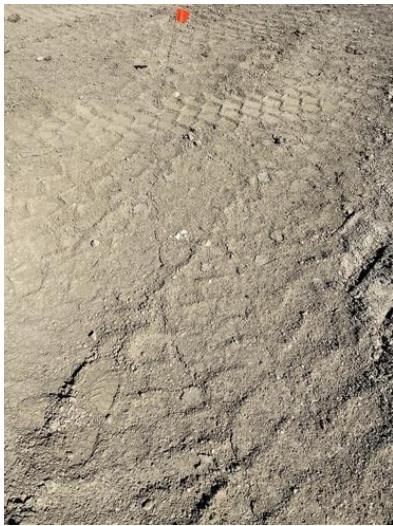
15 ft

Extra Small <0.5 in width

Extra small <0.5" in height

NW to SE

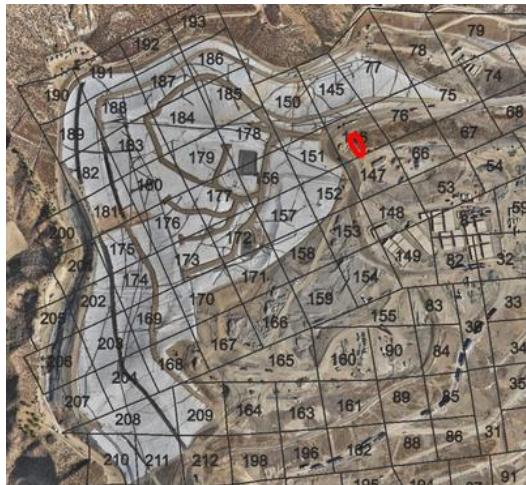
146

**Using the attached image, annotate all areas where inspectors identified a fissure or tension crack.**

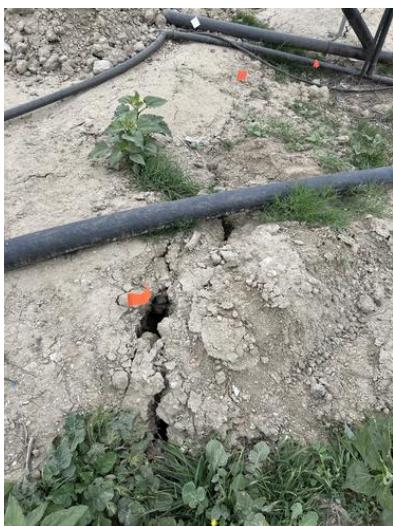
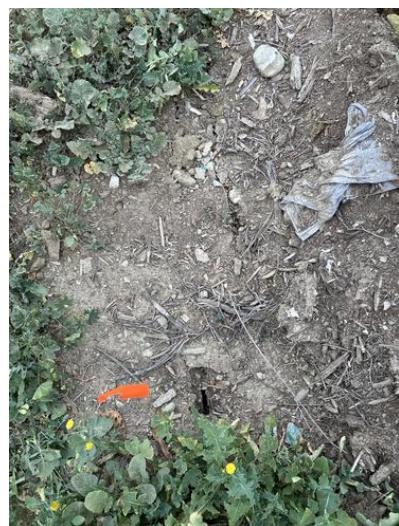
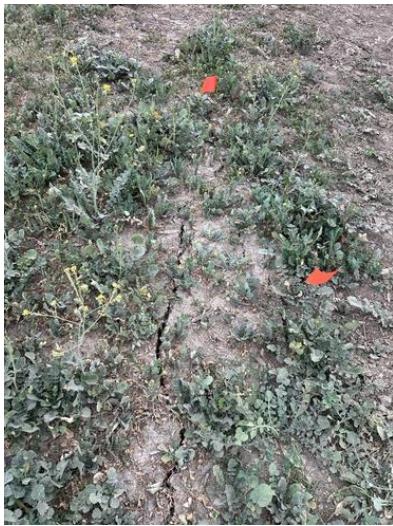
25ft

Medium 2-4" in width

Extra small <0.5" in height

NW to SE

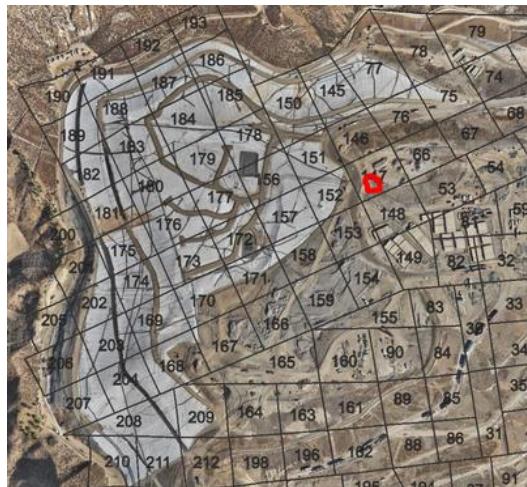
147

**Using the attached image, annotate all areas where inspectors identified a fissure or tension crack.**

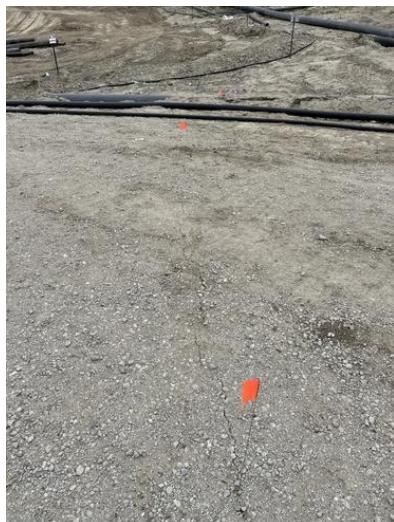
Photo 6

20ft

Extra Small <0.5 in width

Extra small <0.5" in height

N to S

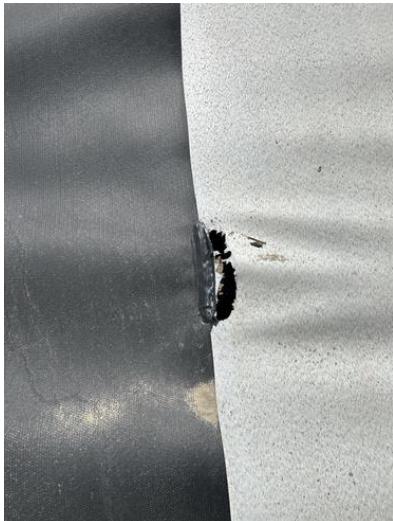
Photo 1

5 inch tear in liner found at 1:10 pm in grid 145. Needs to be extrusion welded.
