CHIQUITA CANYON
A Waste Connections Company

Re: Chiquita Canyon, LLC's Weekly Report on the Documentation and Tracking of Cover Issues

4050 - Chiquita Reaction Area Tracking of Fissures and Tension Cracks

4050 - Geosynthetic Cover Inspection

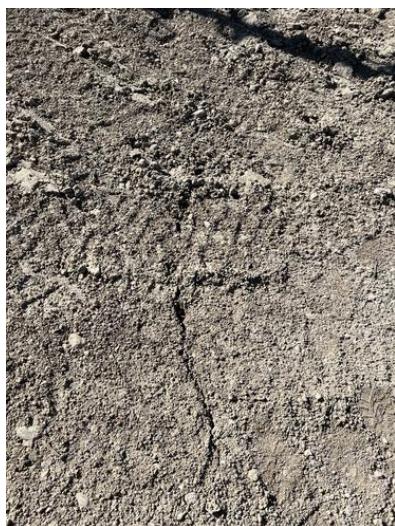
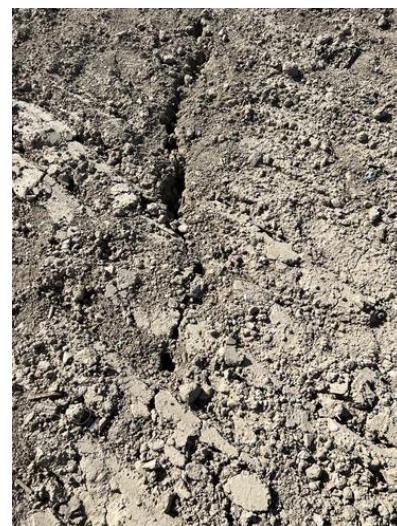
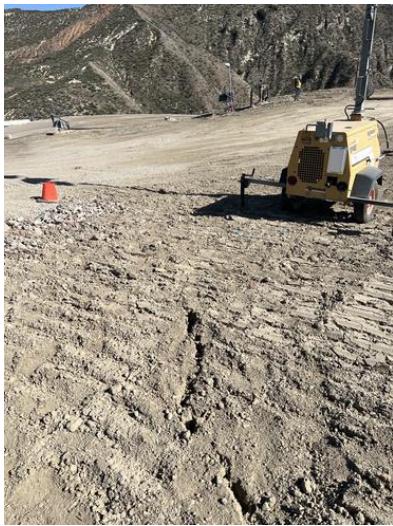
147

35 ft

Medium 2-4" in width

Extra small <0.5" in height

NW to SE

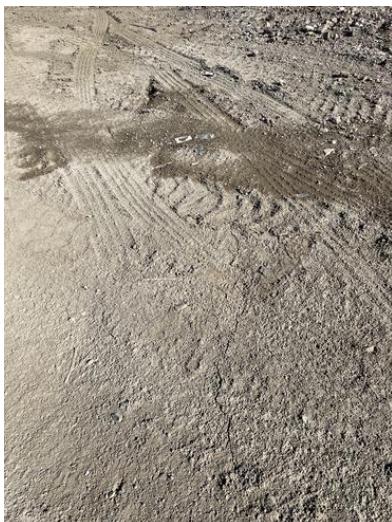
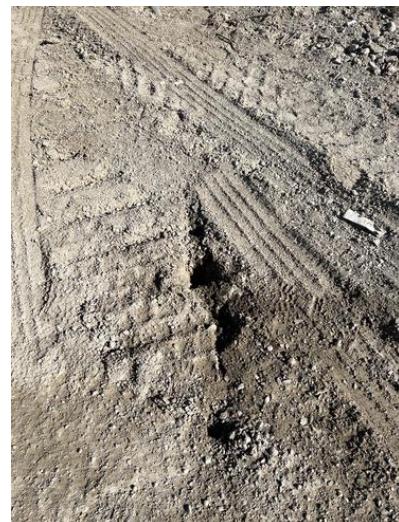
146

20 ft

Medium 2-4" in width

Extra small <0.5" in height

NW to SE

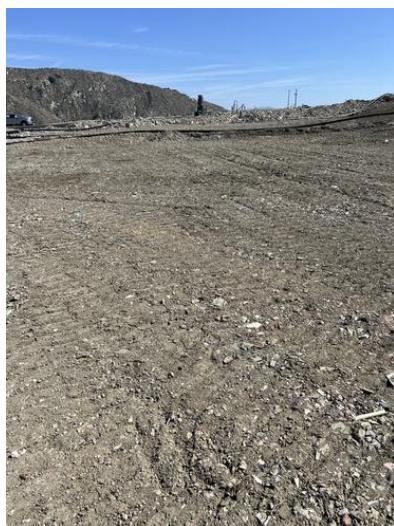
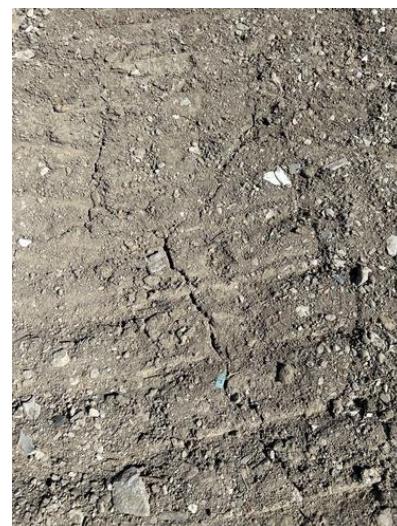
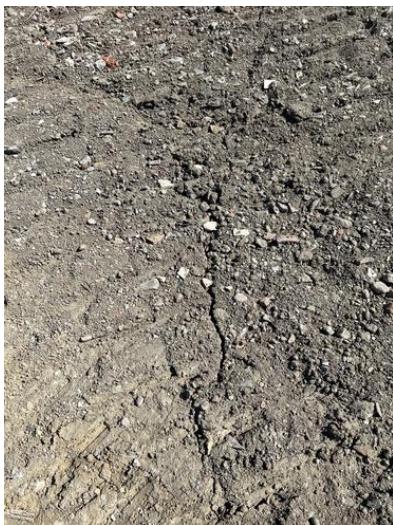
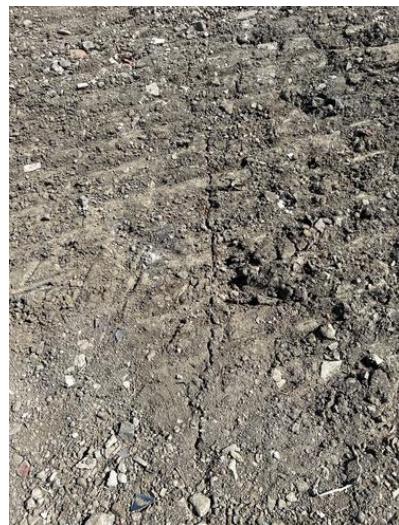
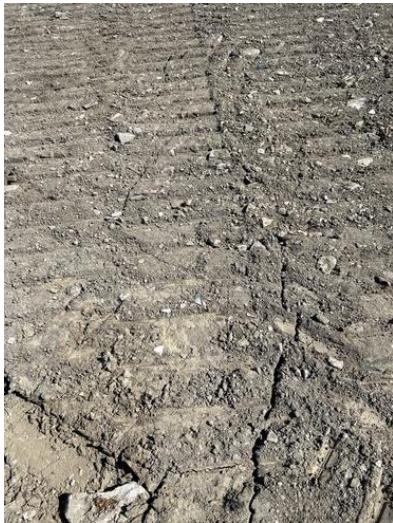
165

20 ft x 60 ft

Small 0.5-2" in width

Extra small <0.5" in height

N to S

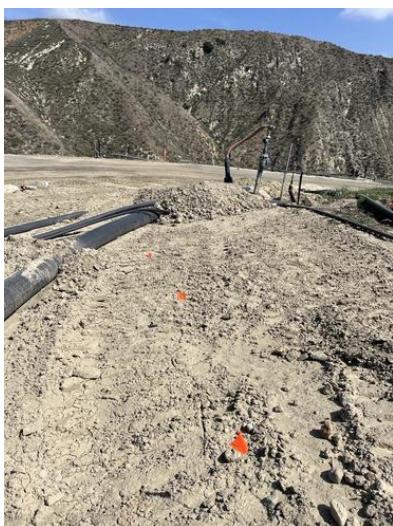
146

12ft

Horizontal Offset (width)	Extra Small <0.5 in width
Vertical Offset (height)	Extra small <0.5" in height
Orientation (direction)	NW to SE

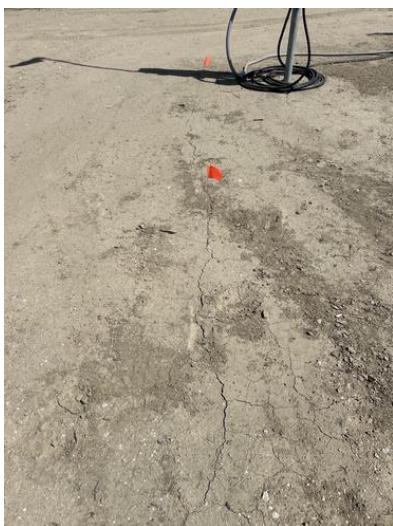
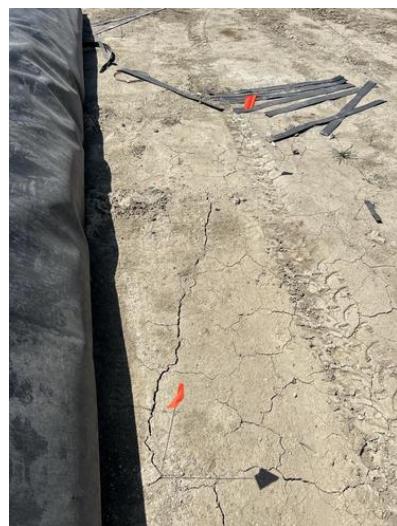
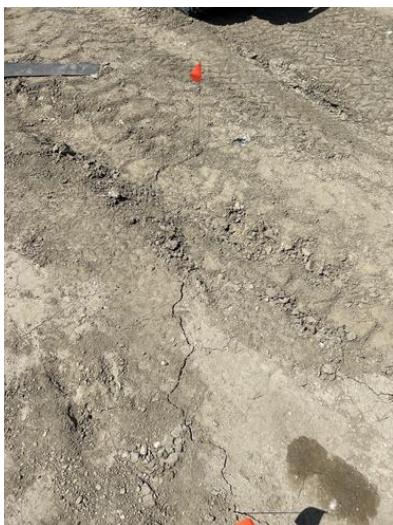
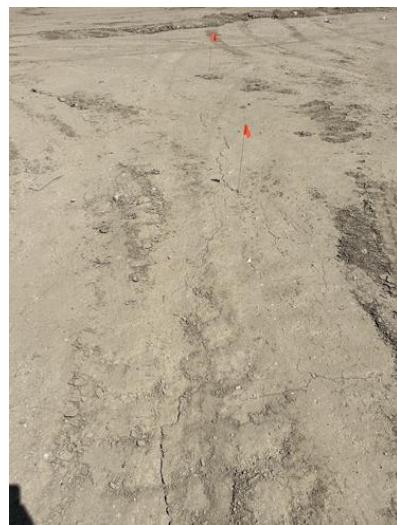
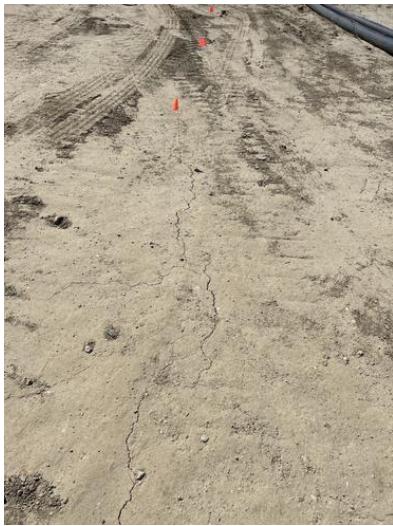
160

20ft x20ft area

Extra Small <0.5 in width

Extra small <0.5" in height

N to S

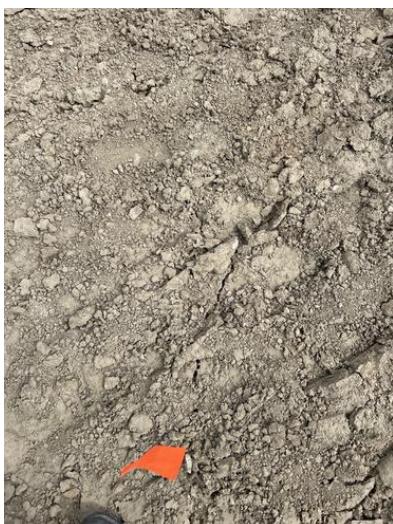
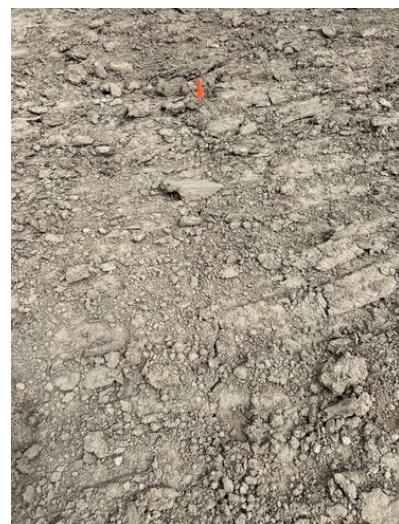
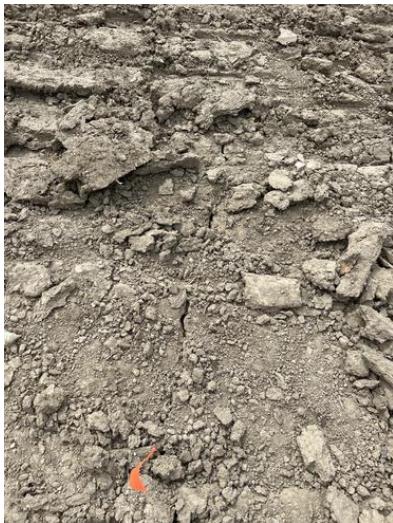
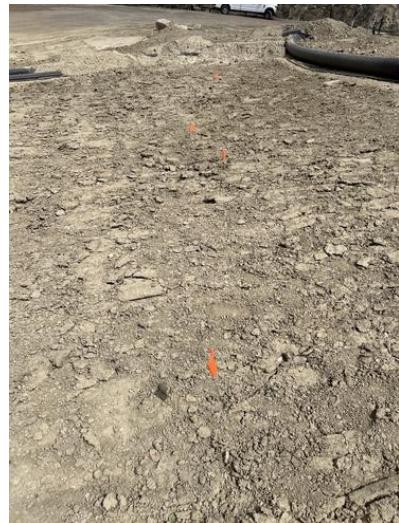
146

20ft

Extra Small <0.5 in width

Extra small <0.5" in height

NW to SE

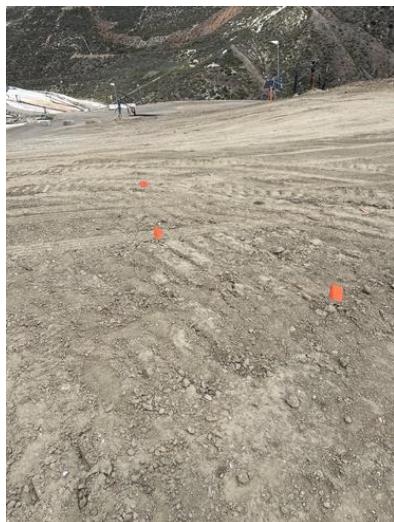
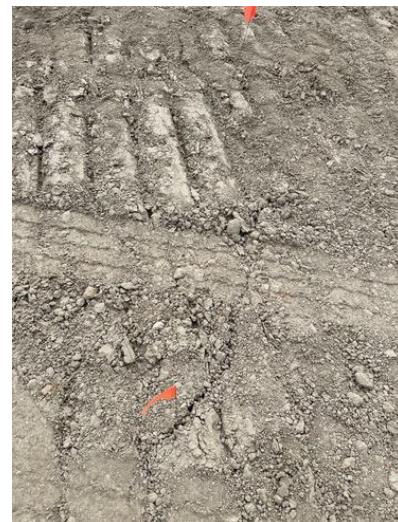
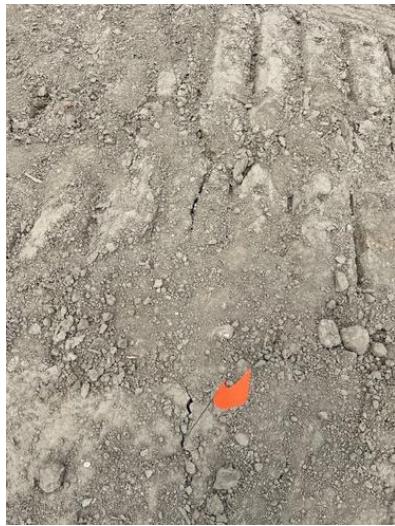
147

6ft

Extra Small <0.5 in width

Extra small <0.5" in height

NW to SE

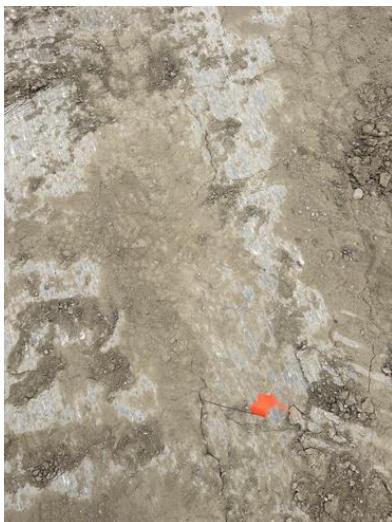
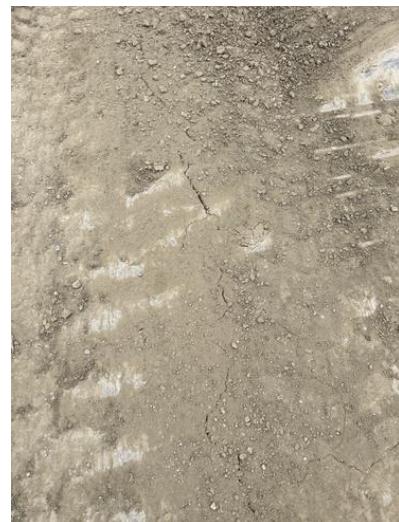
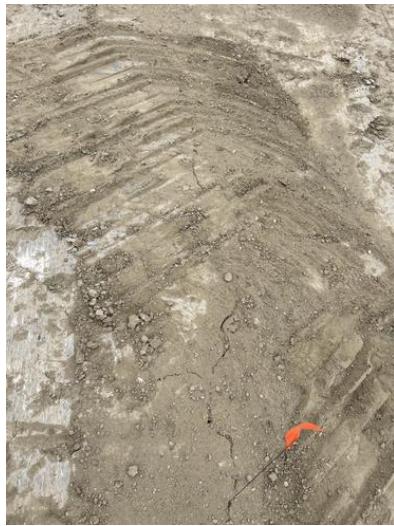
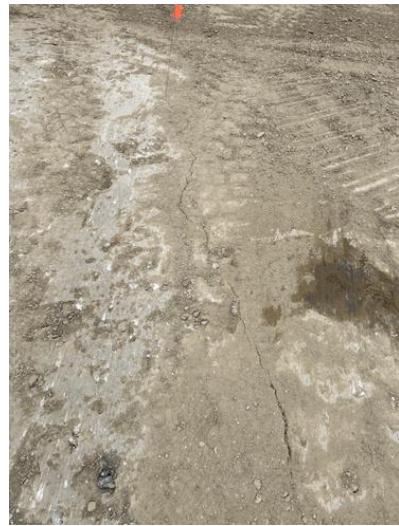
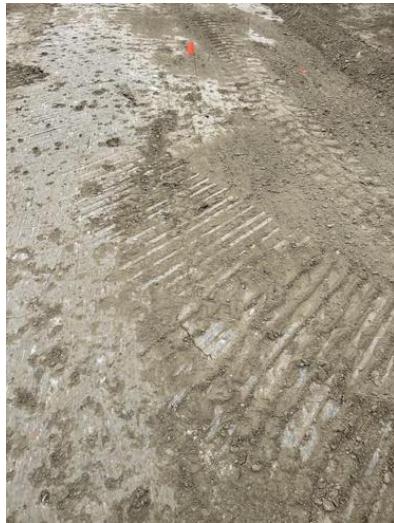
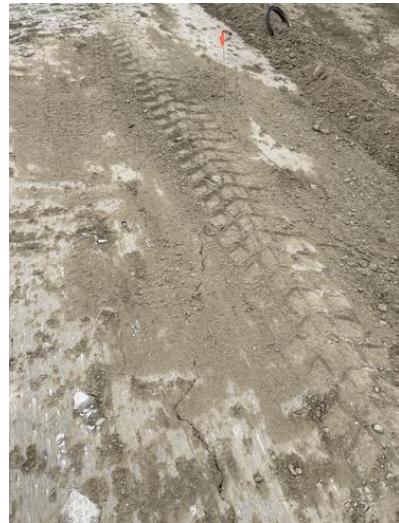
160

7ft x 25ft area

Extra Small <0.5 in width

Extra small <0.5" in height

N to S

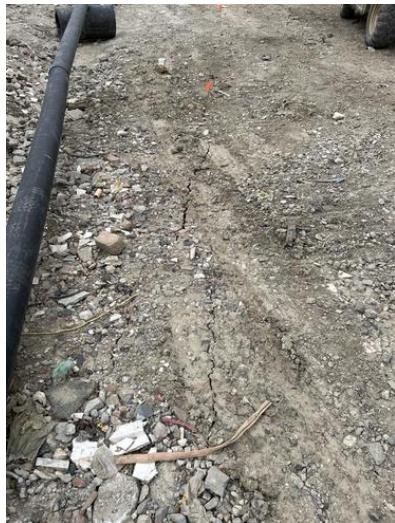
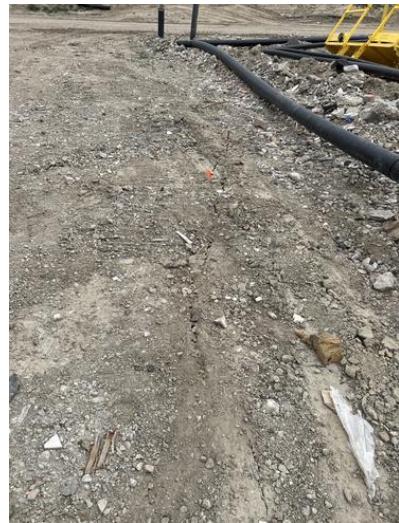
154

25ft

Small 0.5-2" in width

Extra small <0.5" in height

NE to SW

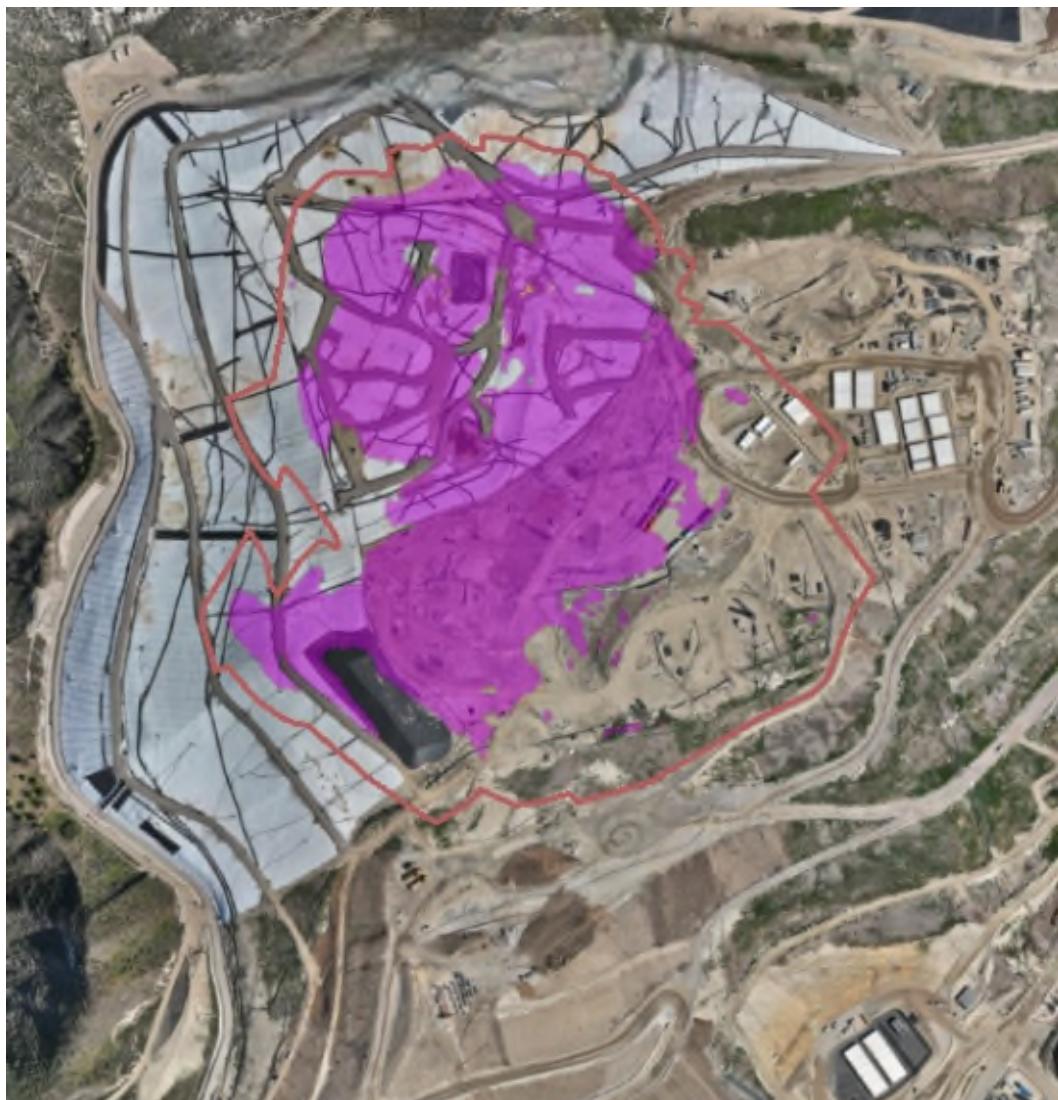
Settlement area between 4/10/2024 and 4/9/2025, submitted on 4/15/2025, and provided again herein for comparison

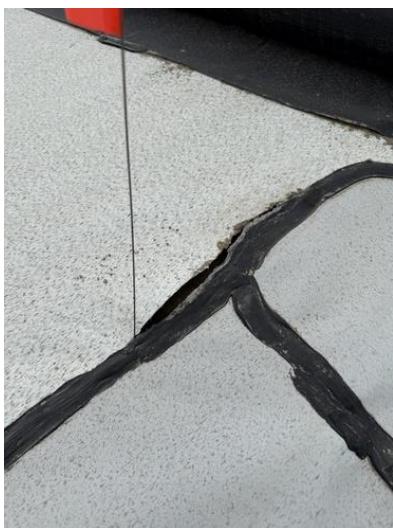
Grid 145

Liner separated at seam. Patch needed

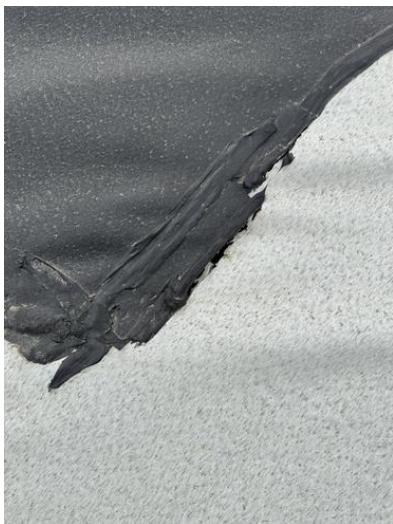
Grid 145

Liner separated at seam. Needs to be patched

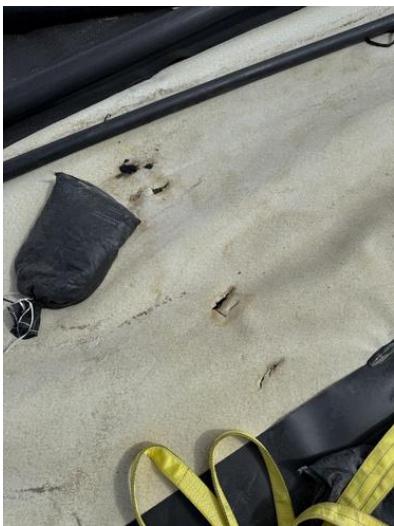
Grid 150

Punctures through liner. Liner needs to be patched
