**CHIQUITA CANYON**  
*A Waste Connections Company*

**Re: Chiquita Canyon, LLC's Weekly Report on the Documentation and Tracking of Cover Issues**

# 4050 - Chiquita Reaction Area Tracking of Fissures and Tension Cracks

# 4050 - Geosynthetic Cover Inspection

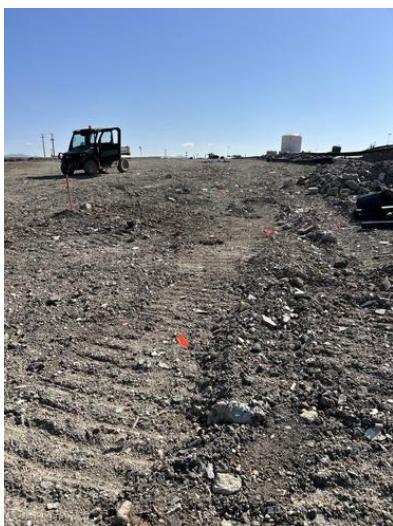
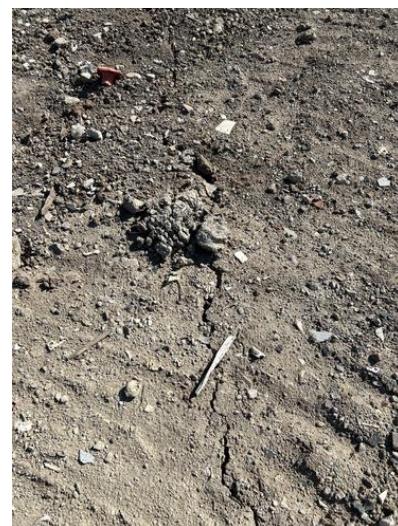
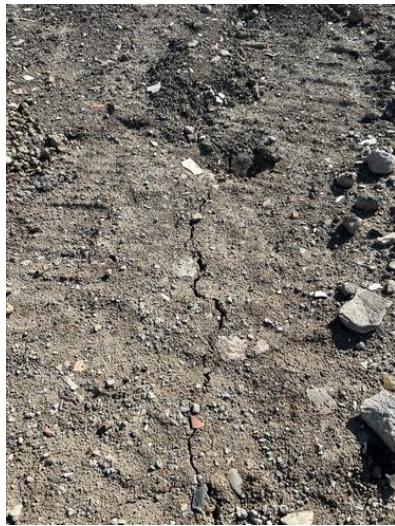
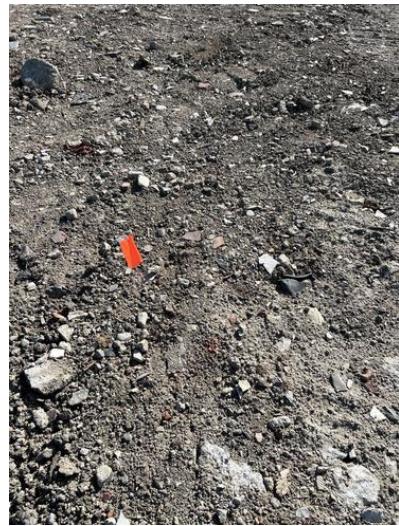
159

45 ft

Small 0.5-2" in width

Extra small <0.5" in height

NE to SW

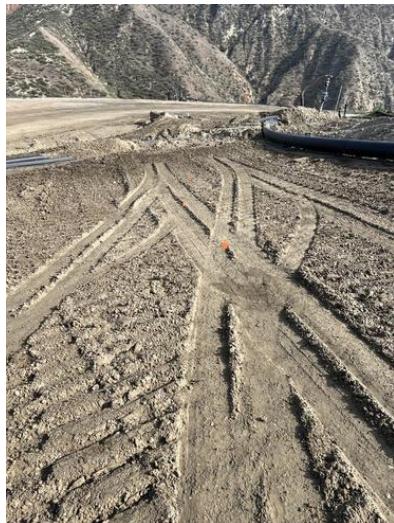
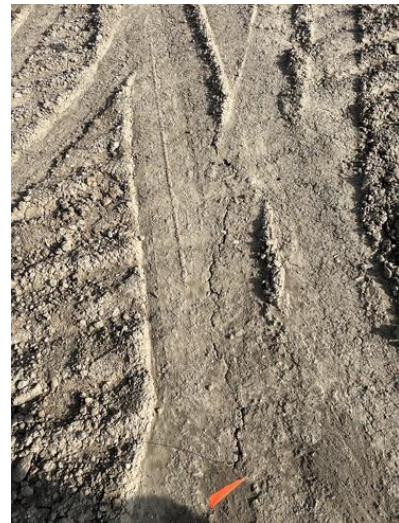
146

16ft

Horizontal Offset (width)	Extra Small <0.5 in width
Vertical Offset (height)	Extra small <0.5" in height
Orientation (direction)	N to S

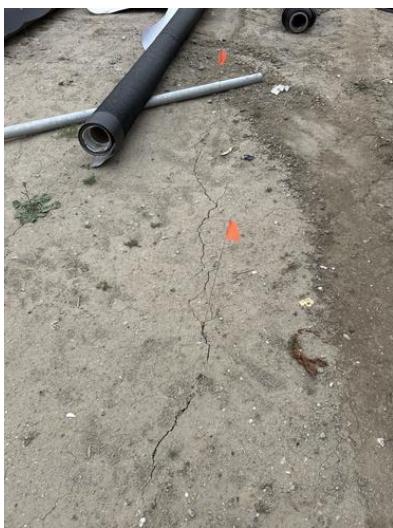
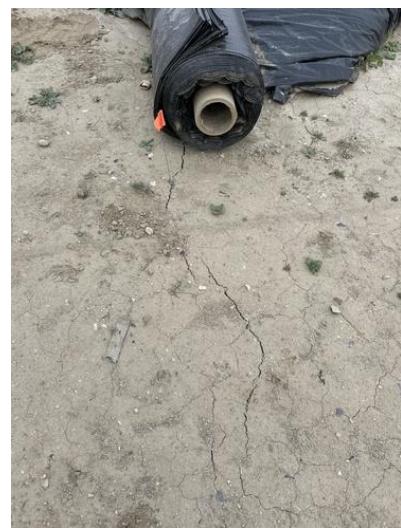
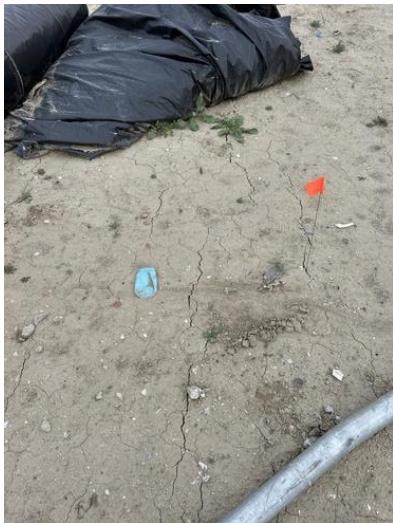
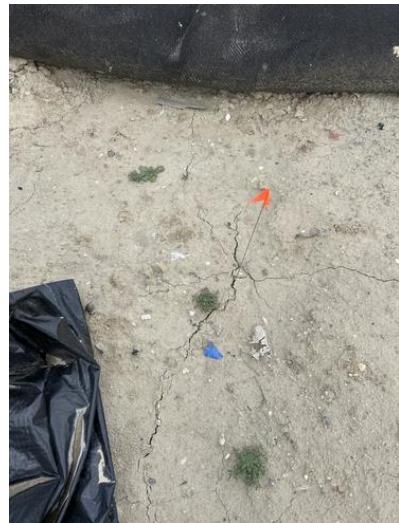
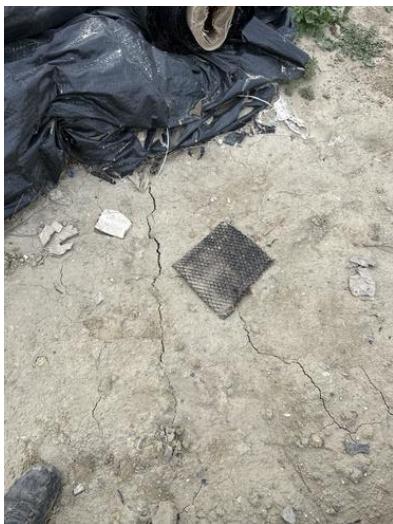
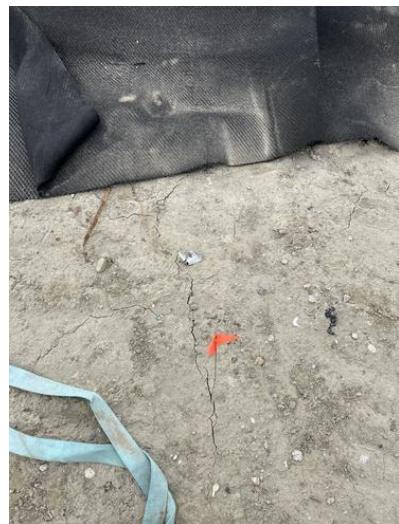
154

20ft x 10ft area

Extra Small <0.5 in width

Extra small <0.5" in height

NE to SW

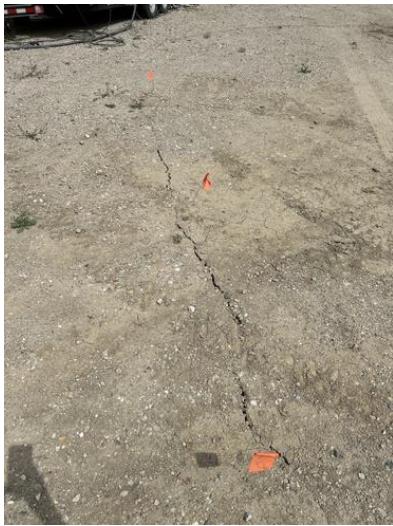
90

7ft

Extra Small <0.5 in width

Extra small <0.5" in height

NW to SE

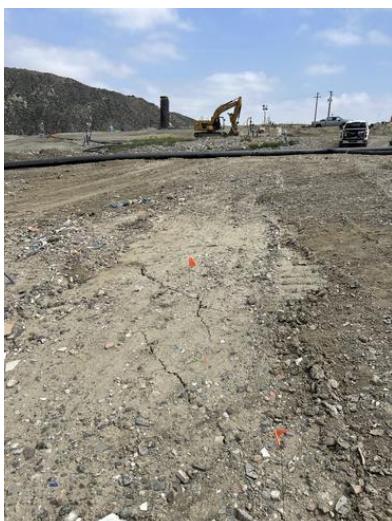
159

8ft

Small 0.5-2" in width

Extra small <0.5" in height

N to S

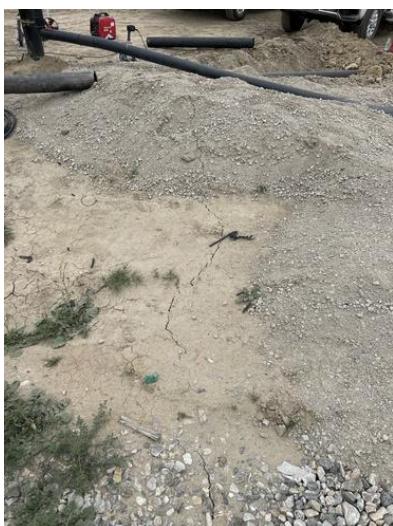
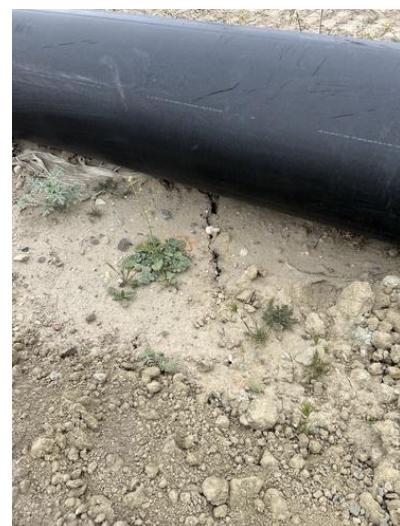
148

20ft x3ft area

Horizontal Offset (width)	Small 0.5-2" in width
Vertical Offset (height)	Extra small <0.5" in height
Orientation (direction)	N to S

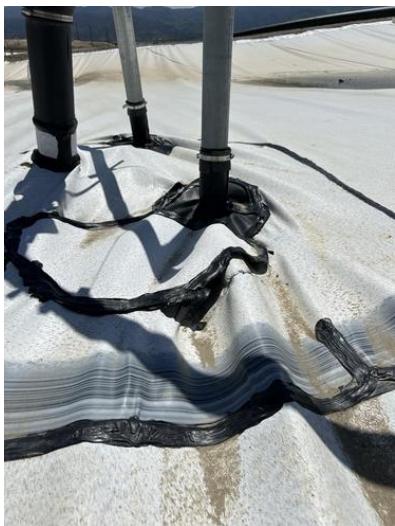
Photo 1

A weld came free and needs to be patched/extrusion welded.

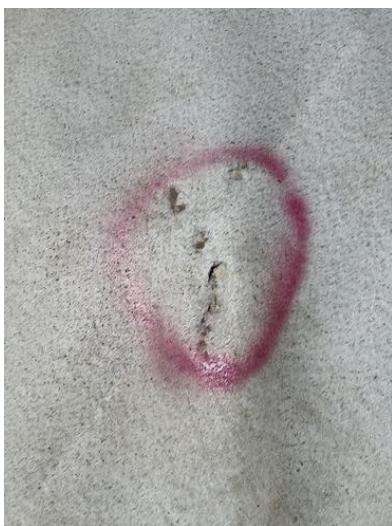
Found 4/28/25 at 2:17pm. Grid 185

Puncture in cover needs to be extrusion welded.

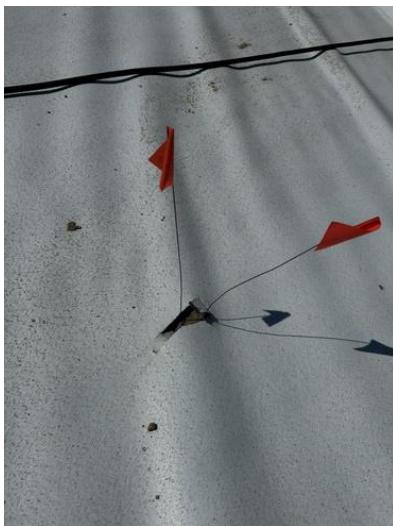
Found 5/2/25 at 12:15. Grid 181

Tear in liner. Needs to be patched
