CHIQUITA CANYON

Re: Chiquita Canyon, LLC's Weekly Report on the Documentation and Tracking of Cover Issues and Monthly Summary

4050 - Chiquita Reaction Area Tracking of Fissures and Tension Cracks

**APRIL 2025 FISSURE AND TENSION CRACK MONITORING SUMMARY
CHIQUITA CANYON LANDFILL
CASTAIC, CALIFORNIA**

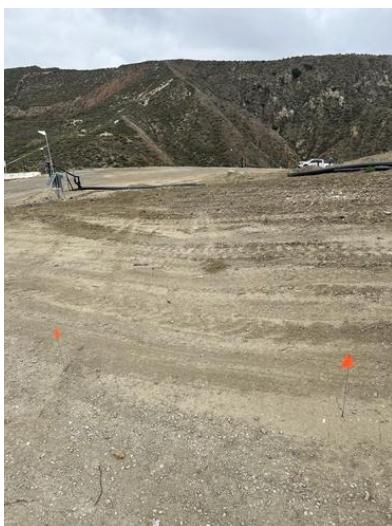
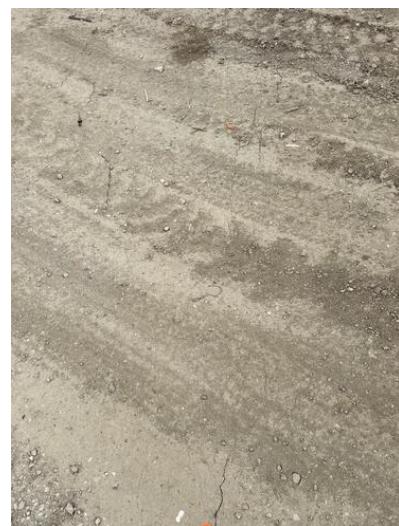
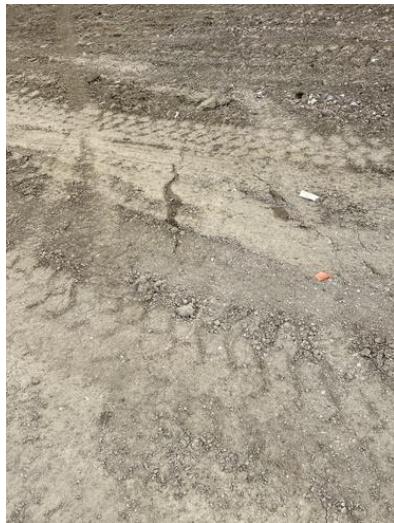
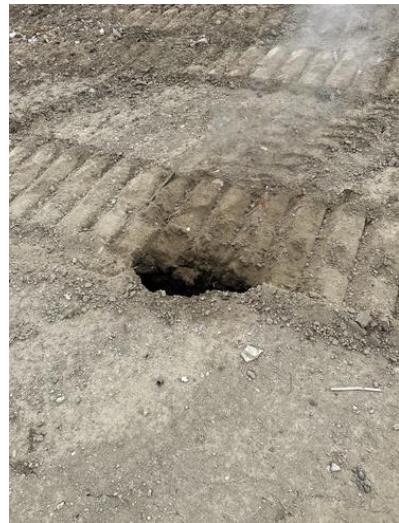
10ft x 25ft

Large >4" in width

Opened wider as it was being track walked

Extra small <0.5" in height

NW to SE

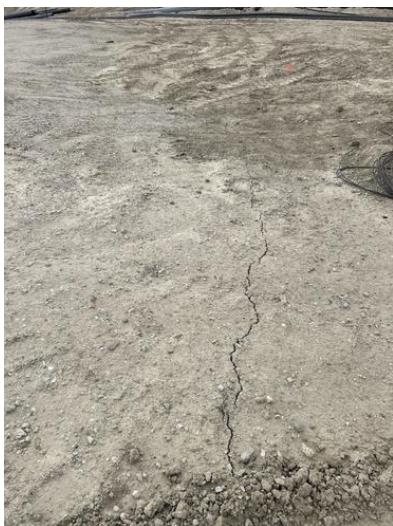
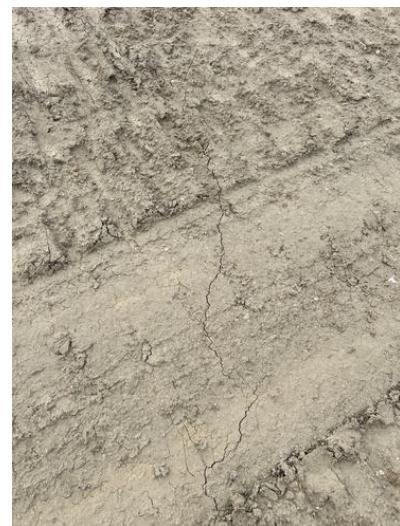
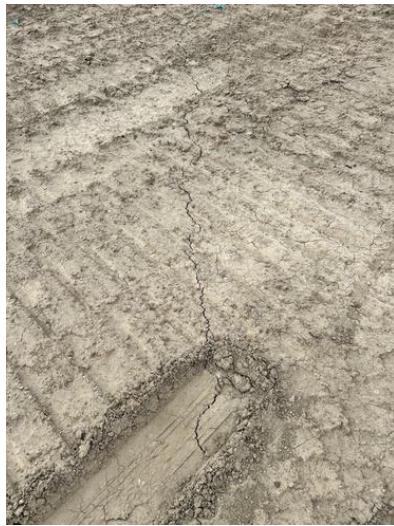
35ft x 30ft

Small 0.5-2" in width

Extra small <0.5" in height

NW to SE

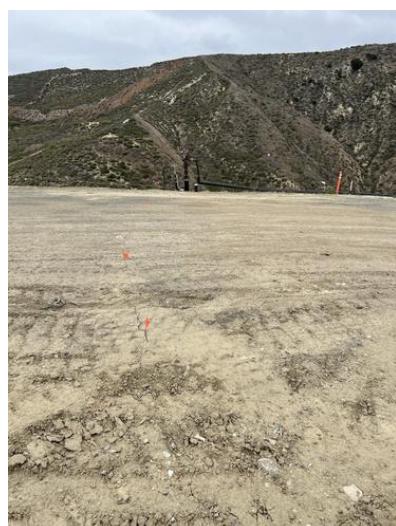
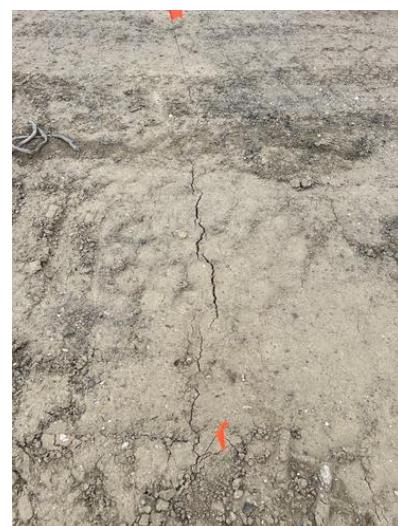
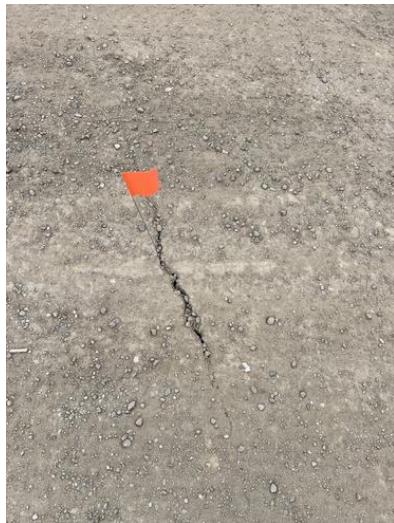
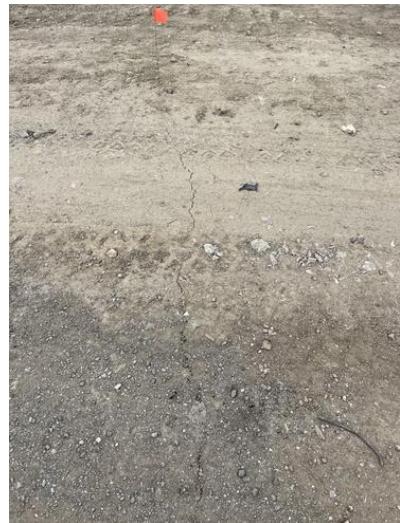
15ft x 40ft

Small 0.5-2" in width

Extra small <0.5" in height

NW to SE

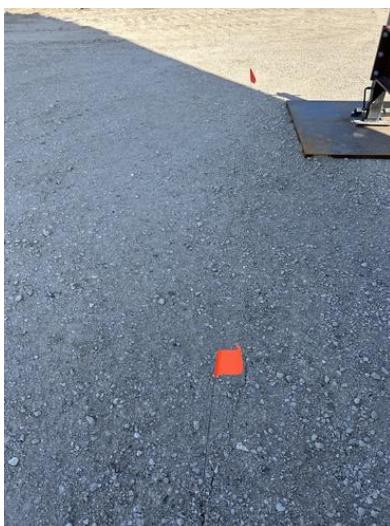
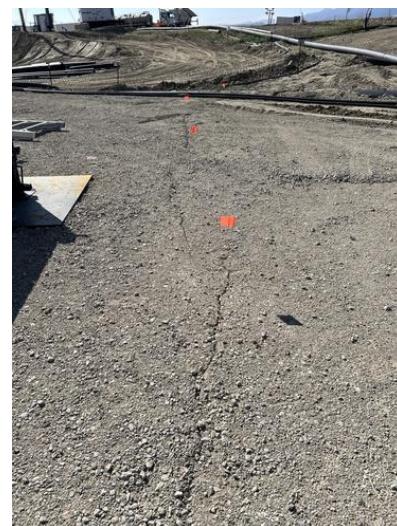
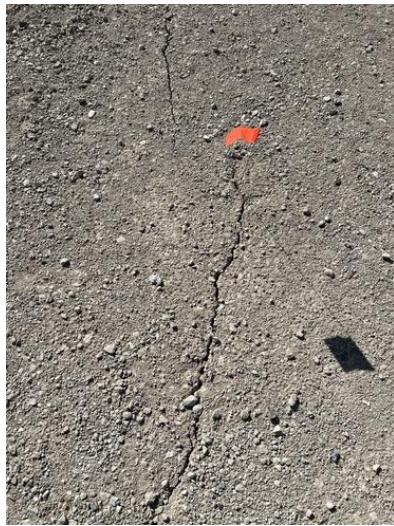
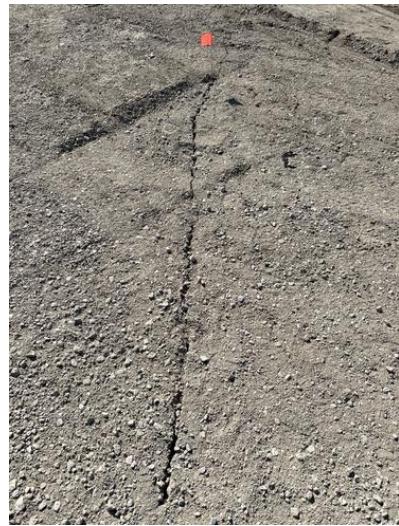
40ft

Small 0.5-2" in width

Extra small <0.5" in height

NW to SE

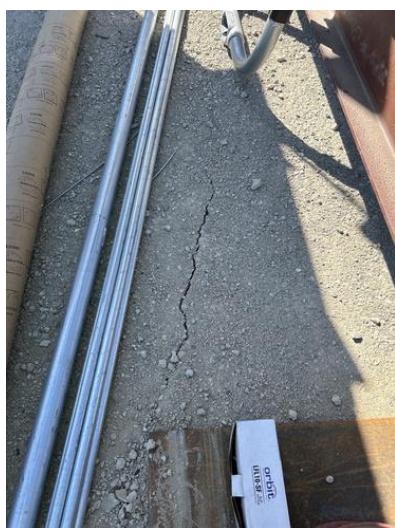
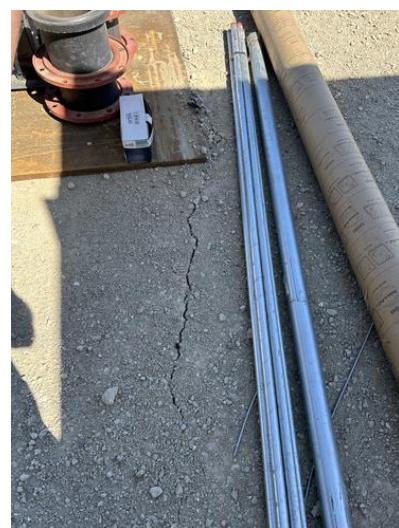
4ft

Horizontal Offset (width)	Extra Small <0.5 in width
Vertical Offset (height)	Extra small <0.5" in height
Orientation (direction)	N to S

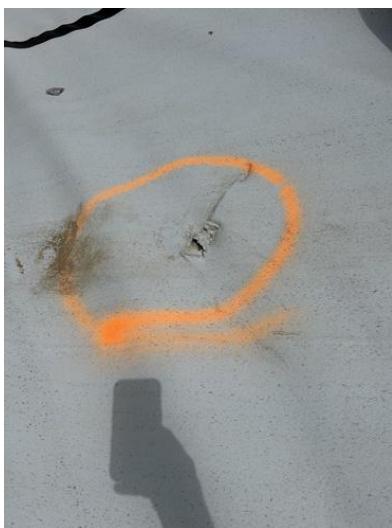
Photo 1

Puncture in cover needs to be extrusion welded.

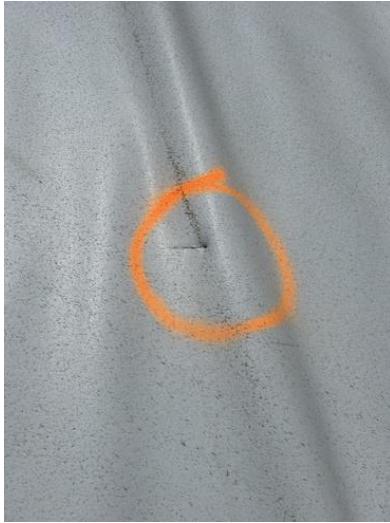
Photo 4

Puncture in cover needs to be extrusion welded.

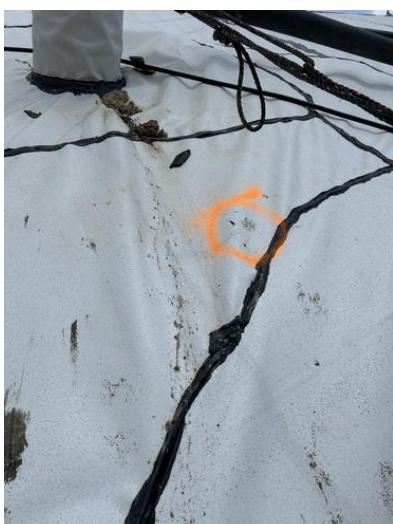
Photo 7

Puncture in cover needs to be extrusion welded.
