Re: Chiquita Canyon, LLC's Weekly Report on the Documentation and Tracking of Cover Issues

4050 - Chiquita Reaction Area Tracking of Fissures and Tension Cracks

12 May 2025 / Tom Roe

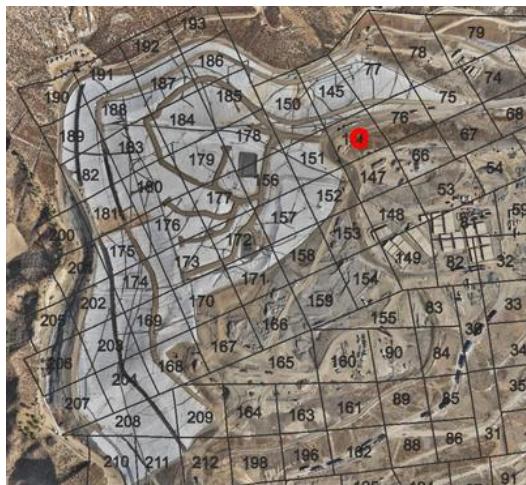
146

Using the attached image, annotate all areas where inspectors identified a fissure or tension crack.

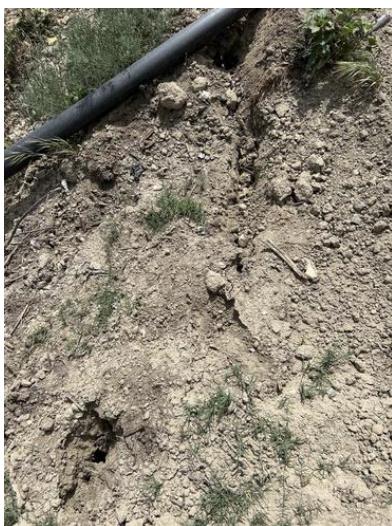
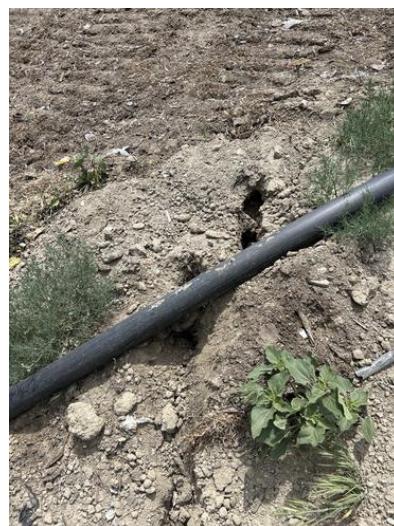
10 ft

Horizontal Offset (width)	Large >4" in width
Vertical Offset (height)	Extra small <0.5" in height
Orientation (direction)	NW to SE

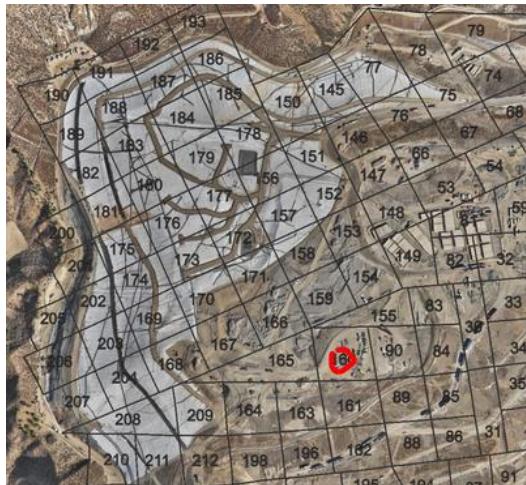
160

Using the attached image, annotate all areas where inspectors identified a fissure or tension crack.

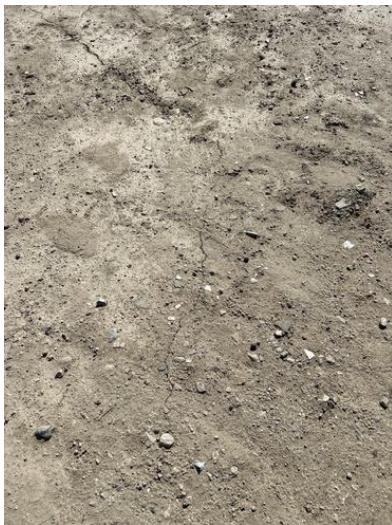
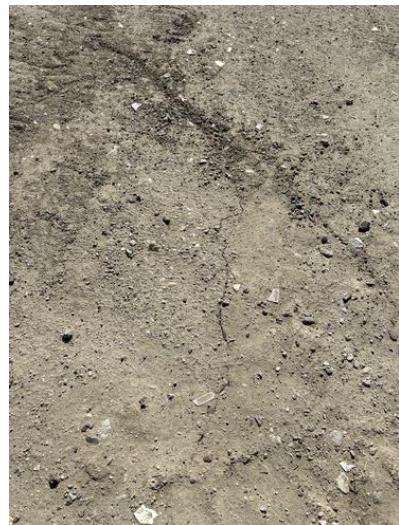
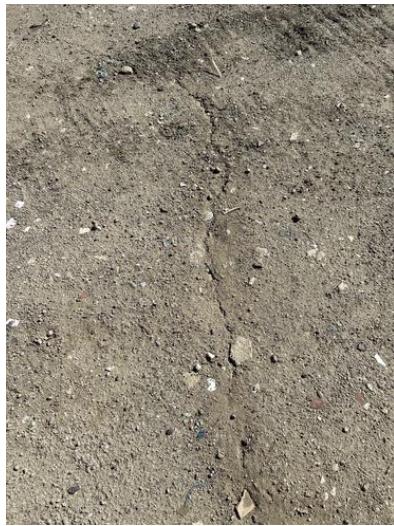
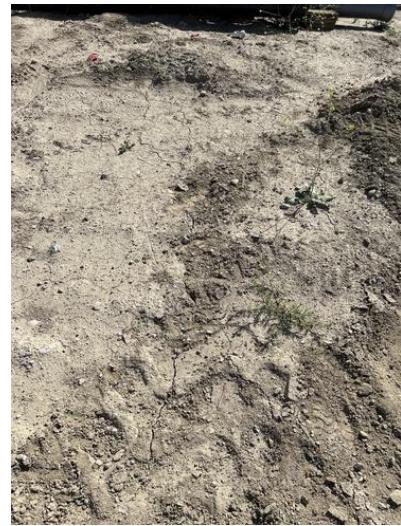
40ft x 20ft

Extra Small <0.5 in width

Extra small <0.5" in height

N to S

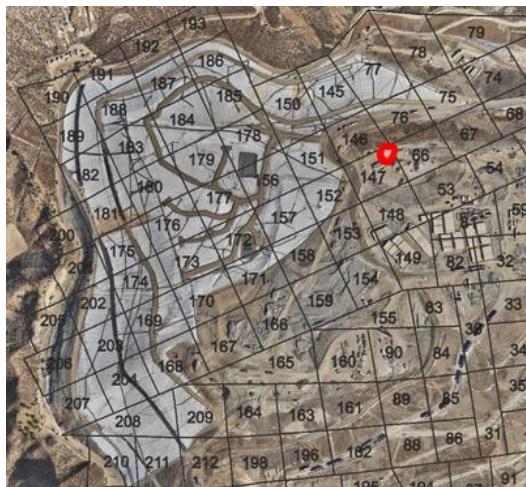
147

Using the attached image, annotate all areas where inspectors identified a fissure or tension crack.

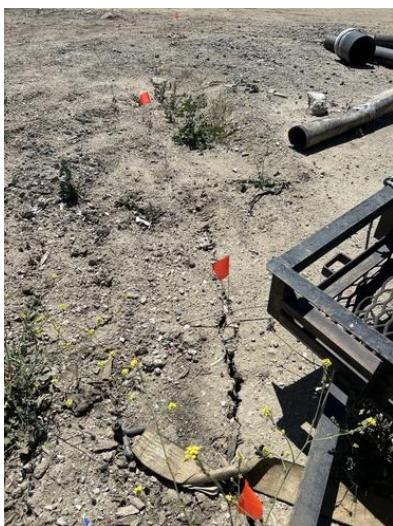
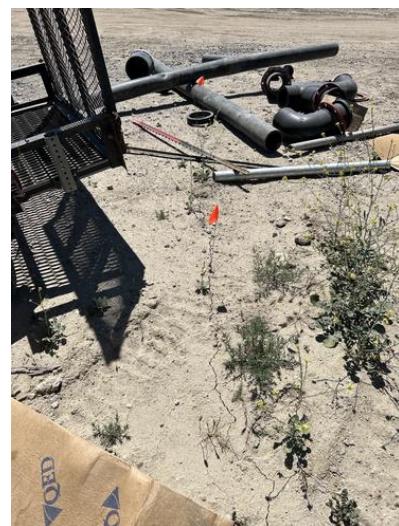
15ft x 8ft area

Horizontal Offset (width)	Small 0.5-2" in width
Vertical Offset (height)	Extra small <0.5" in height
Orientation (direction)	NW to SE
