CHIQUITA CANYON
A Waste Connections Company

Re: Chiquita Canyon, LLC's Weekly Report on the Documentation and Tracking of Cover Issues

Attachment: May 19, 2025 Weekly Cover Issues Report

4050 - Chiquita Reaction Area Tracking of Fissures and Tension Cracks

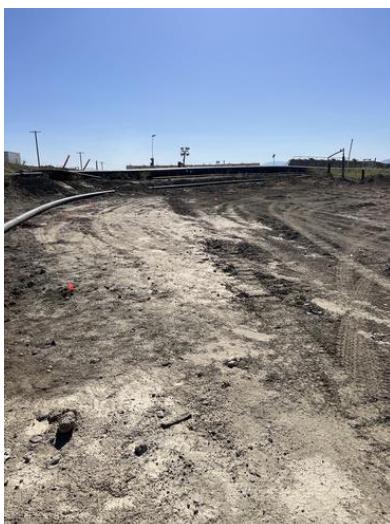
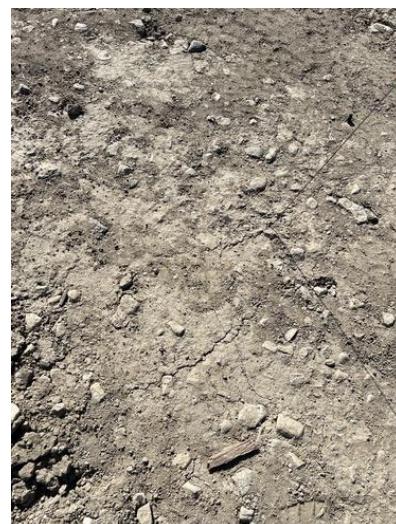
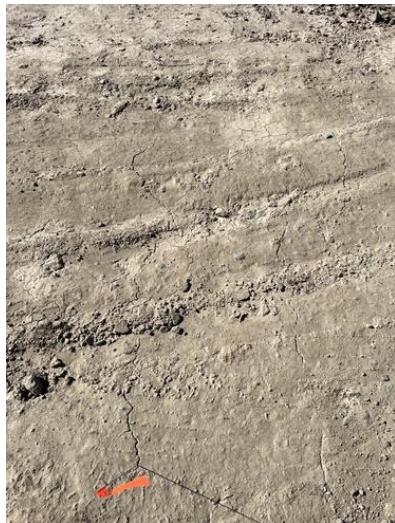
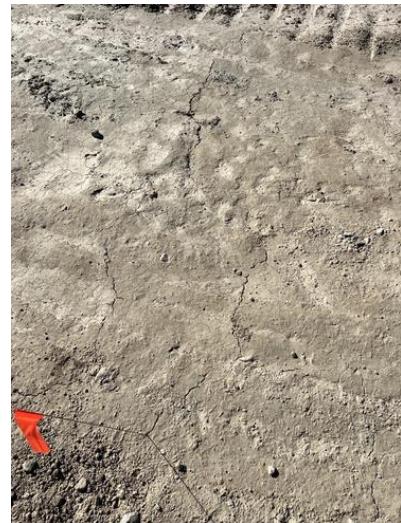
148

12ft x 20ft

Extra Small <0.5 in width

Extra small <0.5" in height

NW to SE

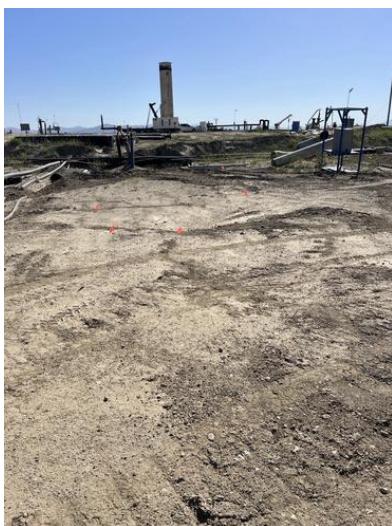
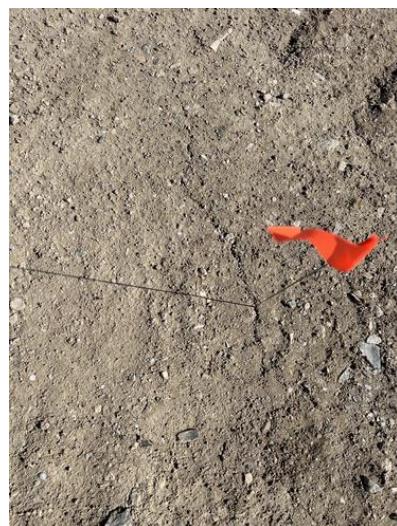
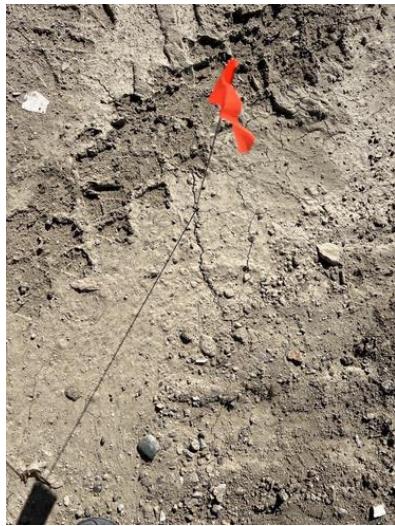
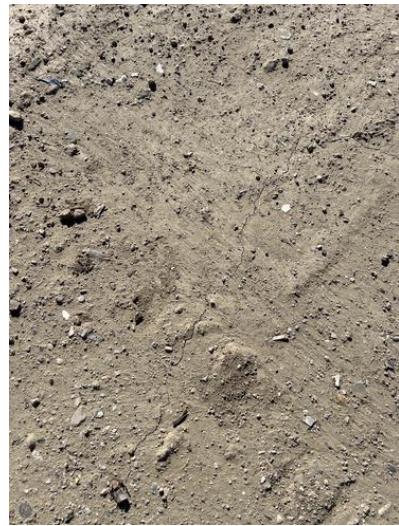
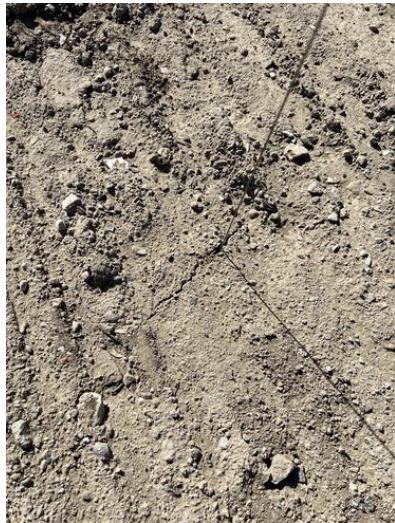
160

25ft x 35ft

Extra Small <0.5 in width

Extra small <0.5" in height

NW to SE

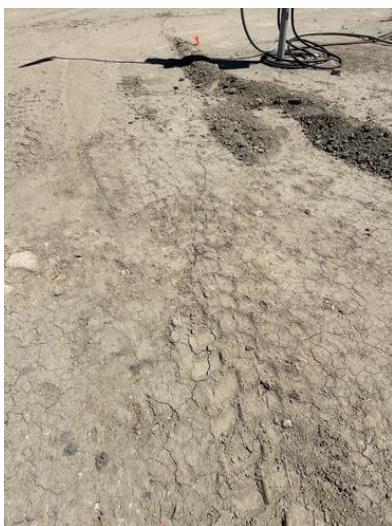
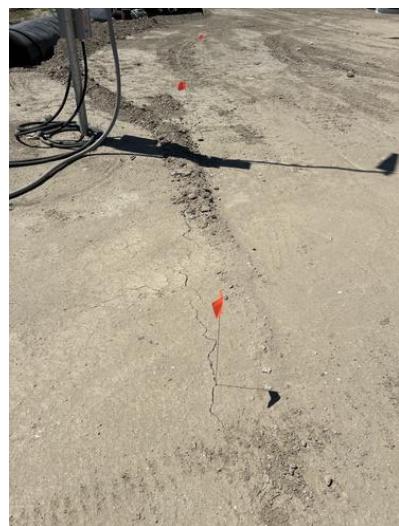
160

16ft

Horizontal Offset (width)	Extra Small <0.5 in width
Vertical Offset (height)	Extra small <0.5" in height
Orientation (direction)	N to S

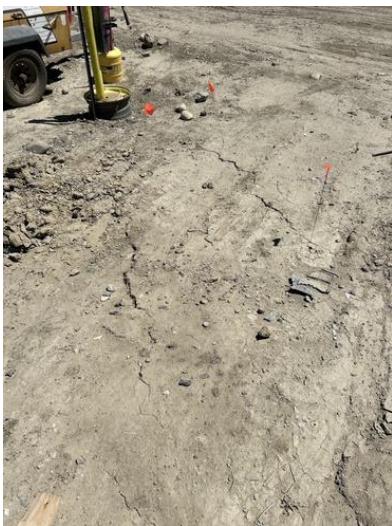
Photo 4

149

5ft x 5ft area

Small 0.5-2" in width

Extra small <0.5" in height

N to S

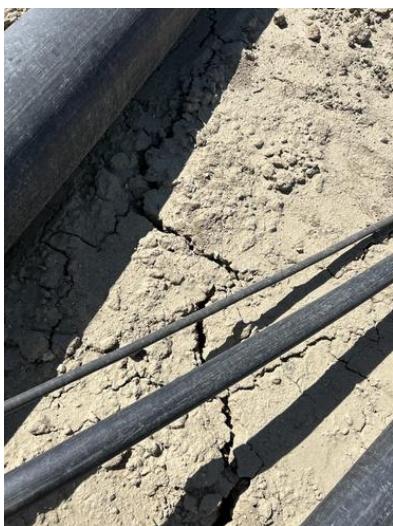
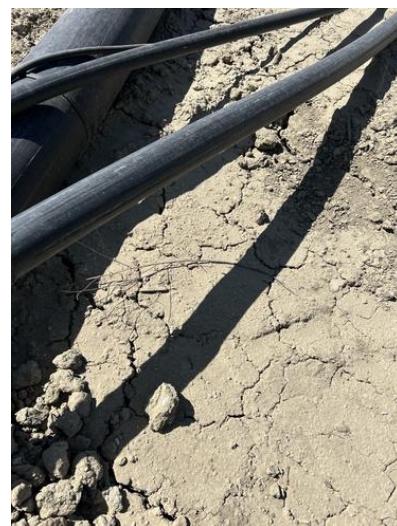
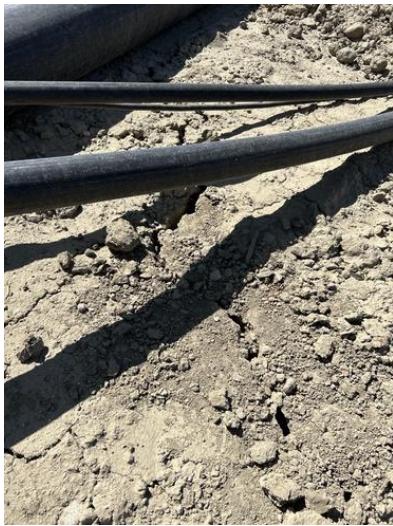
146

6ft x 4ft area

Small 0.5-2" in width

Extra small <0.5" in height

NW to SE

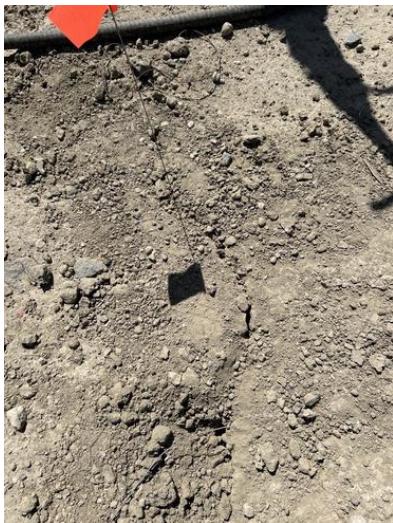
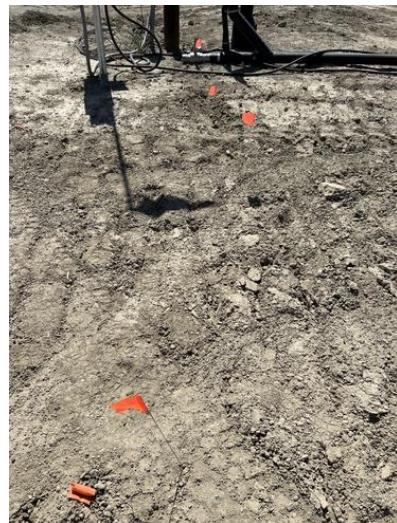
147

7ft

Extra Small <0.5 in width

Extra small <0.5" in height

NW to SE

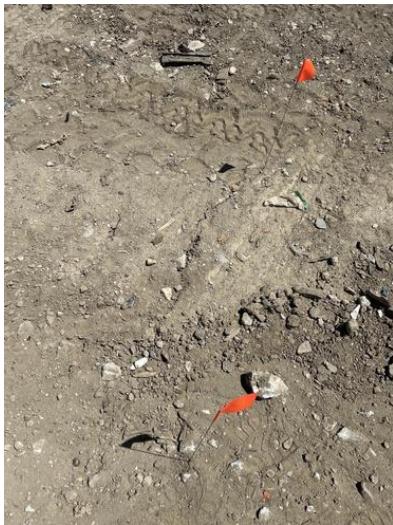
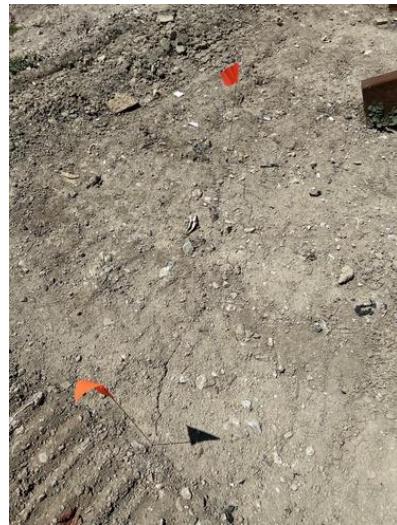
5ft

Extra Small <0.5 in width

Extra small <0.5" in height

NE to SW

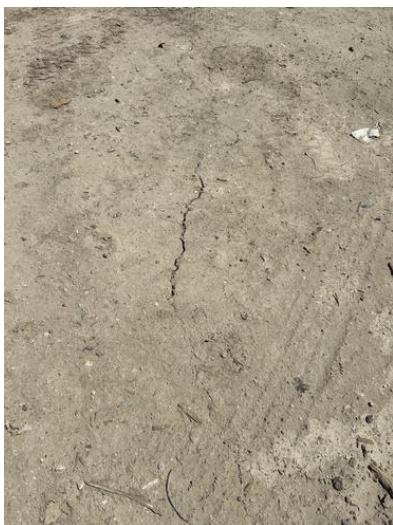
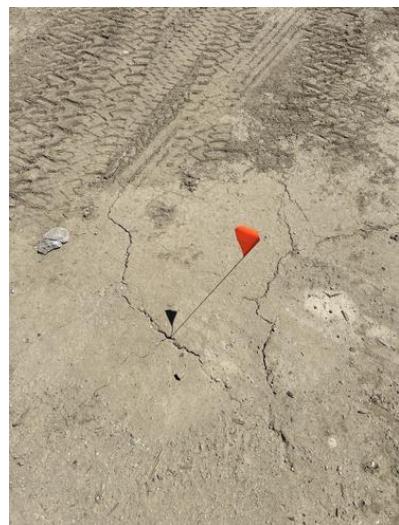
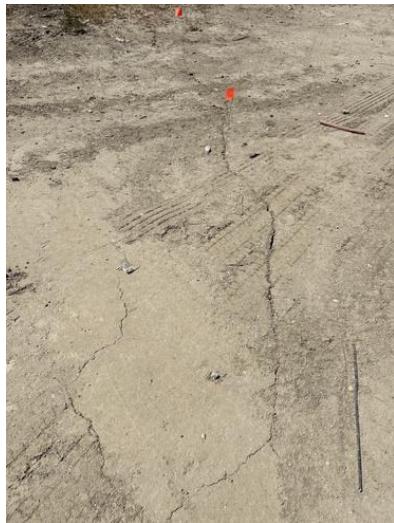
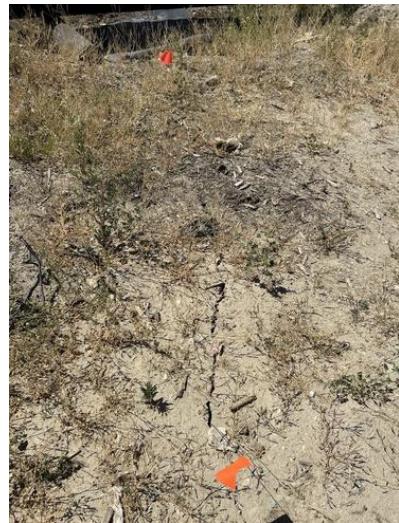
164

9ft x 20ft area

Small 0.5-2" in width

Extra small <0.5" in height

NE to SW

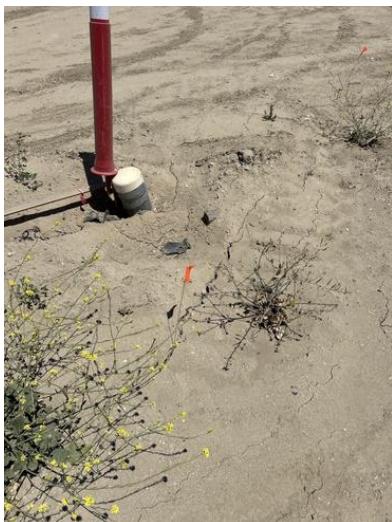
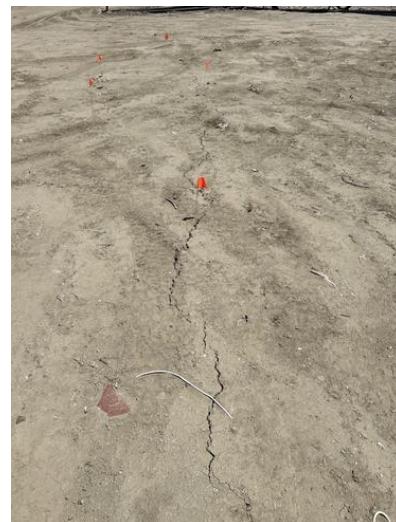
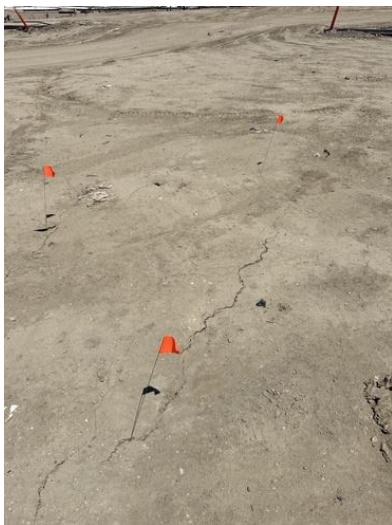
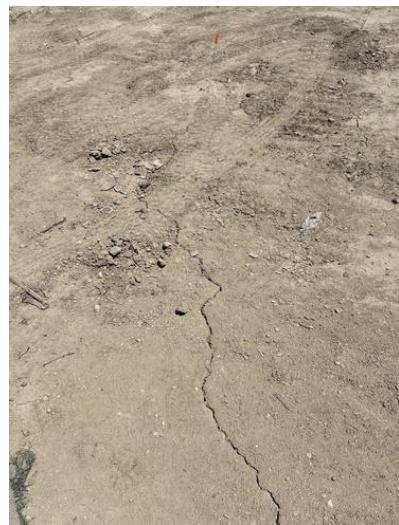
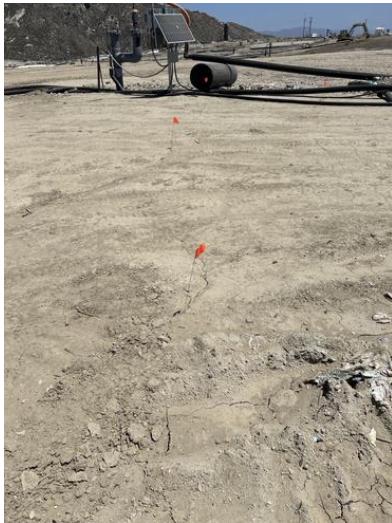
164

20ft x 25ft area

Small 0.5-2" in width

Extra small <0.5" in height

NE to SW

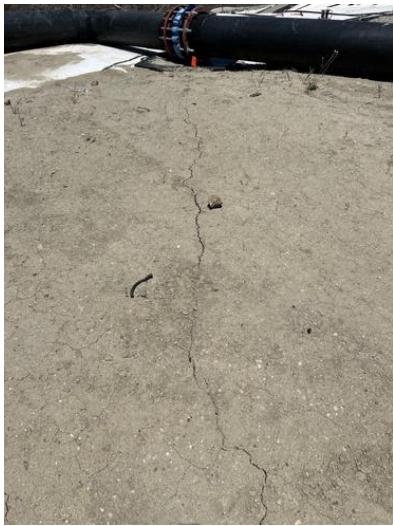
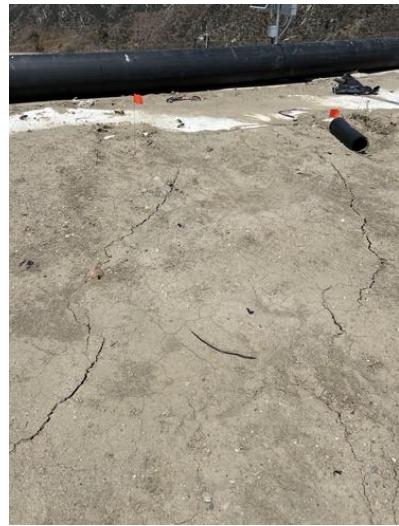
170

10ft x 10ft area

Extra Small <0.5 in width

Extra small <0.5" in height

NW to SE

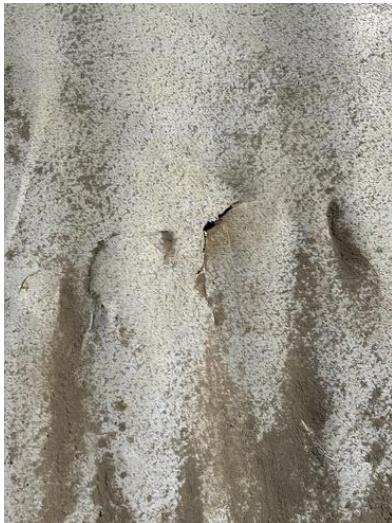
Photo 1

Found 5/19 at 9:29 am in grid 78.

Tear in cover, needs to be patched/extrusion welded.

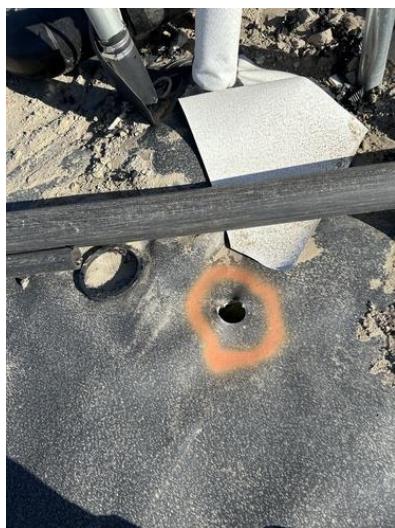
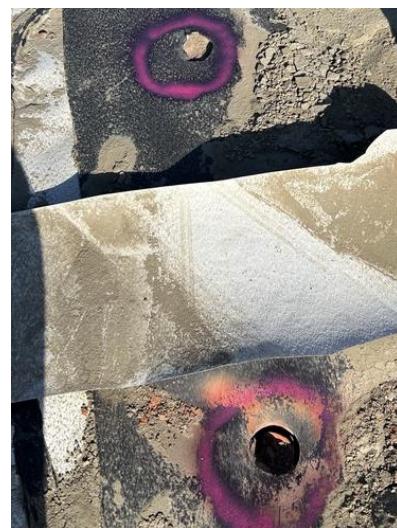
Found on 5/20/25 at 7:45am. Grid 75/76

3 holes from posts that were moved need to be patched and extrusion welded.
