CHIQUITA CANYON
A Waste Connections Company

Re: Chiquita Canyon, LLC's Weekly Report on the Documentation and Tracking of Cover Issues

4050 - Chiquita Reaction Area Tracking of Fissures and Tension Cracks

4050 - Geosynthetic Cover Inspection

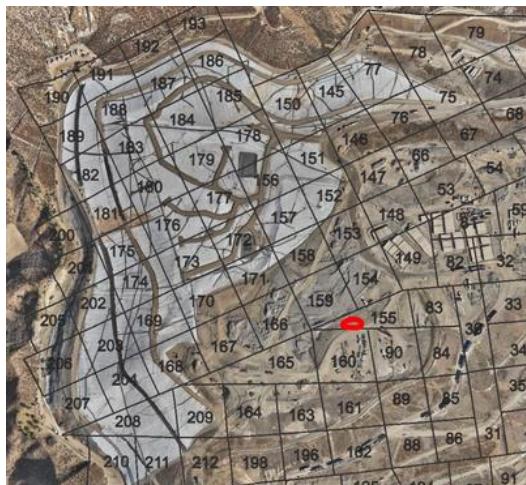
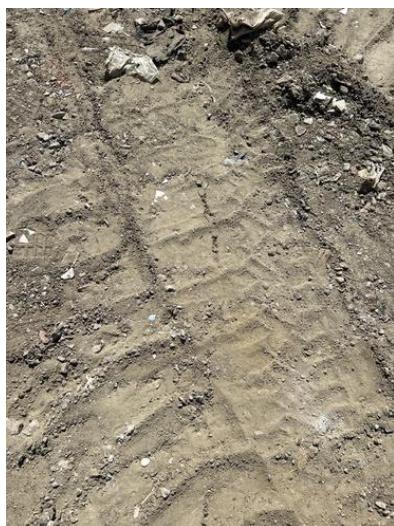
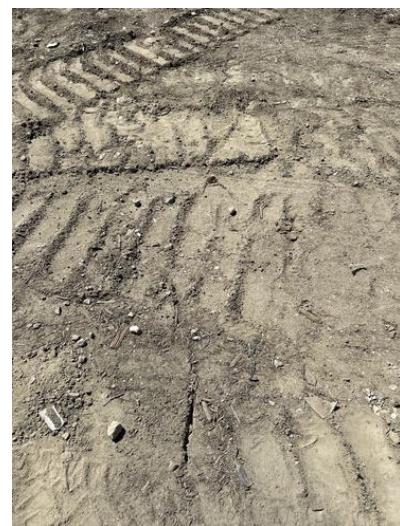
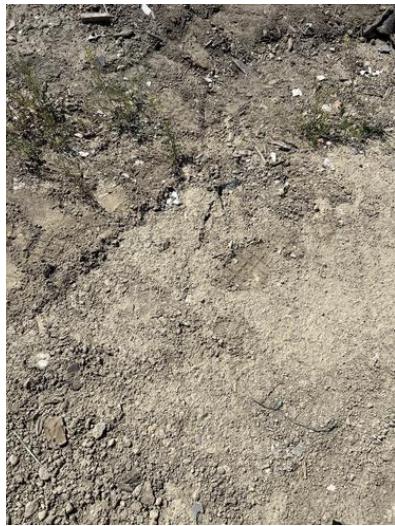
155

20ft x 30ft

Small 0.5-2" in width

Extra small <0.5" in height

NW to SE

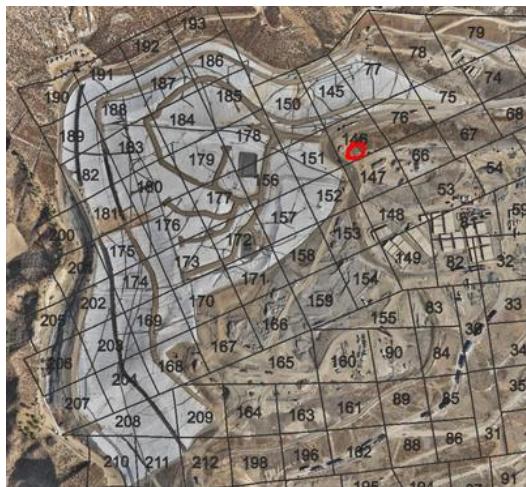
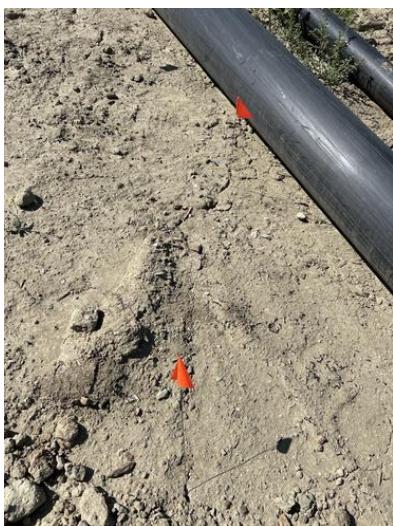
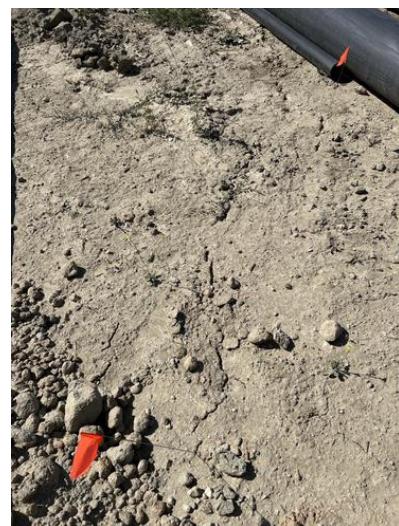
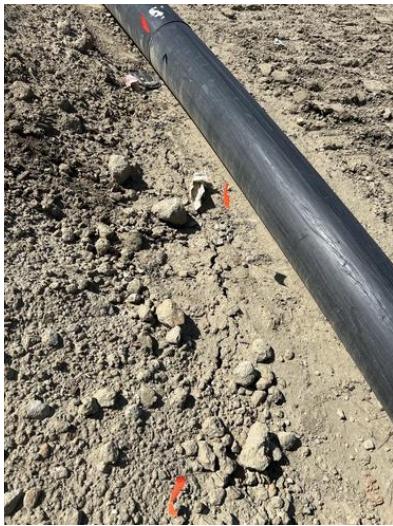
146

4ft x 10ft area

Small 0.5-2" in width

Extra small <0.5" in height

N to S

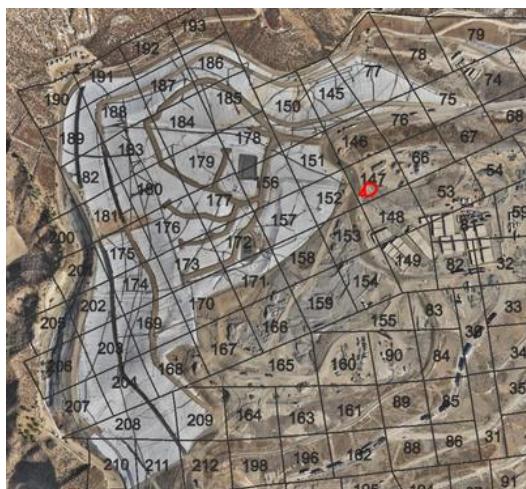
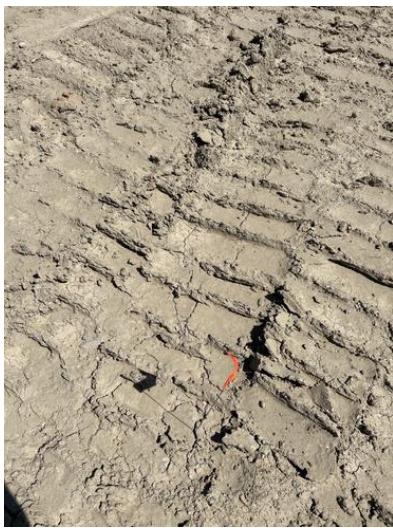
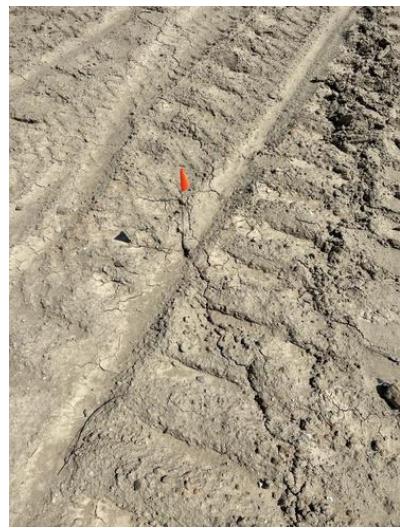
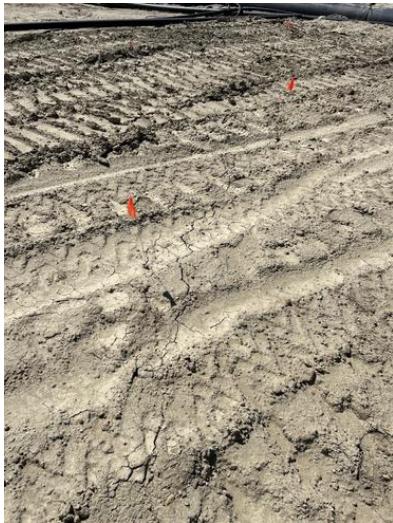
147

16ft

Extra Small <0.5 in width

Extra small <0.5" in height

N to S

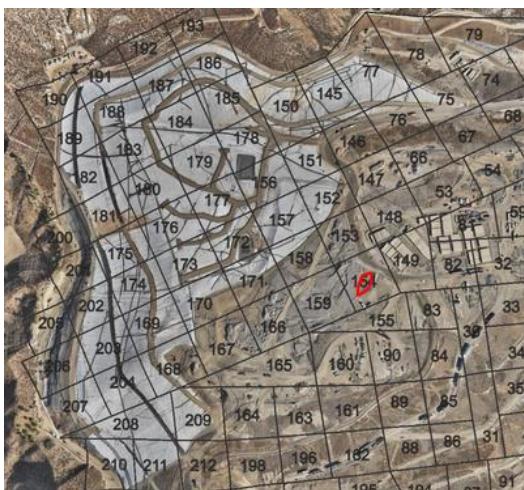
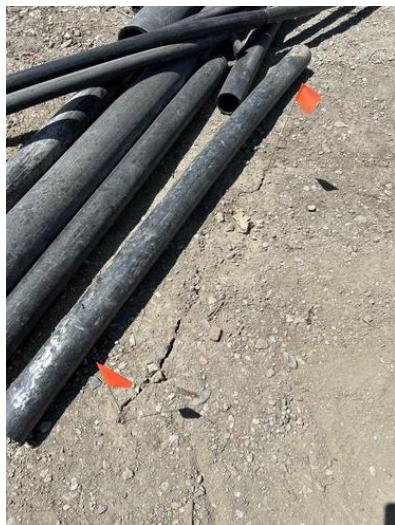
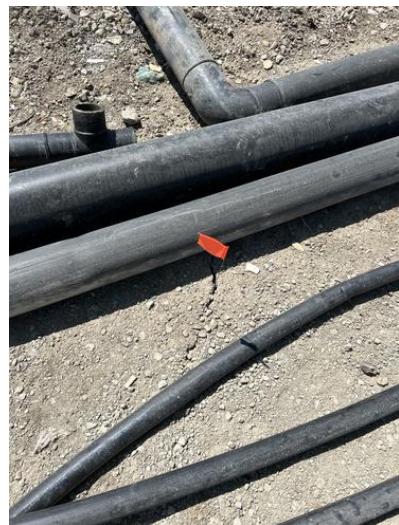
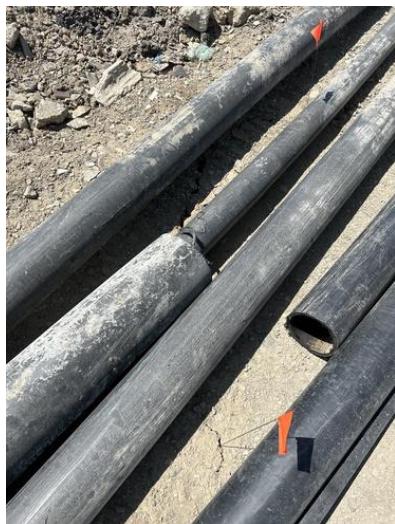
154

10ft x 10 ft area

Small 0.5-2" in width

Extra small <0.5" in height

NE to SW

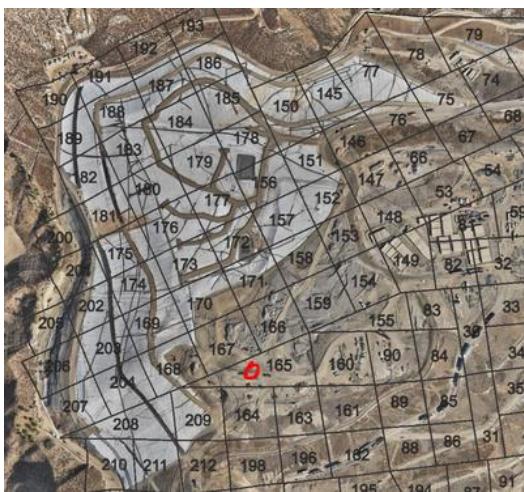
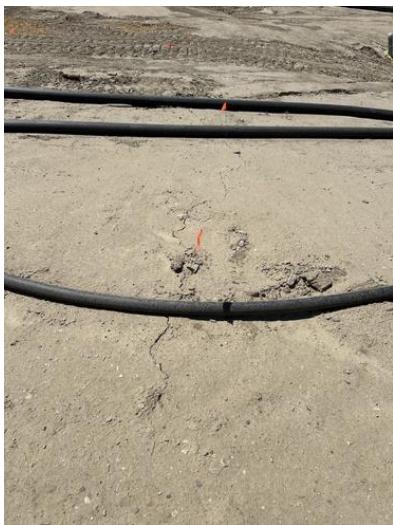
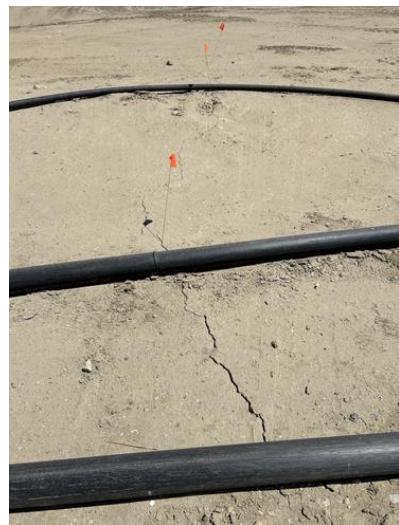
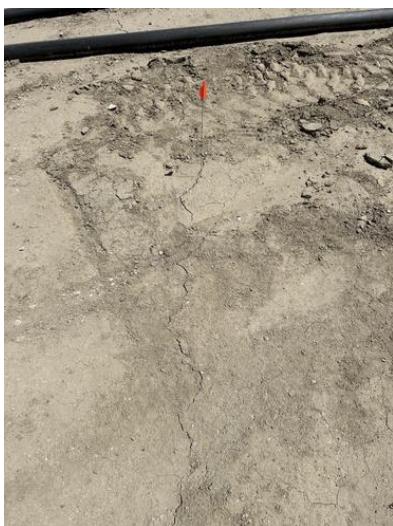
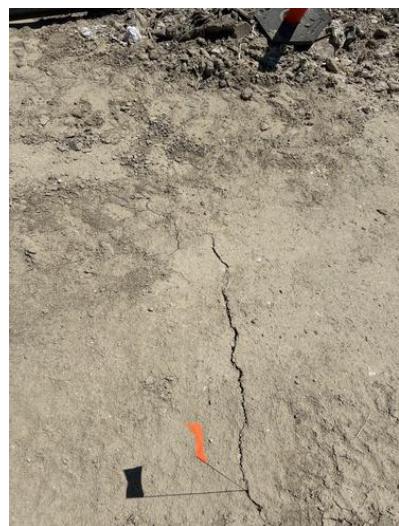
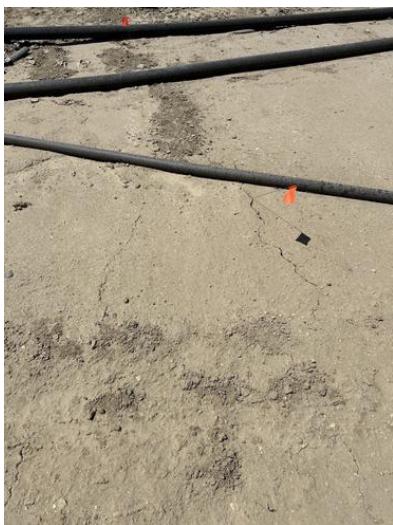
165

10ft x 15ft area

Small 0.5-2" in width

Extra small <0.5" in height

NE to SW

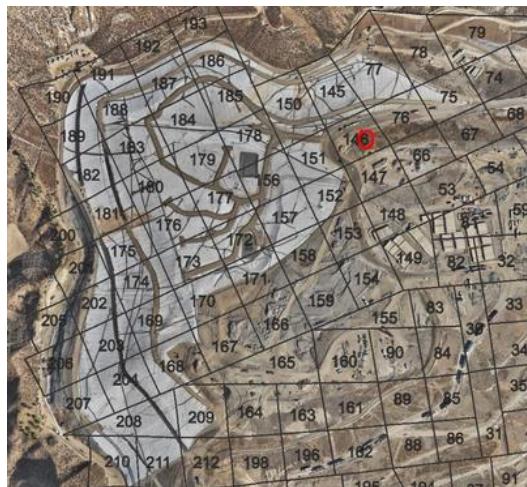
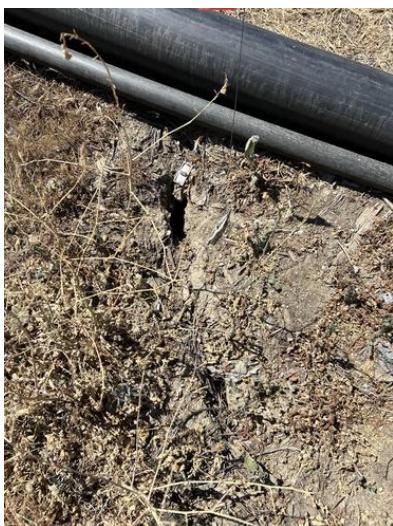
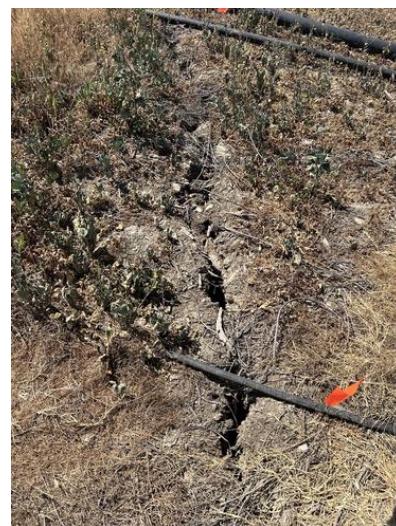
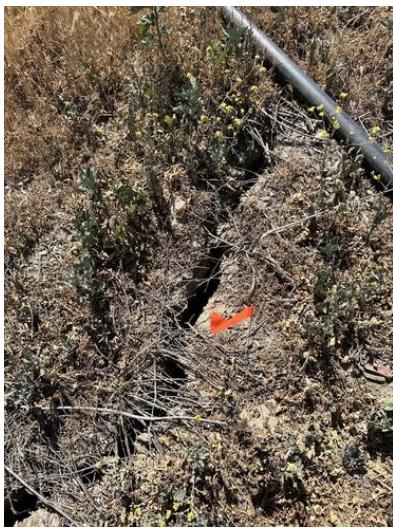
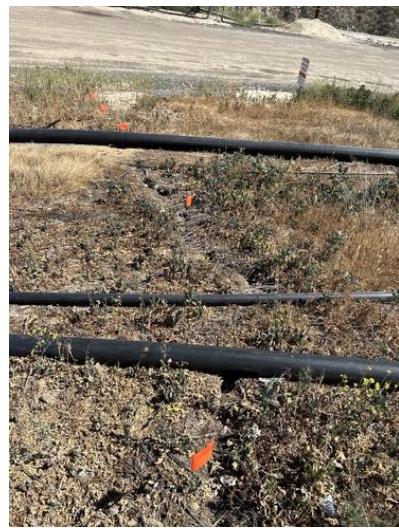
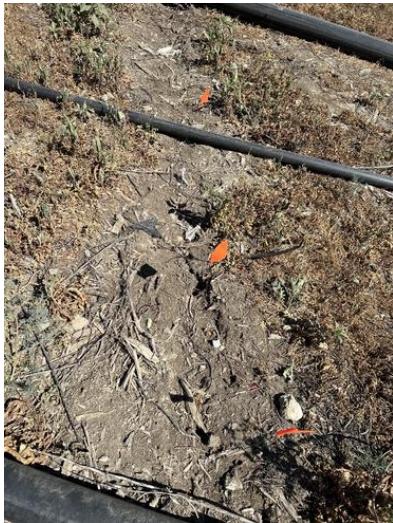
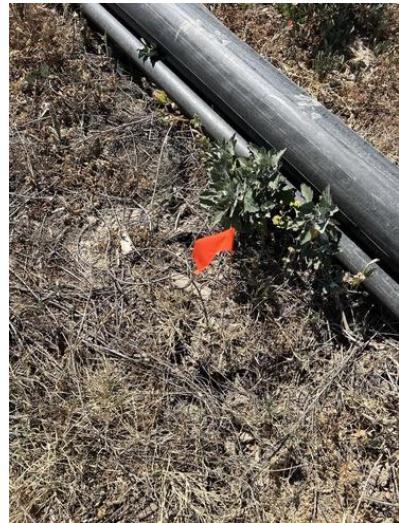
146

15ft x 15ft area

Large >4" in width

Extra small <0.5" in height

NW to SE

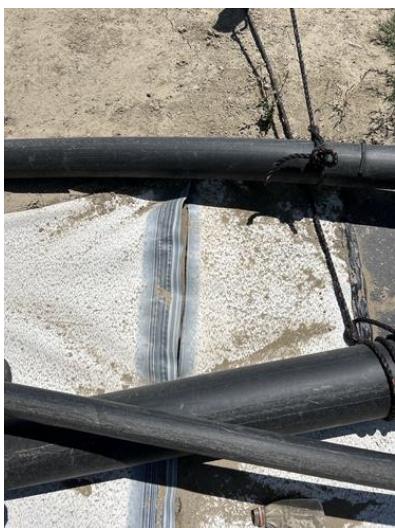
Photo 1

Found 1:28pm on 5/27/25. Grid 146

Separation at seam in the liner.
