# CHIQUITA CANYON

**Ref.: Informe Semanal de Chiquita Canyon, LLC sobre la Documentación y el Seguimiento de Problemas con las Cubiertas y Resumen Mensual**

# 4050 - Chiquita Reaction Area Tracking of Fissures and Tension Cracks

**MAY 2025 FISSURE AND TENSION CRACK MONITORING SUMMARY  
CHIQUITA CANYON LANDFILL  
CASTAIC, CALIFORNIA**

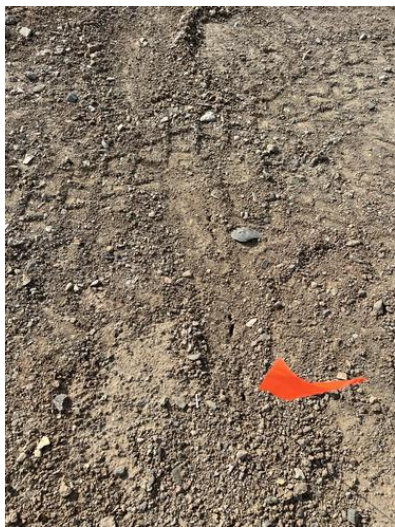
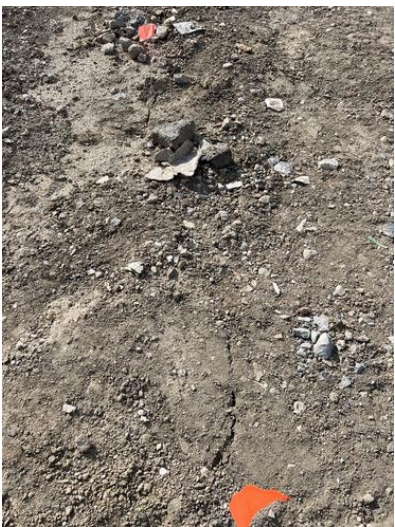
167

**Length of crack (ft) or area containing multiple cracks (ft x ft)** 20ft x 30ft

**Horizontal Offset (width)** Small 0.5-2" in width

**Vertical Offset (height)** Extra small <0.5" in height

**Orientation (direction)** NW to SE

**Description of repairs** Cracks were track walked.

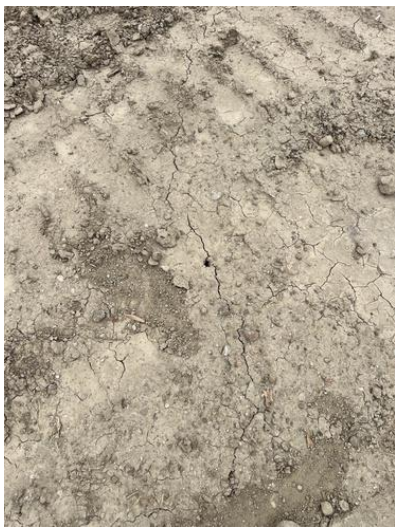
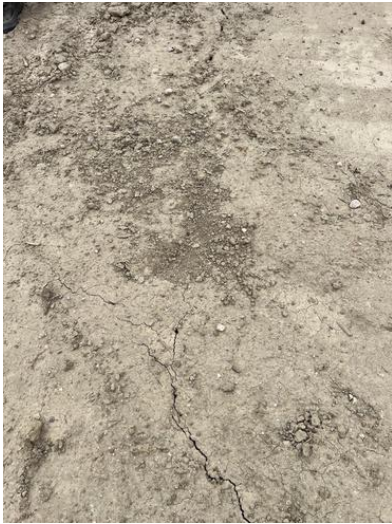
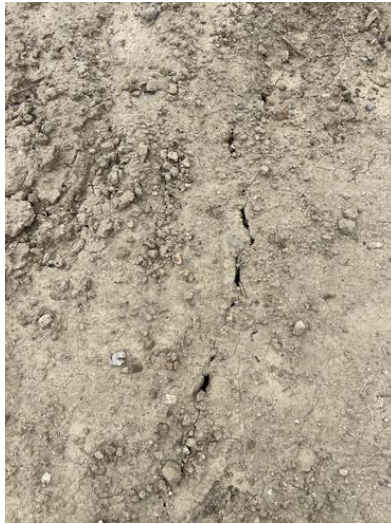
147

**Length of crack (ft) or area containing multiple cracks (ft x ft)** 25ft x 45ft

**Horizontal Offset (width)** Medium 2-4" in width

**Vertical Offset (height)** Extra small <0.5" in height

**Orientation (direction)** NW to SE

Dirt was added and cracks were track walked.

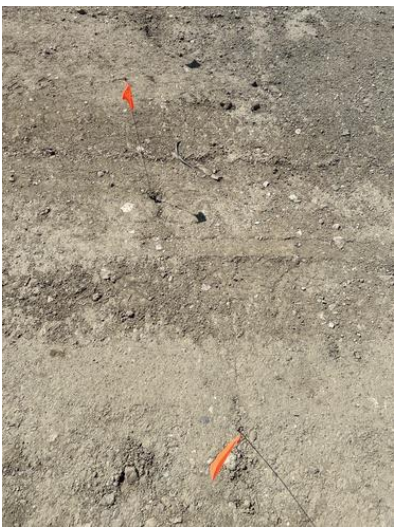
146

10ft

| Horizontal Offset (width) | Small 0.5-2" in width |
| Vertical Offset (height) | Extra small <0.5" in height |
| Orientation (direction) | NW to SE |

| Description of repairs | Cracks were track walked. |

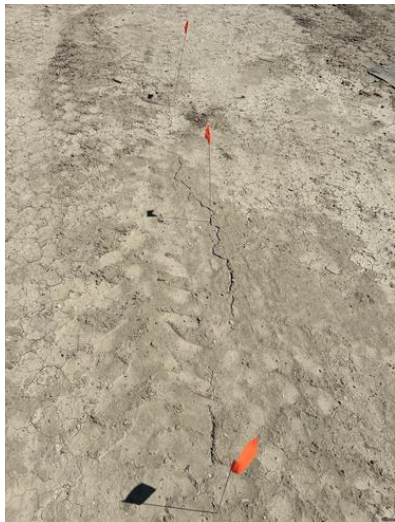
Photo 4

160

6ft

Extra Small <0.5 in width

Extra small <0.5" in height

N to S

| <b>Description of repairs</b> | Cracks were track walked. |

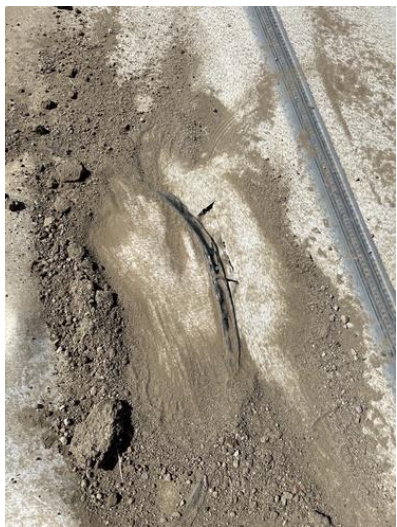
Photo 1

Found 6/2 at 9:25 am in grid 185

Tear in liner. Needs to be patched/extrusion welded.

Tear was sealed with flex tape upon discovery on 6/2. Final repair was completed on 6/3 at
