# CHIQUITA CANYON

**Re: Chiquita Canyon, LLC's Weekly Report on the Documentation and Tracking of Cover Issues and Monthly Summary**

# **Fissures and Tension Cracks**

**MAY 2025 FISSURE AND TENSION CRACK MONITORING SUMMARY**  
**CHIQUITA CANYON LANDFILL**  
**CASTAIC, CALIFORNIA**

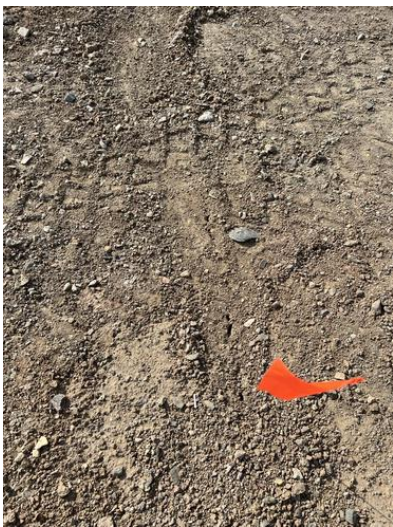
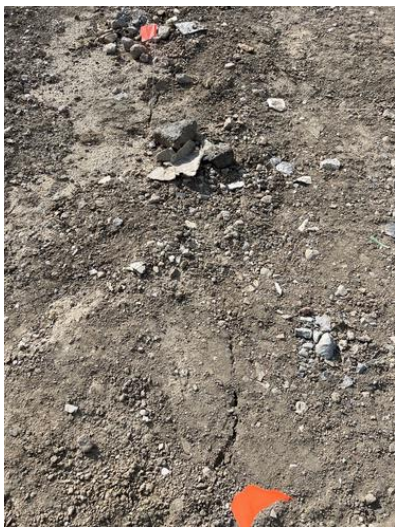
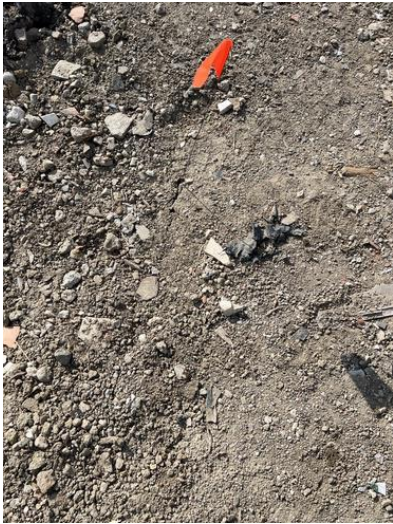
167

**Length of crack (ft) or area containing multiple cracks (ft x ft)** 20ft x 30ft

**Horizontal Offset (width)** Small 0.5-2" in width

**Vertical Offset (height)** Extra small <0.5" in height

**Orientation (direction)** NW to SE

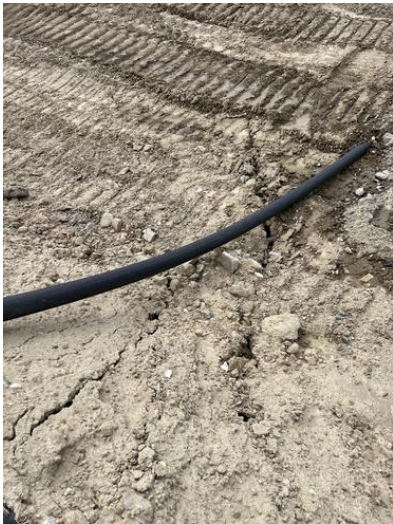
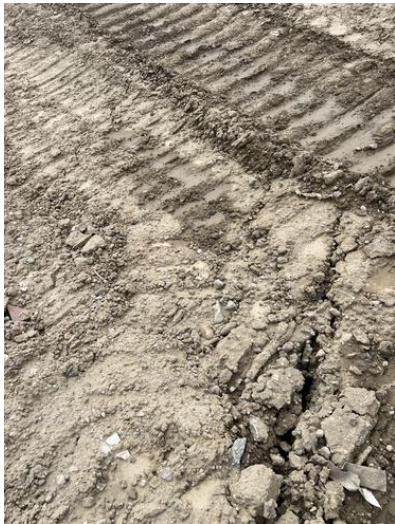
147

5ft x 15ft

Large >4" in width

Extra small <0.5" in height

NW to SE

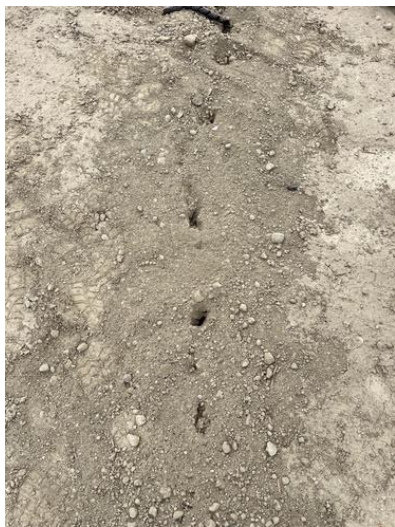
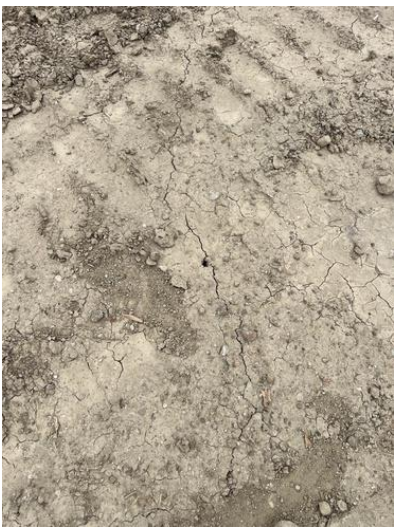
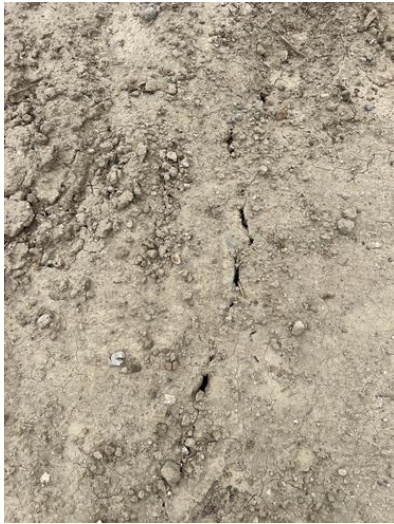
147

**Length of crack (ft) or area containing multiple cracks (ft x ft)** 25ft x 45ft

**Horizontal Offset (width)** Medium 2-4" in width

**Vertical Offset (height)** Extra small <0.5" in height

**Orientation (direction)** NW to SE

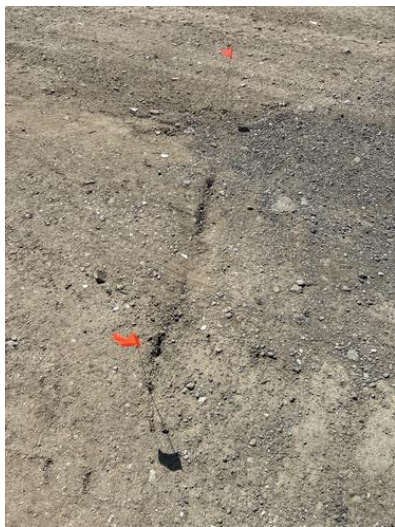
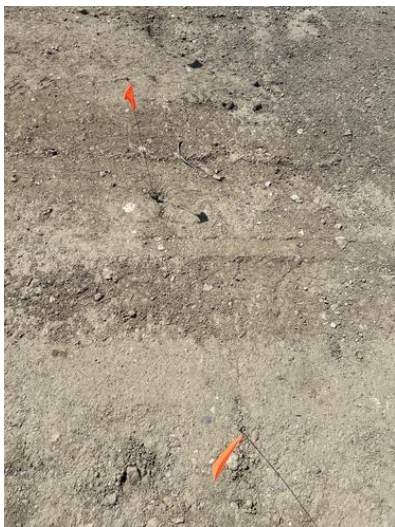
146

10ft

| Horizontal Offset (width) | Small 0.5-2" in width |
| Vertical Offset (height) | Extra small <0.5" in height |
| Orientation (direction) | NW to SE |

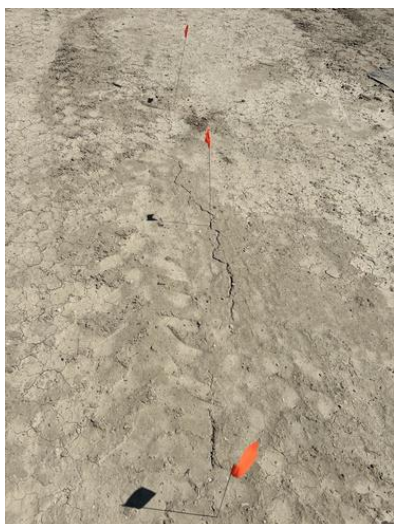
Photo 4

160

6ft

Extra Small <0.5 in width

Extra small <0.5" in height

N to S

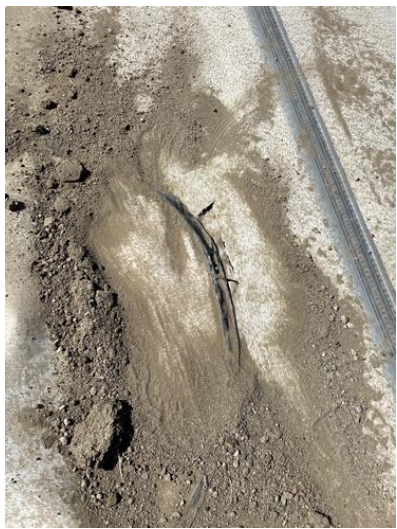
Photo 1

Found 6/2 at 9:25 am in grid 185

Tear in liner. Needs to be patched/extrusion welded.
