**Subject: Leachate Spill Report  
Chiquita Canyon Landfill  
File No. 67-020**

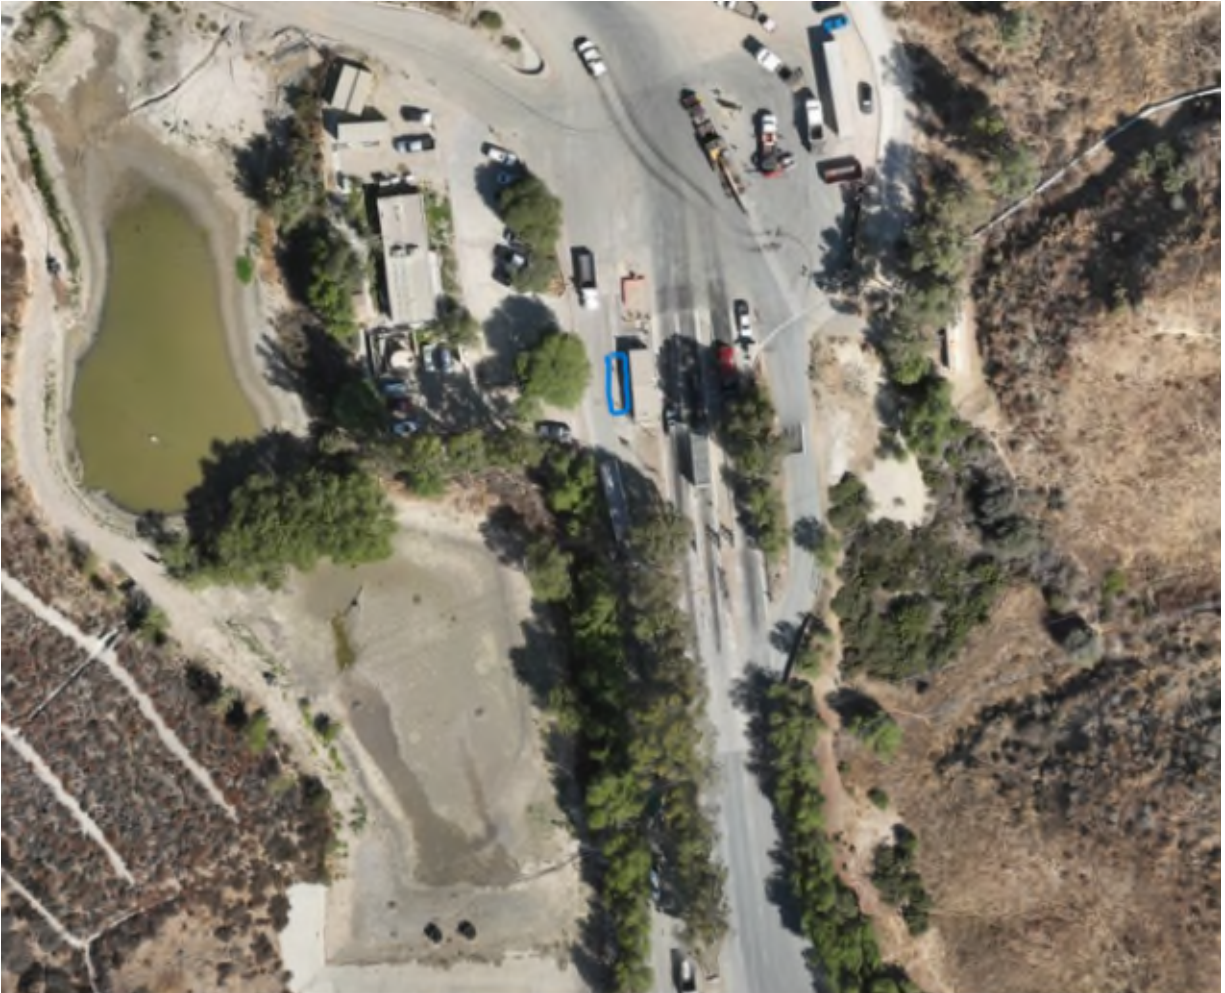
Attachments: Attachment A – Map depicting the location of the spill

The spill occurred in the exit scale of the scale house, as indicated in Attachment A.

On June 11, 2025, at approximately 3:30 p.m., liquid spilled from the top hatch of haul truck trailer filled with leachate. The spill was caused by the driver’s error, who had only secured one of the six bolts on the top of the hatch. The liquid filled the containment area on top of the truck and flowed down the hose in the middle of the trailer and into the pavement before the scale house. Approximately seven (7) gallons of leachate spilled on the exit road near the scale house, but did

not reach the stormwater channel or the stormwater basin. The liquid was dark brown in color with low viscosity and traveled as a light trickle.

Chiquita took prompt action to address the spill by placing a drip pan under the trailer that was releasing liquid and applying absorbent to the affected area, which was later removed. Cleanup was completed on the same day. To prevent a similar spill in the future, Chiquita will monitor drivers when they bolt the top hatch of truck trailers before clearing them to exit the landfill.
