CHIQUITA CANYON
A Waste Connections Company

Re: Chiquita Canyon, LLC's Weekly Report on the Documentation and Tracking of Cover Issues

Attachment: June 24, 2025 Weekly Cover Issues Report

4050 - Chiquita Reaction Area Tracking of Fissures and Tension Cracks

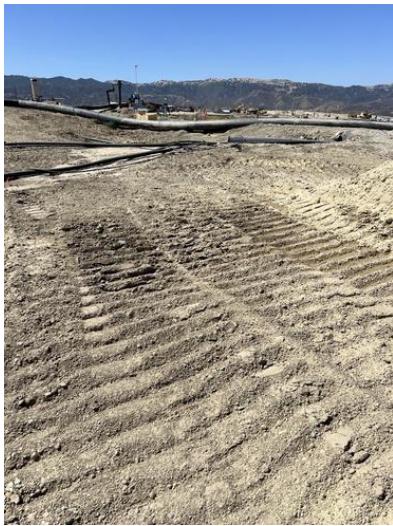
Photo 1

147

25 ft

Small 0.5-2" in width

Extra small <0.5" in height

NW to SE

Cracks were track walked.

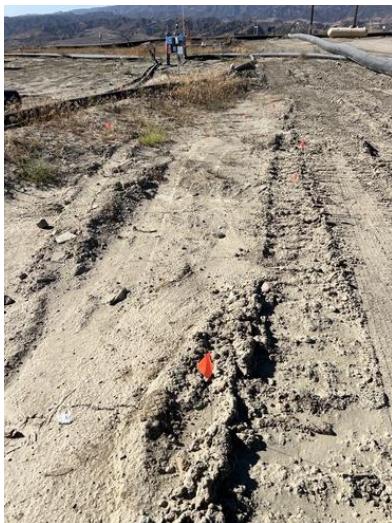
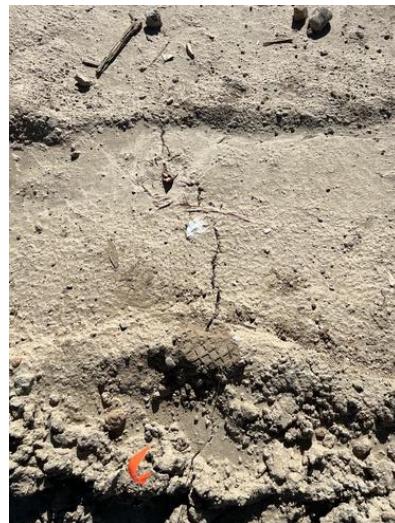
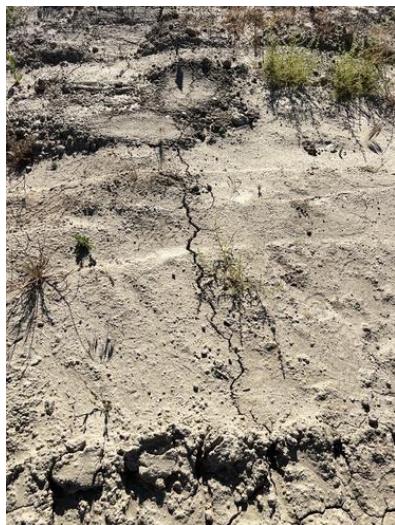
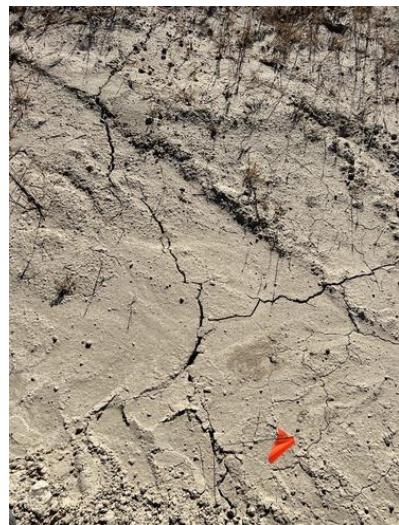
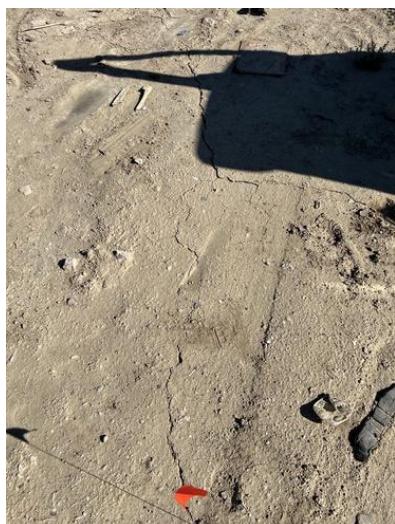
155

40ft x 50ft

Small 0.5-2" in width

Extra small <0.5" in height

NE to SW

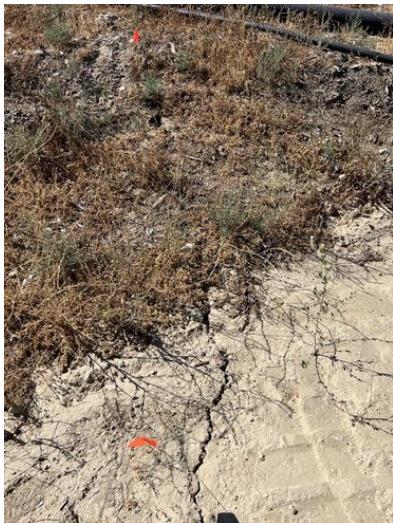
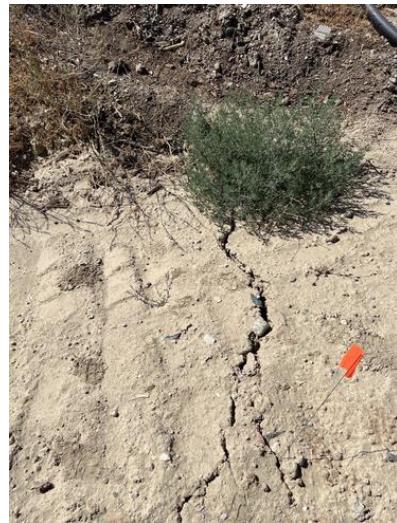
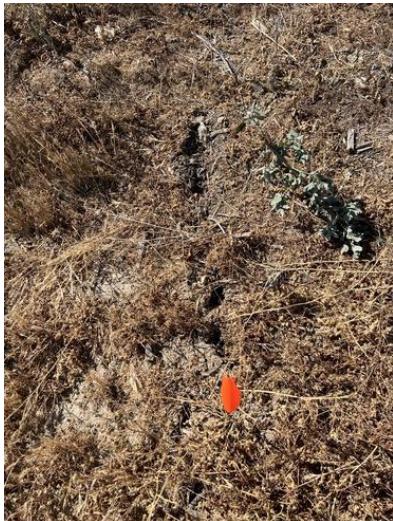
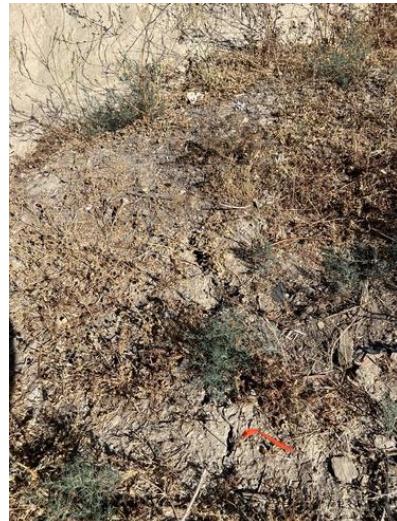
146

30ft x 15ft

Medium 2-4" in width

Extra small <0.5" in height

NW to SE

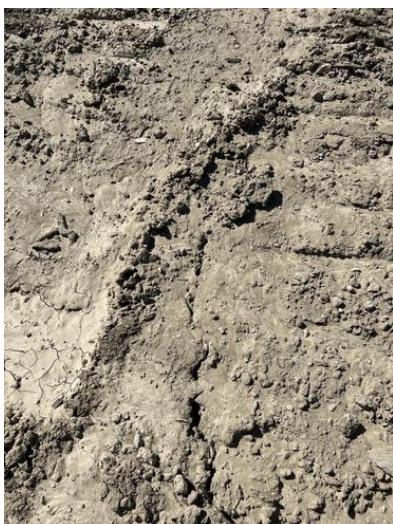
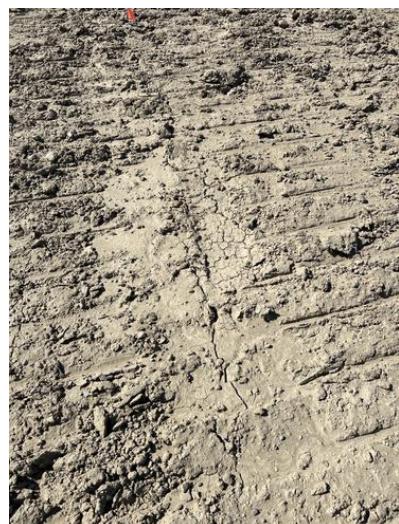
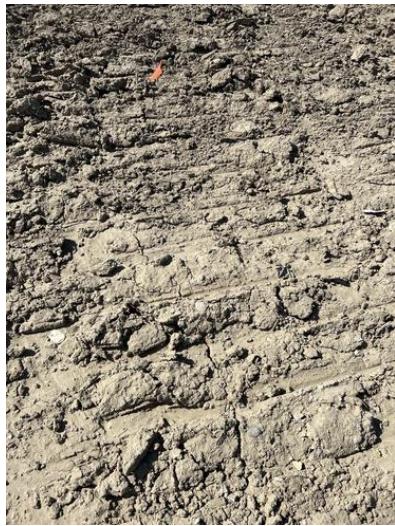
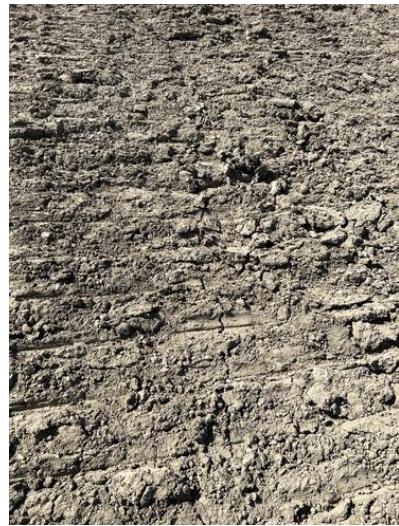
146

25ft

Extra Small <0.5 in width

Extra small <0.5" in height

N to S

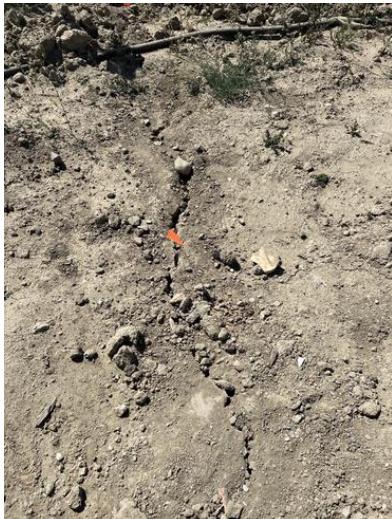
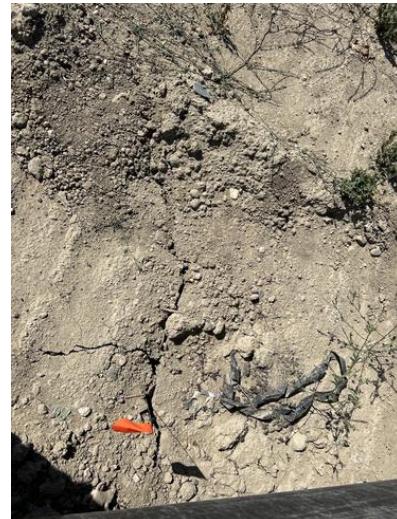
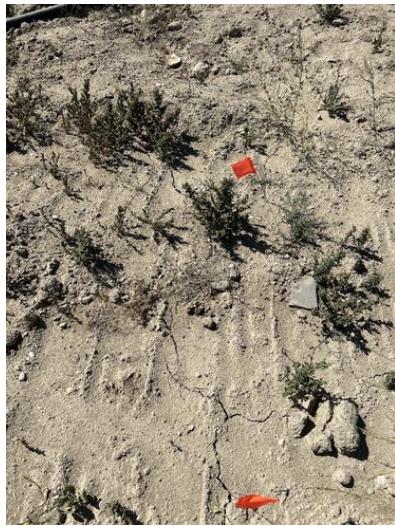
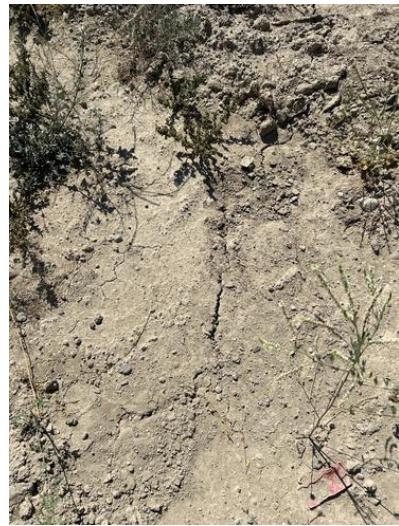
148

20ft x 15ft area

Small 0.5-2" in width

Extra small <0.5" in height

NW to SE

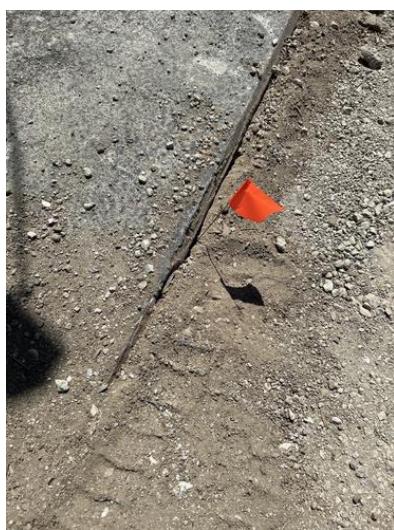
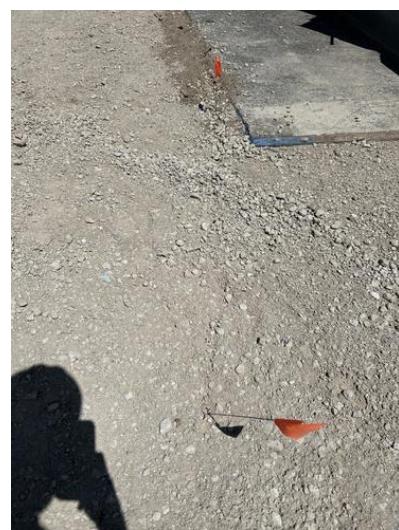
147

10ft

Horizontal Offset (width)	Small 0.5-2" in width
Vertical Offset (height)	Extra small <0.5" in height
Orientation (direction)	NW to SE

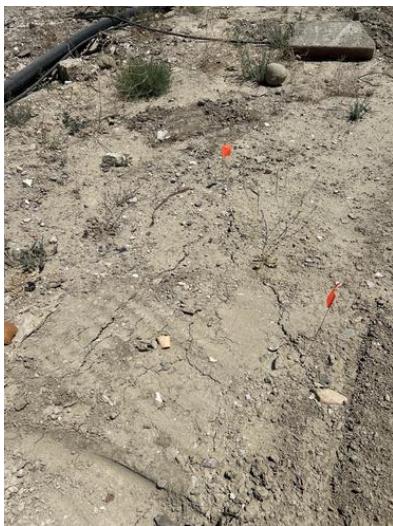
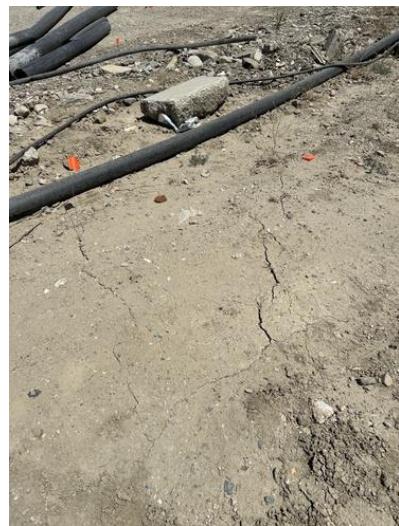
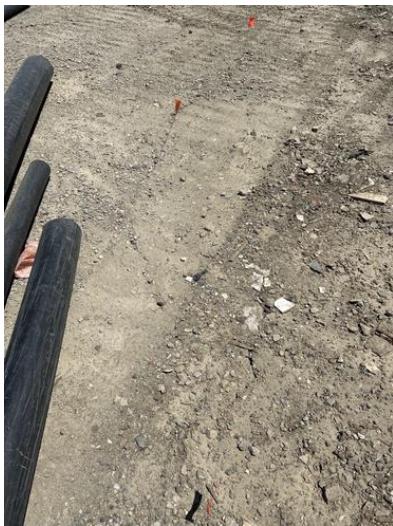
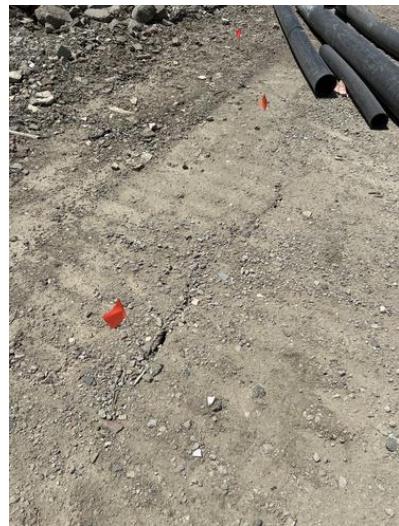
154

20ft x 20ft area

Small 0.5-2" in width

Extra small <0.5" in height

NE to SW

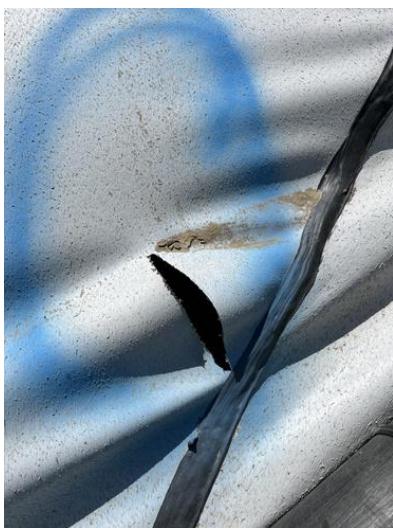
Grid 206

Liner torn, needs to be patched and extrusion welded
