CHIQUITA CANYON
A Waste Connections Company

Re: Chiquita Canyon, LLC's Weekly Report on the Documentation and Tracking of Cover Issues

Attachment: July 1, 2025 Weekly Cover Issues Report

4050 - Chiquita Reaction Area Tracking of Fissures and Tension Cracks

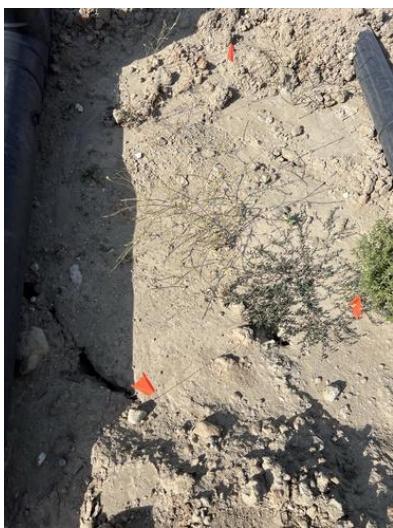
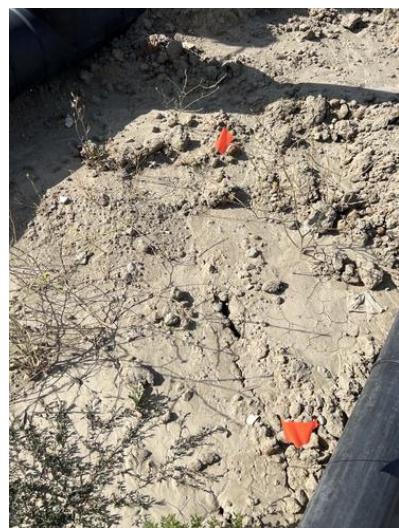
5ft x 5ft

Horizontal Offset (width)	Medium 2-4" in width
Vertical Offset (height)	Small 0.5-2" in height
Orientation (direction)	NW to SE

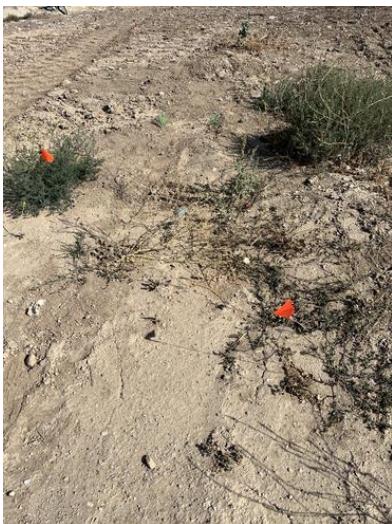
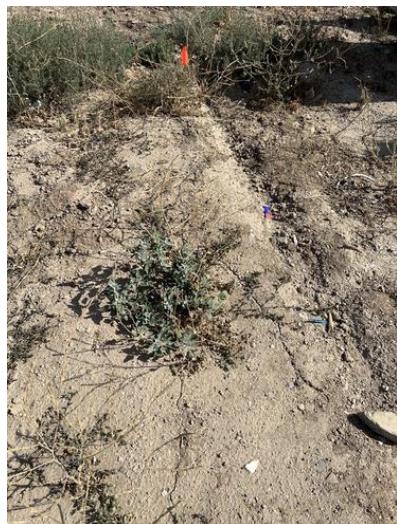
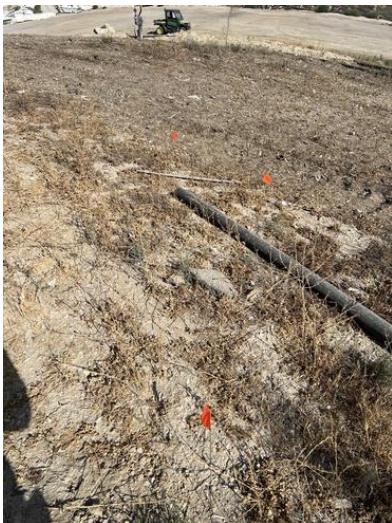
5ft x 25ft

Horizontal Offset (width)	Small 0.5-2" in width
Vertical Offset (height)	Extra small <0.5" in height
Orientation (direction)	NW to SE

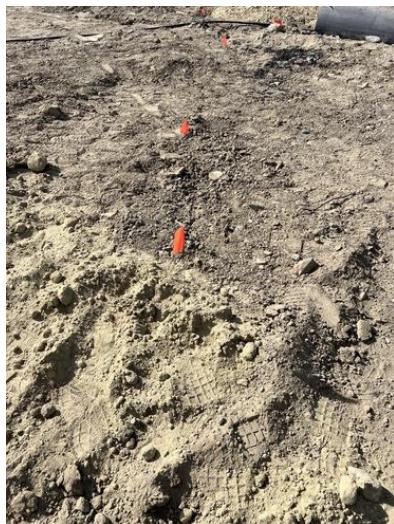
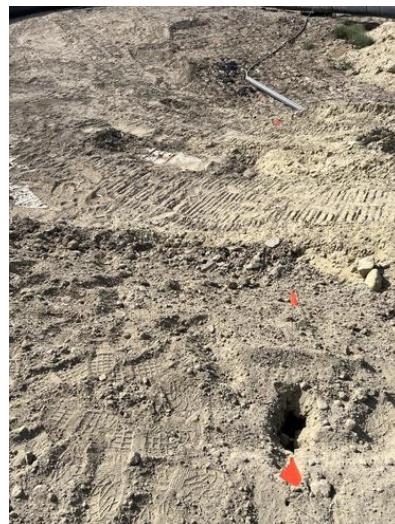
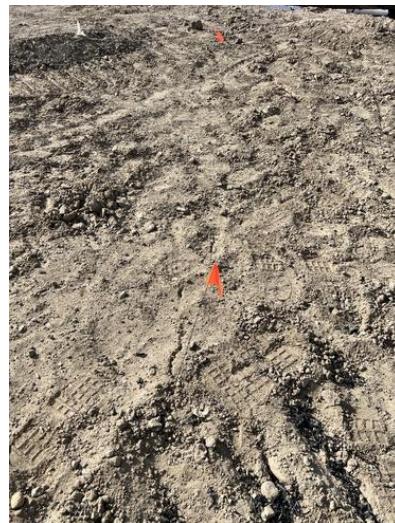
100ft

Large >4" in width

Medium 2-4" in height

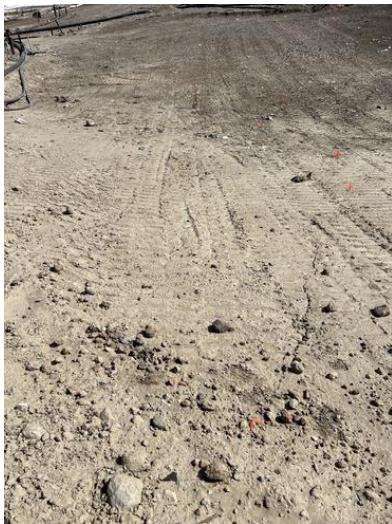
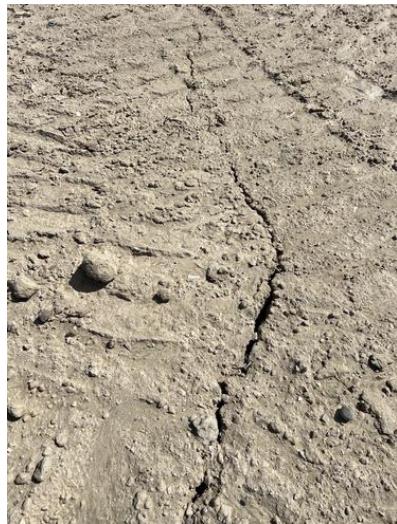
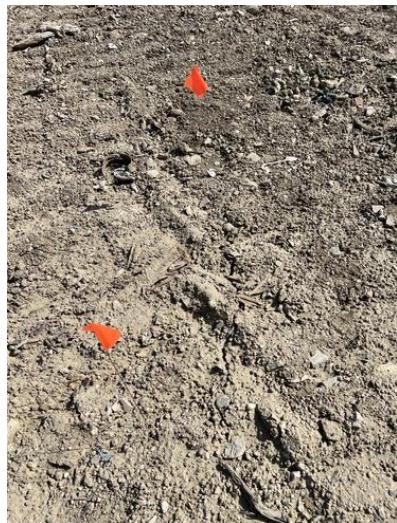
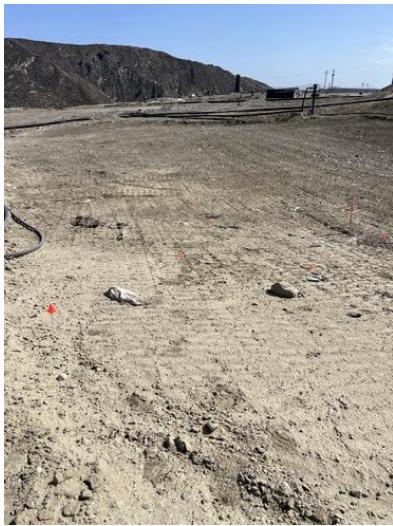
25ft x 150ft

Small 0.5-2" in width

Extra small <0.5" in height

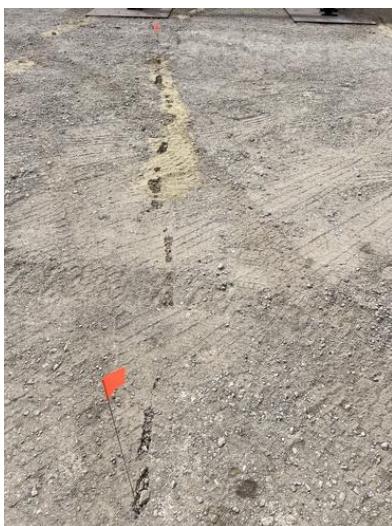
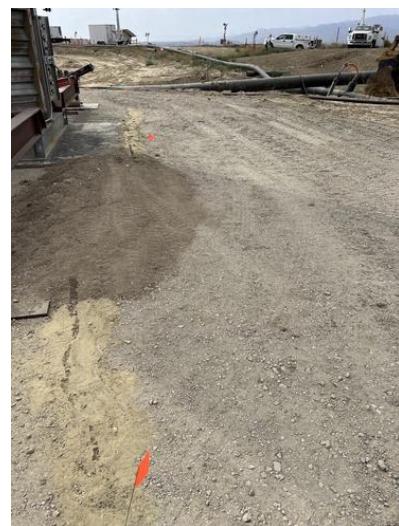
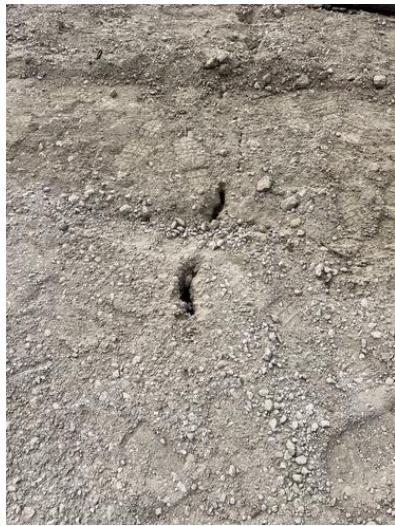
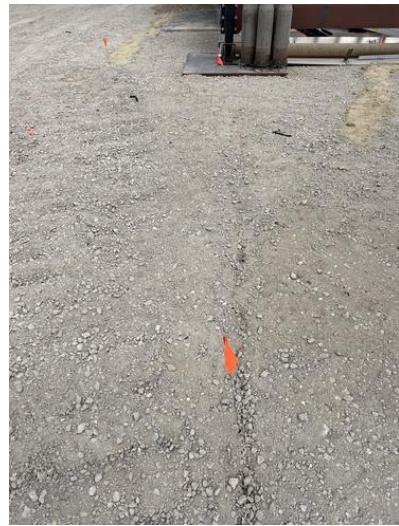
10ft x 75ft

Medium 2-4" in width

Small 0.5-2" in height

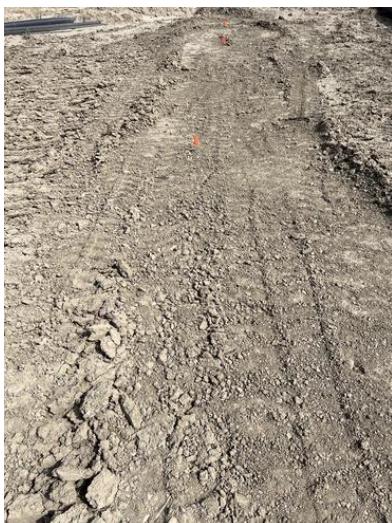
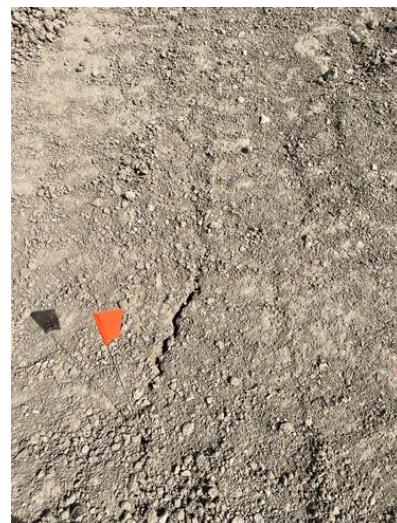
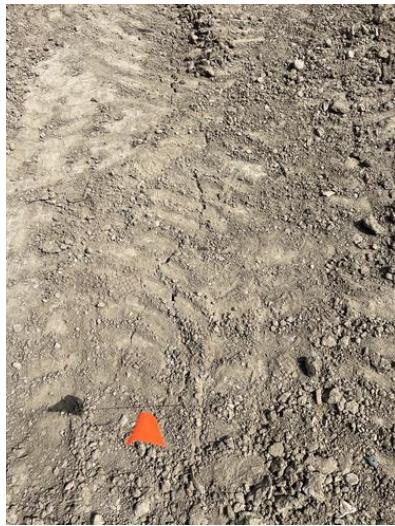
35 ft

Small 0.5-2" in width

Extra small <0.5" in height

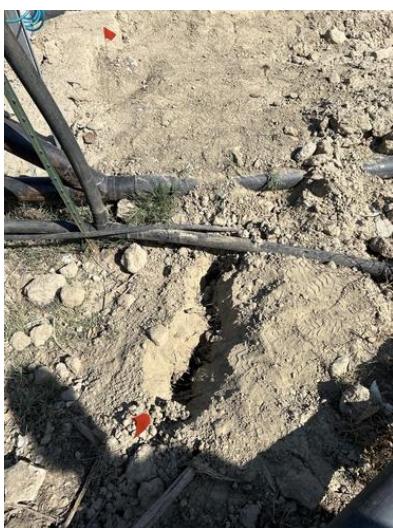
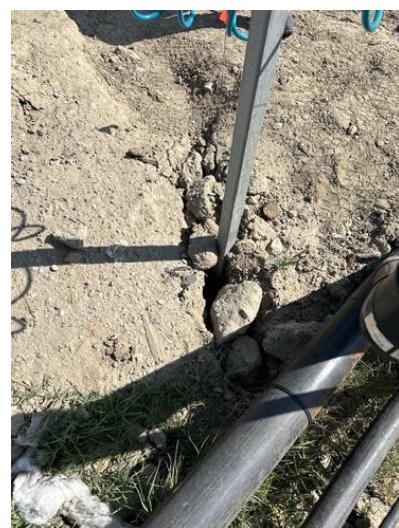
5ft x 5ft

Horizontal Offset (width)	Large >4" in width
Vertical Offset (height)	Medium 2-4" in height
Orientation (direction)	NW to SE

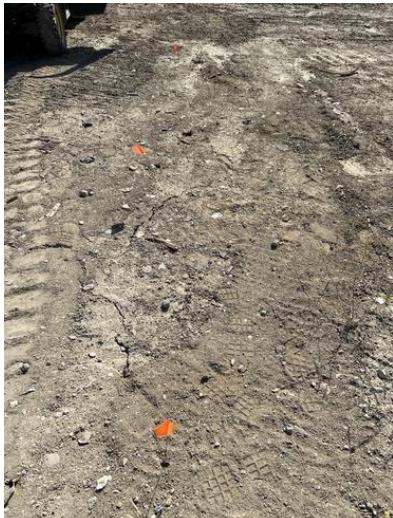
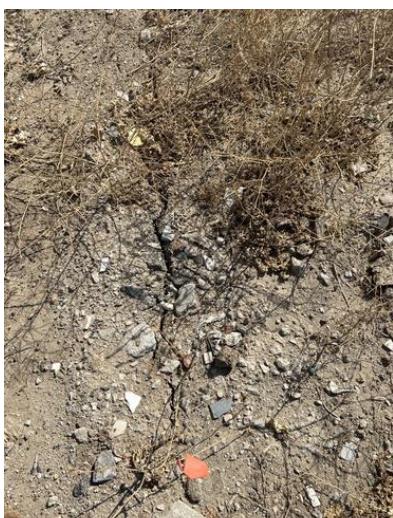
Length of crack (ft) or area containing multiple cracks (ft x ft)	15ft x 25ft
Horizontal Offset (width)	Small 0.5-2" in width
Vertical Offset (height)	Extra small <0.5" in height
Orientation (direction)	NE to SW

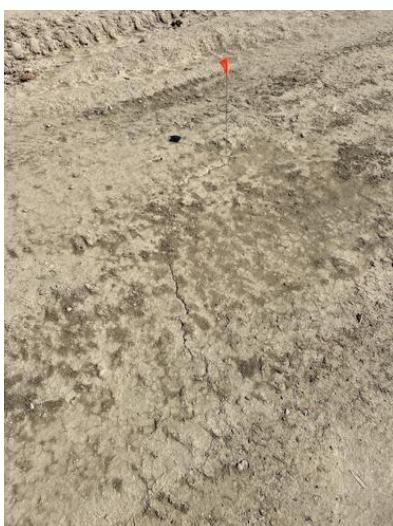
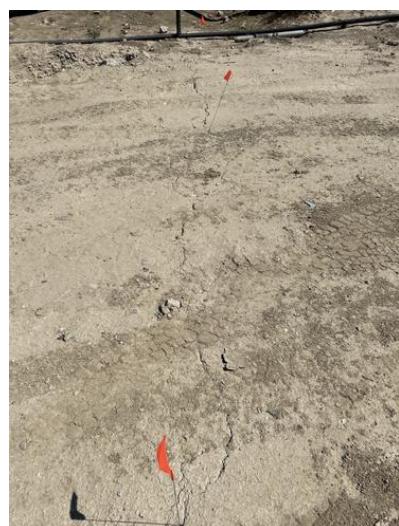
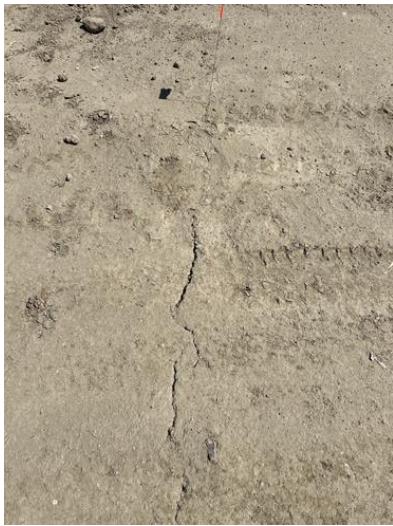
15ft x 20ft area

Extra Small <0.5 in width

Extra small <0.5" in height

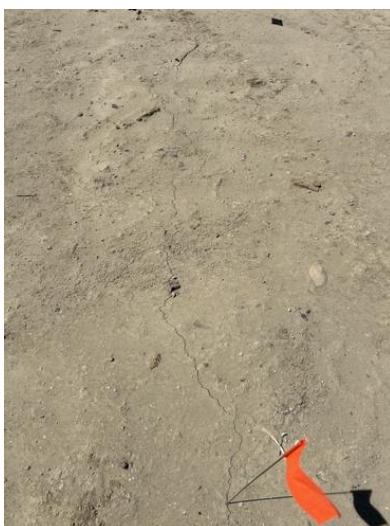
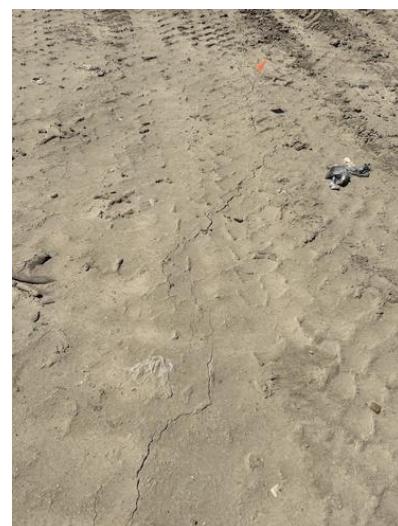
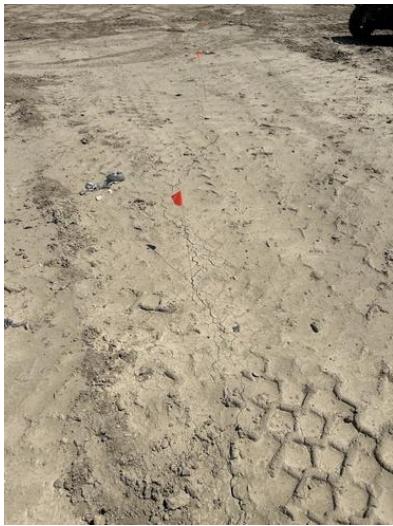
20ft

Extra Small <0.5 in width

Extra small <0.5" in height

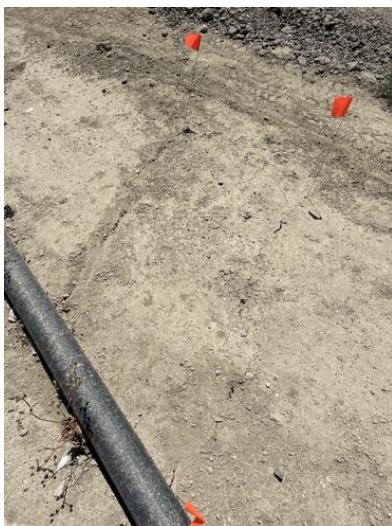
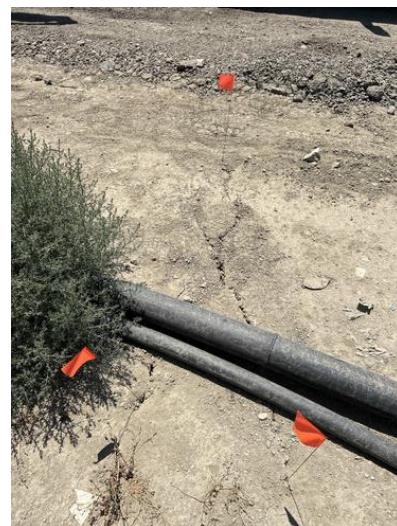
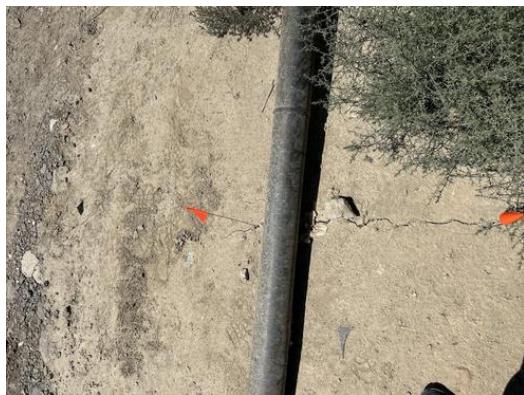
5ft x 15ft area

Small 0.5-2" in width

Extra small <0.5" in height

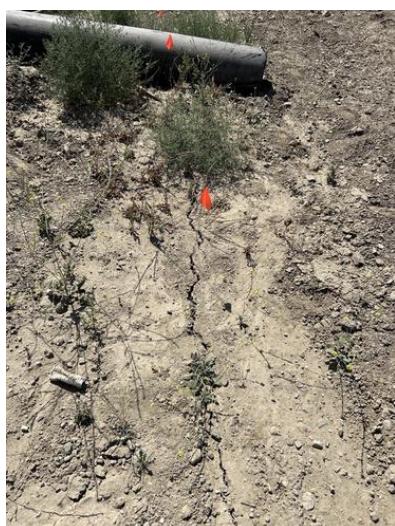
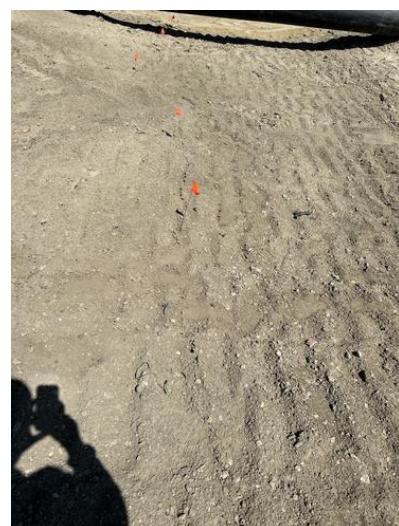
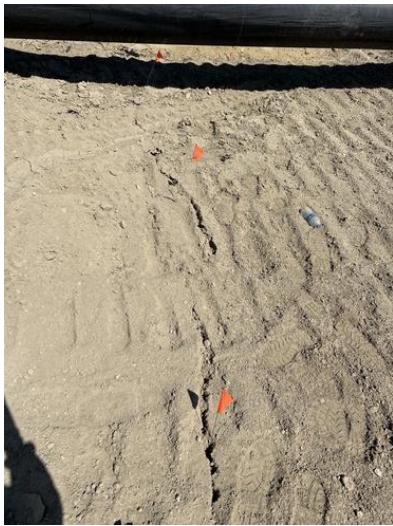
15ft x 15ft area

Small 0.5-2" in width

Extra small <0.5" in height

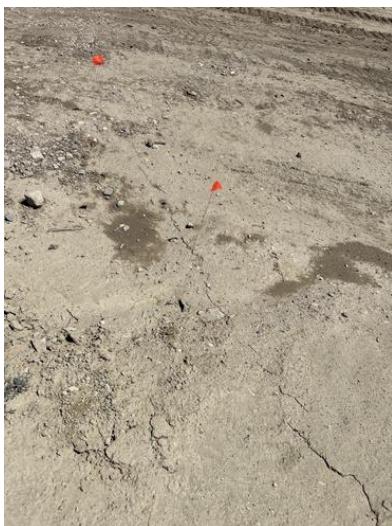
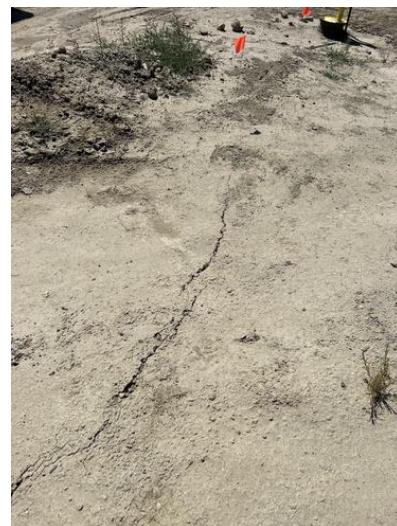
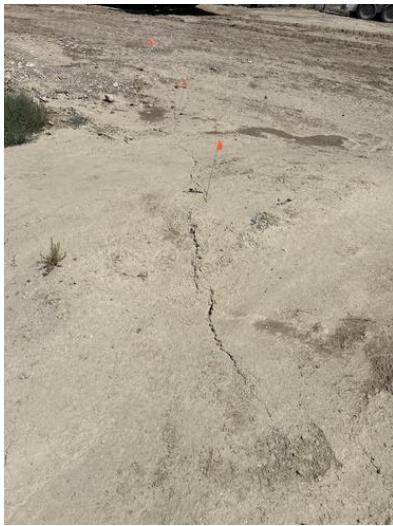
14ft

Extra Small <0.5 in width

Extra small <0.5" in height
