CHIQUITA CANYON
A Waste Connections Company

Re: Chiquita Canyon, LLC's Weekly Report on the Documentation and Tracking of Cover Issues

Attachment: July 15, 2025 Weekly Cover Issues Report

4050 - Chiquita Reaction Area Tracking of Fissures and Tension Cracks

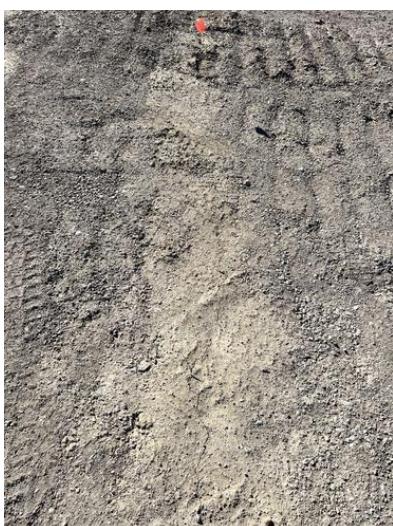
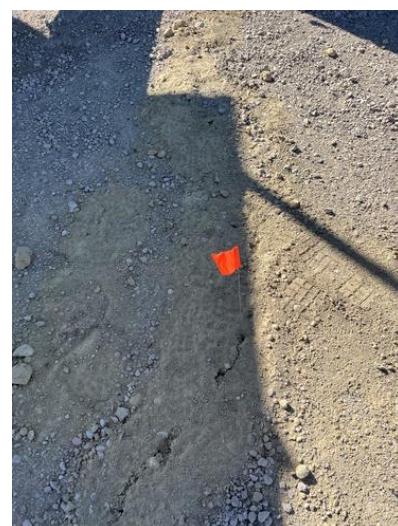
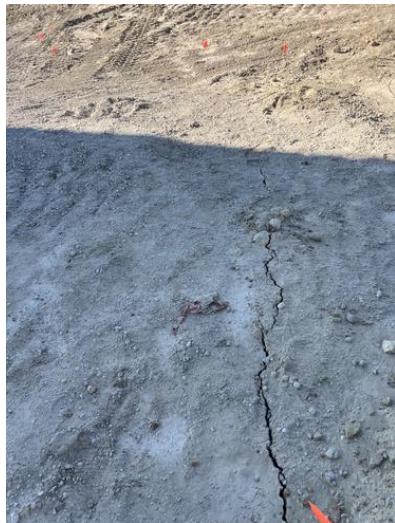
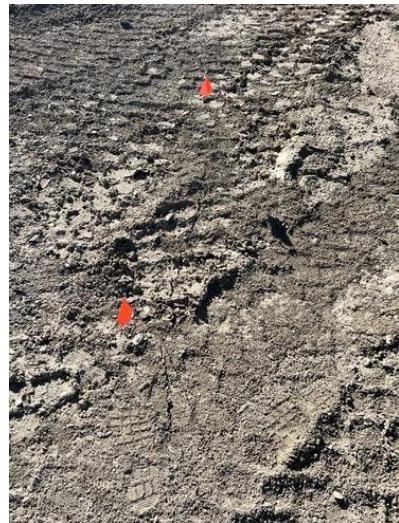
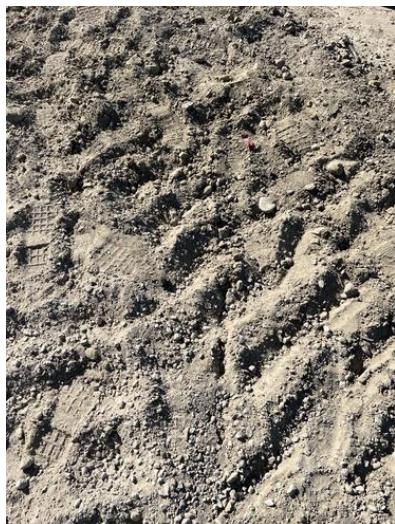
147

60ft x 20ft

Small 0.5-2" in width

Small 0.5-2" in height

NW to SE

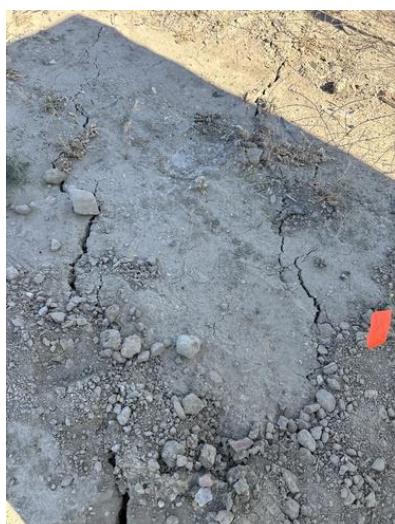
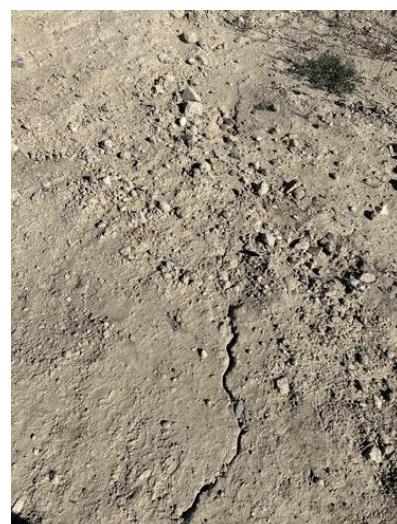
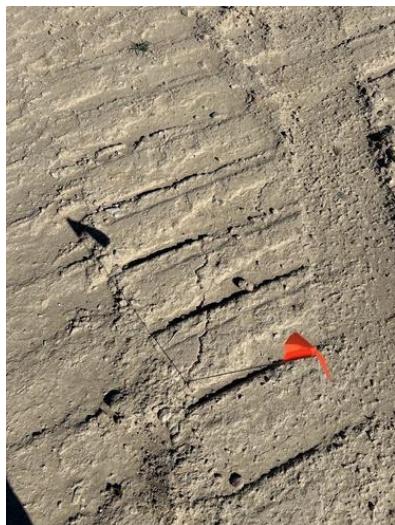
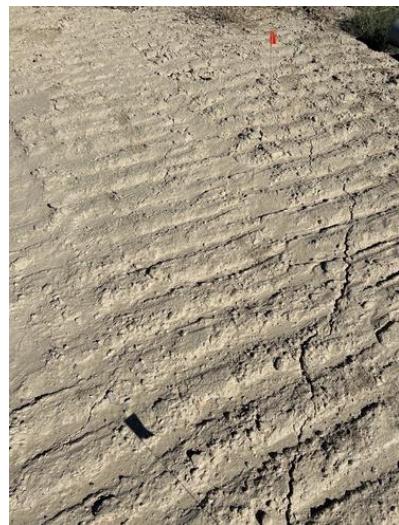
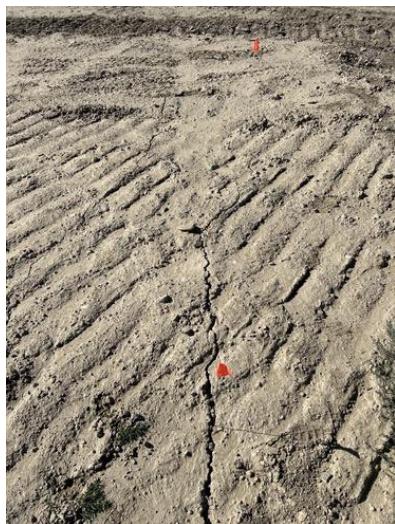
148

15ft x 90 ft

Small 0.5-2" in width

Extra small <0.5" in height

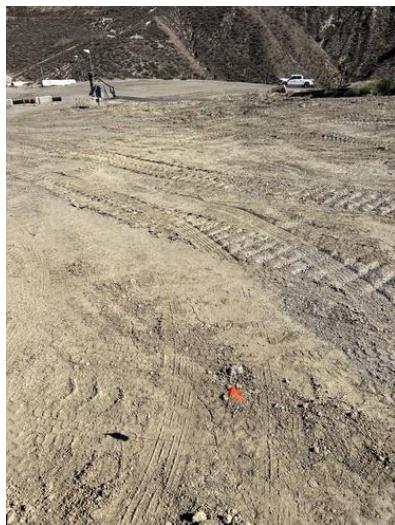
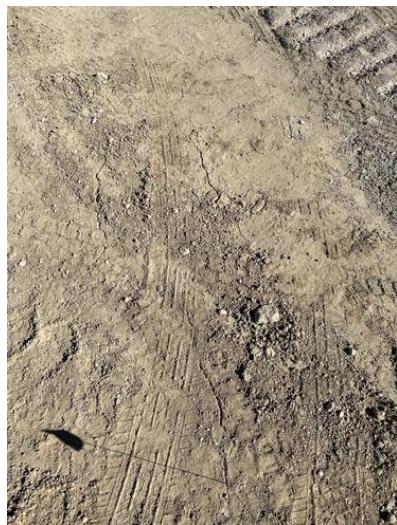
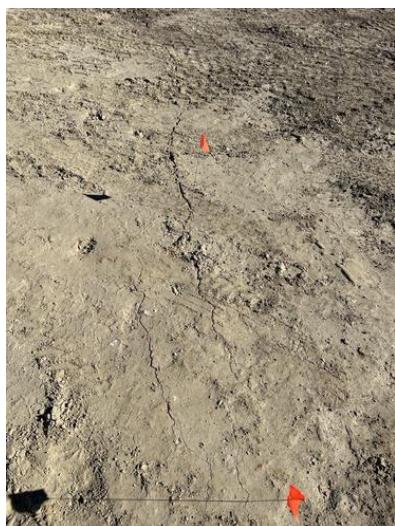
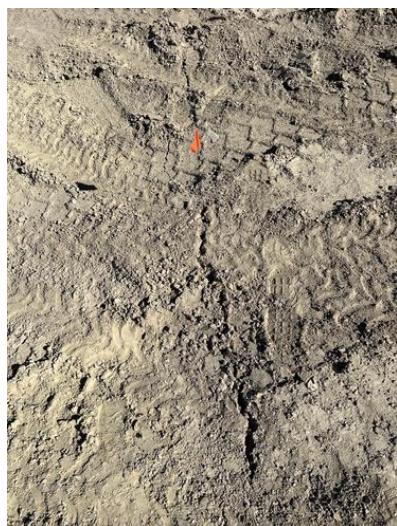
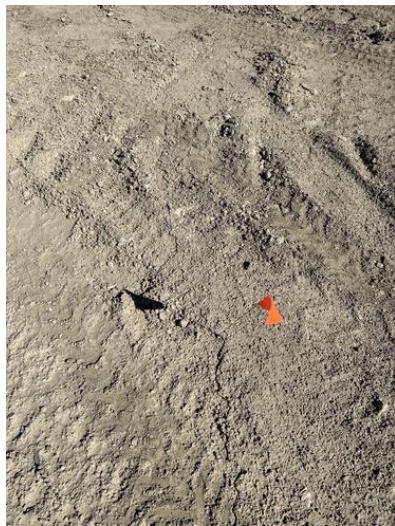
146.147

75ft x 10ft

Small 0.5-2" in width

Vertical Offset (height)	Extra small <0.5" in height
Orientation (direction)	NW to SE
Location	Castaic CA 91384 United States (34.435861046615685, -118.64704999217318)
Was Fissure or Crack fixed? If yes, add photo and description of repairs performed	Yes

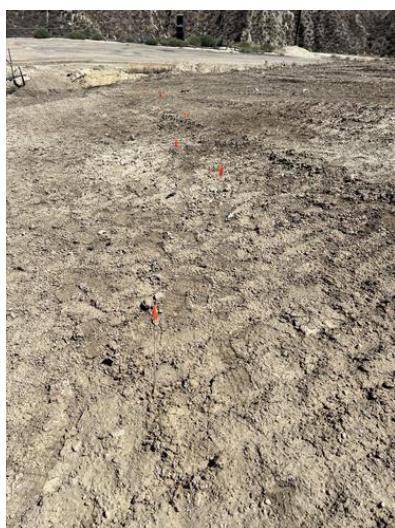
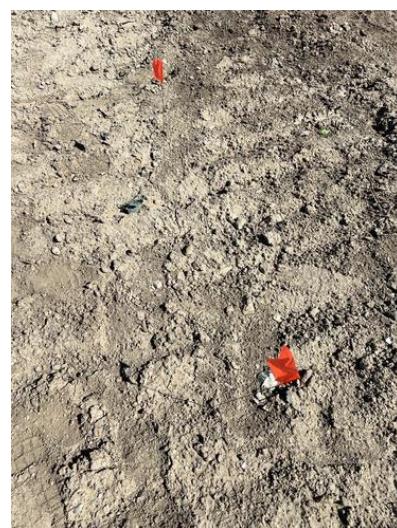
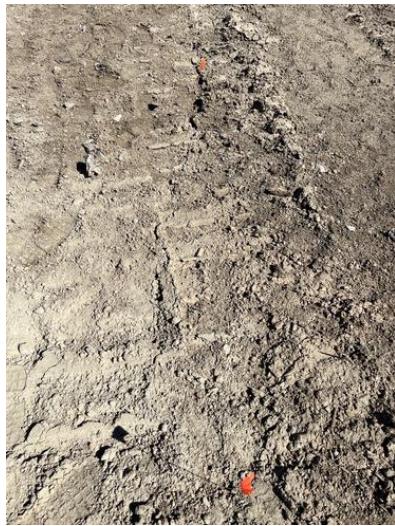
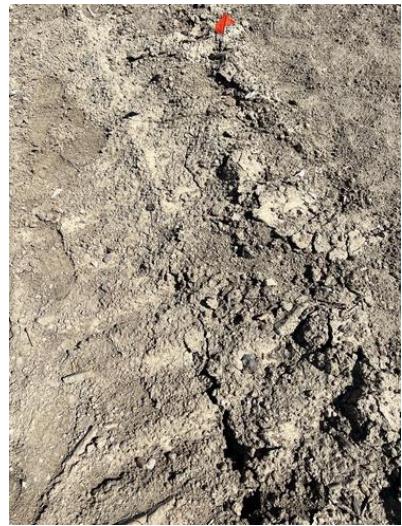
146

30 ft

Small 0.5-2" in width

Extra small <0.5" in height

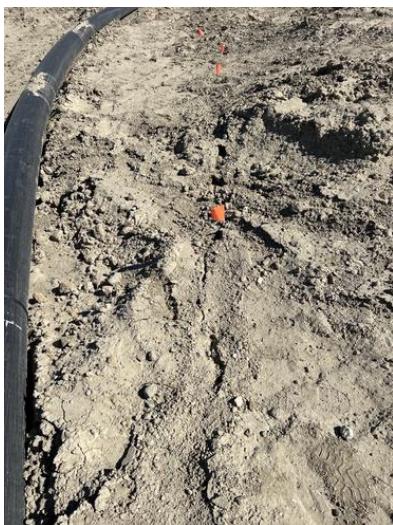
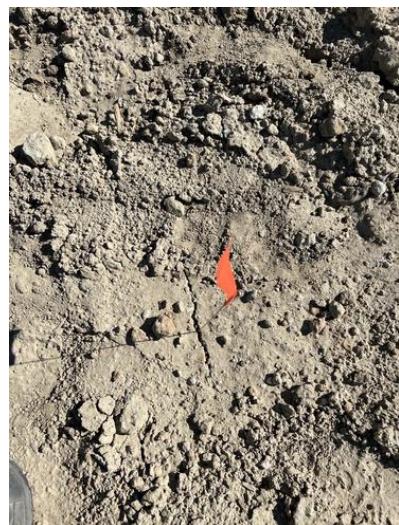
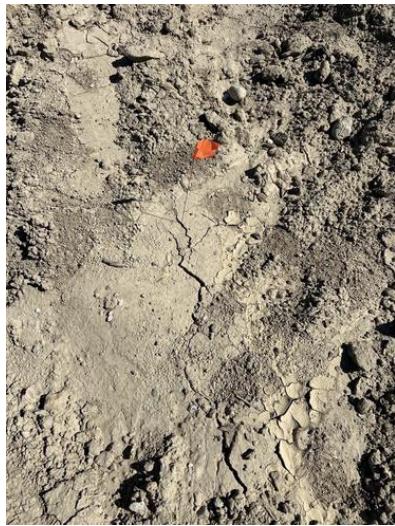
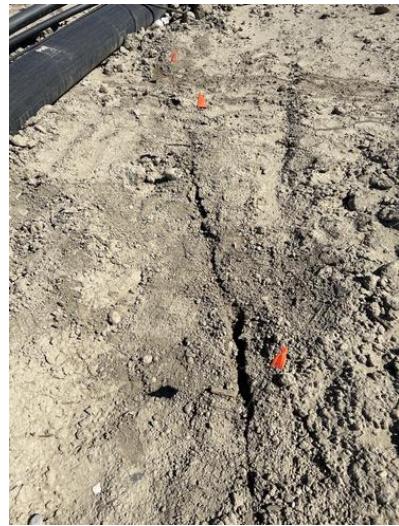
146

30ft

Medium 2-4" in width

Extra small <0.5" in height

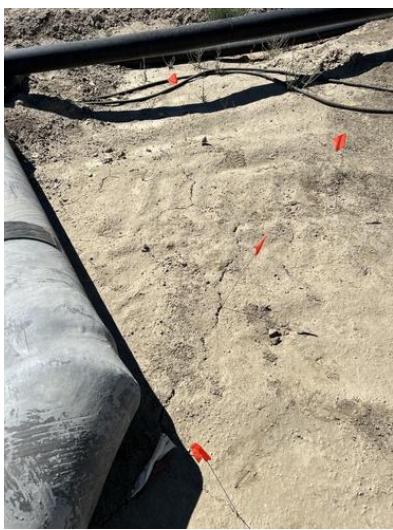
Photo 6

160

6ft

Extra Small <0.5 in width

Vertical Offset (height)	Extra small <0.5" in height
Orientation (direction)	N to S
Location	Castaic CA 91384 United States (34.433353112561186, -118.6473044774155)
Was Fissure or Crack fixed? If yes, add photo and description of repairs performed	Yes

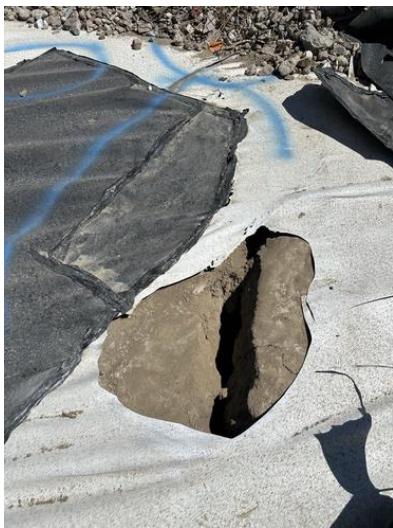
Photo 1

Found at 7:57am in Grid 145

Liner piece was torn off. Needs to be patched
