Re: Chiquita Canyon, LLC's Weekly Report on the Documentation and Tracking of Cover Issues

4050 - Chiquita Reaction Area Tracking of Fissures and Tension Cracks

4050 - Geosynthetic Cover Inspection

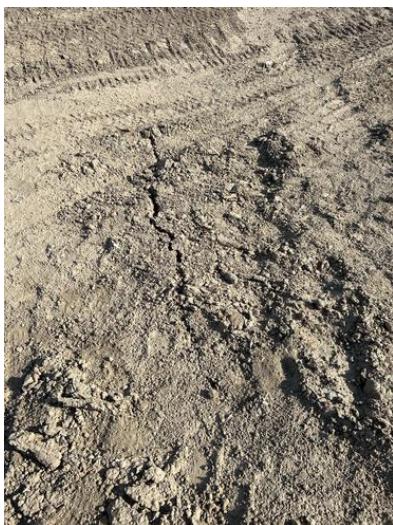
Photo 1

8 ft

Horizontal Offset (width)	Small 0.5-2" in width
Vertical Offset (height)	Extra small <0.5" in height
Orientation (direction)	NW to SE

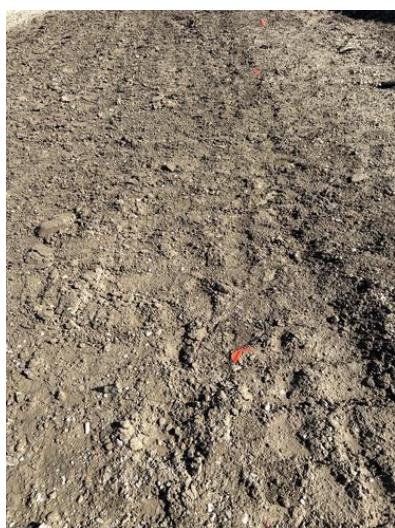
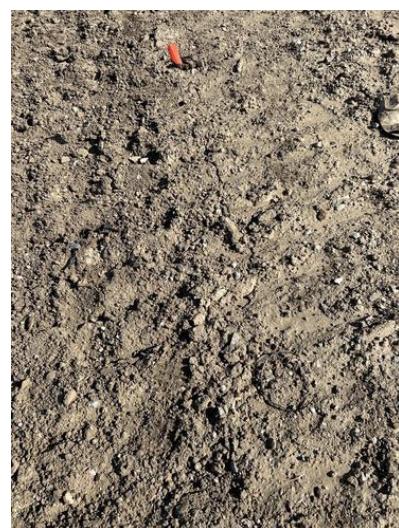
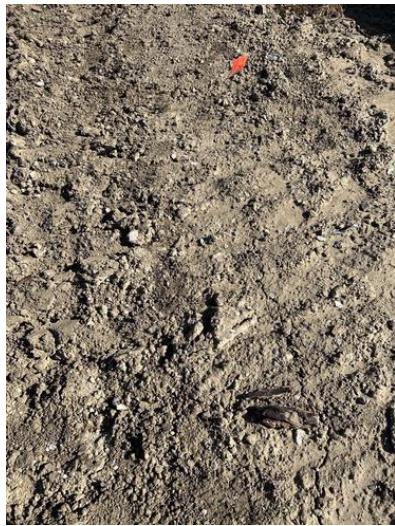
25ft

Small 0.5-2" in width

Extra small <0.5" in height

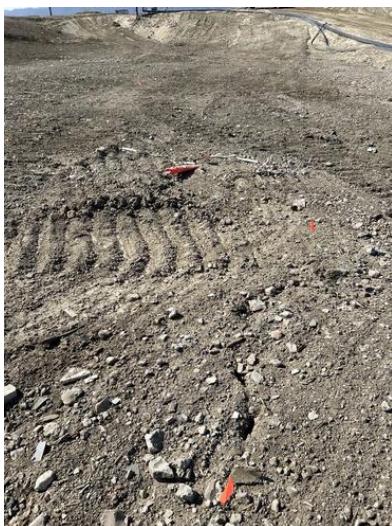
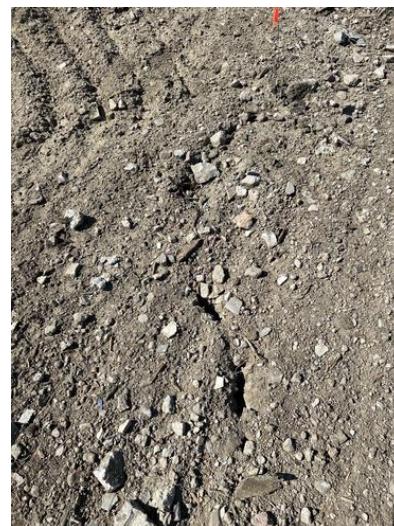
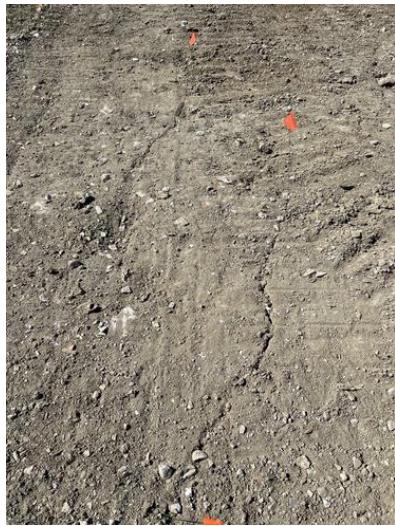
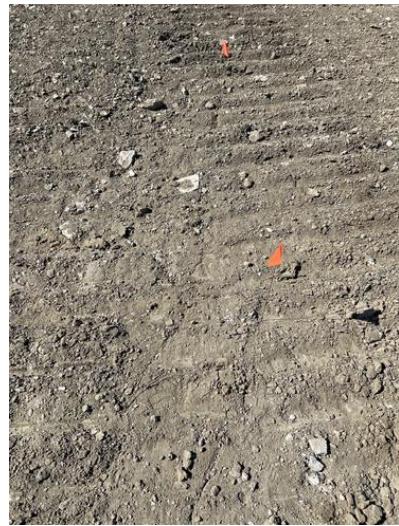
50ft x 15ft, no single crack was over 50ft

Medium 2-4" in width

Small 0.5-2" in height

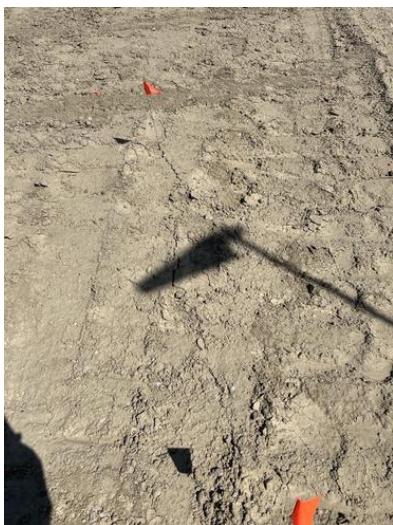
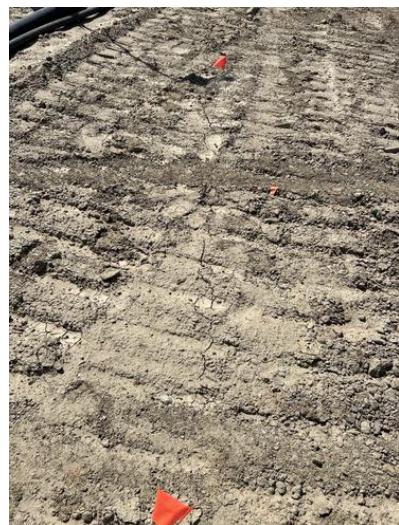
14ft

Horizontal Offset (width)	Extra Small <0.5 in width
Vertical Offset (height)	Extra small <0.5" in height
Orientation (direction)	NW to SE

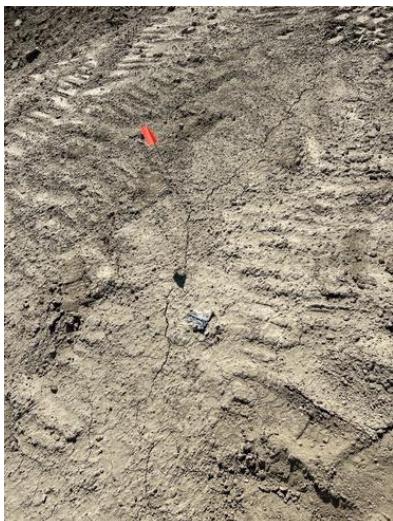
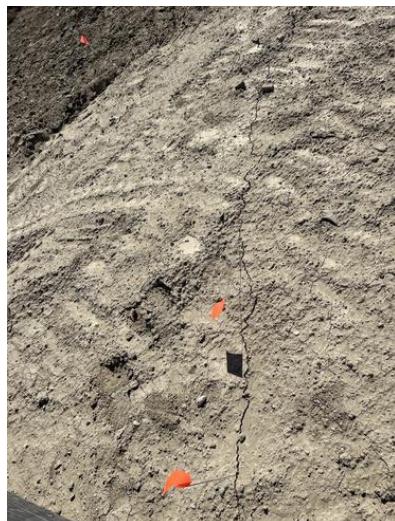
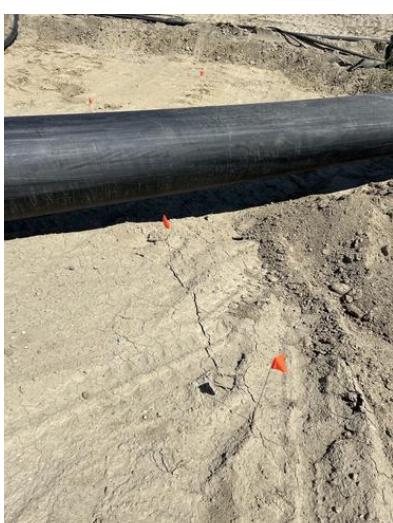
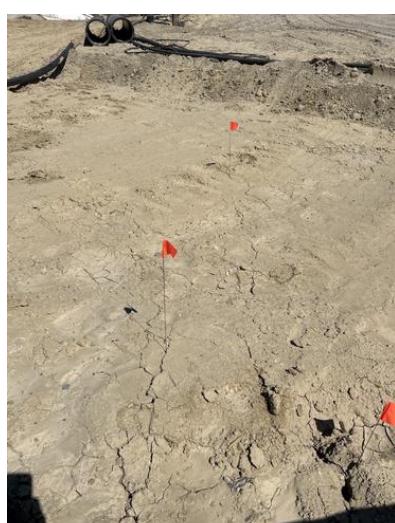
20ft x 10ft area

Small 0.5-2" in width

Extra small <0.5" in height

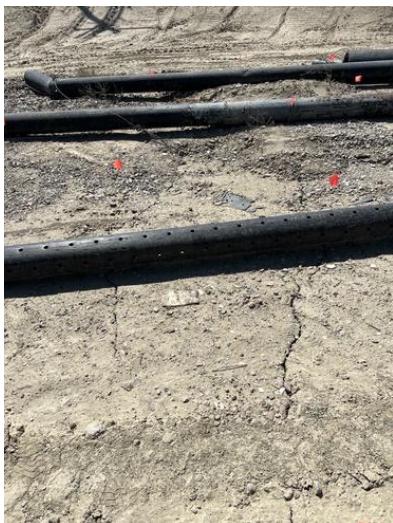
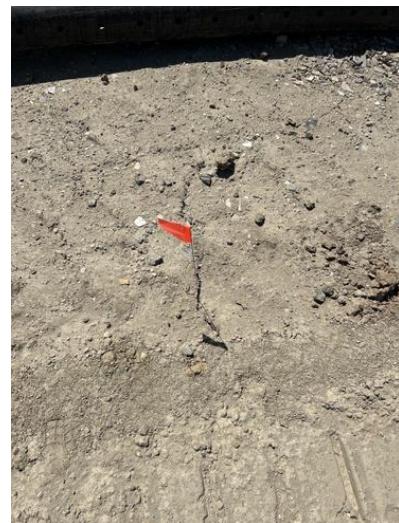
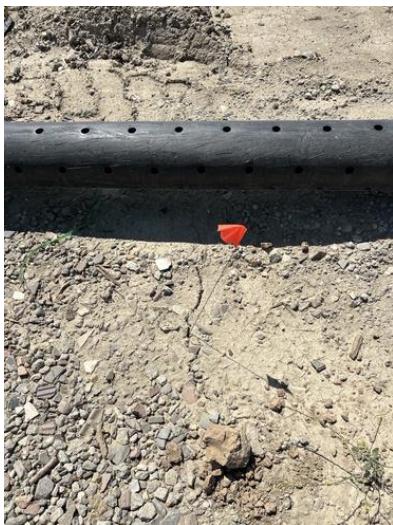
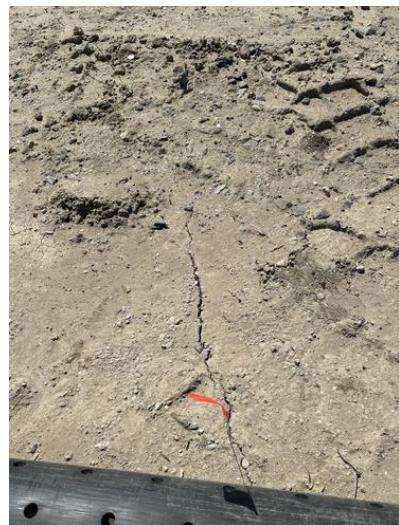
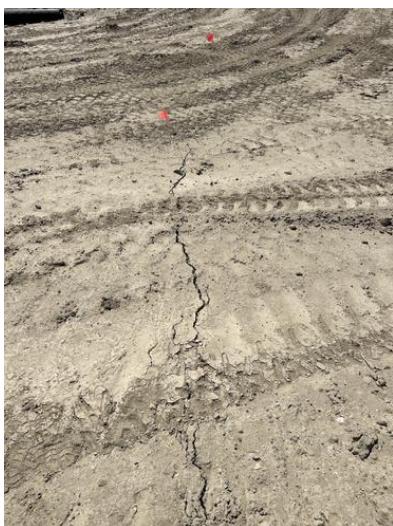
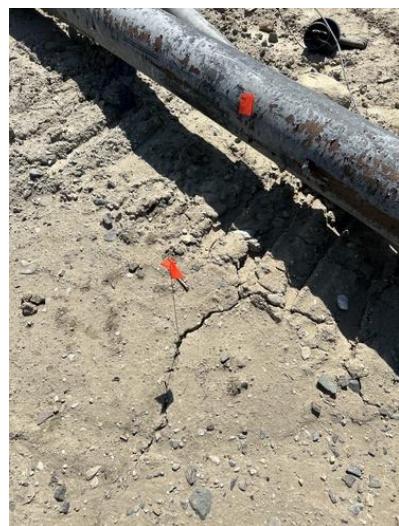
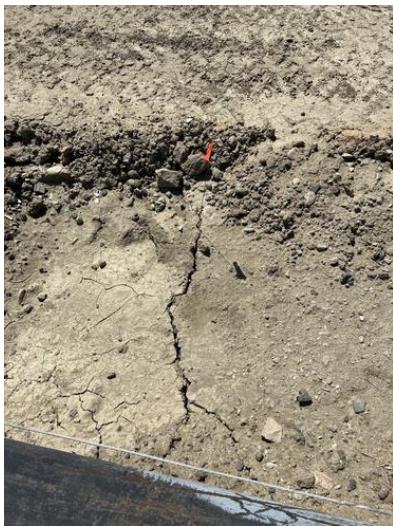
20ft x 20ft area

Small 0.5-2" in width

Extra small <0.5" in height

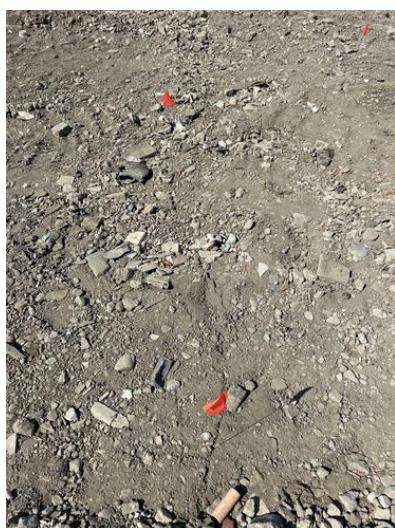
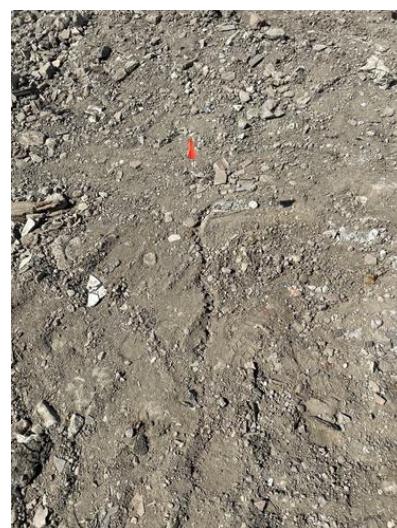
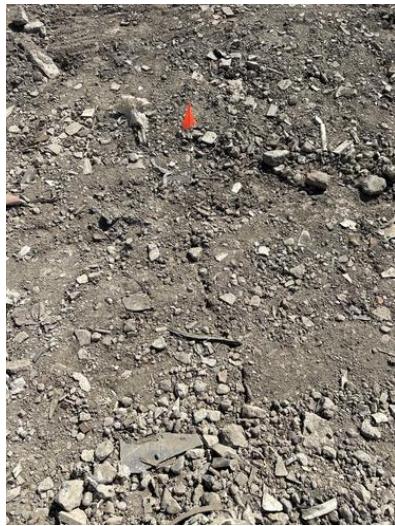
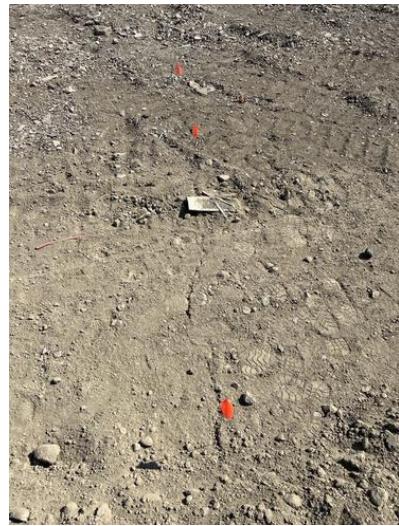
15ft x 10ft

Extra Small <0.5 in width

Extra small <0.5" in height

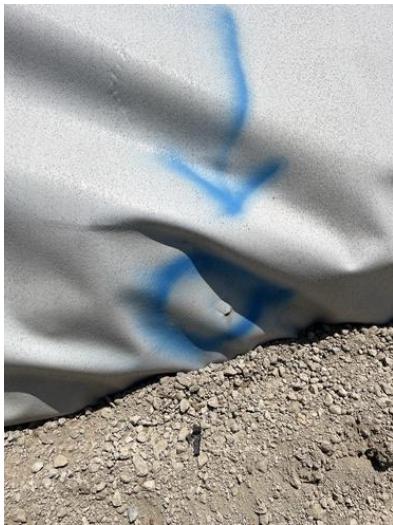
Photo 1

Tear in liner needs to be extrusion welded.

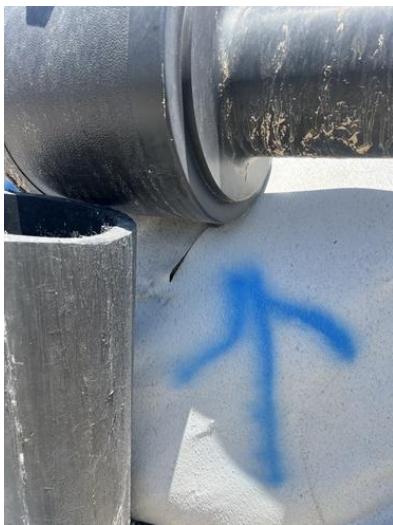
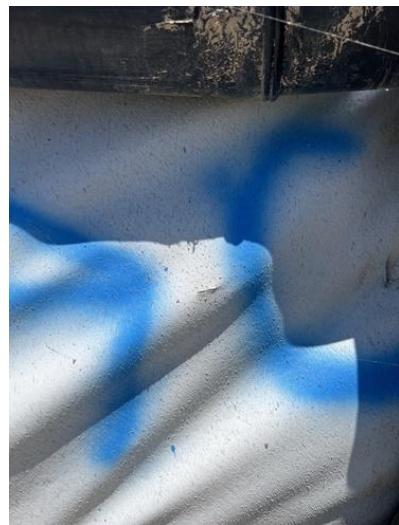
Two tears side by side need to be extrusion welded.

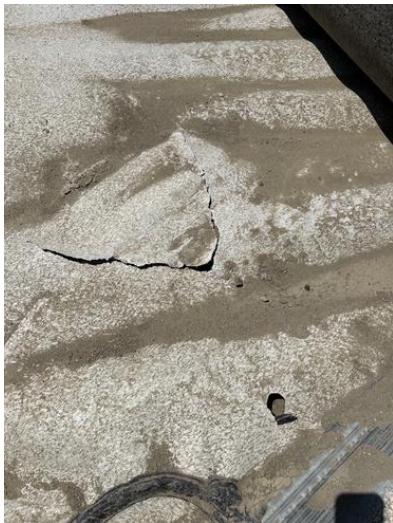
Photo 1

Liner torn, needs to be patched
