CHIQUITA CANYON
A Waste Connections Company

Re: Chiquita Canyon, LLC's Weekly Report on the Documentation and Tracking of Cover Issues

4050 - Chiquita Reaction Area Tracking of Fissures and Tension Cracks

4050 - Geosynthetic Cover Inspection

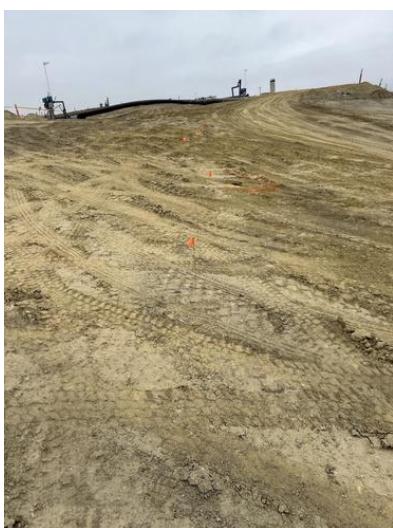
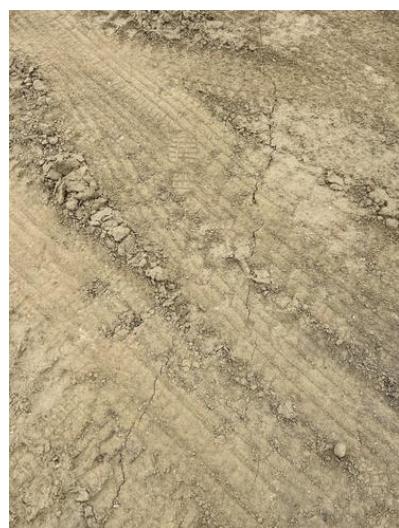
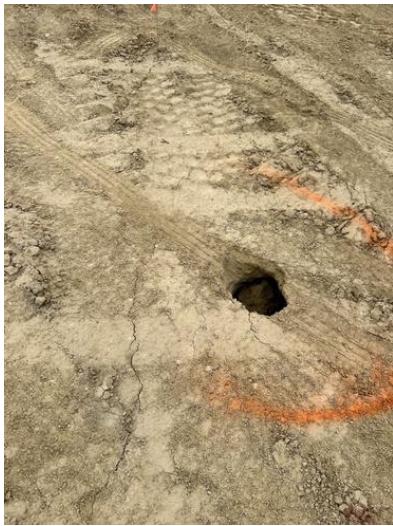
147

30ft x 3ft

Large >4" in width

Large >4" in height

NW to SE

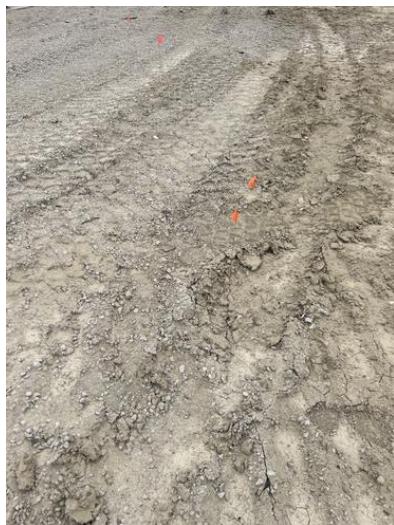
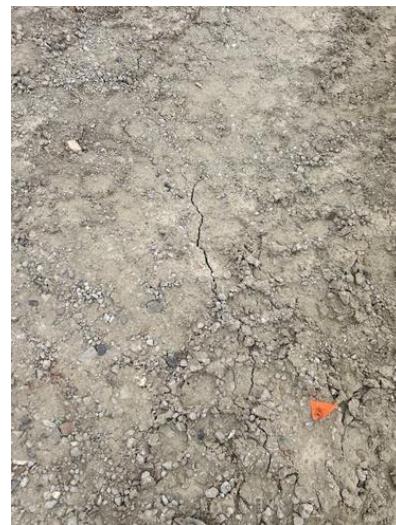
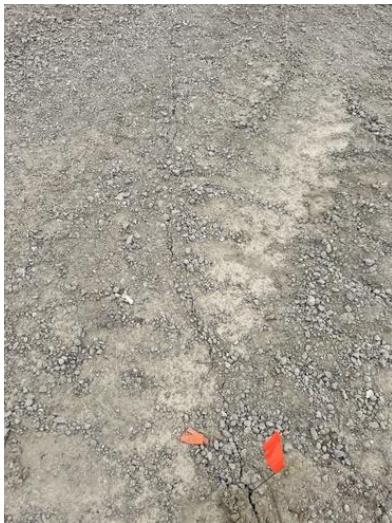
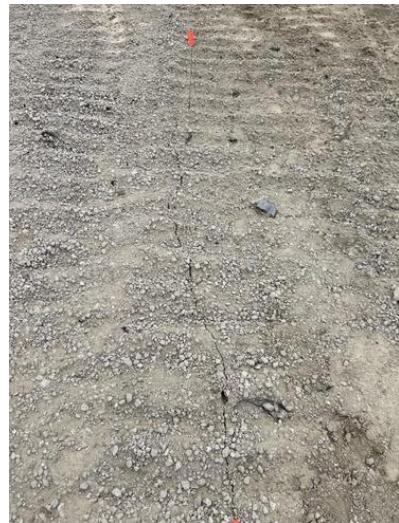
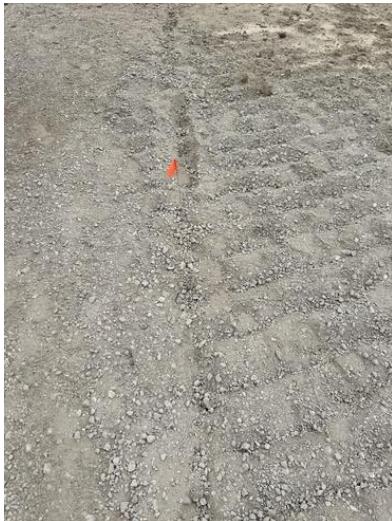
147

25ft x 40ft

Medium 2-4" in width

Small 0.5-2" in height

NW to SE

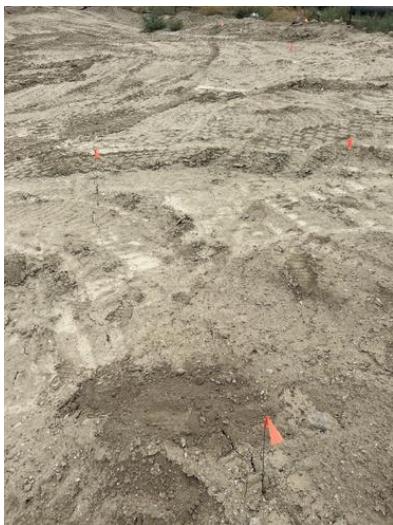
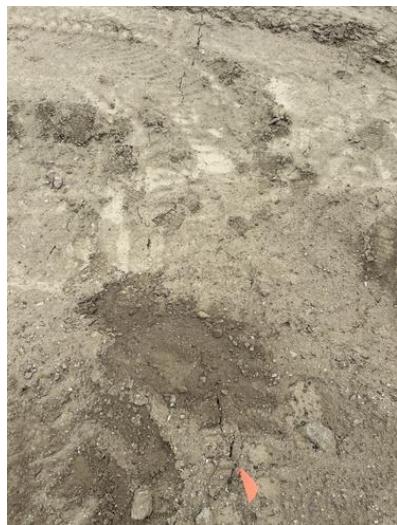
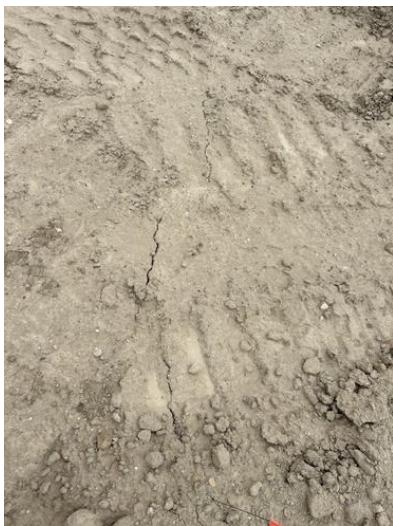
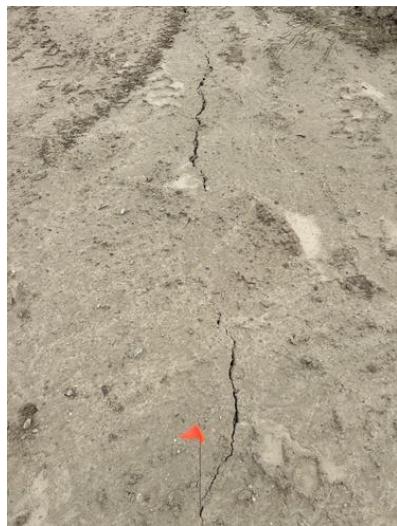
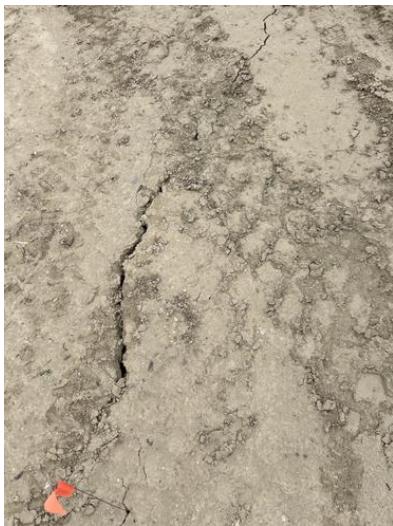
148

40ft x 10ft

Small 0.5-2" in width

Vertical Offset (height)	Extra small <0.5" in height
Orientation (direction)	NW to SE
Location	Castaic CA 91384 United States (34.435416665305205, -118.64633611529703)
Was Fissure or Crack fixed? If yes, add photo and description of repairs performed	Yes

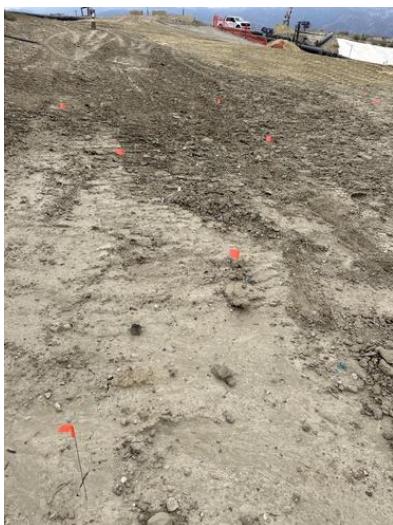
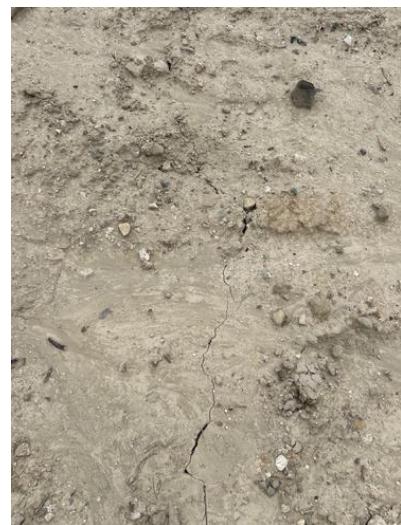
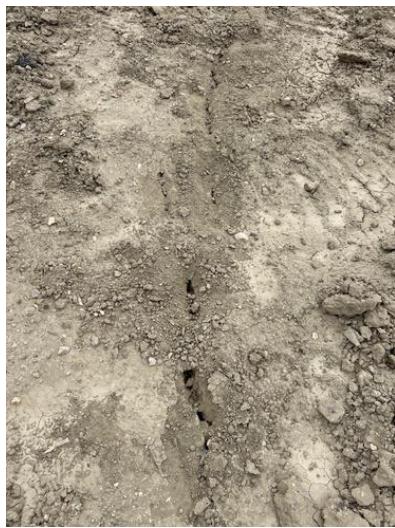
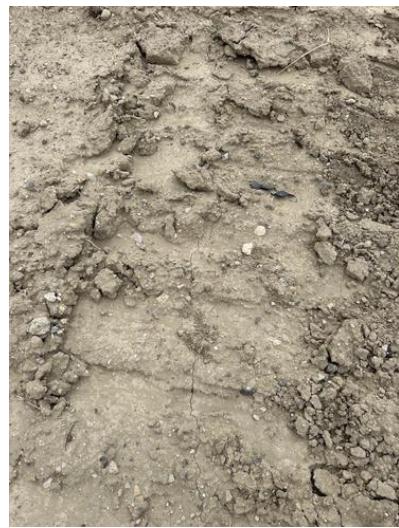
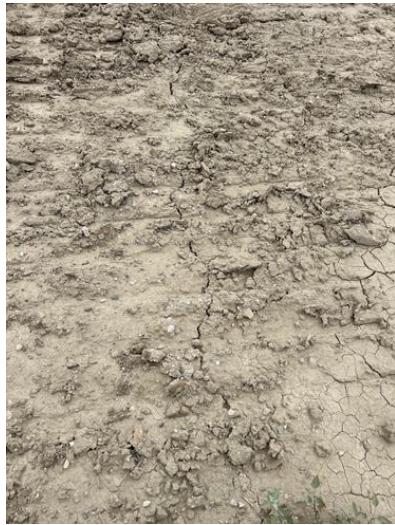
146

15ft x 25ft

Medium 2-4" in width

Small 0.5-2" in height

NW to SE

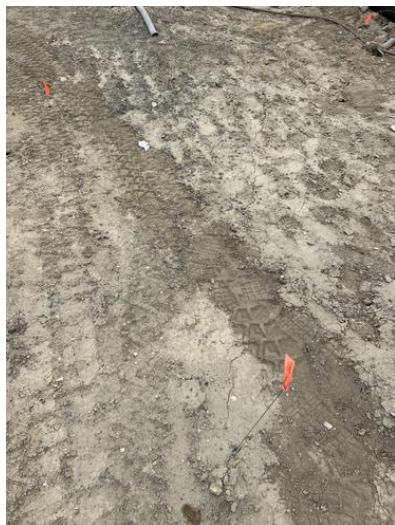
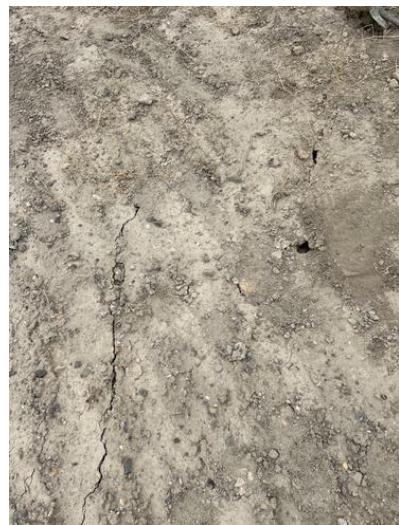
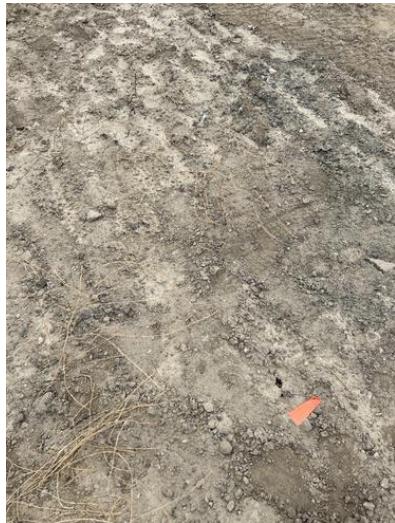
148

5ft x 10ft

Small 0.5-2" in width

Extra small <0.5" in height

NW to SE

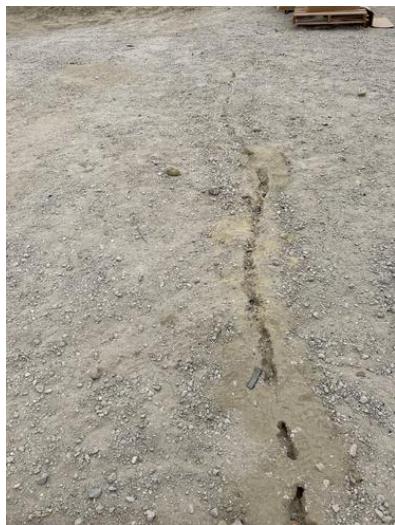
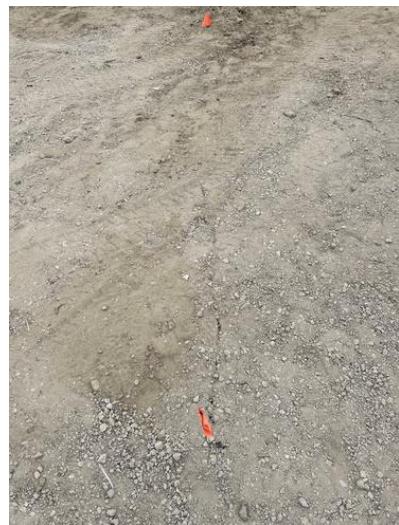
147

35ft

Medium 2-4" in width

Small 0.5-2" in height

NW to SE

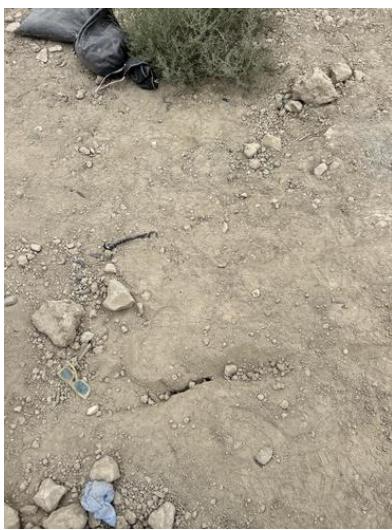
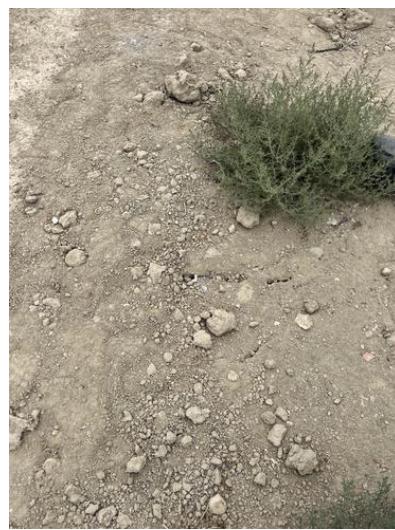
146

10ft x 4ft

Small 0.5-2" in width

Vertical Offset (height)	Extra small <0.5" in height
Orientation (direction)	NW to SE
Location	Castaic CA 91384 United States (34.43647688490362, -118.64706340829491)
Was Fissure or Crack fixed? If yes, add photo and description of repairs performed	Yes

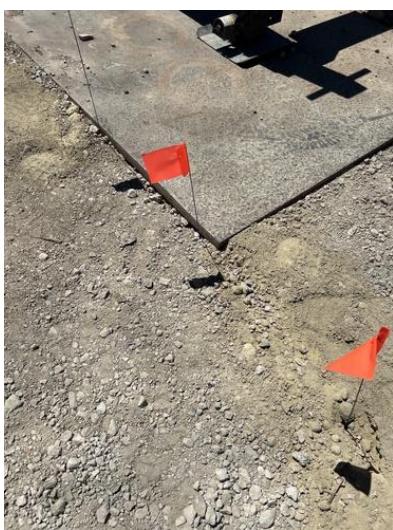
Photo 1

147

2ft

Horizontal Offset (width)	Extra Small <0.5 in width
Vertical Offset (height)	Extra small <0.5" in height
Orientation (direction)	N to S
