**Asunto:** Vertedero de Chiquita Canyon - Cubierta Geosintética - Medida de Mitigación 4.1  
**Importancia:** Normal  
**Sensibilidad:** Ninguna  
[2025-07-21 EVOH Deployment Records.pdf](#); [4050 2025-07-07 Milestone 2B Chiquita Canyon LF](#)

A continuación se encuentra la actualización de Chiquita de la primera semana sobre el estado de la instalación de la cubierta de geomembrana de EVOH de 60-mil en el Vertedero de Chiquita Canyon, conforme a la Medida de Mitigación 4.1 de la Orden de Cumplimiento de la LEA emitida el 1 de mayo de 2025.

## REPAIR LOG

| Project Name:<br>Chiquita Canyon Cell 8 Tank Farm | | Project No.<br>RM22.1077 | | Daily Field Report Sequence Number:<br>059 | |

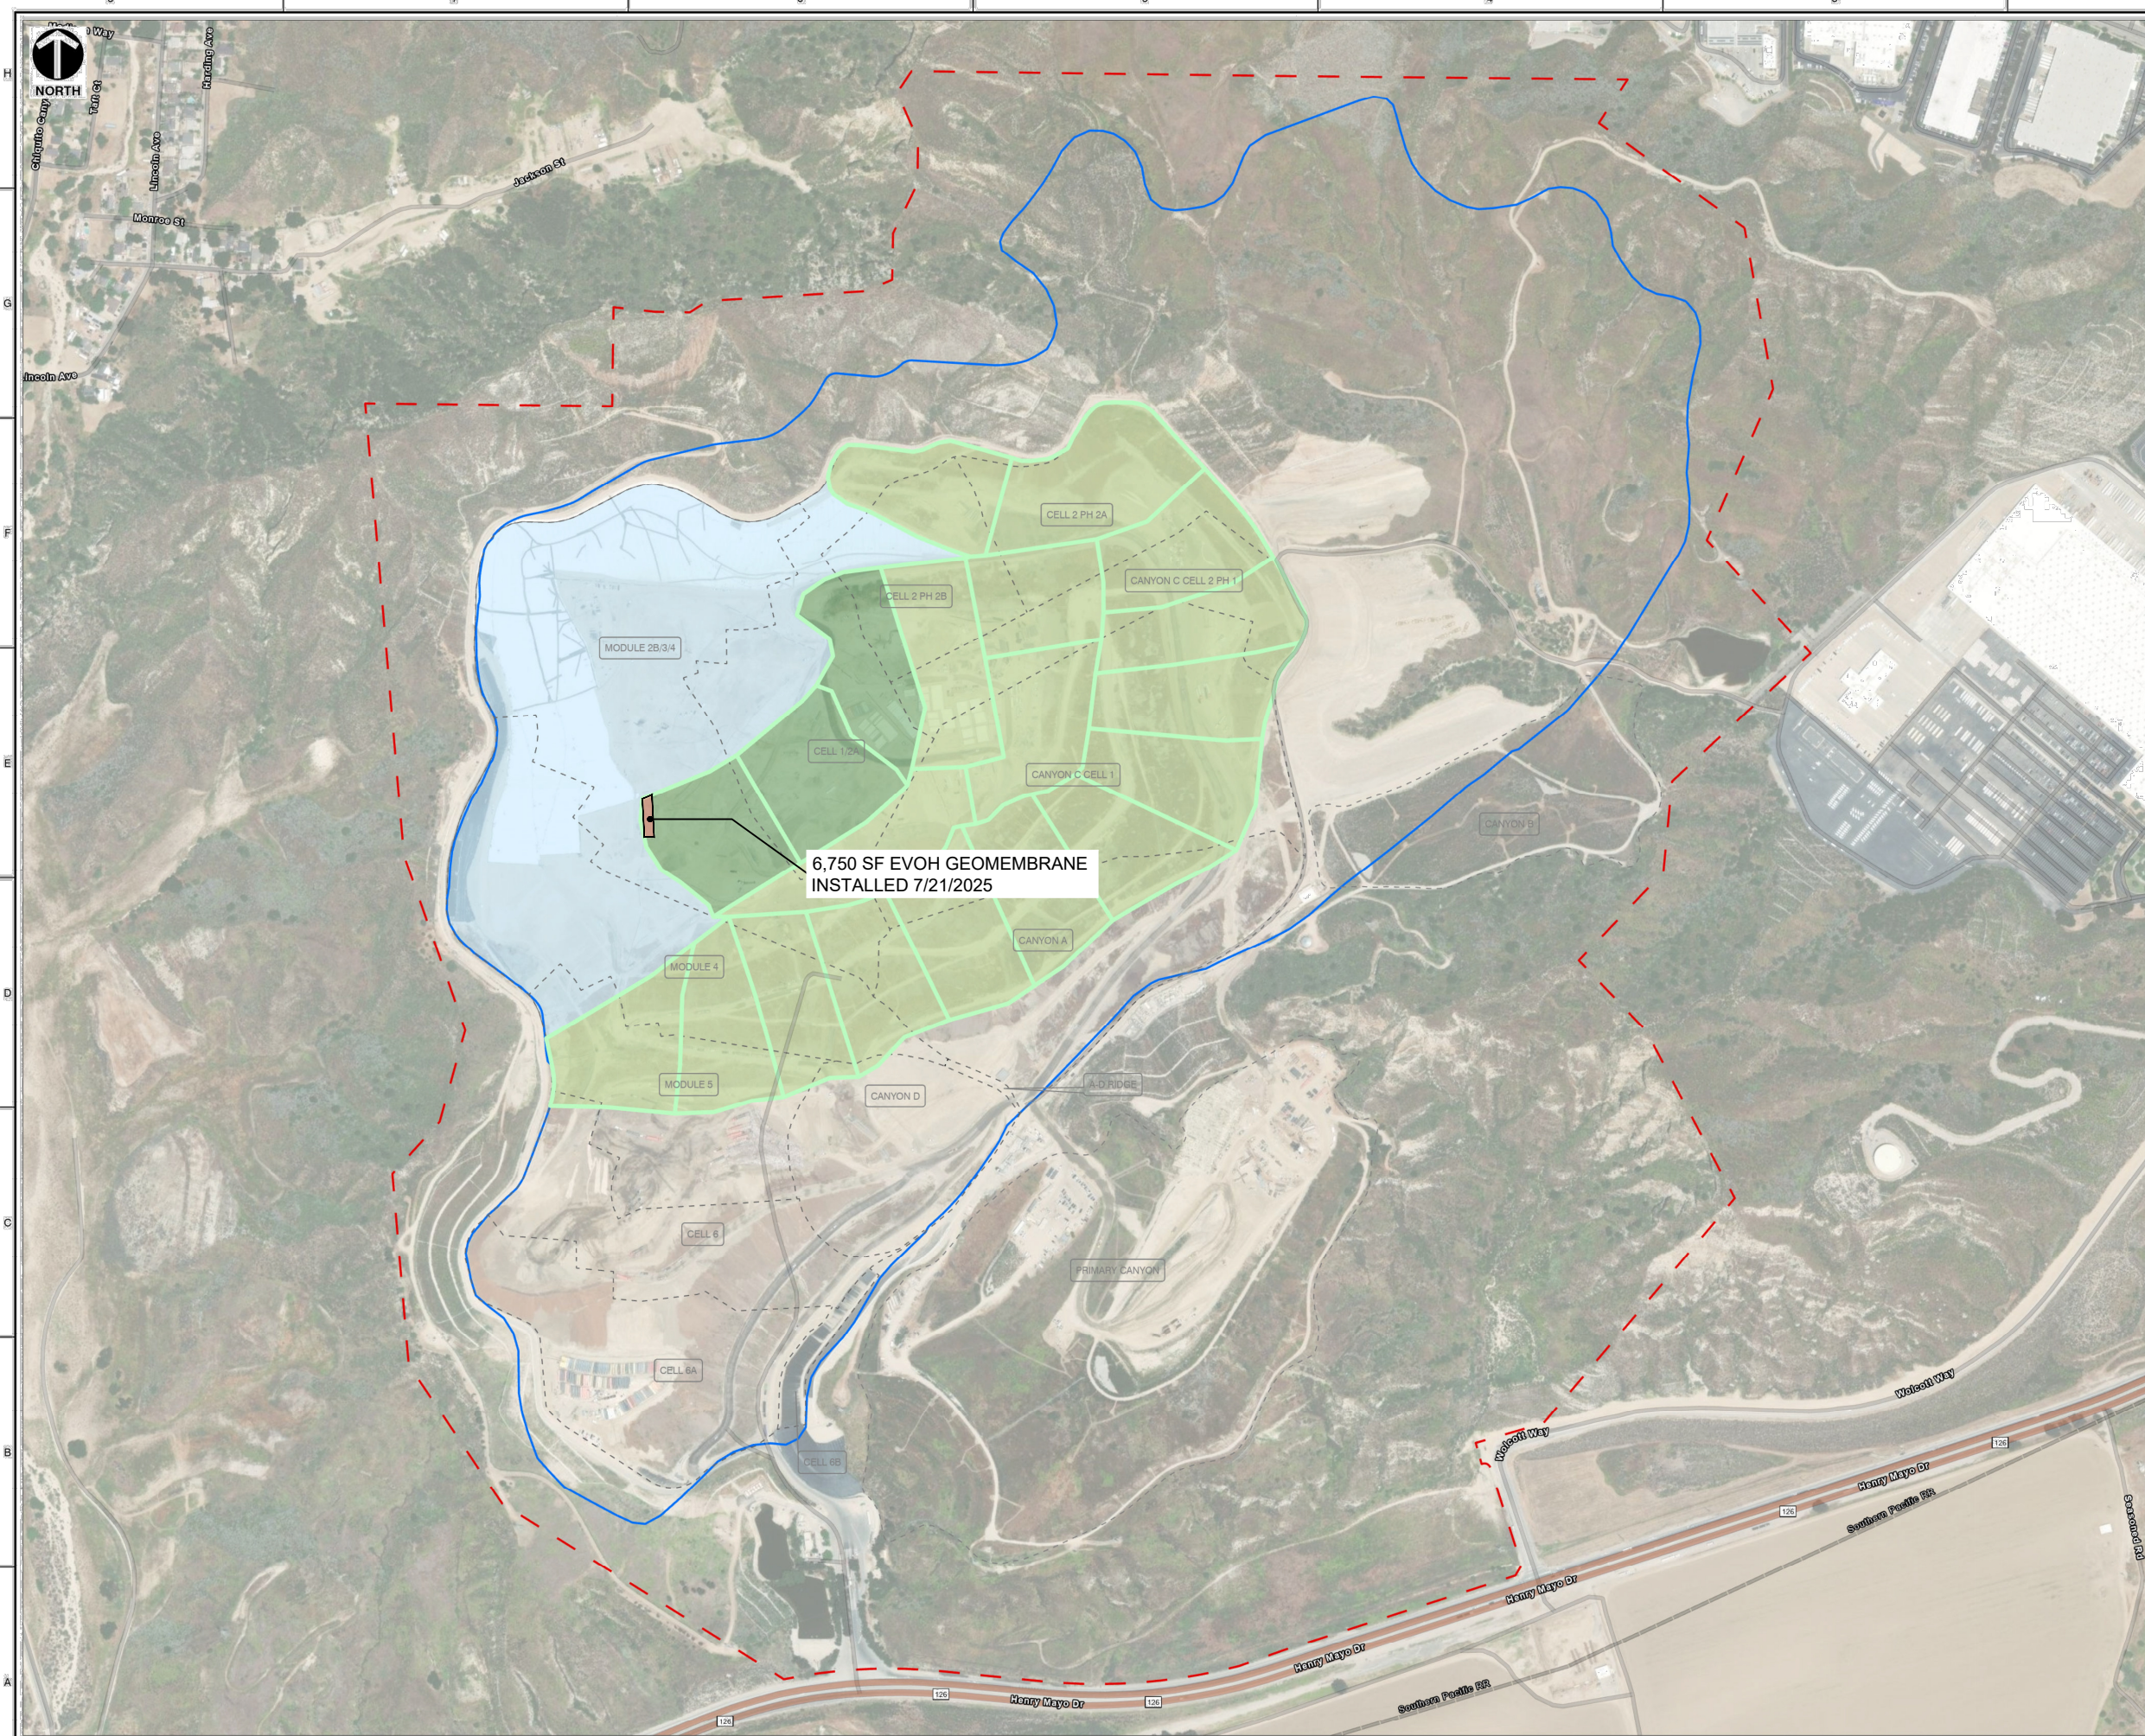
FIGURE NO. **2A**

La Figura 1 muestra la extensión aproximada de la cubierta de geomembrana instalada al día de hoy, como también la zona de cobertura de geomembrana descrita en el anteproyecto del plan de trabajo para la extensión de la cubierta de geomembrana de fecha 16 de mayo de 2025 presentada a la LEA y al DTSC. Se debe tener en cuenta que Chiquita está evaluando esta área de extensión prevista en respuesta a la correspondencia del 24 de julio de 2025 de la EPA de EE.UU. También se adjunta a esta presentación el mapa isopáquico mensual de junio de 2025 y el mapa de la zona reactiva de junio de 2025 presentado como parte de la determinación mensual del Comité de la Reacción con fecha 10 de julio de 2025. Debido a limitaciones técnicas, actualmente no podemos crear una figura que incluya todos los datos descritos en la sección 4.1 de la Orden de Cumplimiento de la LEA de 2025, pero estamos trabajando activamente en una solución y prevemos tener un mapa optimizado para futuras presentaciones.

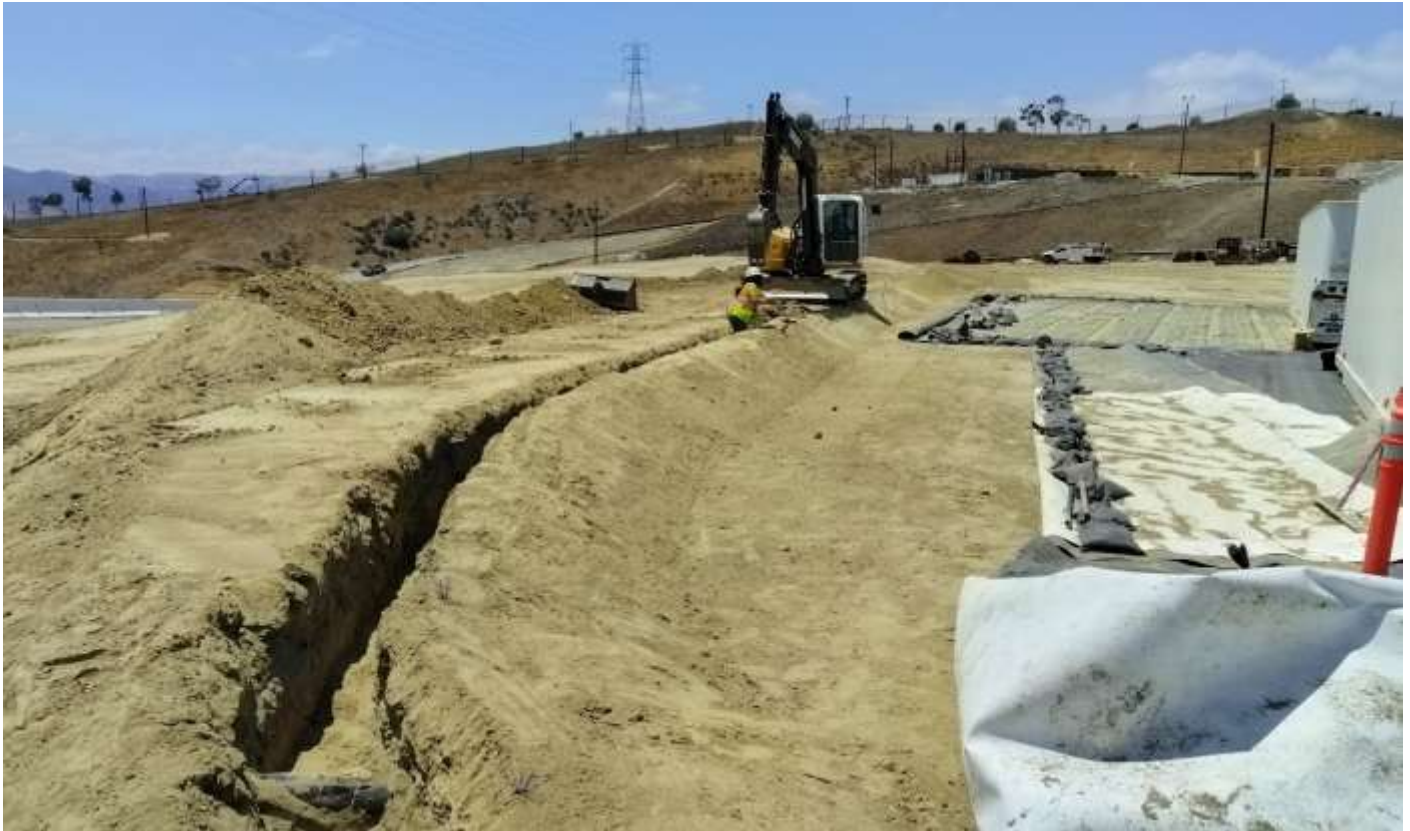
*Picture 1: Anchor trench construction (Pad #1).*

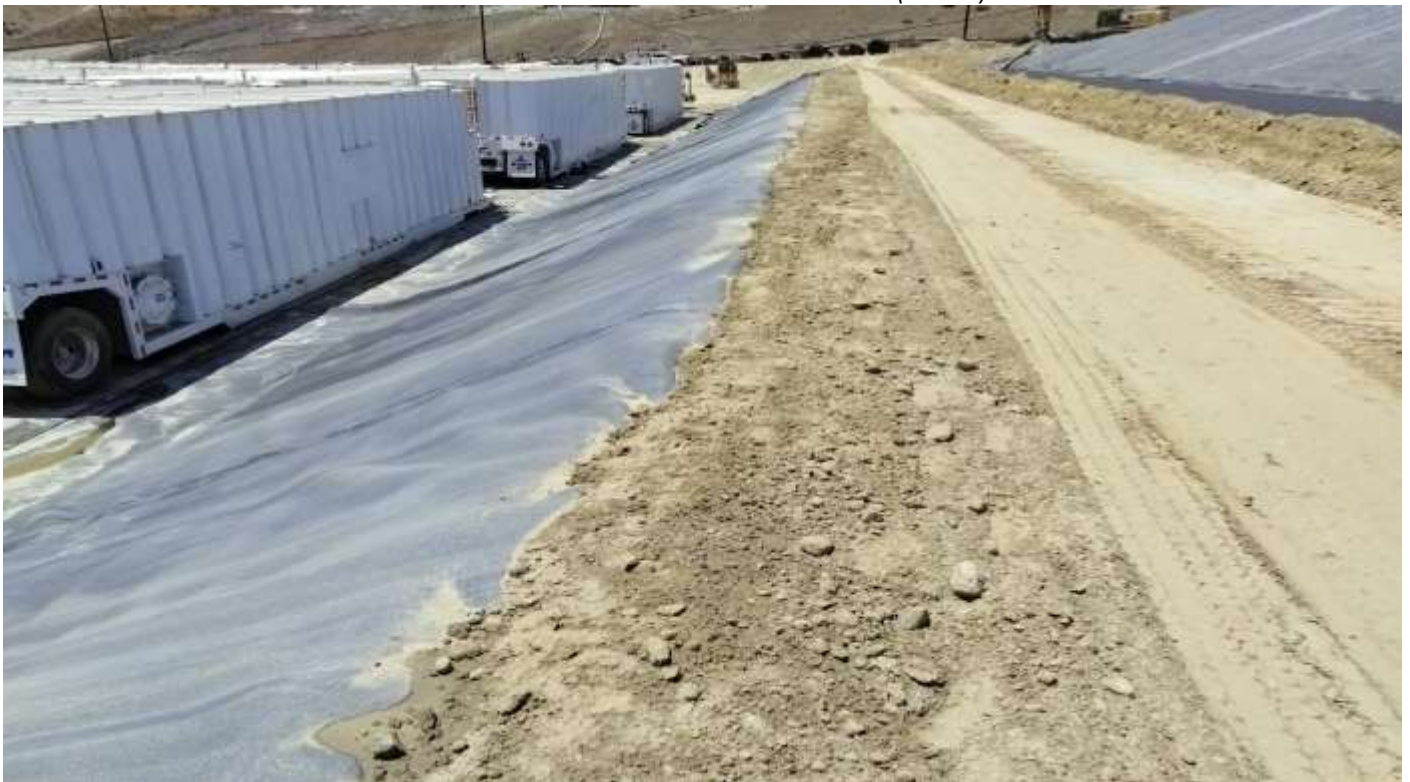
*Picture 2: Pad 1 East Slope Backfill*

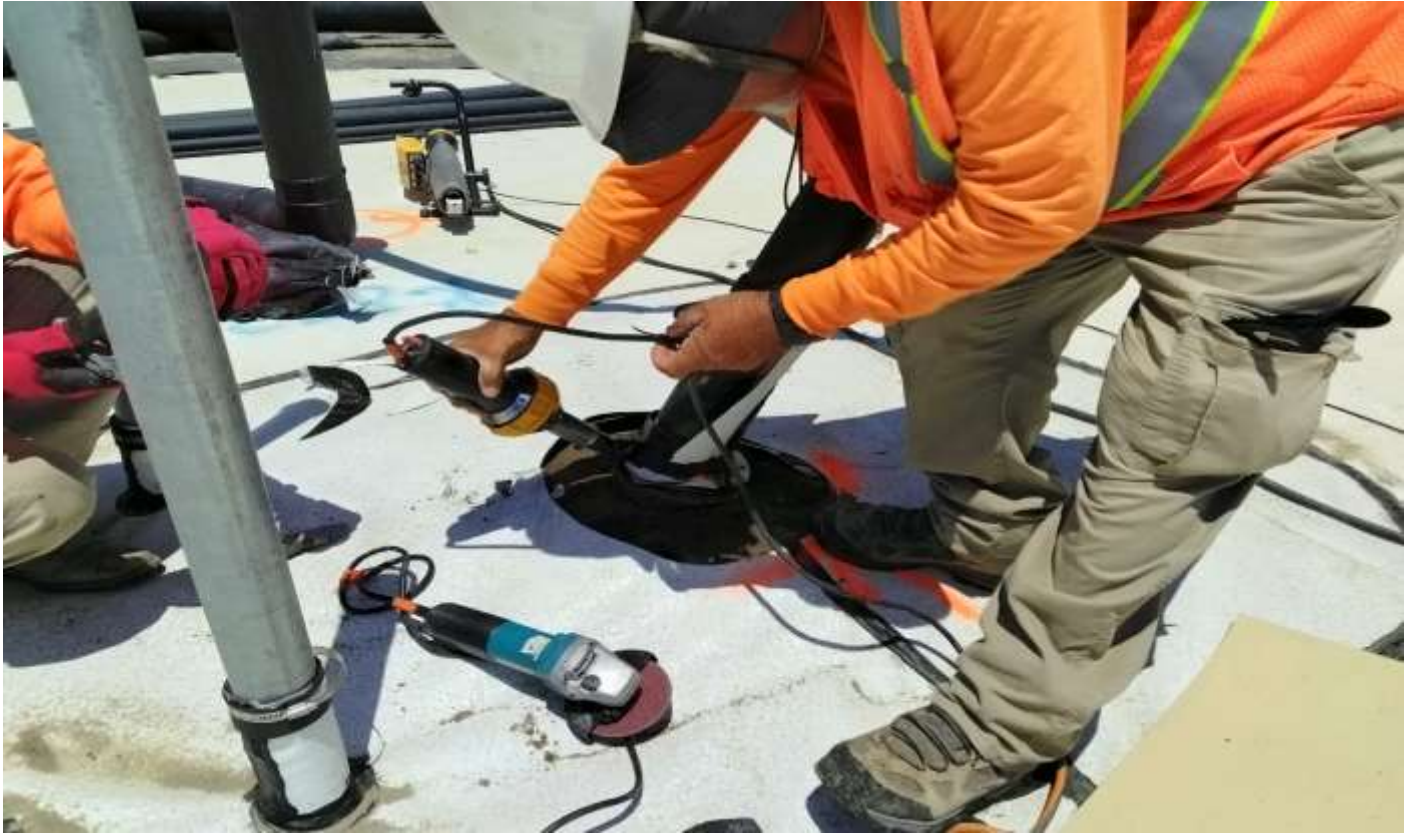
*Picture 3: Fabricated Pipe Boots (Top deck)*

- Geomembrane panels (P1-P2) were deployed on top deck (new cap area).
- Panel seams were wedge welded and welds were air tested, no leaks indicated.
- Repairs were extrusion welded and extrusion welded seams were vacuum box tested. Tests did not indicate any leaks.
- Pipe boots were fabricated at penetrations.
- Trial welds were performed and observed prior to welding.
