CHIQUITA CANYON
A Waste Connections Company

Re: Chiquita Canyon, LLC's Weekly Report on the Documentation and Tracking of Cover Issues

Attachment: August 5, 2025 Weekly Cover Issues Report

4050 - Chiquita Reaction Area Tracking of Fissures and Tension Cracks

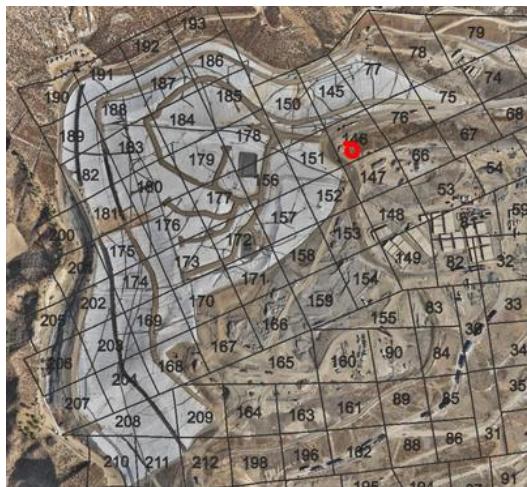
146

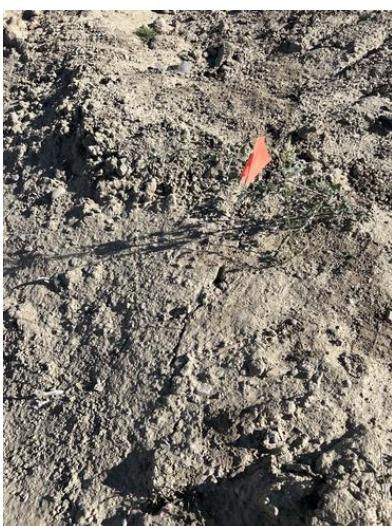
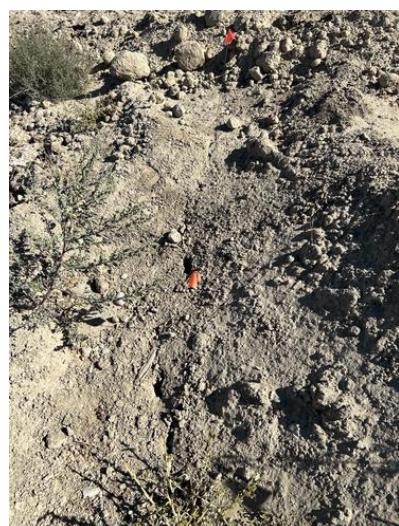
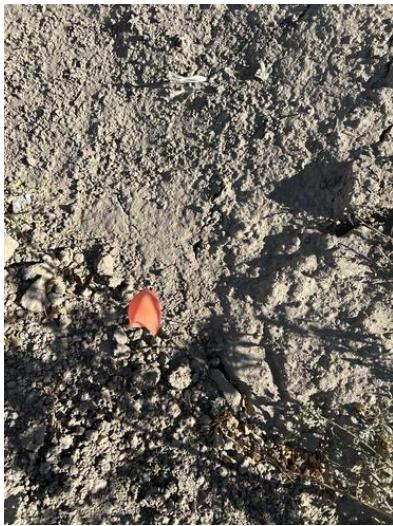
10ft x 3ft

Small 0.5-2" in width

Extra small <0.5" in height

NW to SE

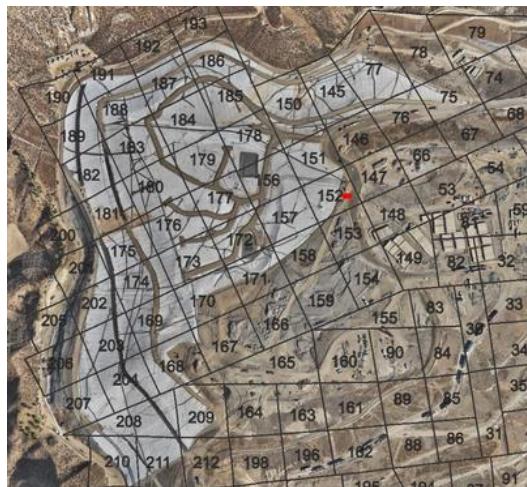
152

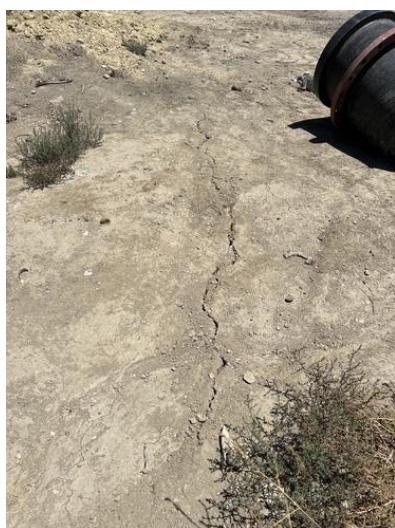
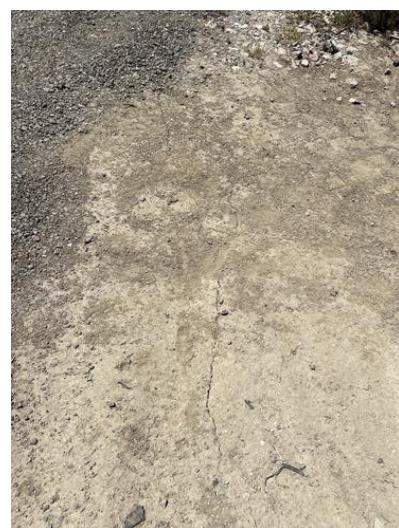
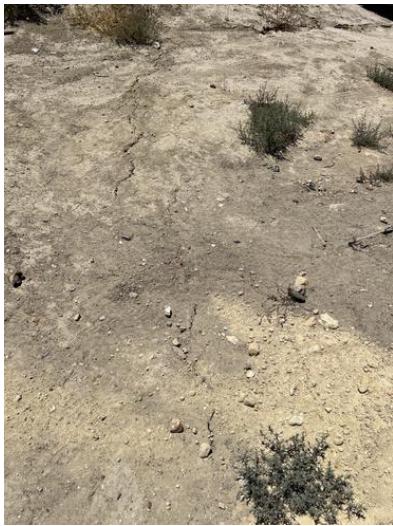
10 ft x 5 ft

Medium 2-4" in width

Extra small <0.5" in height

NW to SE

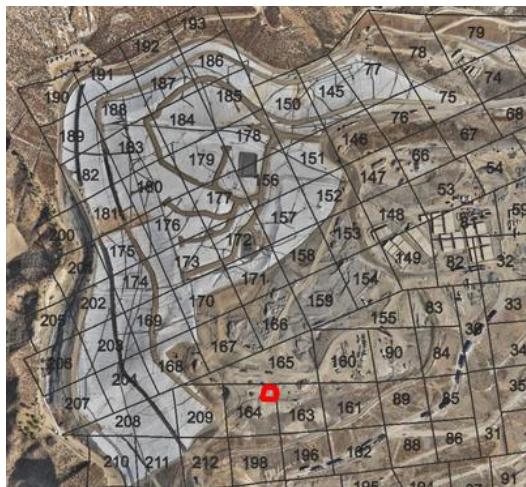
164

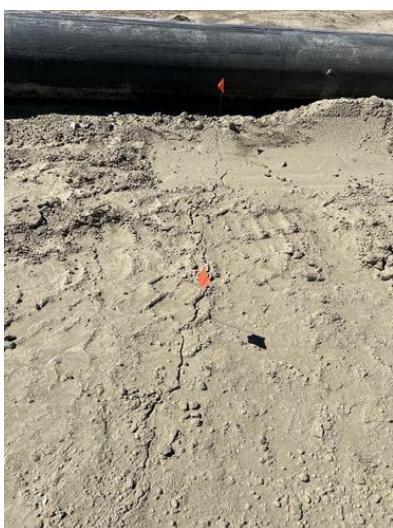
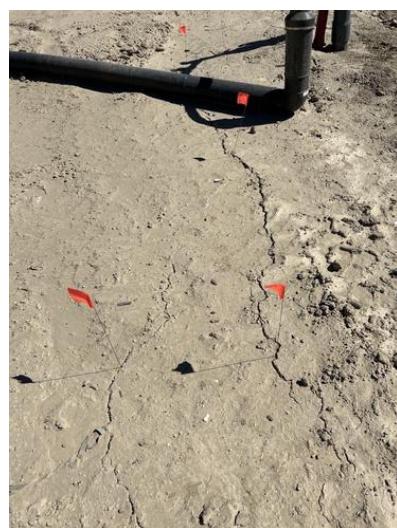
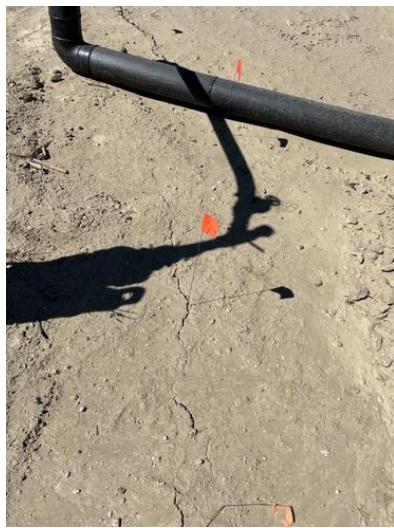
4ft x 17ft area

Small 0.5-2" in width

Extra small <0.5" in height

NE to SW
