August 11, 2025

**Subject: Leachate Spill Report  
Chiquita Canyon Landfill  
File No. 67-020**

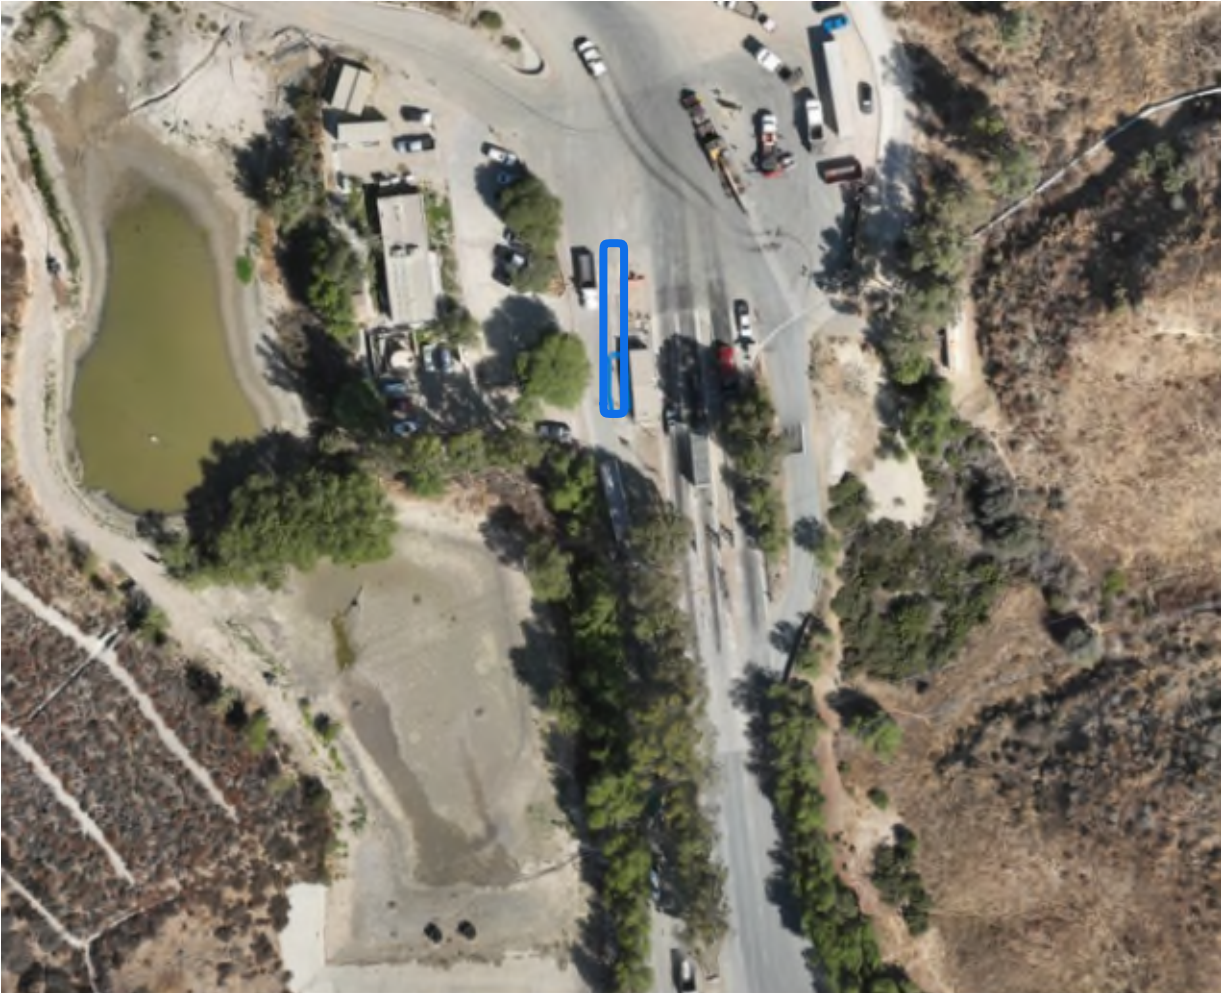
Attachments: Attachment A – Map depicting the location of the spill

The spill occurred near the exit scale of the scale house, as indicated in Attachment A.

On August 4, 2025, at approximately 12:20 p.m., to the best of Chiquita’s knowledge, it appears that after completing their filling, a third-party truck driver did not fully secure the top hatch of their trailer, thereby allowing leachate to spill from the hatch when the truck descended toward the outbound scale. The spill was the fault of the driver and did not reach the stormwater channel or either stormwater basin. The manifest number associated with the release is 020750486FLE. The liquid was dark brown in color with low viscosity, and traveled as a light trickle.

Chiquita personnel took prompt action to address the spill by applying absorbent to the affected area, which was later removed and disposed accordingly. Cleanup was completed on the same day and took approximately one hour to complete. To prevent similar spills in the future, Chiquita personnel will verify that the top hatches of third-party haul trucks are closed before trucks are allowed to leave the tank farm.
