CHIQUITA CANYON
A Waste Connections Company

Re: Chiquita Canyon, LLC's Weekly Report on the Documentation and Tracking of Cover Issues and Monthly Summary

4050 - Chiquita Reaction Area Tracking of Fissures and Tension Cracks

JULY 2025 FISSURE AND TENSION CRACK MONITORING SUMMARY

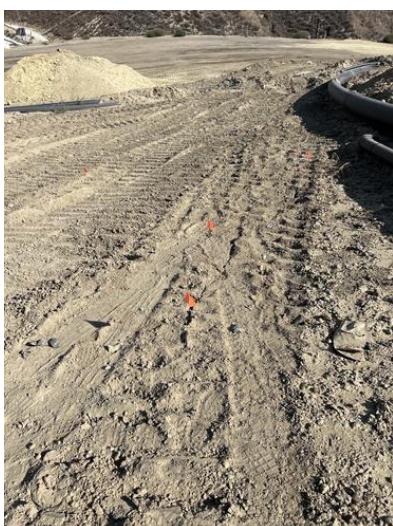
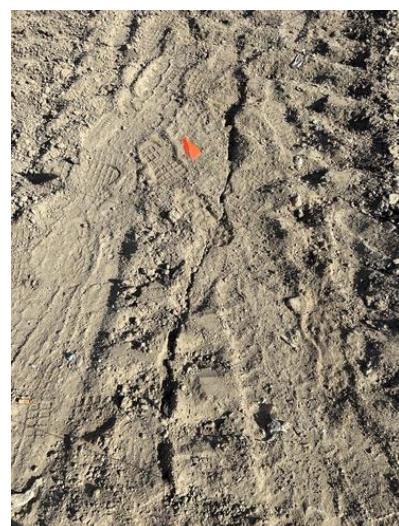
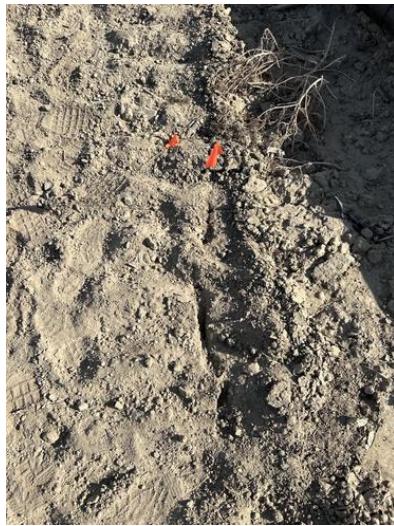
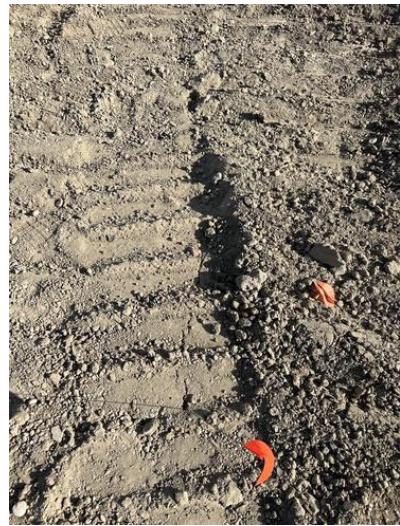
146

8ft x 12ft

Small 0.5-2" in width

Extra small <0.5" in height

N to S

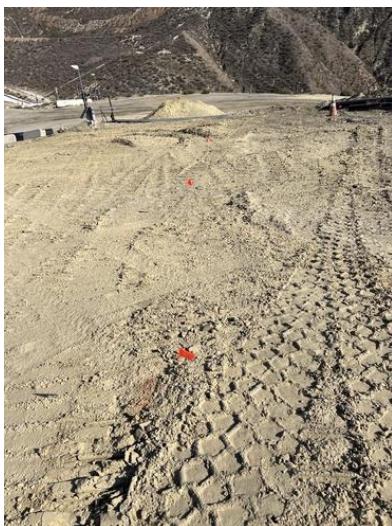
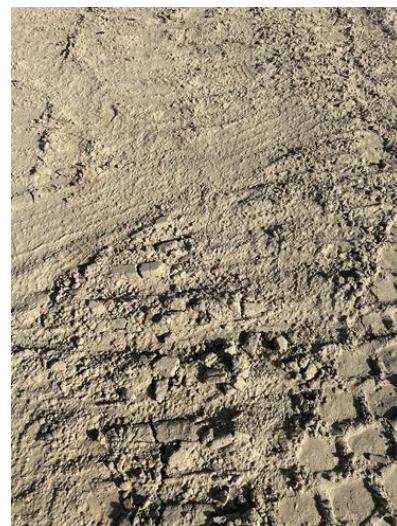
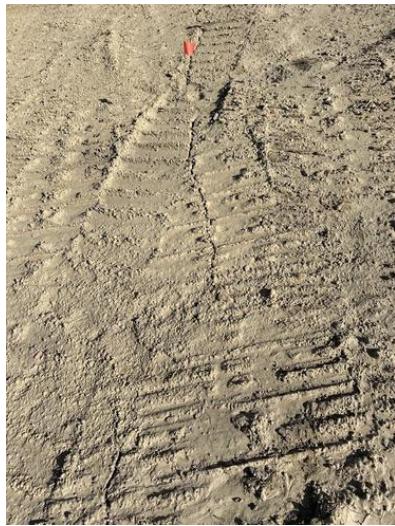
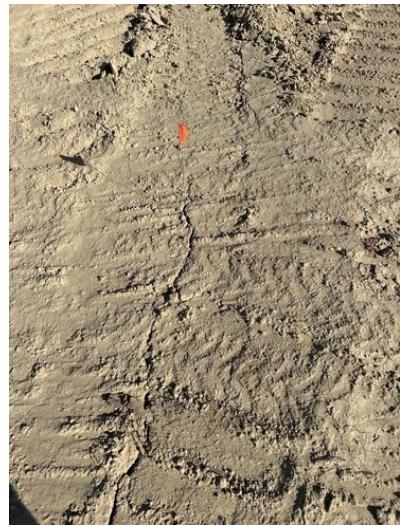
147

40ft

Small 0.5-2" in width

Extra small <0.5" in height

NW to SE

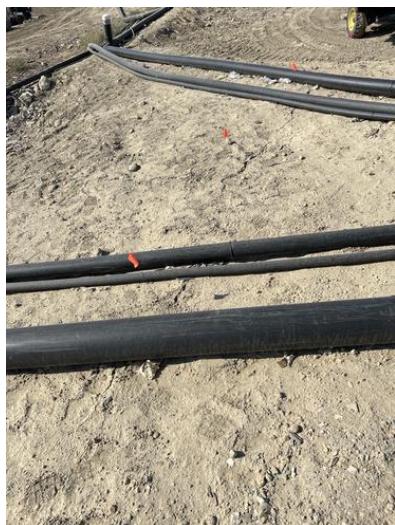
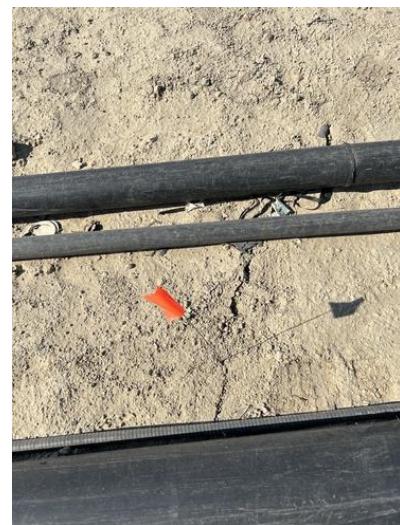
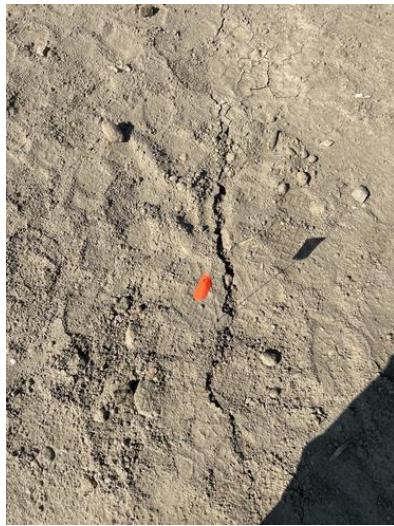
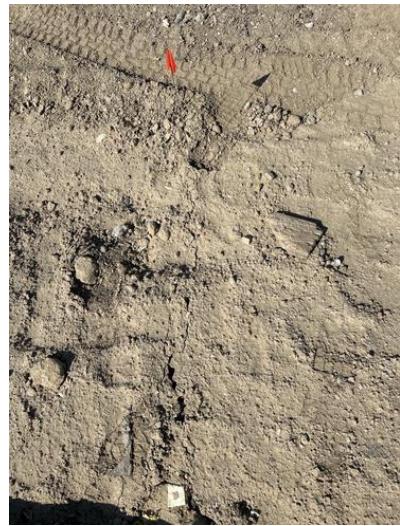
154

25ft

Small 0.5-2" in width

Extra small <0.5" in height

NE to SW

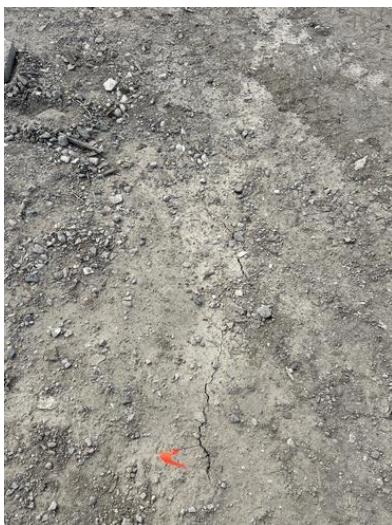
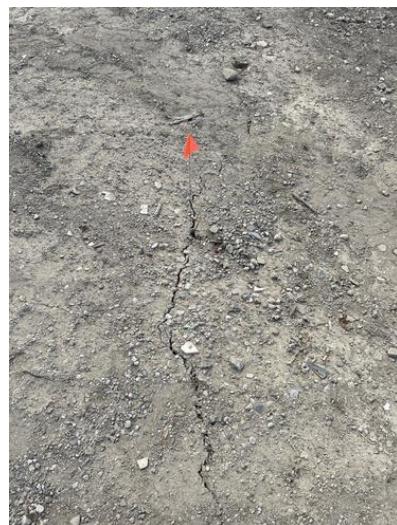
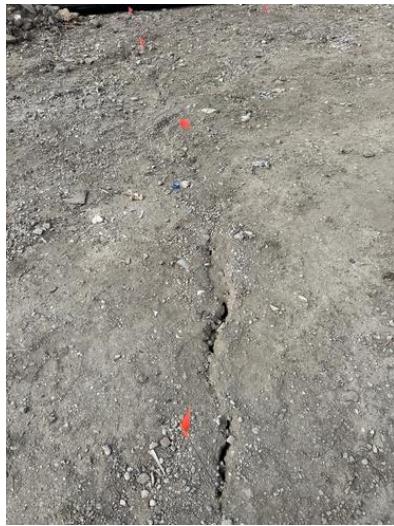
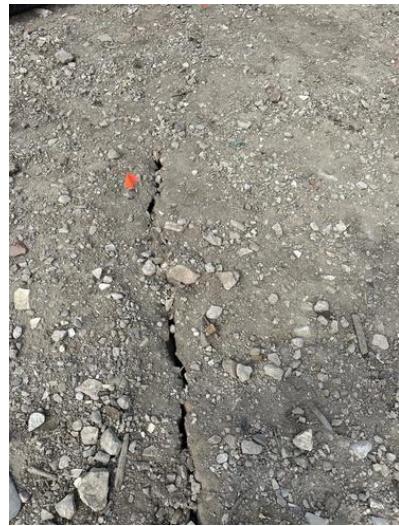
159

35ft x 30ft

Medium 2-4" in width

Small 0.5-2" in height

NE to SW

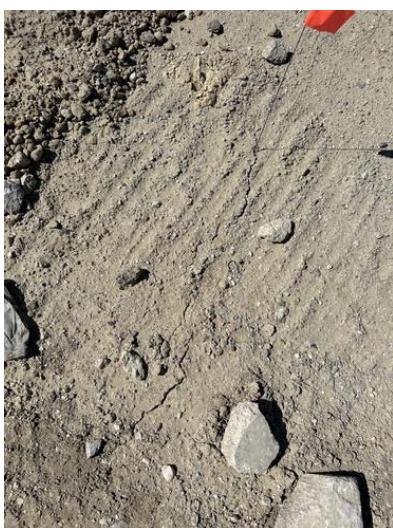
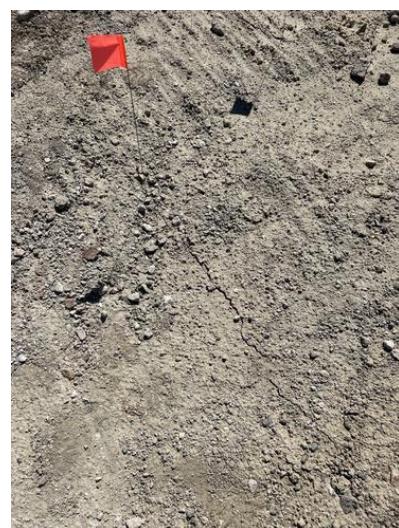
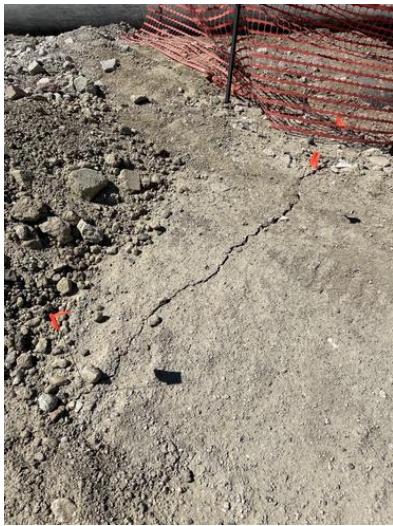
147

2ft x 9ft area

Small 0.5-2" in width

Extra small <0.5" in height

E to W

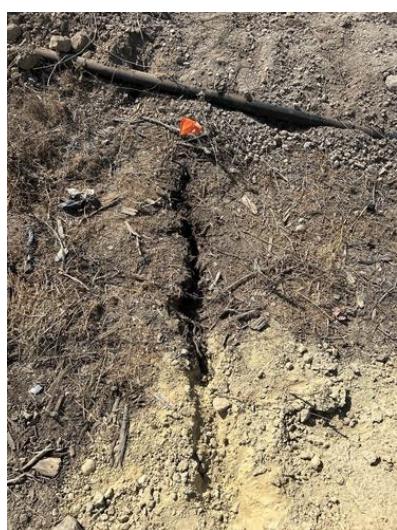
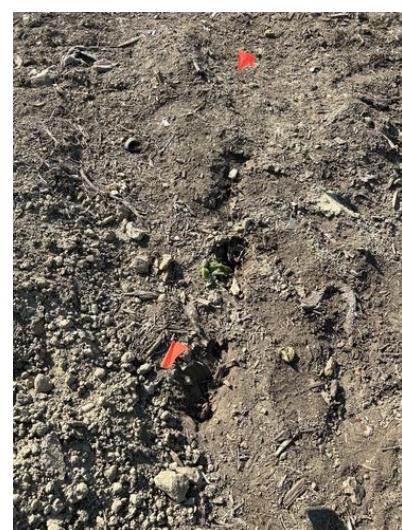
146

15ft

Horizontal Offset (width)	Medium 2-4" in width
Vertical Offset (height)	Extra small <0.5" in height
Orientation (direction)	NW to SE

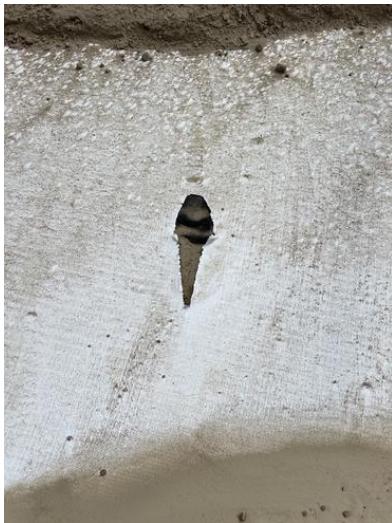
Photo 1

Tear in liner needs to be patched and extrusion welded.
