Re: Chiquita Canyon, LLC's Weekly Report on the Documentation and Tracking of Cover Issues

4050 - Chiquita Reaction Area Tracking of Fissures and Tension Cracks

4050 - Geosynthetic Cover Inspection

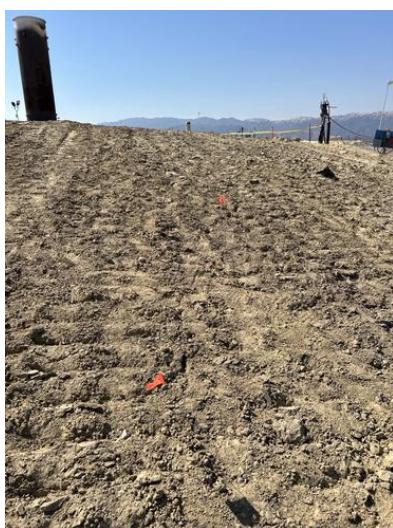
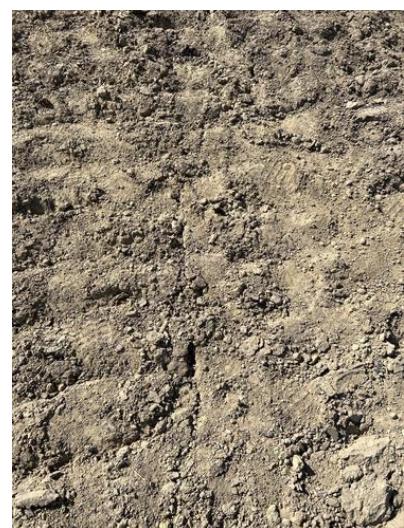
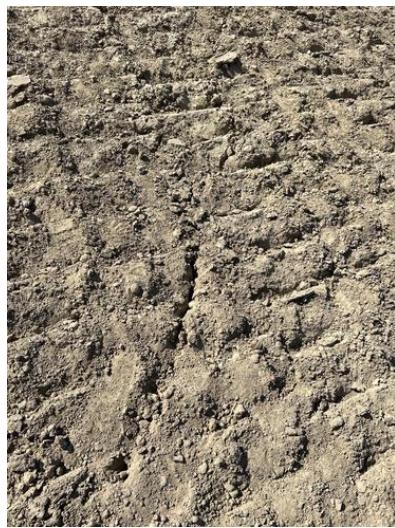
146

30ft

Small 0.5-2" in width

Extra small <0.5" in height

N to S

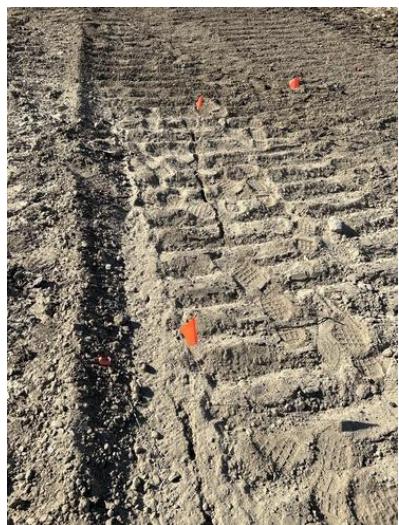
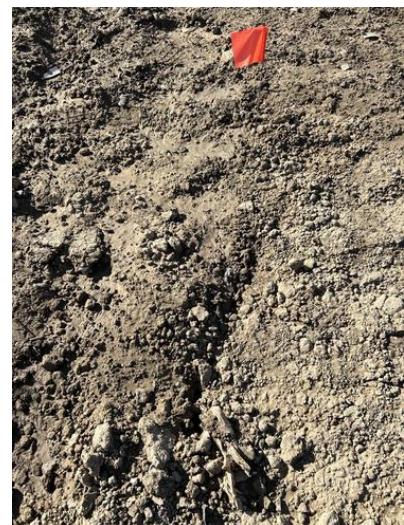
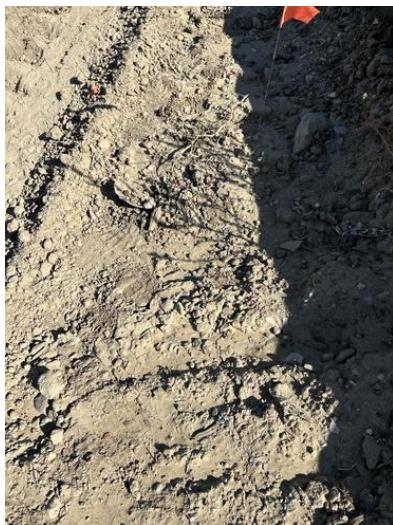
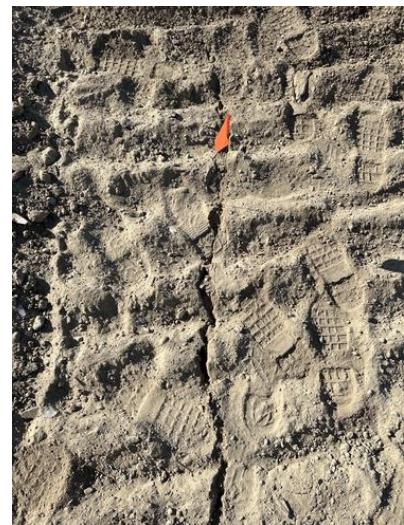
146

10ft x 25ft

Small 0.5-2" in width

Extra small <0.5" in height

NW to SE

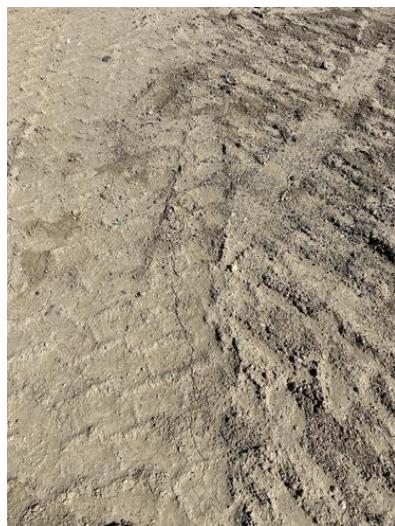
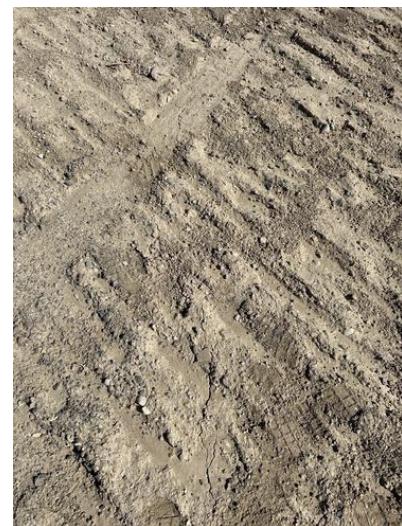
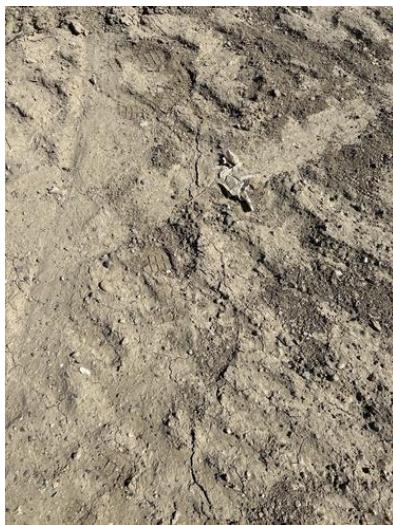
148

17ft x 10ft

Extra Small <0.5 in width

Extra small <0.5" in height

N to S

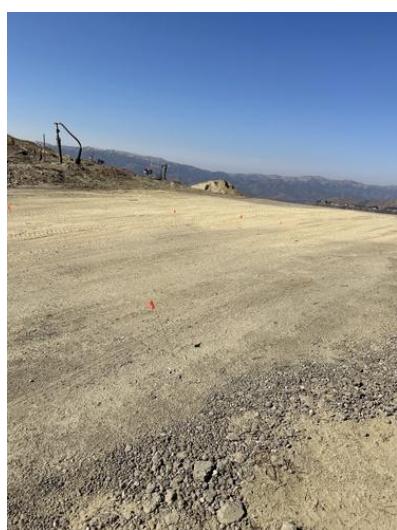
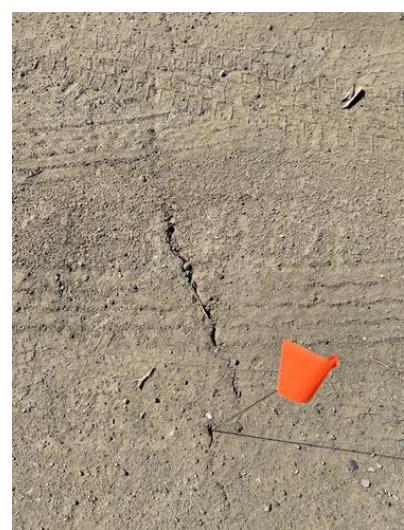
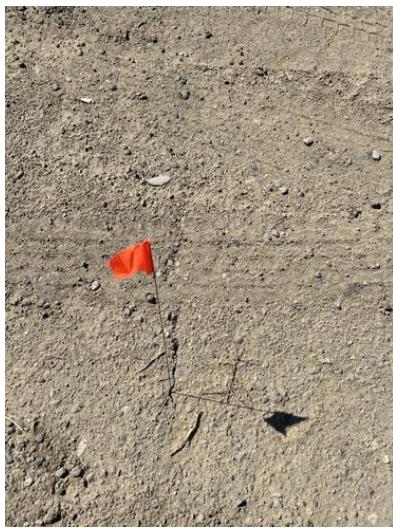
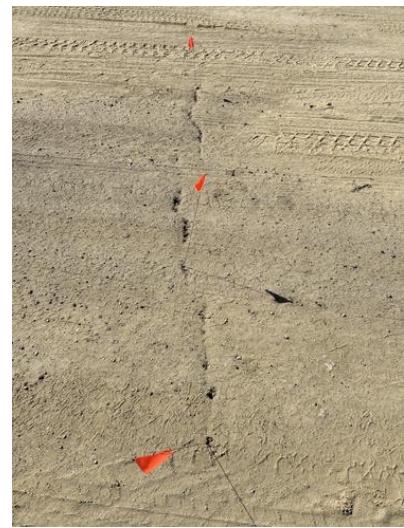
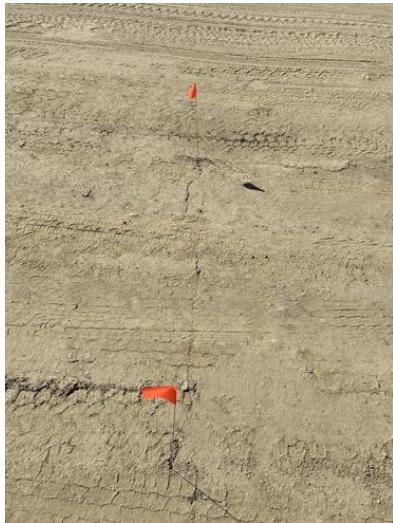
146

45ft x 35ft

Small 0.5-2" in width

Extra small <0.5" in height

NW to SE

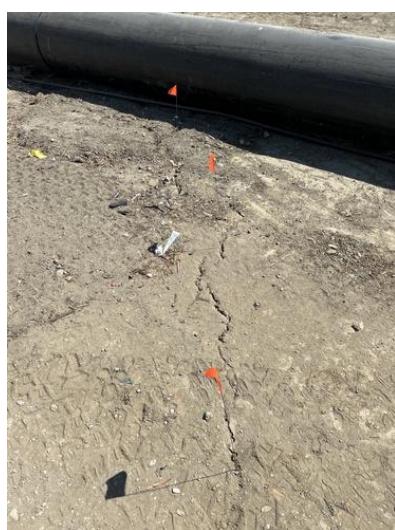
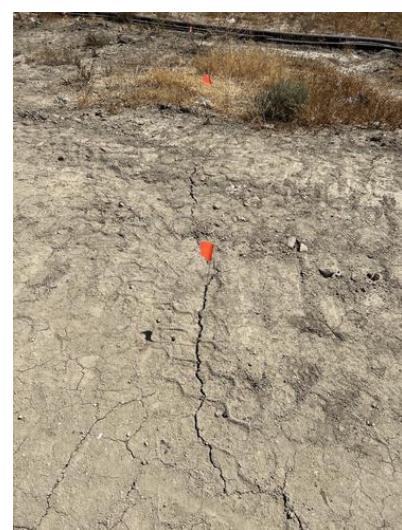
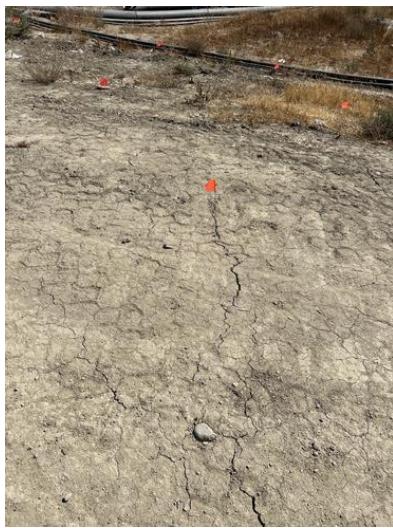
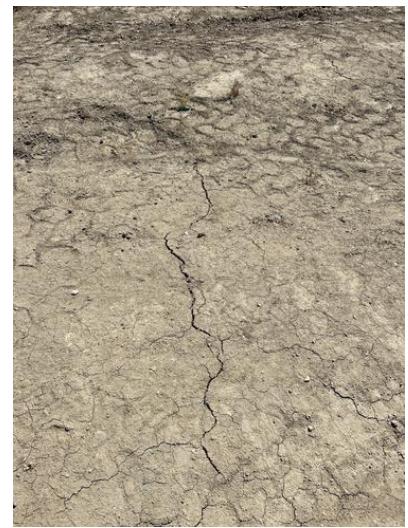
90

20x 30ft area

Small 0.5-2" in width

Small 0.5-2" in height

NE to SW

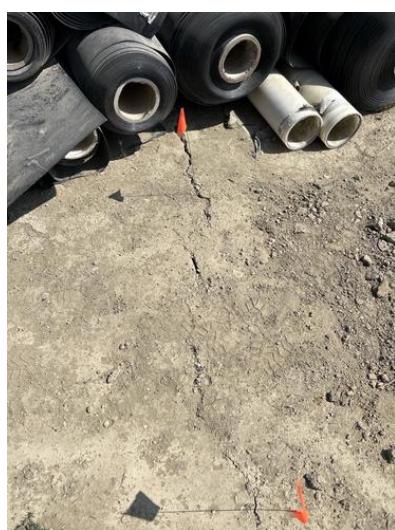
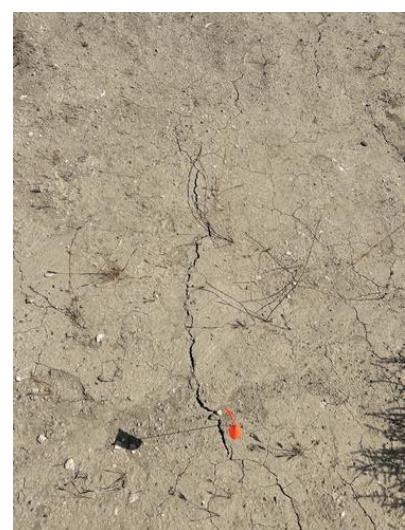
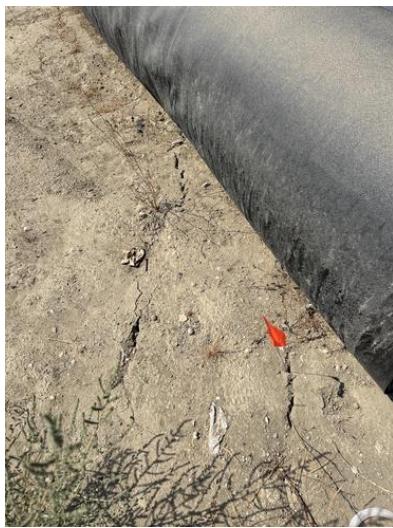
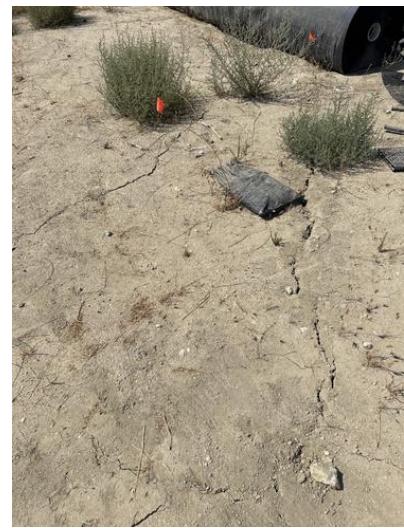
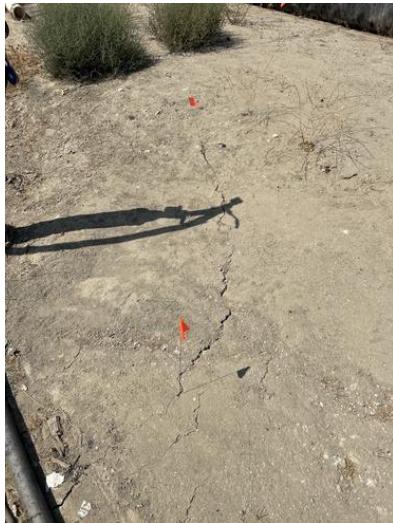
160

20ft x 30ft area

Small 0.5-2" in width

Extra small <0.5" in height

NE to SW

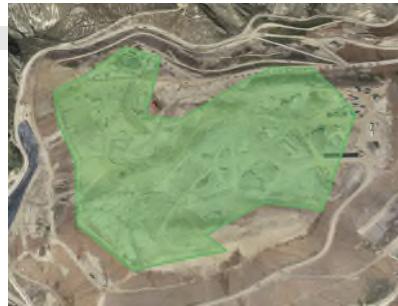
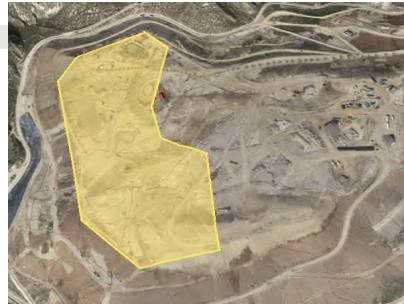
- The charts on the following page show the settlement in cubic yards measured at a fixed location.
 - Chiquita restaked the survey benchmarks between July 31, 2025 and August 13, 2025 to maintain accuracy. Chiquita believes that the restaking has caused the data to show an inflated amount of settlement, which does not accurately convey the true rate of settlement. Chiquita will continue to evaluate the data in the coming weeks.
