Subject: Leachate Leak Report

Chiquita Canyon Landfill

File No. 67-020

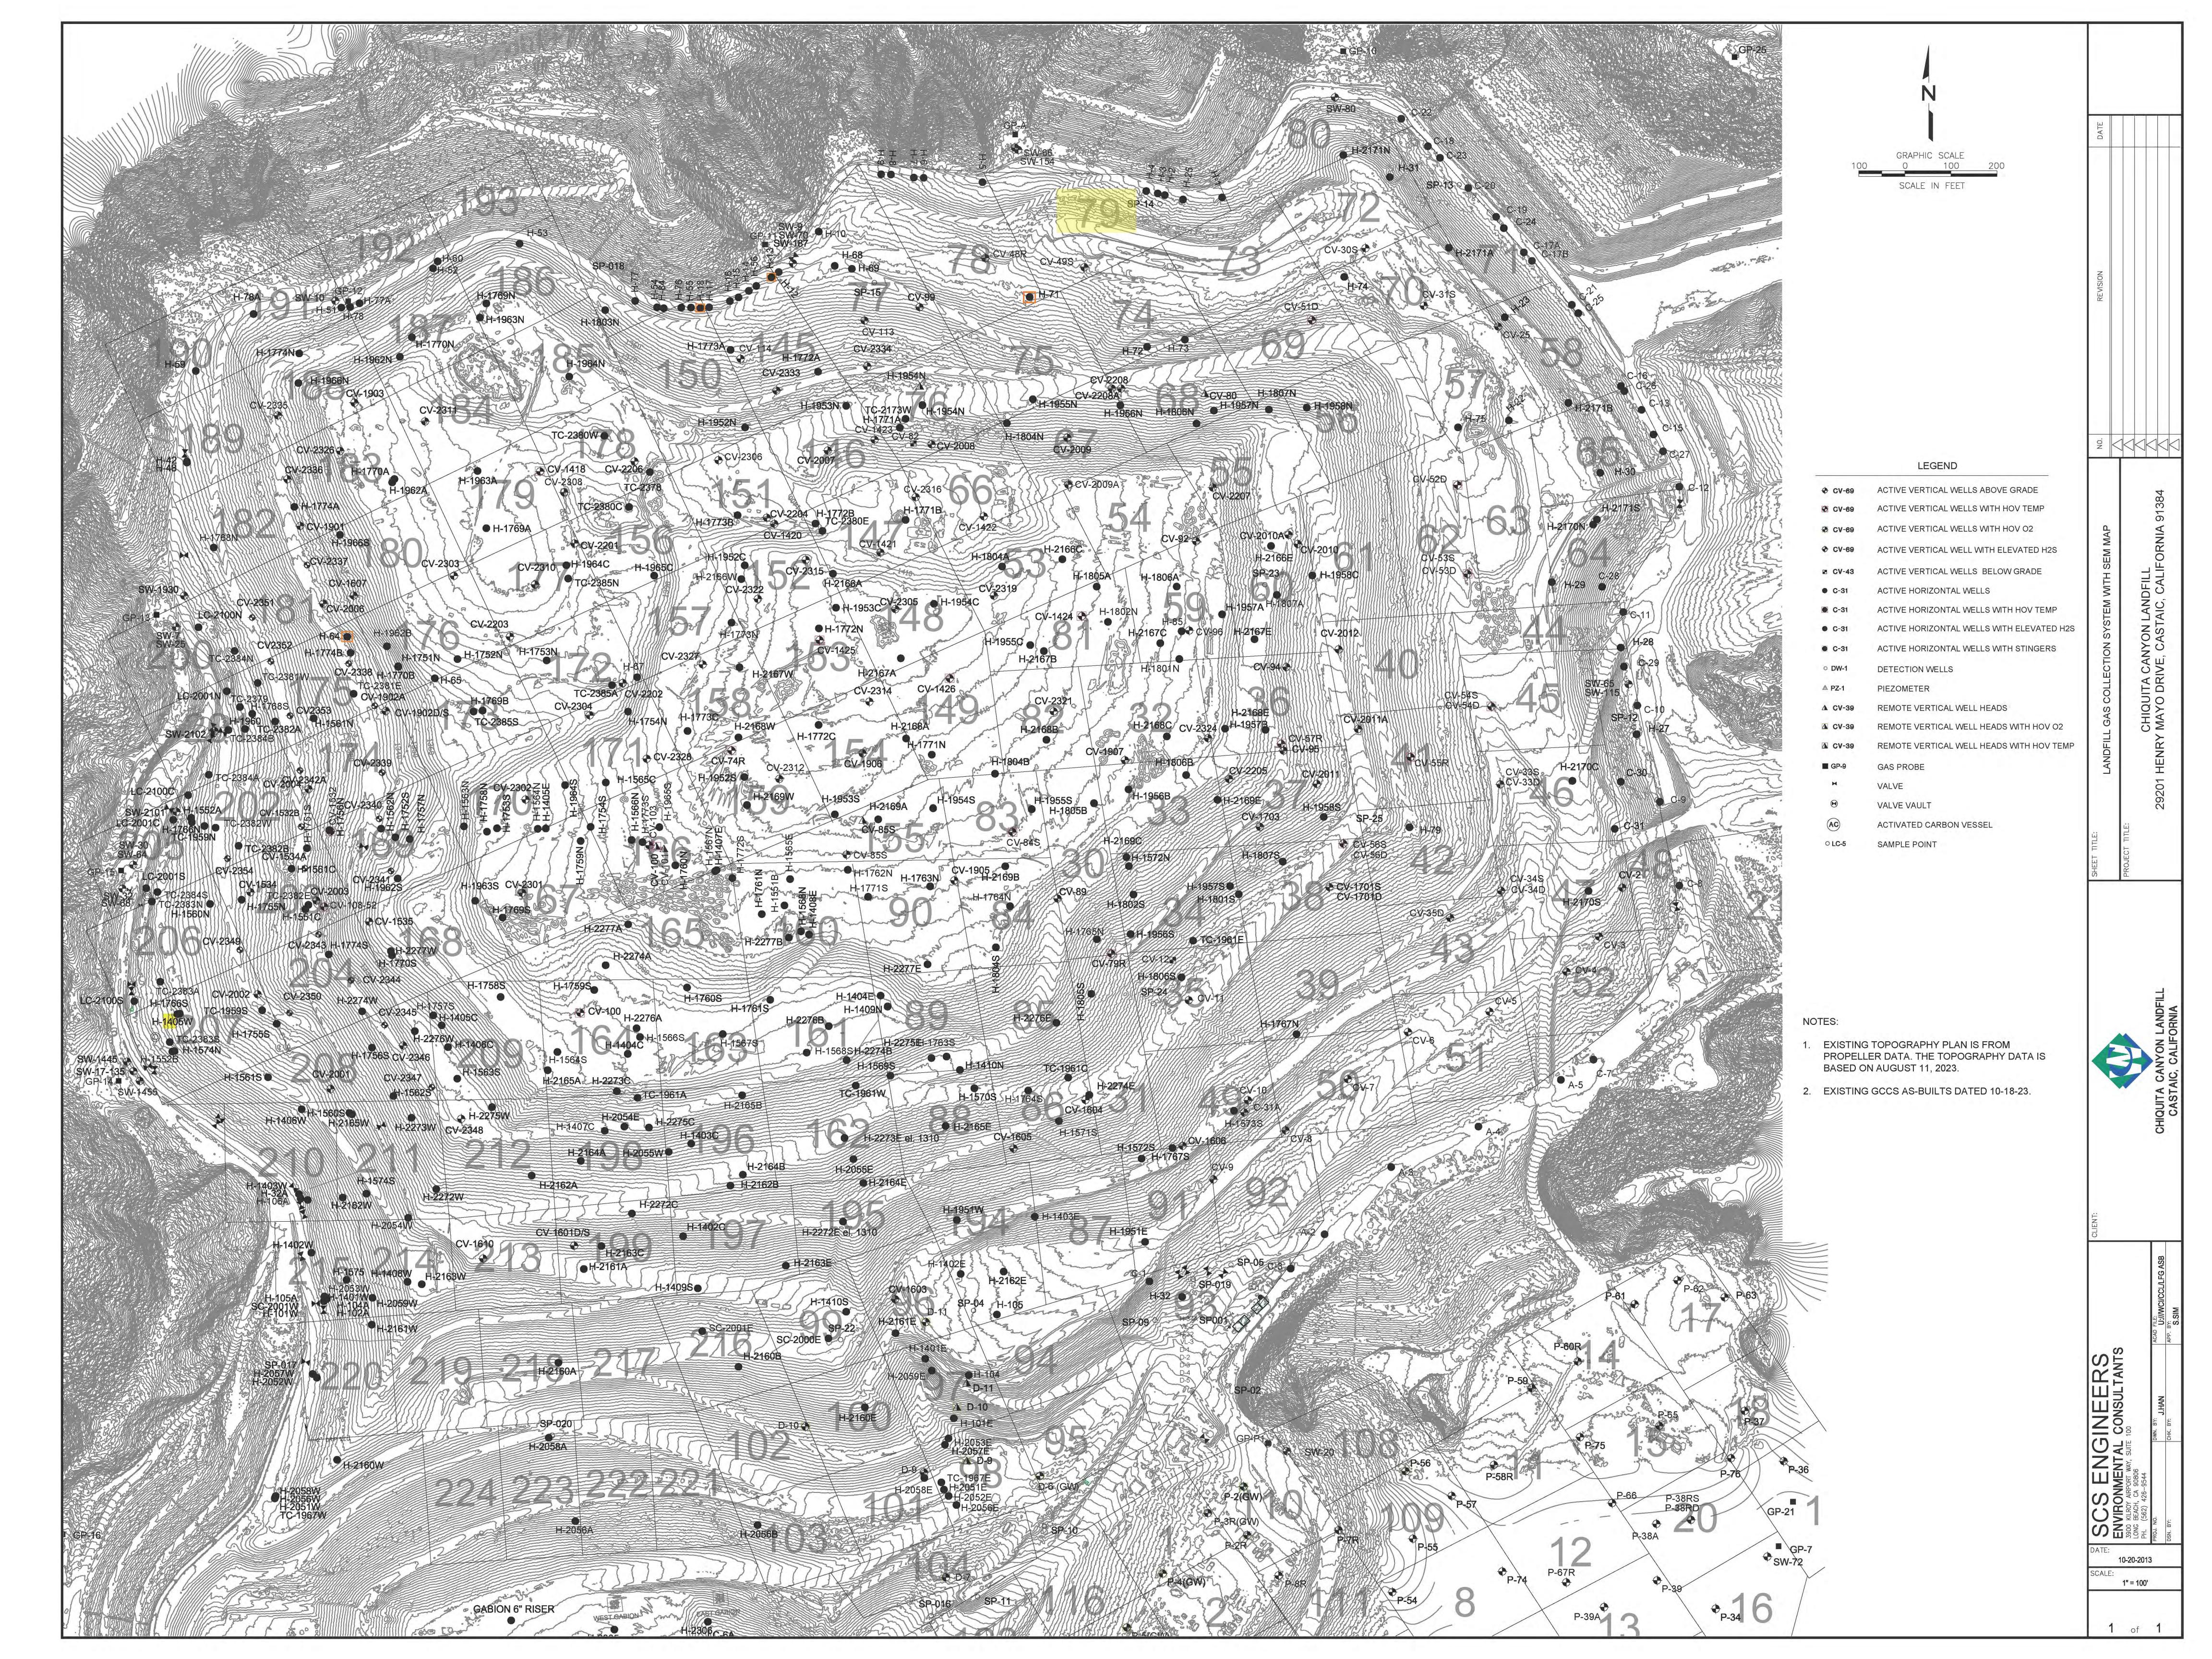
Attachments: Attachment A – Map depicting the location of the leak

The leak occurred in North Sump 4 located in grid 79, as indicated in Attachment A.

On August 13, 2025, at approximately 2:00 p.m., to the best of Chiquita's knowledge, it appears that the air compressor connected to two sump pumps in North Sump 4 malfunctioned, which stopped the flow of air to the sump pumps and prevented them from pumping. As a result, liquids backed up into and pooled around the toe drain, crossed the perimeter road, and entered into the stormwater channel. The leak is attributable to equipment malfunction. The liquid was dark brown in color with low viscosity, and traveled as a light trickle.

Upon discovering the leak, Chiquita staff immediately built a check dam to stop the liquid in the stormwater channel and prevent it from reaching the stormwater basin. Chiquita staff additionally worked to repair the inoperable pumps to begin drawing down liquid from the sump and toe drain. Chiquita personnel deployed a vacuum truck to remove standing liquids and dewater the sump and toe drain. The initial phase of cleanup commenced immediately and took approximately two hours to complete. The following day, August 14, 2025, Chiquita pressure washed the stormwater channel while applying vacuum to collect all wash water. All liquids and soil impacted by the leak, including the check dam, were collected and contained in a dewatering bin, which will be sampled and disposed.

To prevent similar leaks from occurring in the future, Chiquita will continue to inspect the sump pumps located in North Sump 4 on a daily basis and replace any pumps found to be inoperable to prevent liquids from backing up.
