Re: Chiquita Canyon, LLC's Weekly Report on the Documentation and Tracking of Cover Issues

4050 - Chiquita Reaction Area Tracking of Fissures and Tension Cracks

4050 - Geosynthetic Cover Inspection

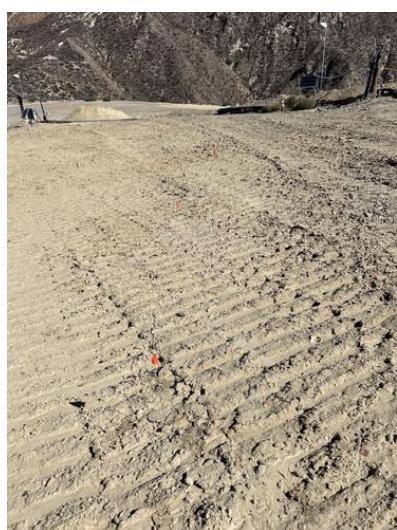
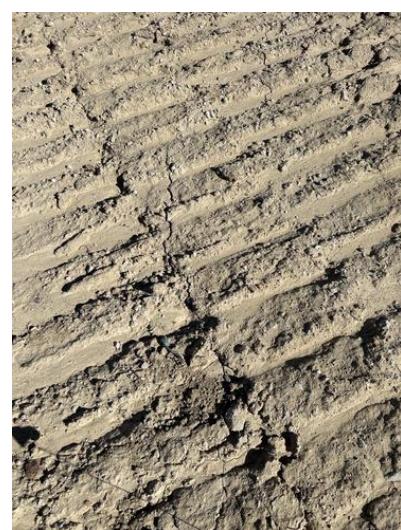
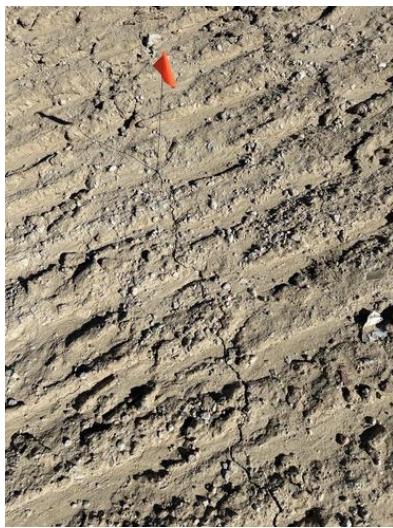
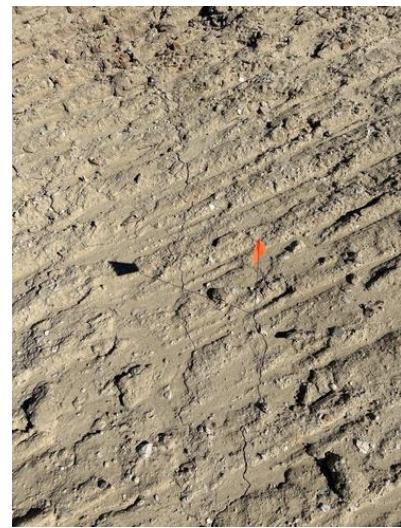
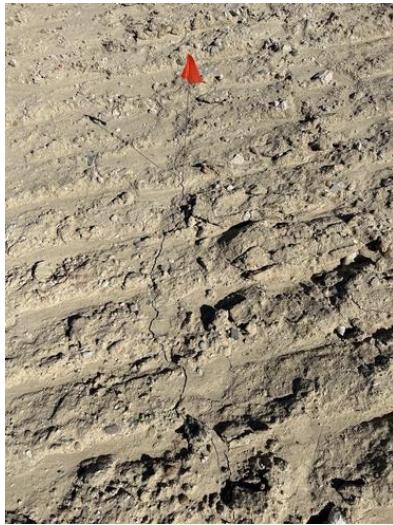
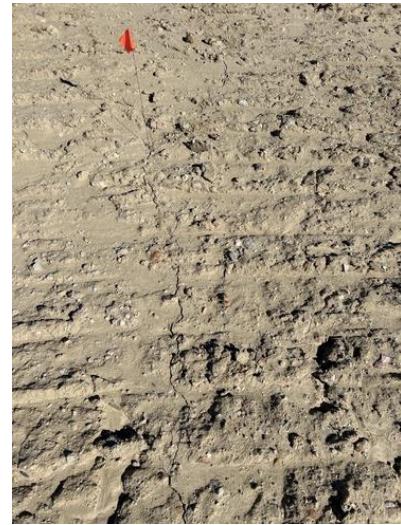
147

75ft x 5ft

No individual crack was over 50ft

Extra Small <0.5 in width

Extra small <0.5" in height

NW to SE

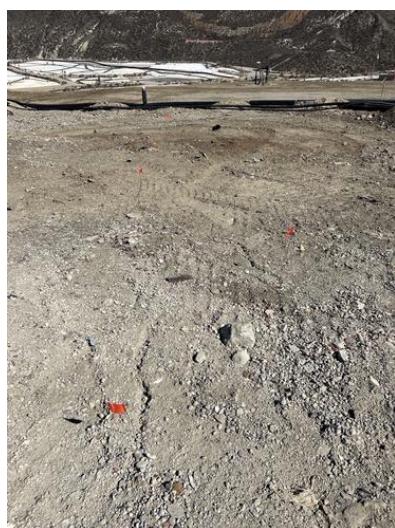
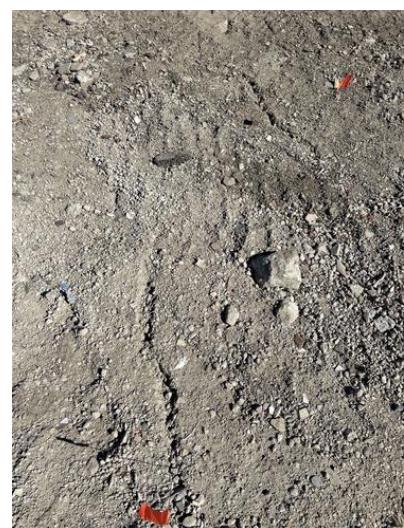
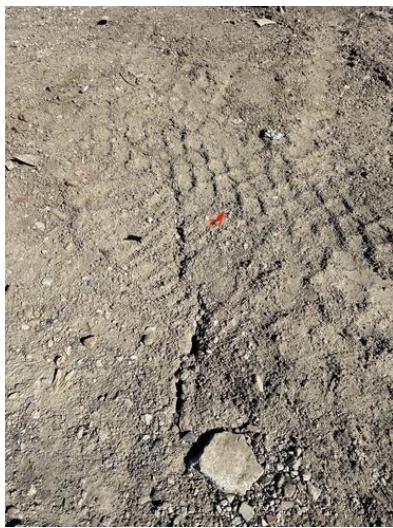
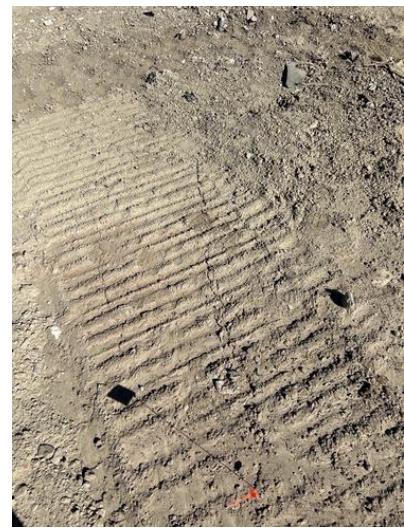
159

55ft x 20ft

No crack was over 50ft

Small 0.5-2" in width

Small 0.5-2" in height

NW to SE

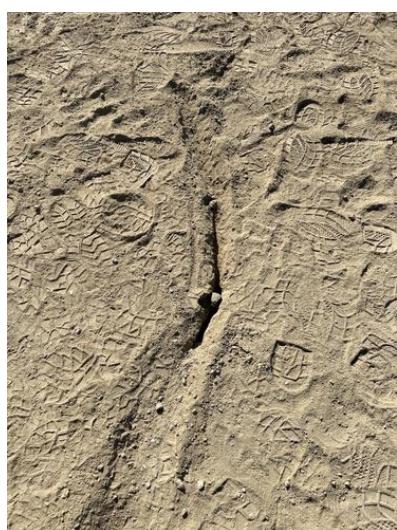
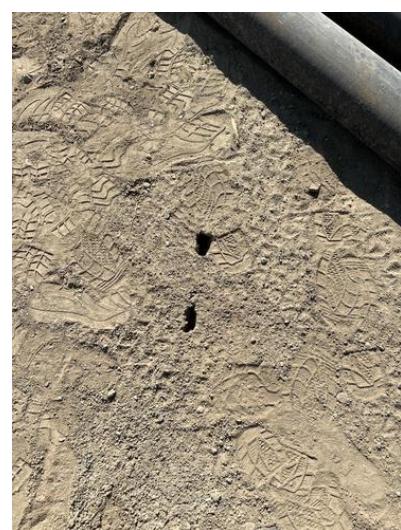
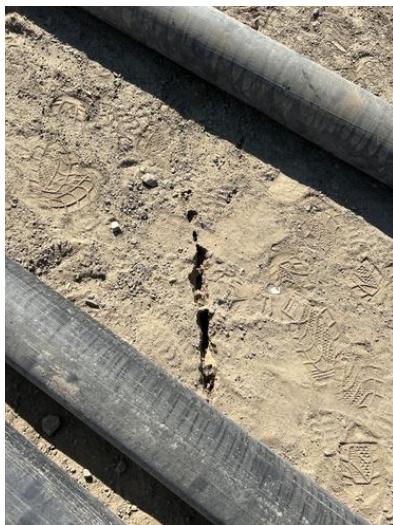
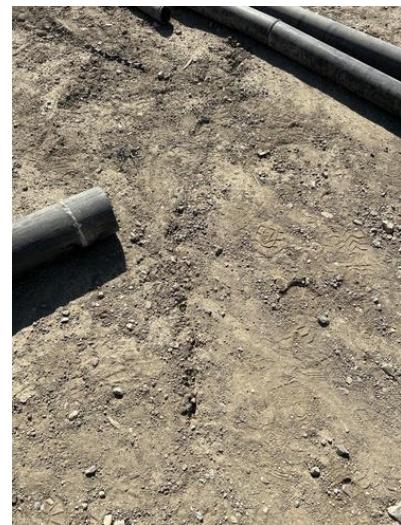
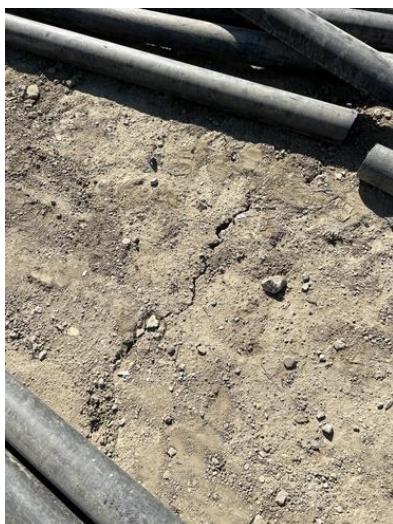
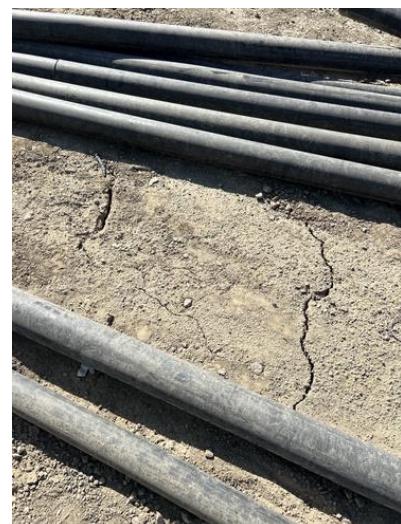
147

6ft x 20ft area

Medium 2-4" in width

Small 0.5-2" in height

NW to SE
