**Subject:** Leachate Leak Report

**Chiquita Canyon Landfill**

File No. 67-020

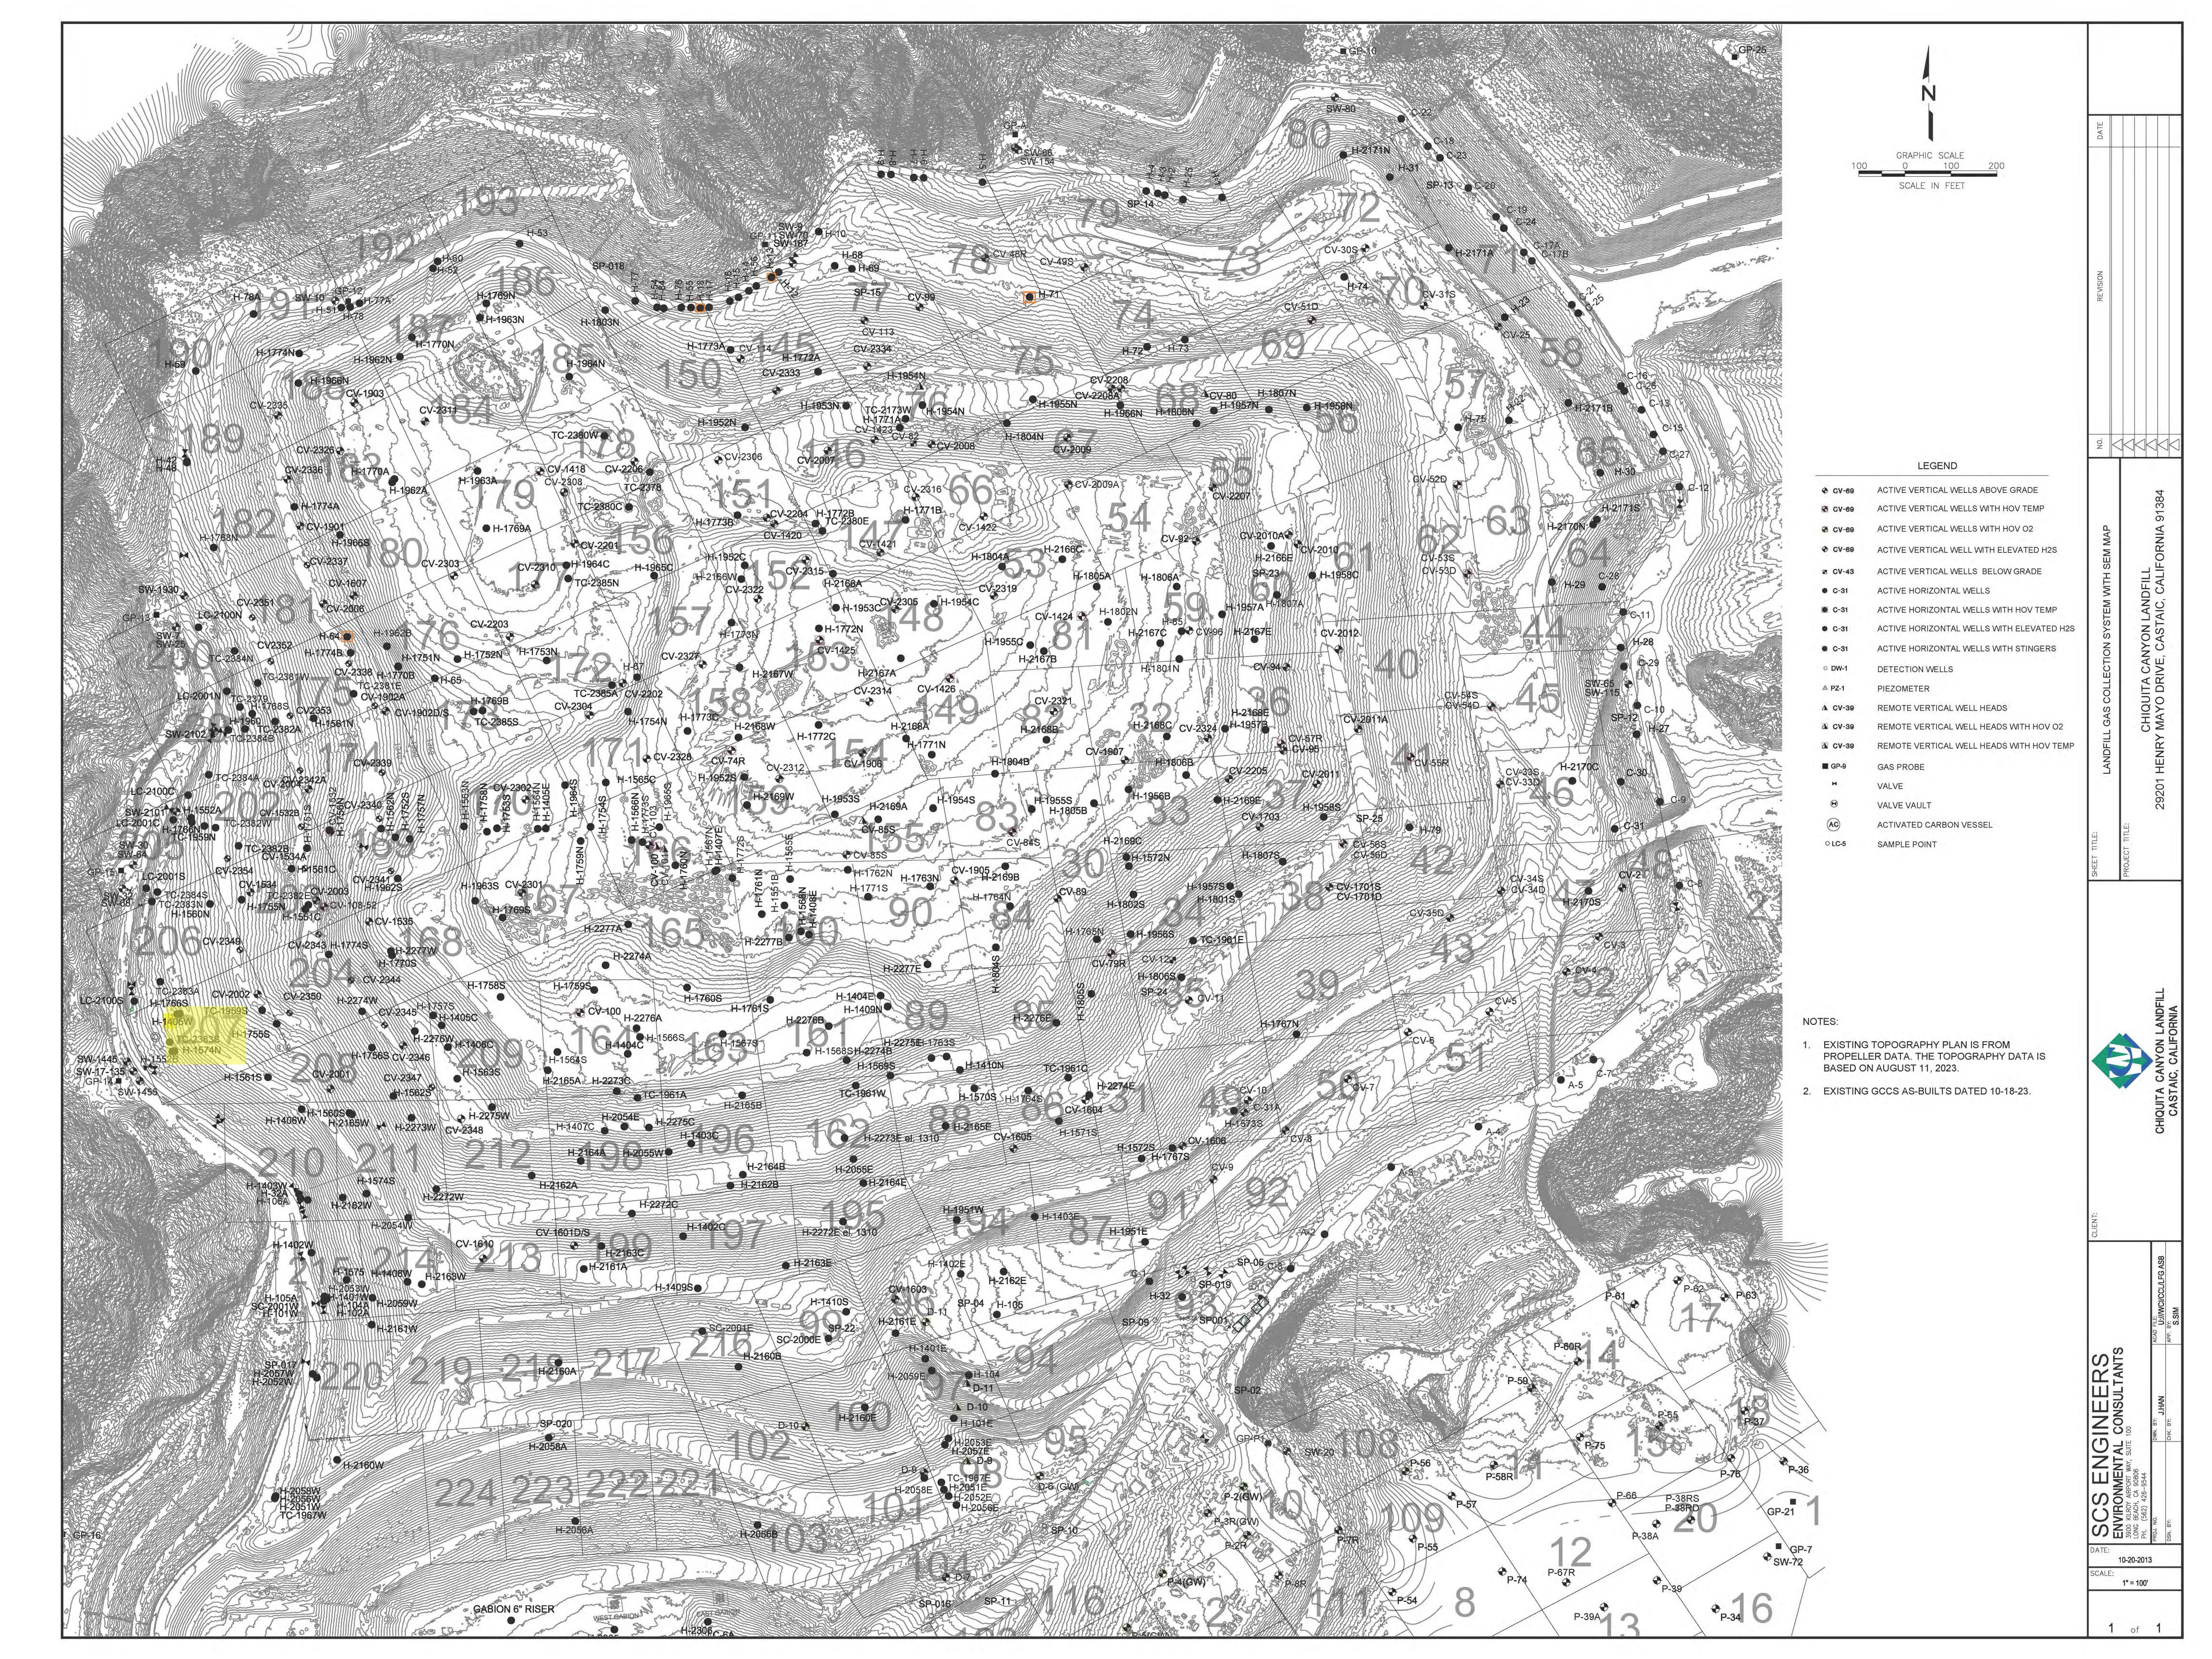
Attachments: Attachment A – Map depicting the location of the leak

The leak occurred from a pump Sump 5 located in grid 207, as indicated in Attachment A.

On August 26, 2025, at approximately 2:45 p.m., to the best of Chiquita's knowledge, it appears while a pump in sump #5 was turned off to perform maintenance on the forcemain, liquid pooled and overflowed at the sump before Chiquita could complete the ongoing maintenance. The liquid crossed the perimeter road and approximately two (2) gallons of liquid entered into the stormwater channel. The liquid was dark brown in color with low viscosity, and traveled as a light trickle.

Upon discovering the leak, Chiquita staff immediately placed soil on top of the liquid to stop and contain the flow. Chiquita also promptly built a check dam to stop the liquid in the stormwater channel from traveling to a stormwater basin. A vacuum truck removed all standing liquid from the ground and was used to lower the liquid level in sump #5. All liquids were sent for treatment with the granulated activated carbon unit, and all soil from the impacted area was placed in a roll off bin and will be sampled for proper disposal. Clean up commenced immediately and was completed the same day.

To prevent similar leaks from occurring in the future, while performing maintenance on the forcemain in the future, if the pump is turned off during maintenance, a vacuum truck will be used to collect liquids to ensure the liquids do not pool.
