**CHIQUITA CANYON**  
*A Waste Connections Company*

**Re: Chiquita Canyon, LLC's Weekly Report on the Documentation and Tracking of Cover Issues**

# 4050 - Chiquita Reaction Area Tracking of Fissures and Tension Cracks

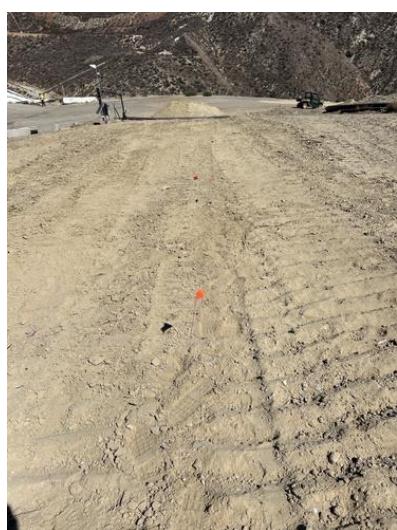
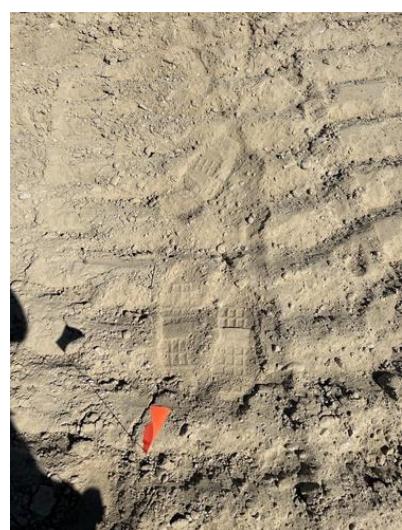
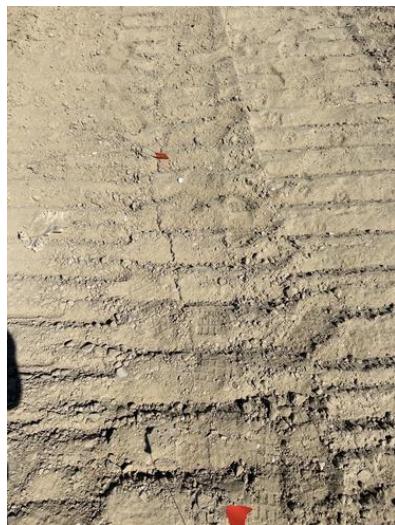
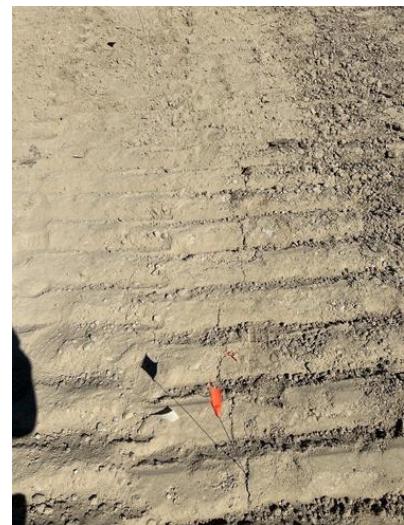
65ft

Crack starts and stops, no section longer than 50ft.

Small 0.5-2" in width

Extra small <0.5" in height

NW to SE

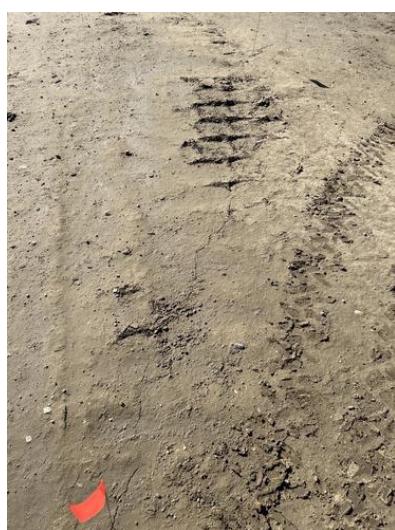
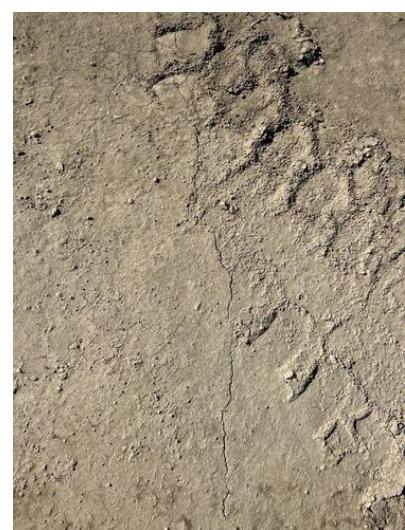
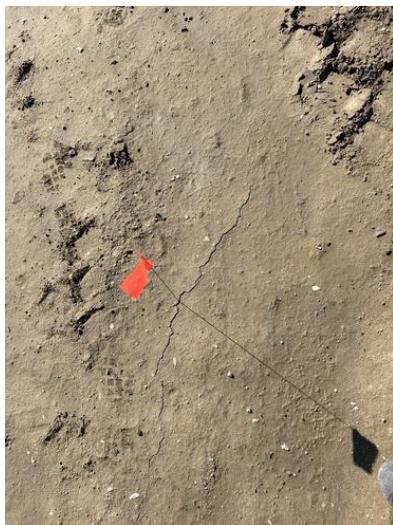
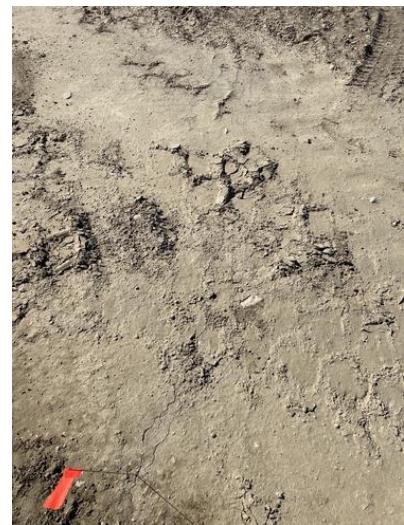
70ft x 20ft

No crack over 50ft

Extra Small <0.5 in width

Extra small <0.5" in height

NW to SE

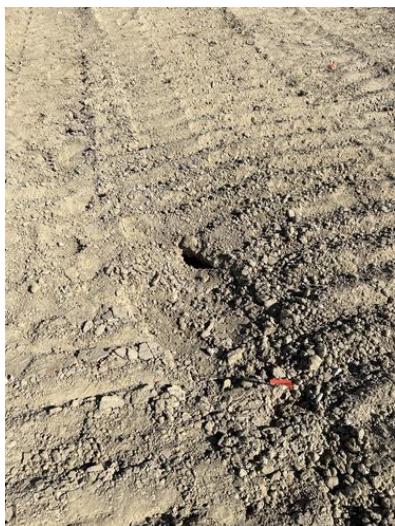
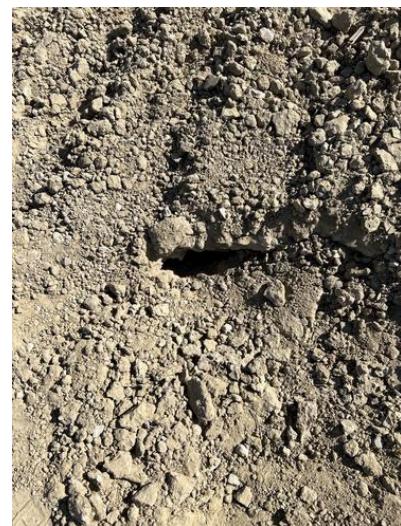
1ft

Medium 2-4" in width

Large >4" in height

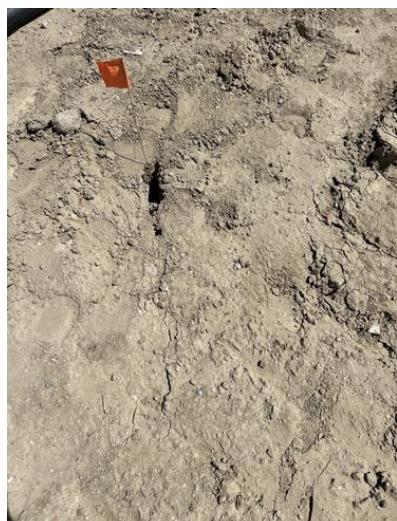
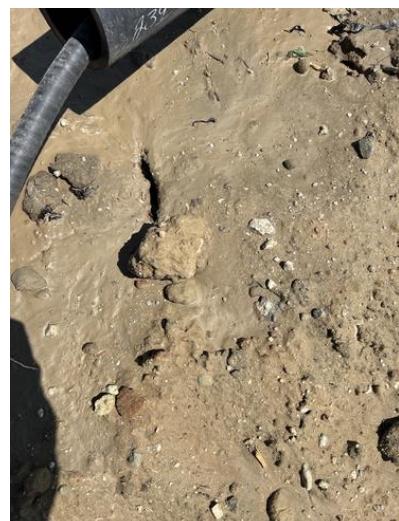
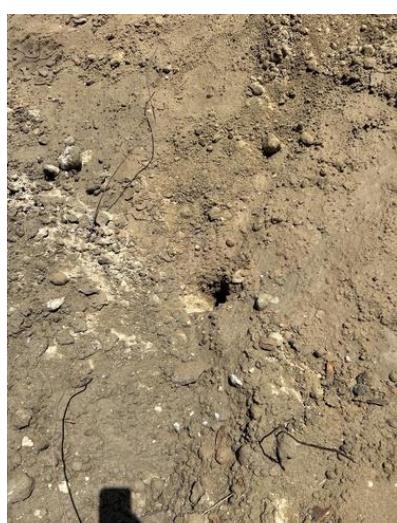
25ft x 25ft

Medium 2-4" in width

Medium 2-4" in height

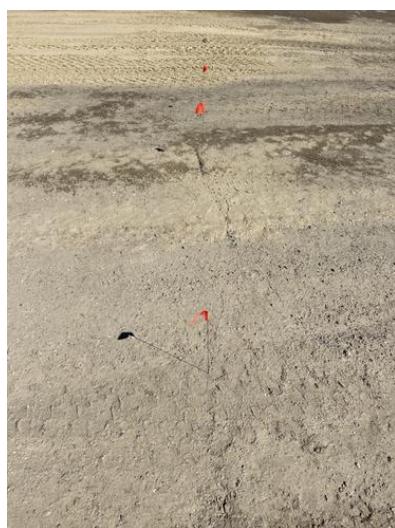
Photo 1

12ft

Horizontal Offset (width)	Small 0.5-2" in width
Vertical Offset (height)	Extra small <0.5" in height
Orientation (direction)	NW to SE

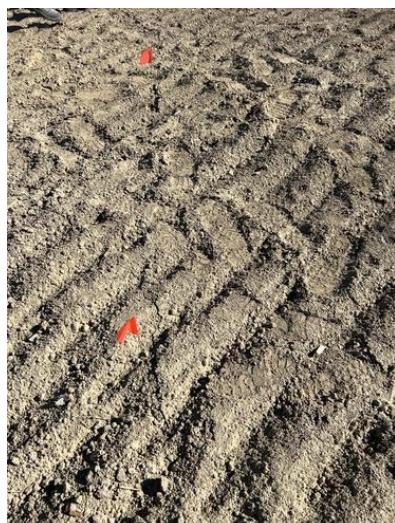
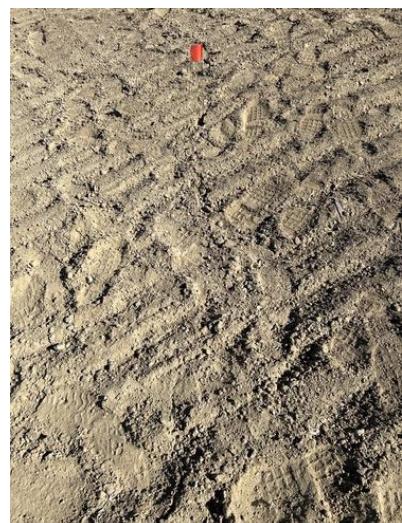
30 ft

Small 0.5-2" in width

Extra small <0.5" in height

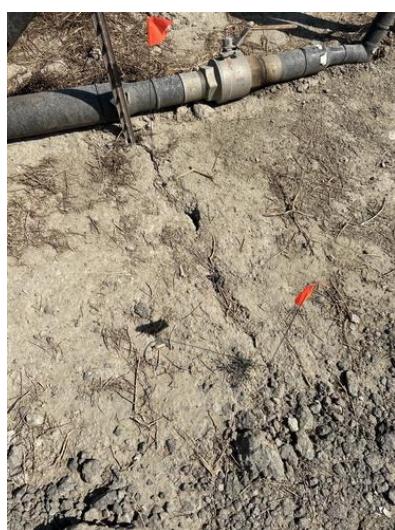
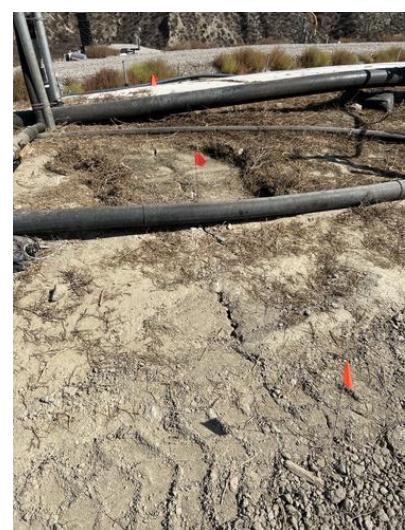
6ft x 8ft area

Horizontal Offset (width)	Small 0.5-2" in width
Vertical Offset (height)	Extra small <0.5" in height
Orientation (direction)	N to S
Location	Castaic CA 91384 United States (34.436278288569255, -118.64688054904764)
Was Fissure or Crack fixed? If yes, add photo and description of repairs performed	Yes
Photo 3

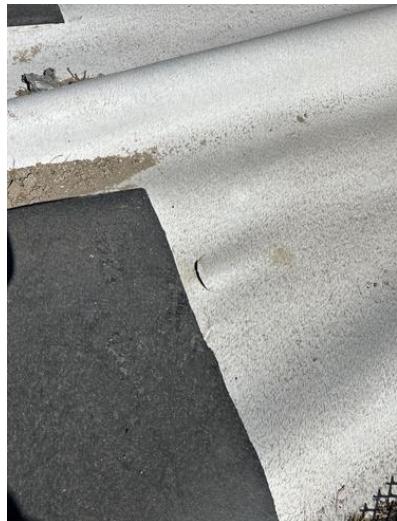
Photo 1

Small tear in liner needs to be extrusion welded.

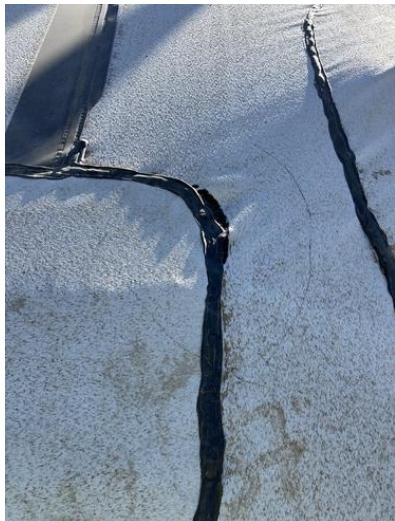
Photo 1

Tear in weld on liner, needs to be patched and extrusion welded.
