CHIQUITA CANYON
A Waste Connections Company

Re: Chiquita Canyon, LLC's Weekly Report on the Documentation and Tracking of Cover Issues

4050 - Chiquita Reaction Area Tracking of Fissures and Tension Cracks

4050 - Geosynthetic Cover Inspection

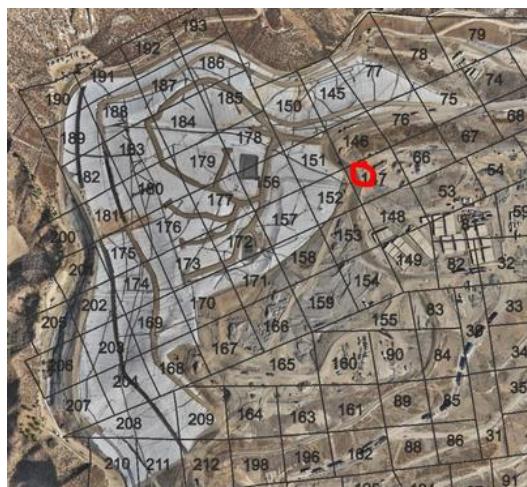
147

Using the attached image, annotate all areas where inspectors identified a fissure or tension crack.

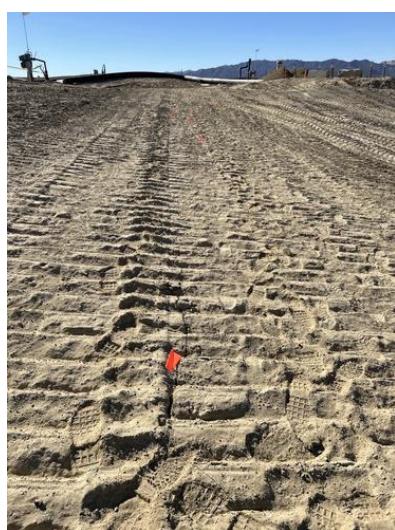
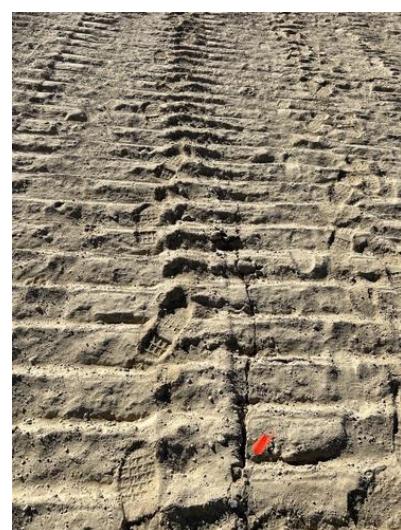
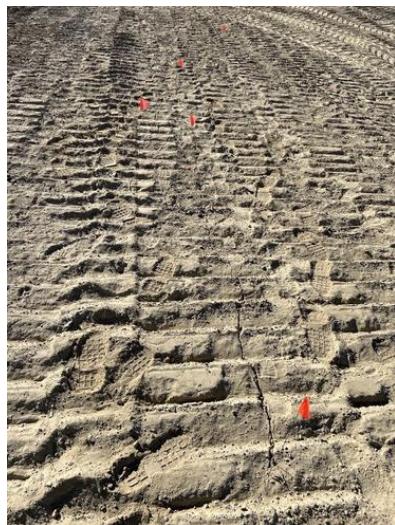
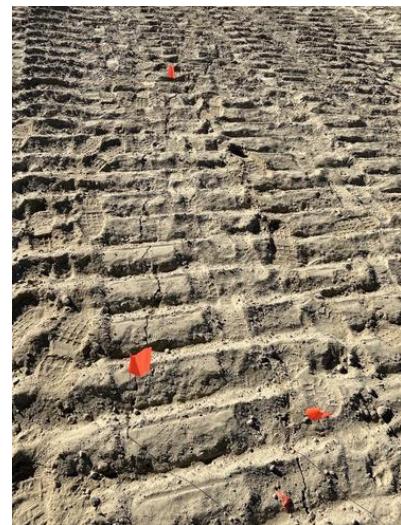
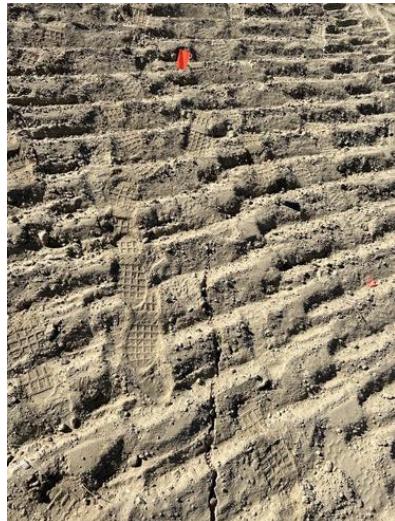
65ft x 5ft

No individual crack longer than 50ft

Small 0.5-2" in width

Extra small <0.5" in height

NW to SE

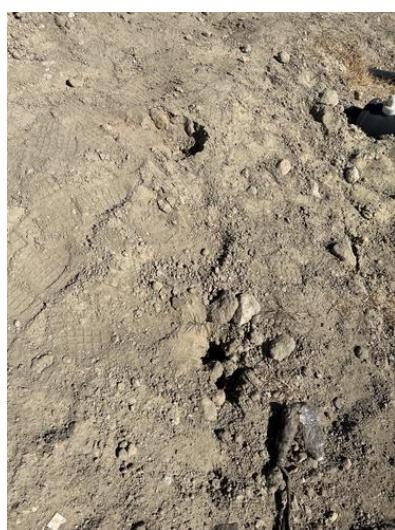
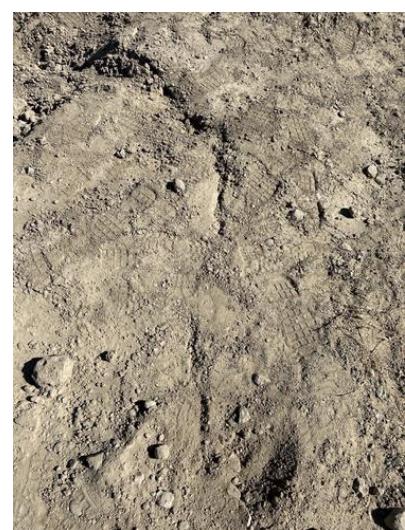
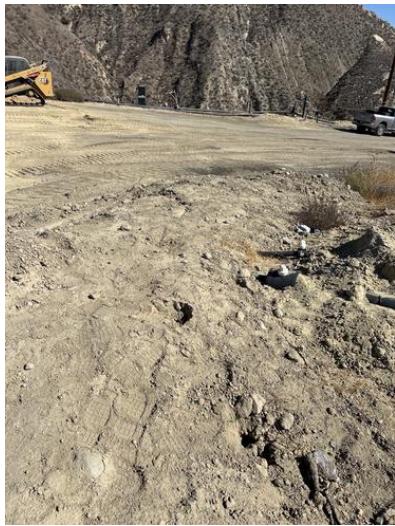
4ft x 25ft

Large >4" in width

Small 0.5-2" in height

N to S

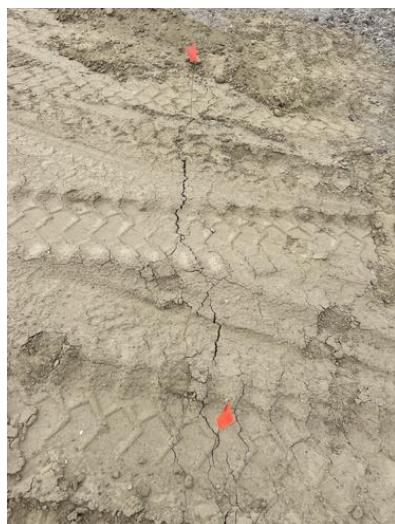
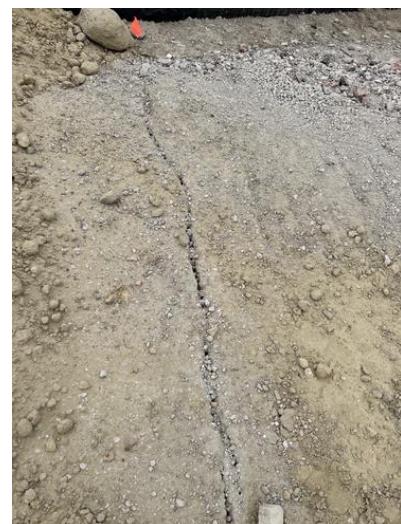
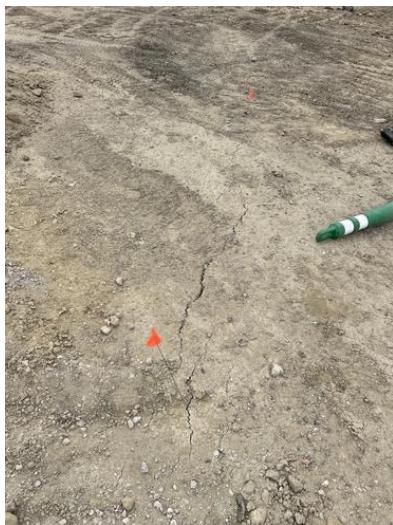
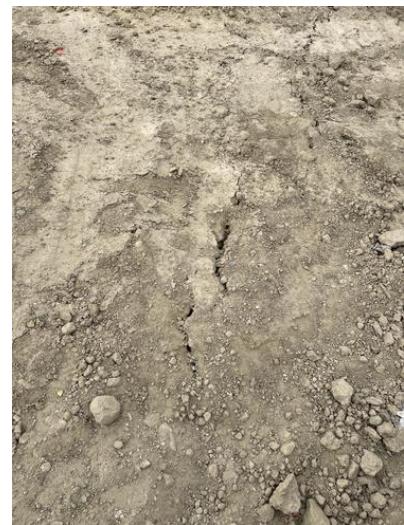
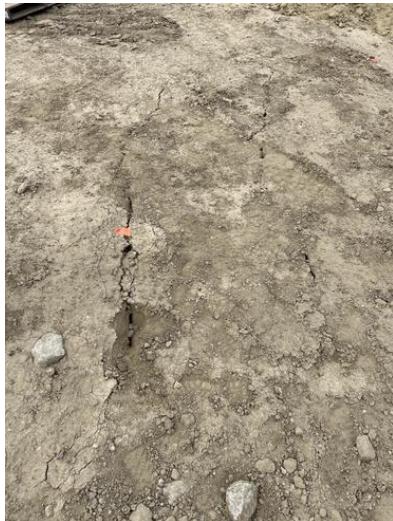
45ft x 25ft

Medium 2-4" in width

Extra small <0.5" in height

NE to SW

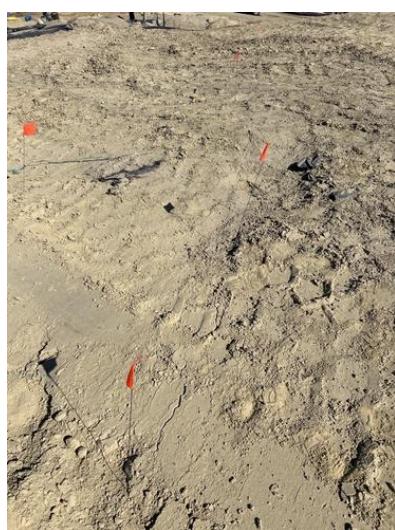
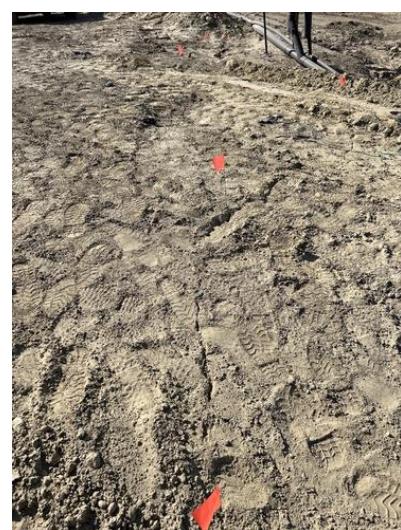
10ft

Horizontal Offset (width)	Small 0.5-2" in width
Vertical Offset (height)	Extra small <0.5" in height
Orientation (direction)	NE to SW
Location	Castaic CA 91384 United States (34.4363079757237, -118.64719990277636)
Was Fissure or Crack fixed? If yes, add photo and description of repairs performed	Yes

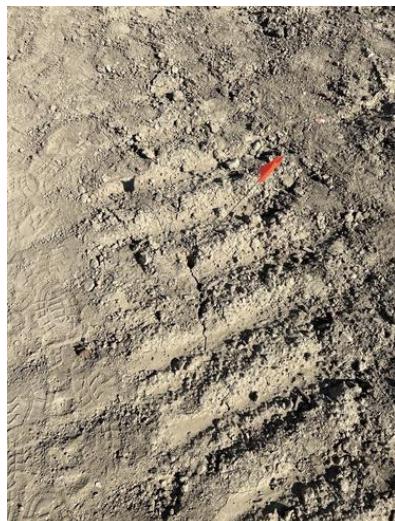
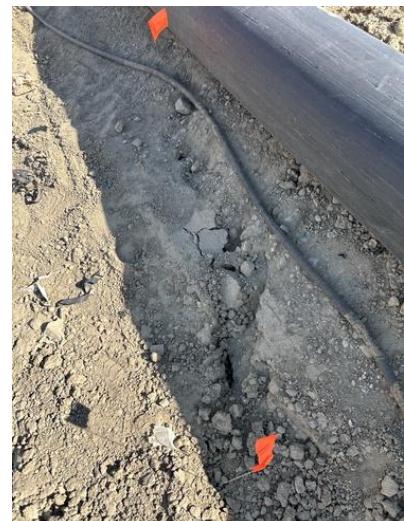
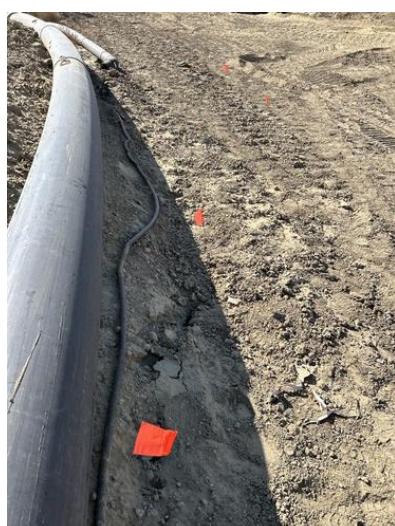
Length of crack (ft) or area containing multiple cracks (ft x ft) 12ft

Horizontal Offset (width)	Small 0.5-2" in width
Vertical Offset (height)	Extra small <0.5" in height
Orientation (direction)	NE to SW

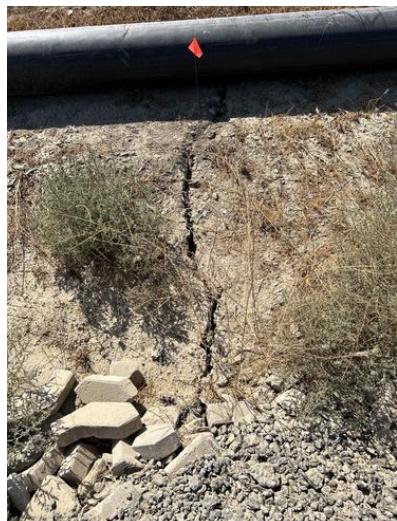
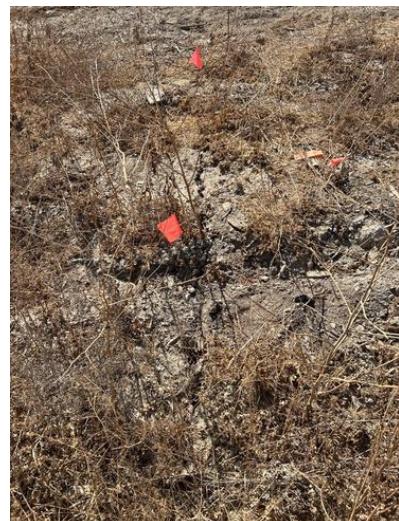
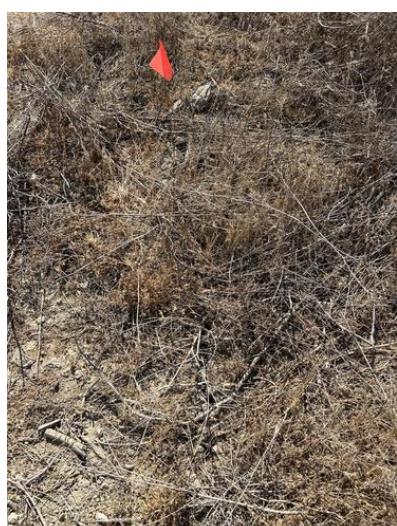
Length of crack (ft) or area containing multiple cracks (ft x ft)	20ft
Horizontal Offset (width)	Medium 2-4" in width
Vertical Offset (height)	Extra small <0.5" in height
Orientation (direction)	N to S

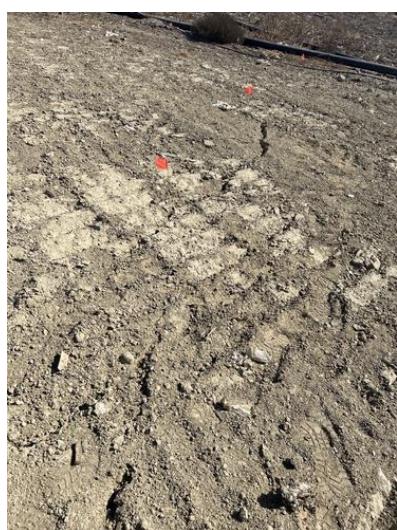
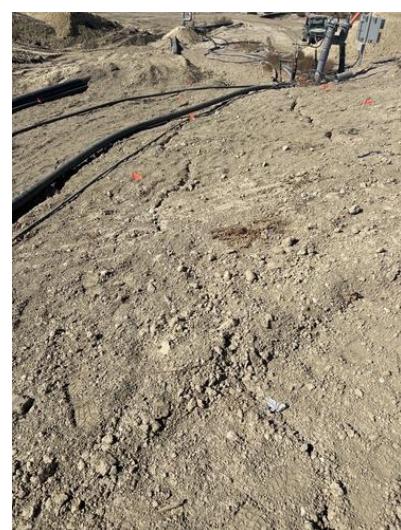
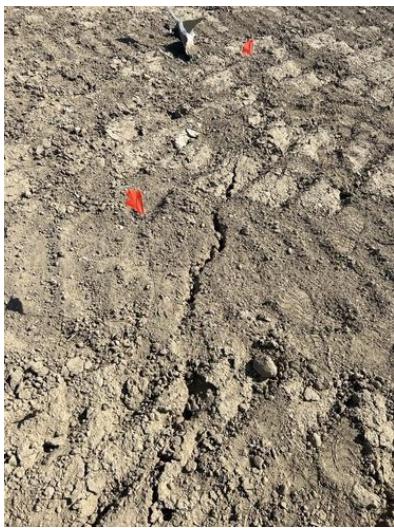
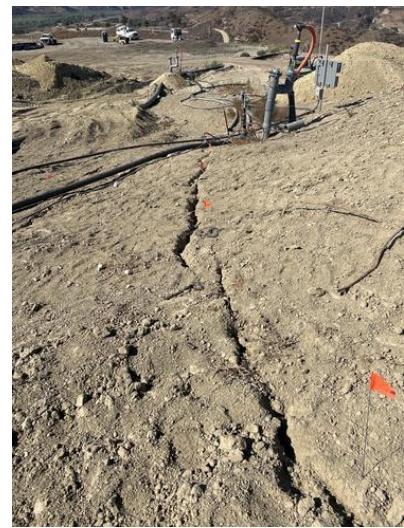
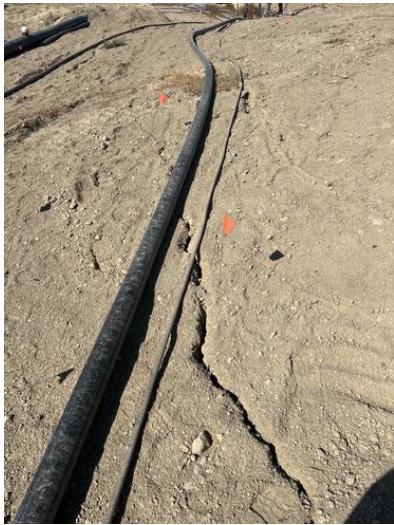
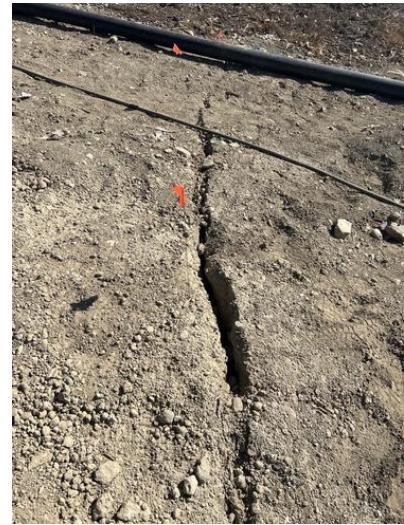
40ft x 50ft area

Multiple cracks running through area with longest crack being about 50ft

Horizontal Offset (width)	Large >4" in width
Vertical Offset (height)	Extra small <0.5" in height
Orientation (direction)	NE to SW

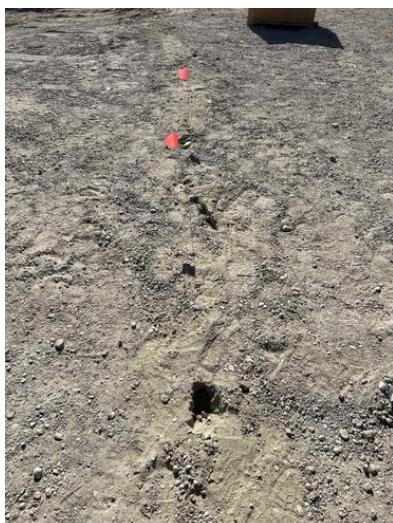
Photo 12

7ft

Medium 2-4" in width

Extra small <0.5" in height

NW to SE
