September 17, 2025

**Subject: Leachate Leak Report  
Chiquita Canyon Landfill  
File No. 67-020**

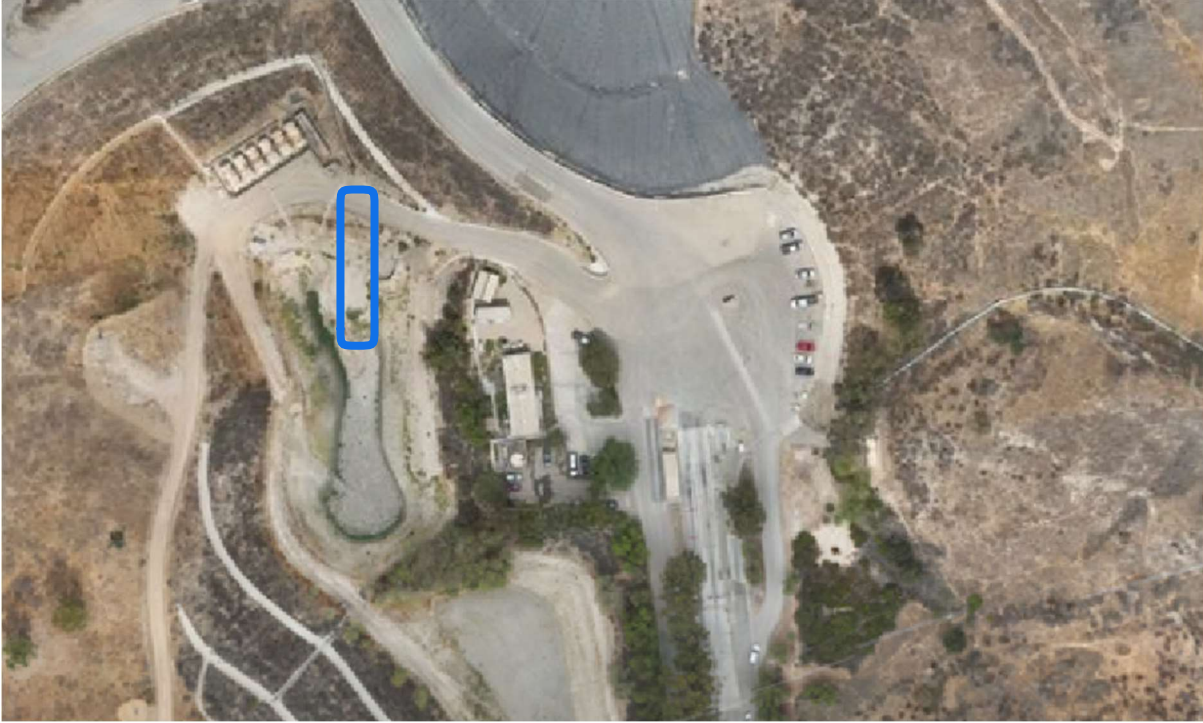
Attachments: Attachment A – Map depicting the location of the leak

The leak occurred from a sump near leachate collection manifold 1 located near the front office at the entrance of the Landfill – as depicted in Attachment A.

On September 10, 2025, at approximately 1:00 a.m., to the best of Chiquita’s knowledge, it appears that the leachate collection manifold sump filled with solids which restricted the flow of liquids to the pump. As a result, the sump filled with liquids and subsequently, portions of those liquids flowed out of the compression fittings on the top of the sump. Chiquita attributes this leak to

equipment malfunction. The liquid was dark brown in color with low viscosity, and traveled as a light trickle.

Chiquita staff promptly applied absorbent to the impacted area in order to contain the liquid on the paved road. Chiquita's third-party contractor collected the soil and any standing liquid from the stormwater basin, which was dry at the time of the leak. All of the material collected during cleanup was placed in a roll off bin and will be sampled for proper disposal. Cleanup commenced immediately and was completed within 8.5 hours.

To prevent similar leaks from occurring in the future, Chiquita will continue to conduct routine maintenance on the sumps within the Landfill. Chiquita has also installed a temporary secondary containment system around this sump and is actively developing a more permanent solution.
