CHIQUITA CANYON
A Waste Connections Company

Re: Chiquita Canyon, LLC's Weekly Report on the Documentation and Tracking of Cover Issues

Attachment: September 23, 2025 Weekly Cover Issues Report

4050 - Chiquita Reaction Area Tracking of Fissures and Tension Cracks

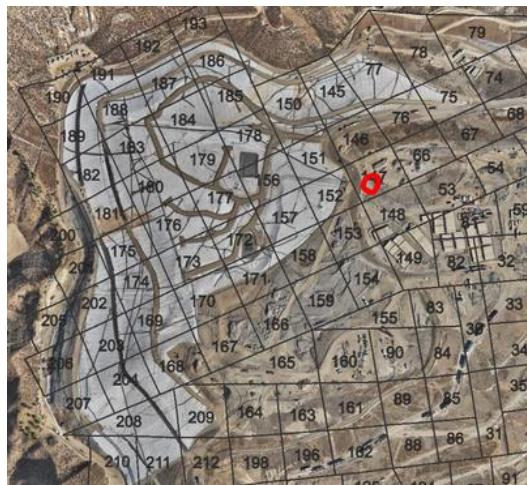
147

Using the attached image, annotate all areas where inspectors identified a fissure or tension crack.

60ft x 5ft

No single crack over 50ft

Small 0.5-2" in width

Extra small <0.5" in height

NW to SE

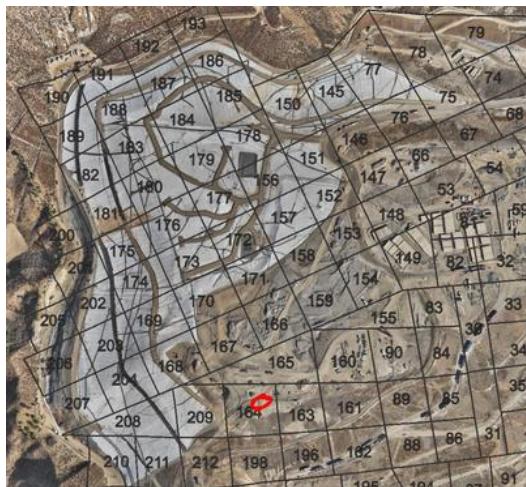
164

Using the attached image, annotate all areas where inspectors identified a fissure or tension crack.

75ft x 20ft area

Numerous cracks running through area. With longest individual crack being about 20ft

Horizontal Offset (width)	Small 0.5-2" in width
Vertical Offset (height)	Extra small <0.5" in height
Orientation (direction)	NE to SW

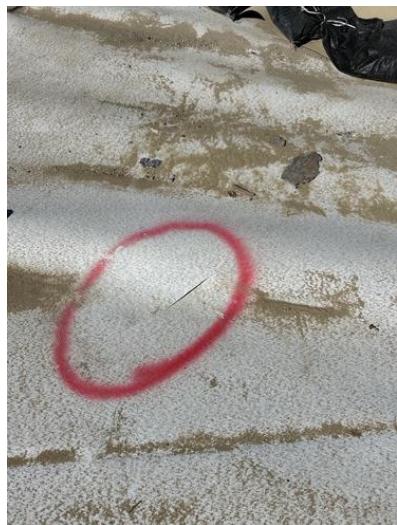
Photo 1

Cut in liner needs to be
patched/extrusion welded.
