Re: Chiquita Canyon, LLC's Weekly Report on the Documentation and Tracking of Cover Issues

Attachment: September 30, 2025 Weekly Cover Issues Report

4050 - Chiquita Reaction Area Tracking of Fissures and Tension Cracks

4050 - Geosynthetic Cover Inspection

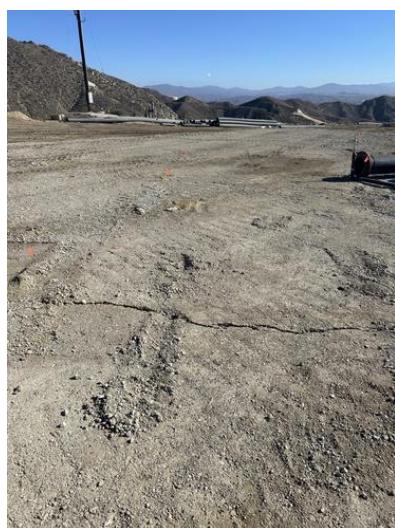
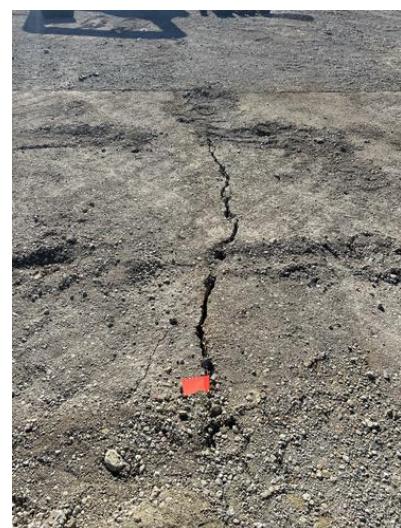
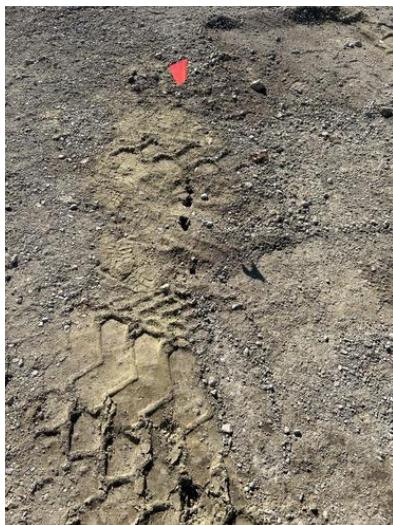
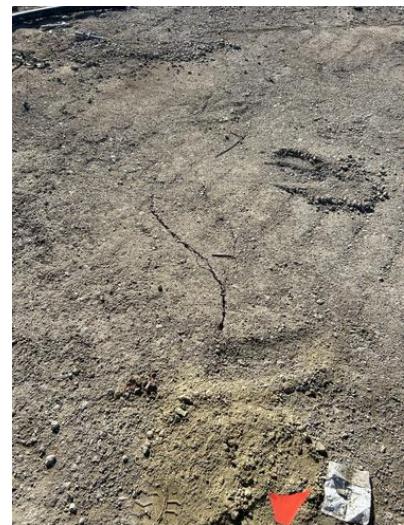
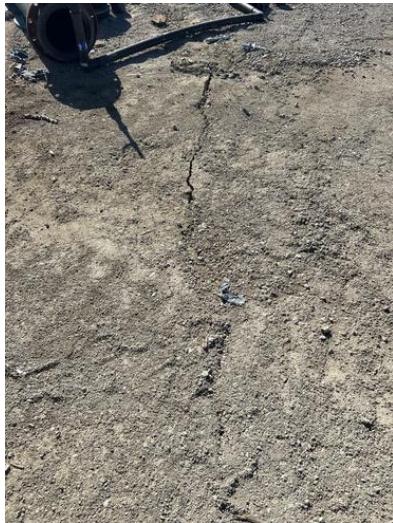
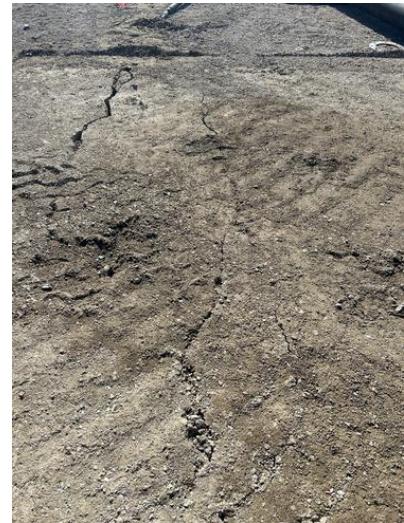
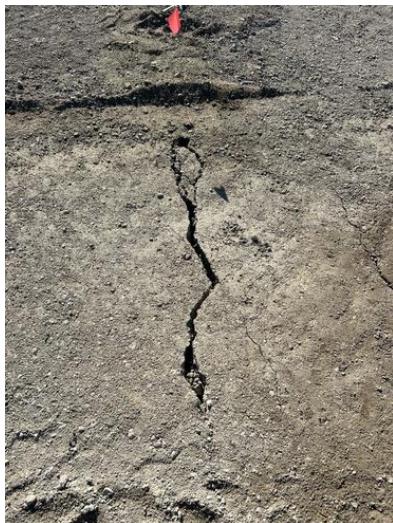
147

30ft x 20ft area

Medium 2-4" in width

Extra small <0.5" in height

NW to SE

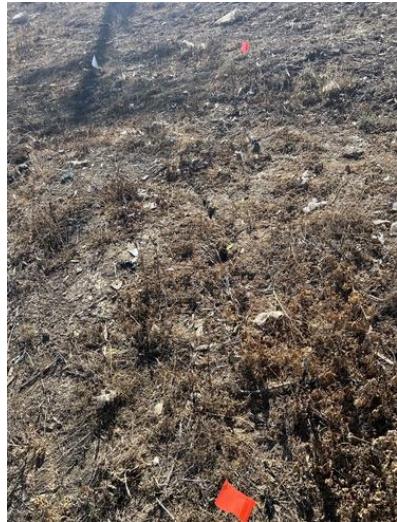
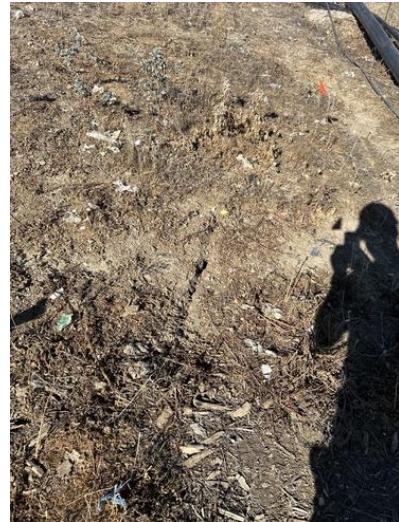
146

5ft

Medium 2-4" in width

Extra small <0.5" in height

NW to SE

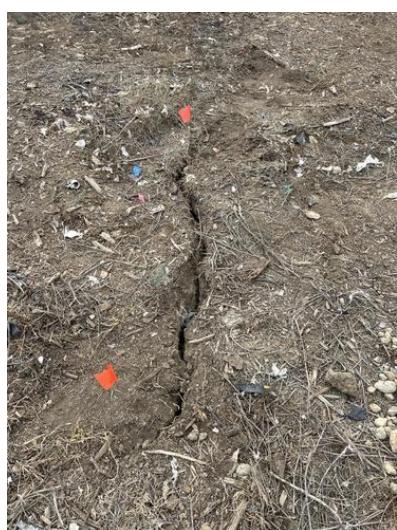
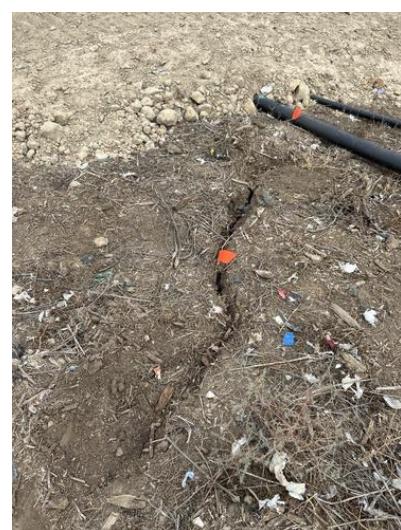
146

8 ft

Horizontal Offset (width)	Medium 2-4" in width
Vertical Offset (height)	Extra small <0.5" in height
Orientation (direction)	N to S

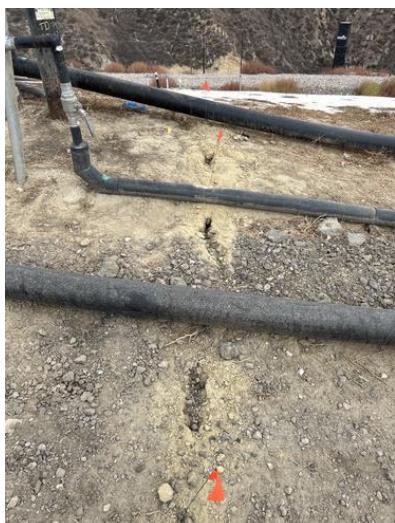
Photo 5

146

6ft

Medium 2-4" in width

Extra small <0.5" in height

N to S

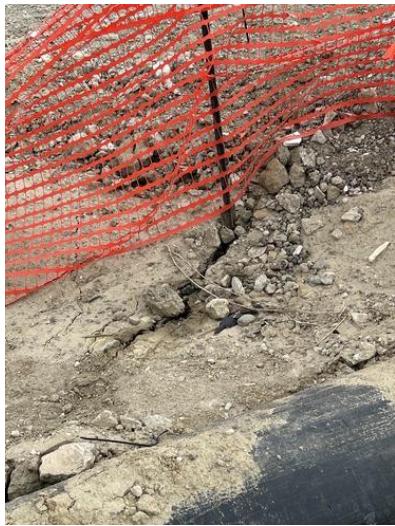
Photo 8

152

4ft

Medium 2-4" in width

Small 0.5-2" in height

NW to SE

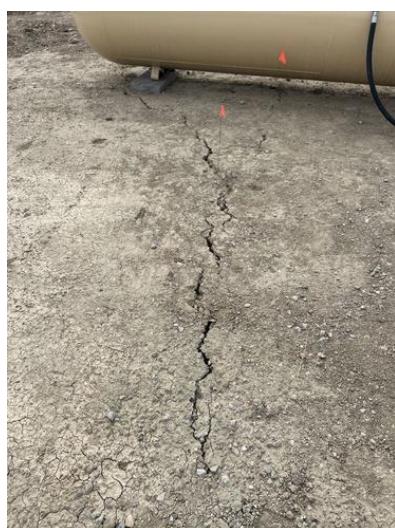
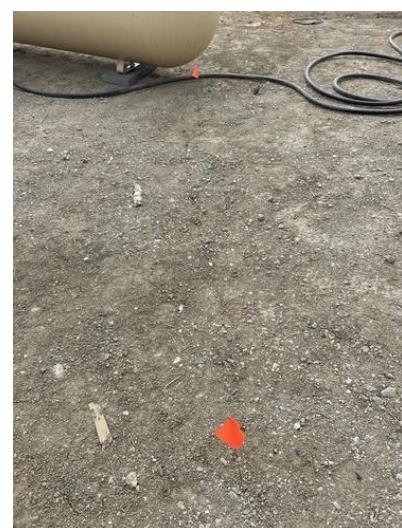
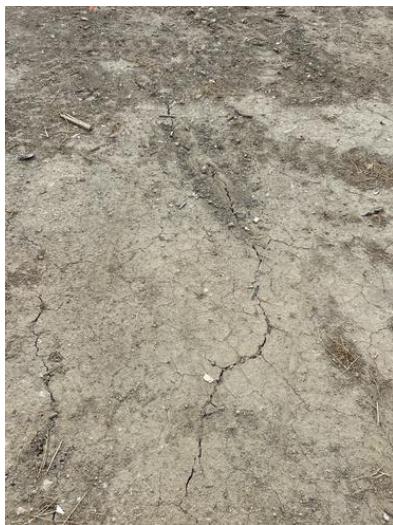
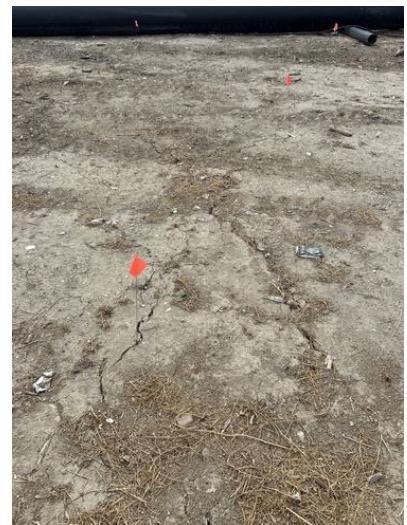
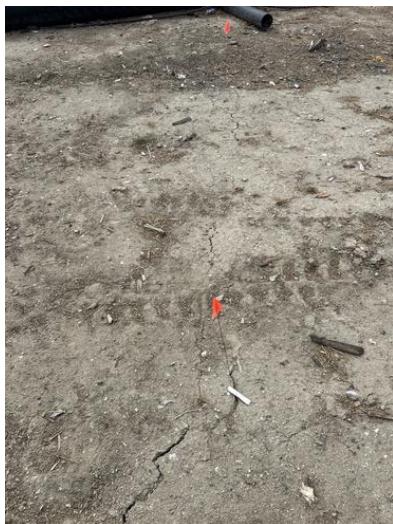
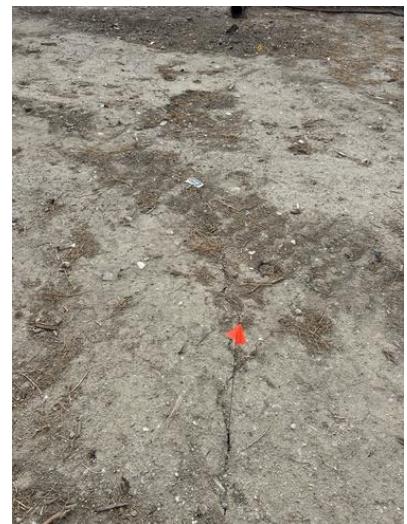
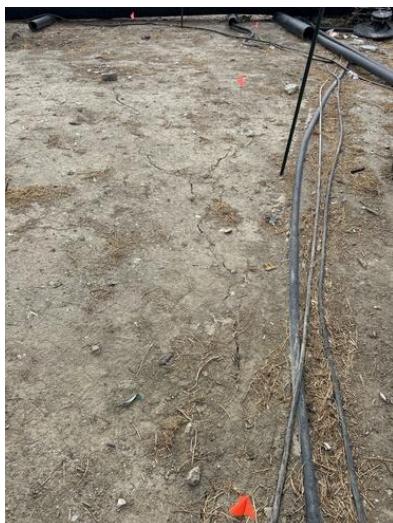
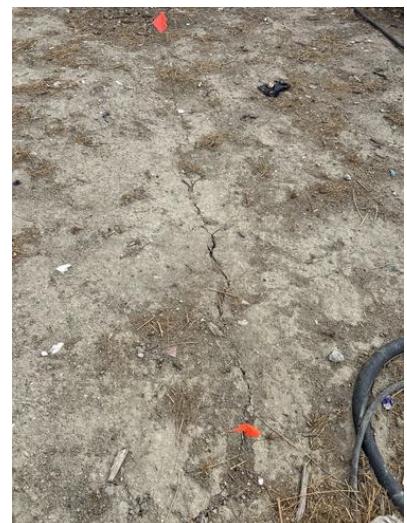
90

45ft x 40ft area

Small 0.5-2" in width

Extra small <0.5" in height

N to S

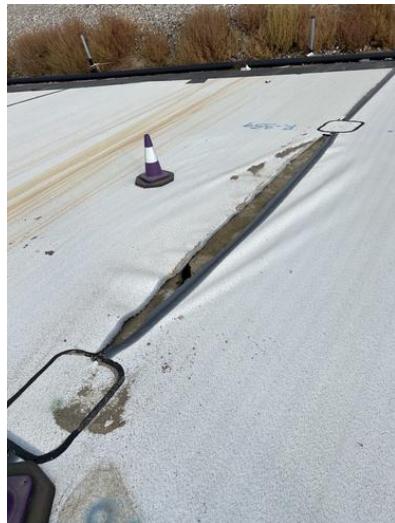
Photo 1

Tear at seam in liner. Needs to be patched and extrusion welded.
