CHIQUITA CANYON
A Waste Connections Company

Re: Chiquita Canyon, LLC's Weekly Report on the Documentation and Tracking of Cover Issues

4050 - Chiquita Reaction Area Tracking of Fissures and Tension Cracks

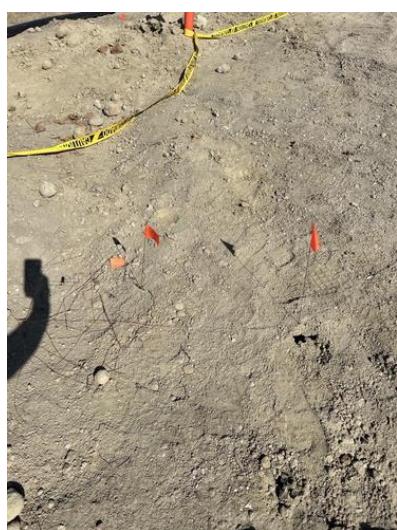
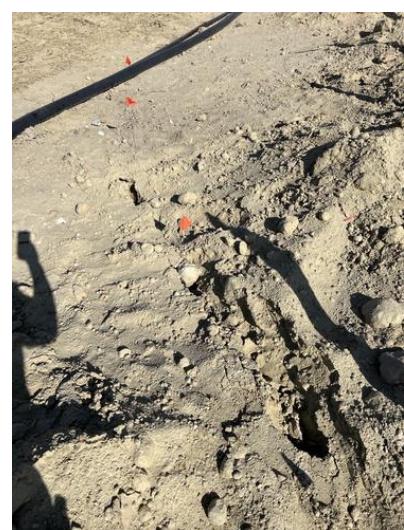
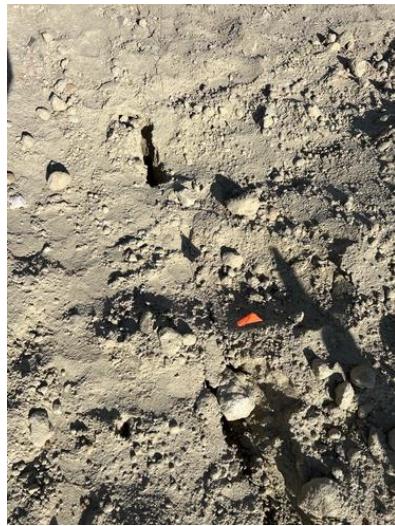
147

25ft x 2ft

Medium 2-4" in width

Extra small <0.5" in height

NW to SE

Cracks were track walked.

Dirt was also added.

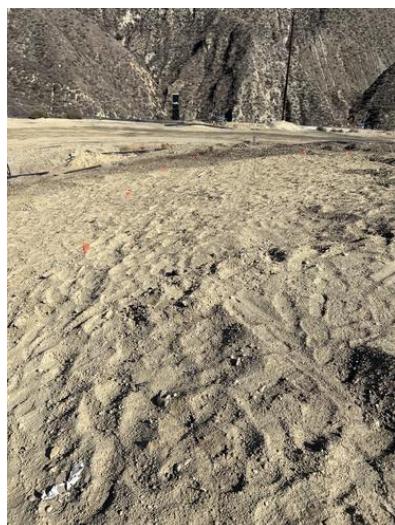
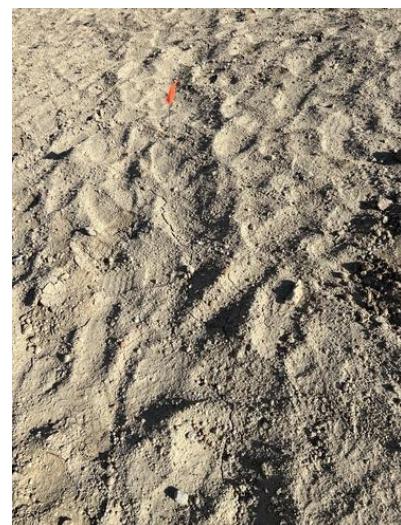
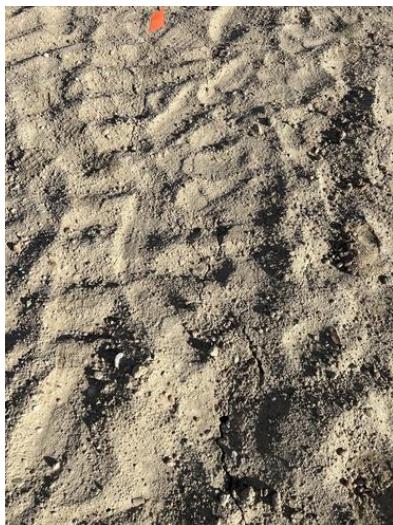
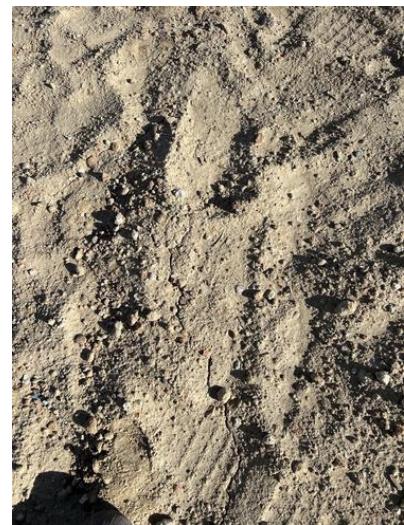
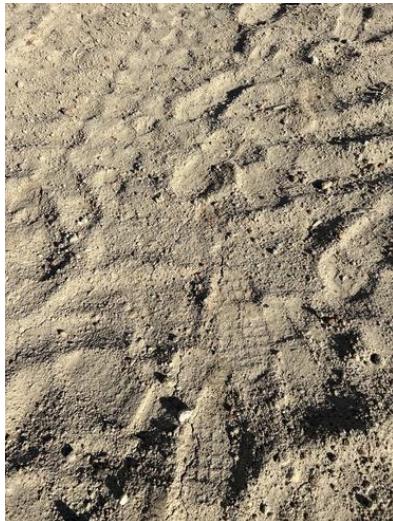
146

40ft x 20ft

Small 0.5-2" in width

Extra small <0.5" in height

N to S

Cracks were track walked.

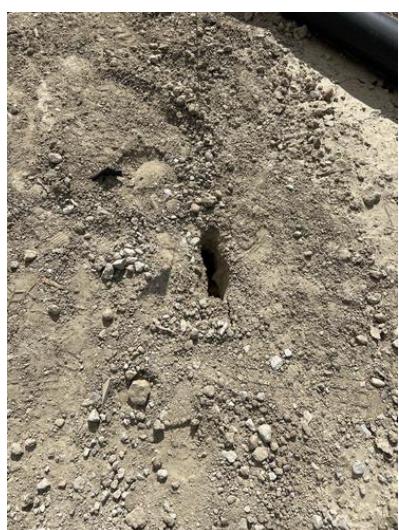
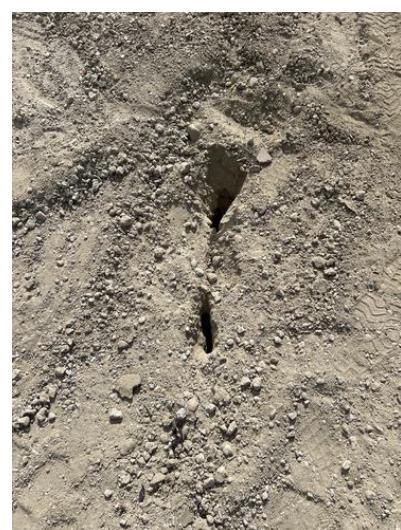
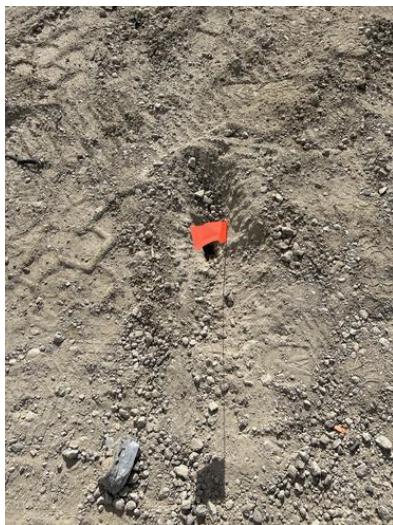
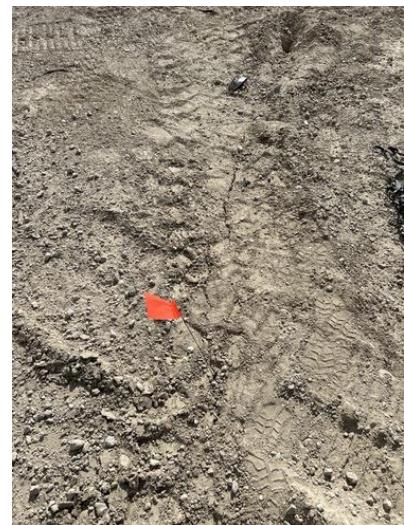
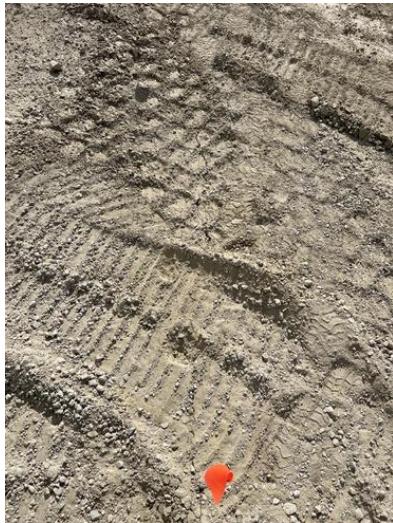
147

30ft

Crack is 30ft long in total with soil creating a bridge over parts of crack

Medium 2-4" in width

Extra small <0.5" in height

NW to SE

Cracks were track walked.

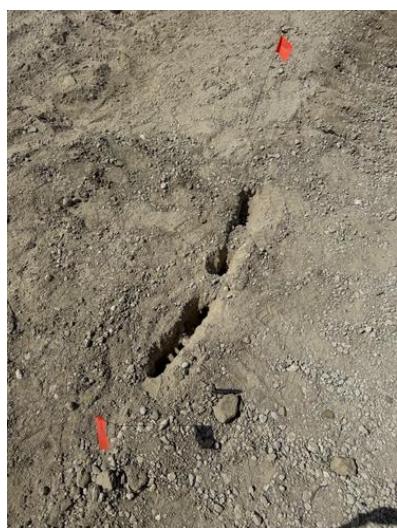
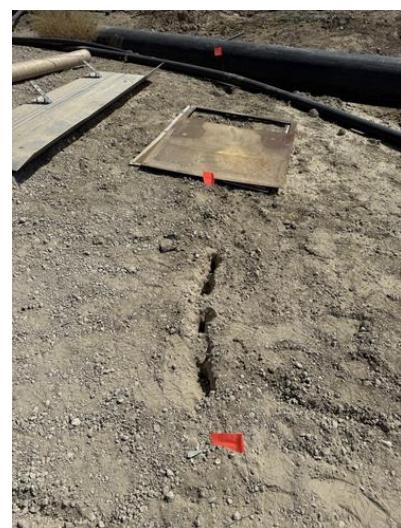
147

8ft

Horizontal Offset (width)	Medium 2-4" in width
Vertical Offset (height)	Extra small <0.5" in height
Orientation (direction)	NW to SE

Cracks were broken up and compacted with excavator
