**Re: Chiquita Canyon, LLC's Weekly Report on the Documentation and
Tracking of Cover Issues, Monthly Summary and Monthly Isopach Map**

4050 - Chiquita Reaction Area Tracking of Fissures and Tension Cracks

4050 - Geosynthetic Cover Inspection

**SEPTEMBER 2025 FISSURE AND TENSION CRACK MONITORING SUMMARY
CHIQUITA CANYON LANDFILL
CASTAIC, CALIFORNIA**

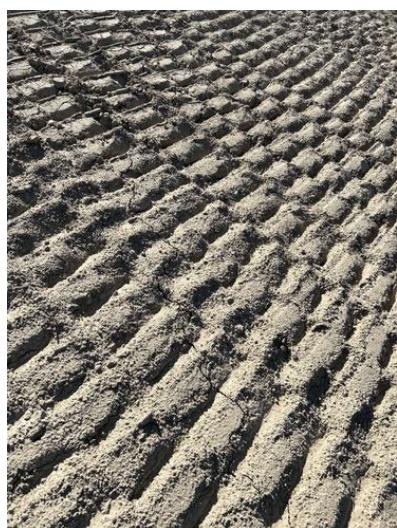
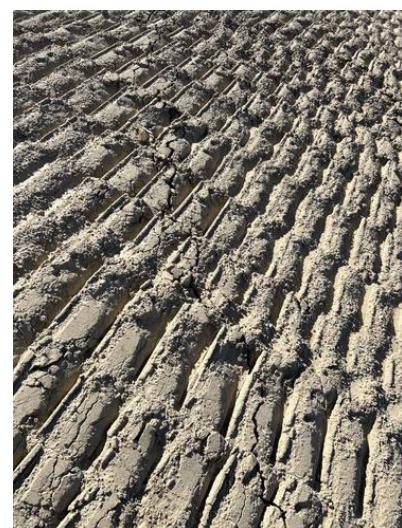
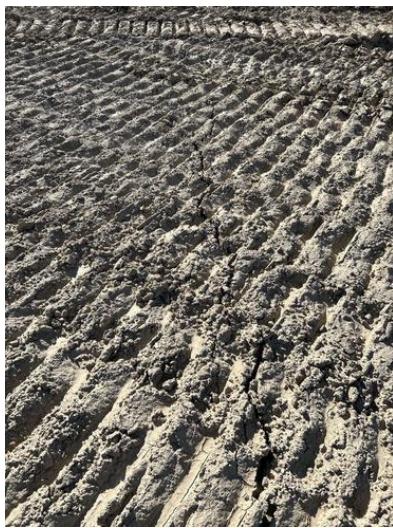
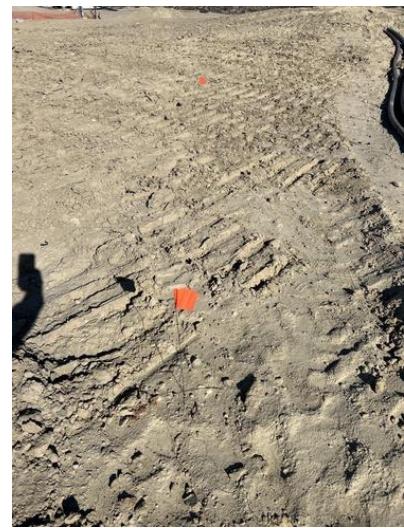
147

80ft x 20ft

Longest individual crack was approximately 30ft

Small 0.5-2" in width

Extra small <0.5" in height

NW to SE

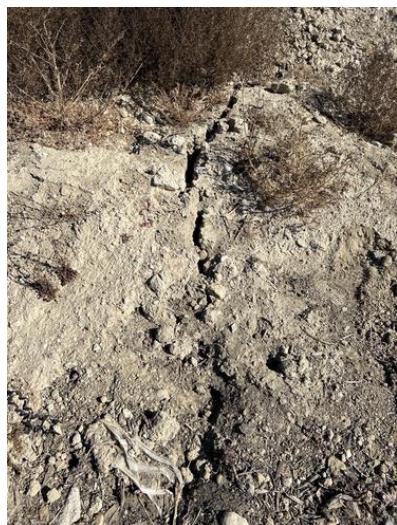
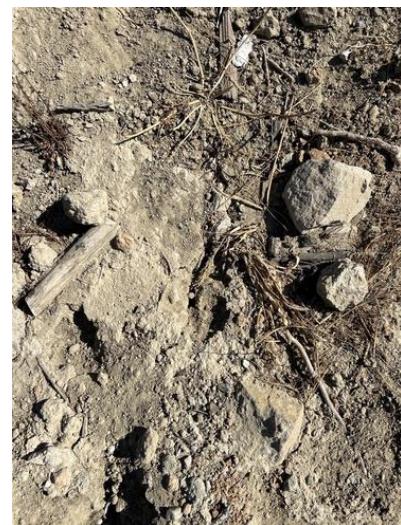
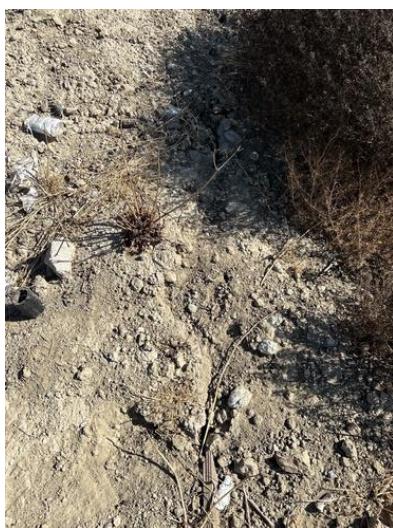
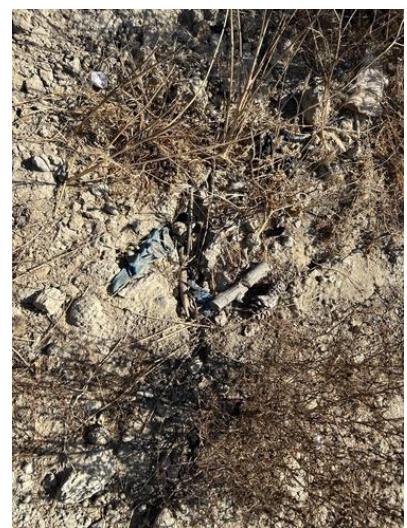
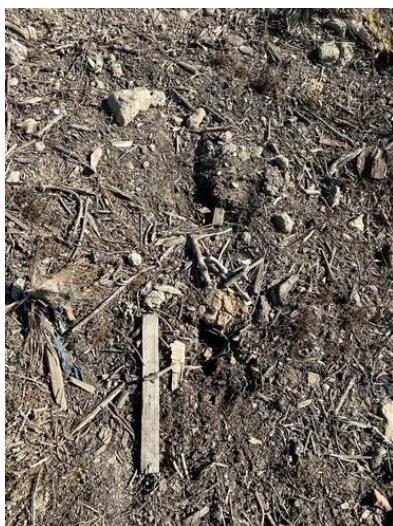
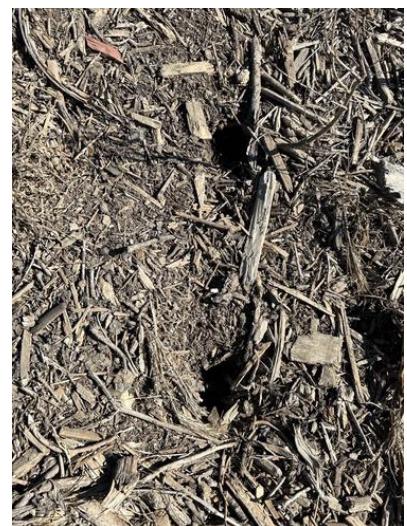
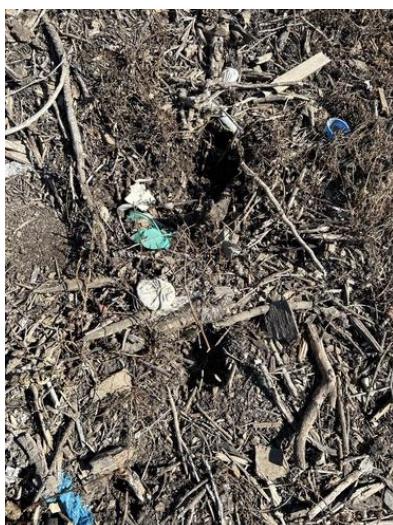
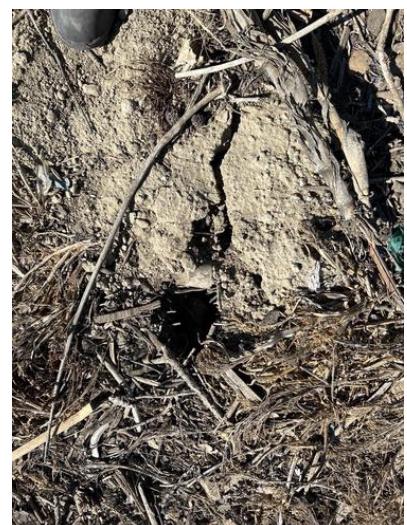
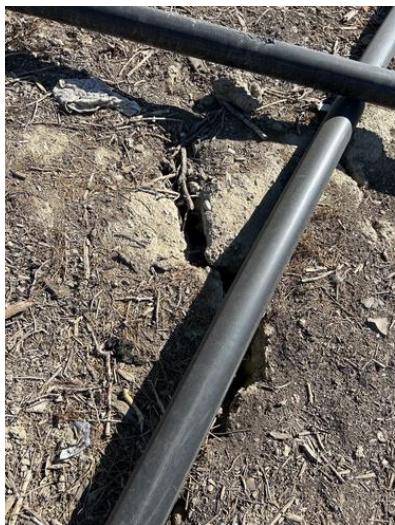
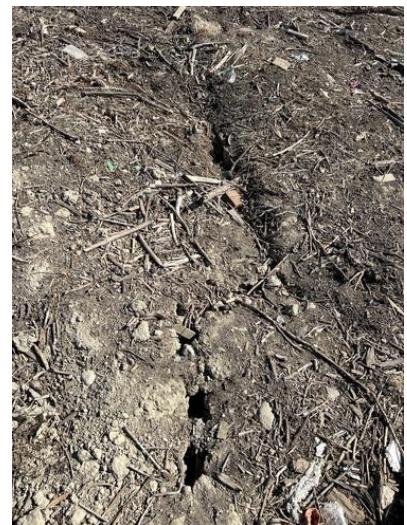
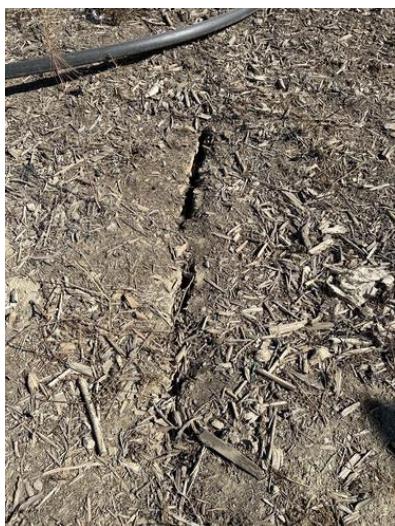
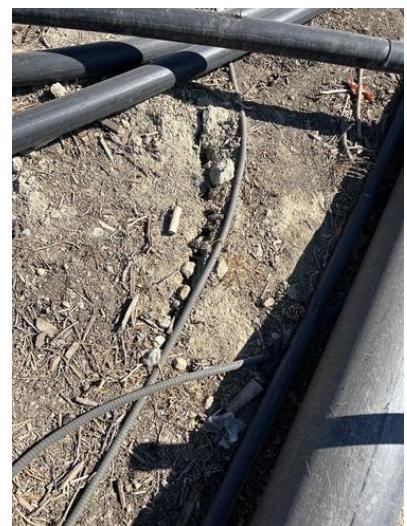
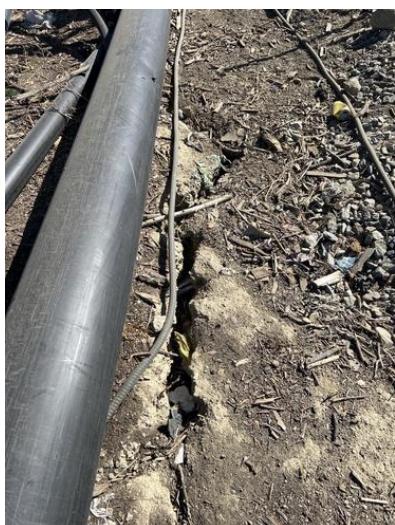
163

Longest individual crack about 15ft

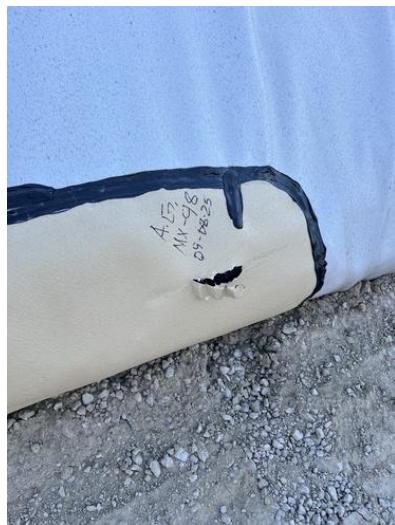
Photo 1

Tear in liner needs to be patched/extrusion welded.

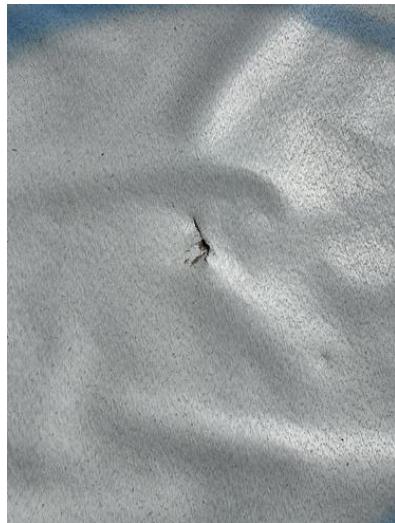
Photo 1

Small tear in liner. Needs to be patched and extrusion welded

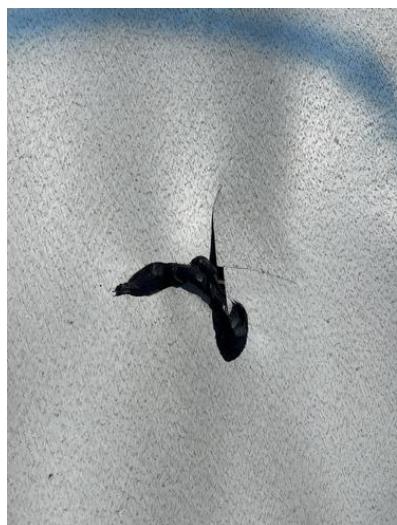
Photo 4

Small tear in liner. Needs to be patched and extrusion welded

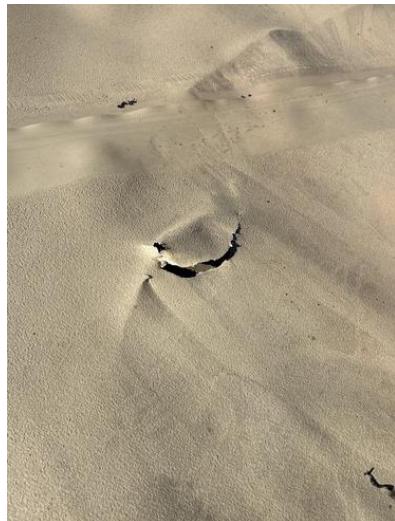
Photo 1

Tear in liner. Needs to be patched and extrusion welded

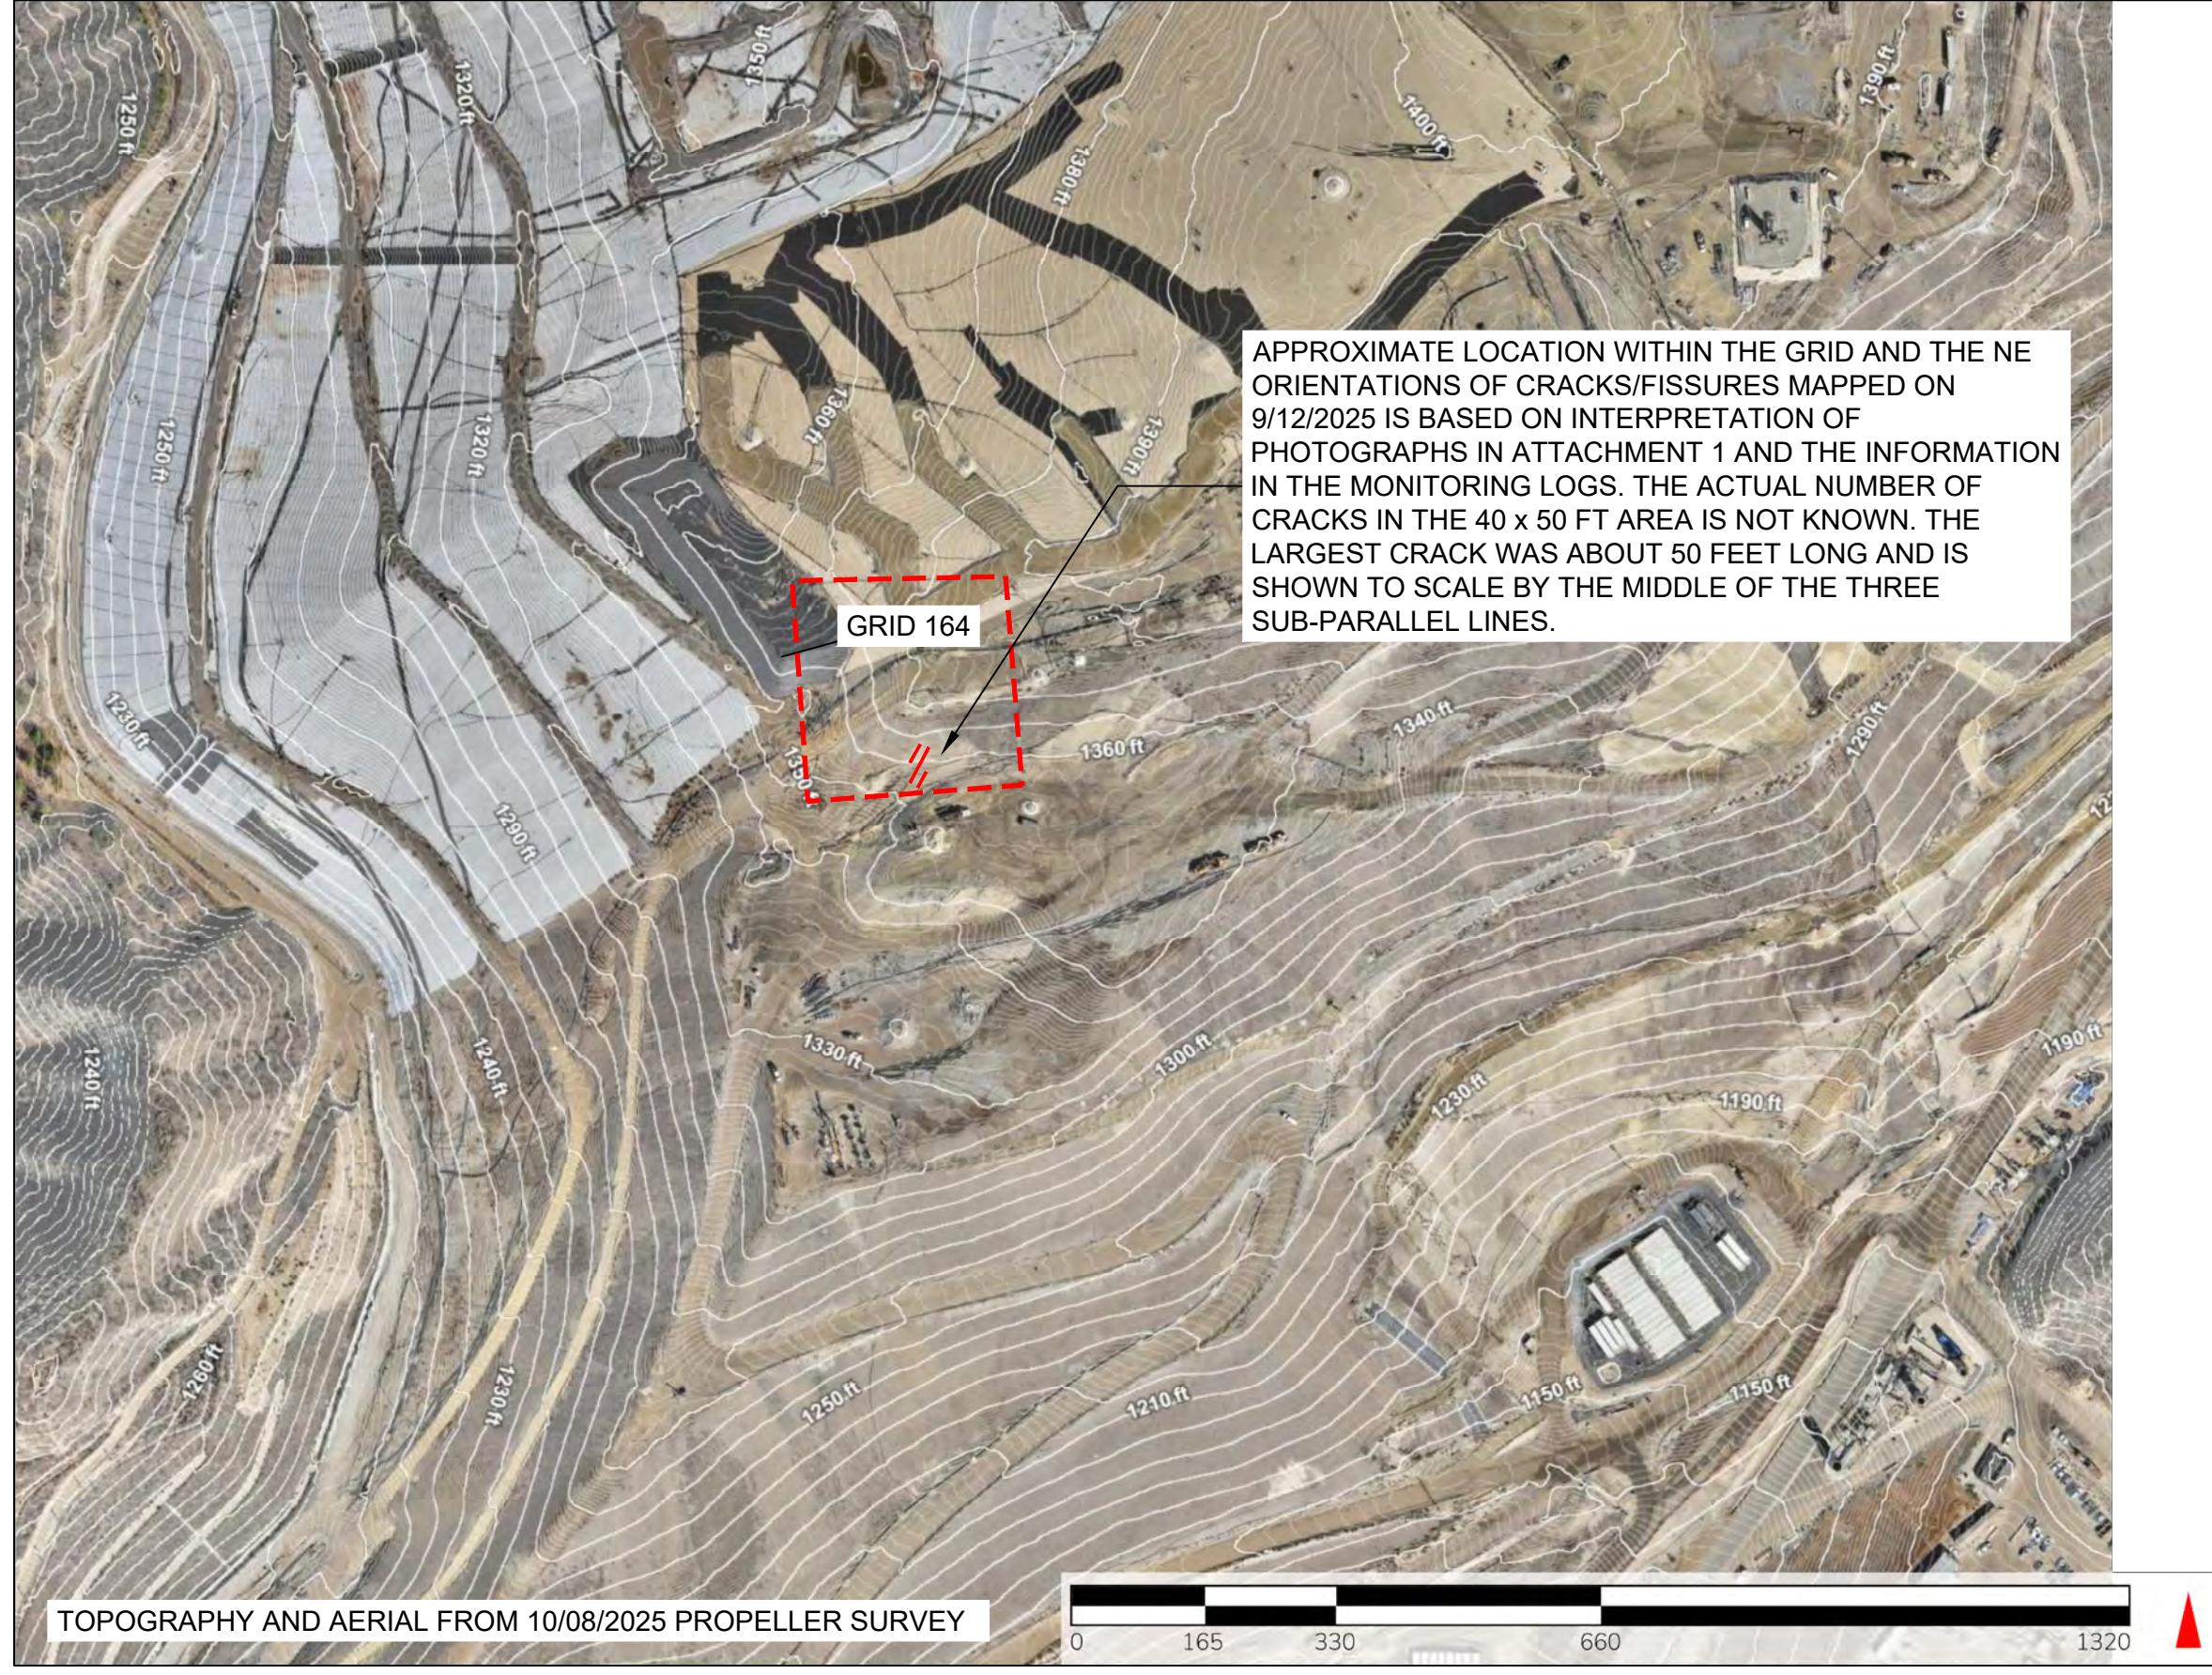
FIGURE 3

The surface cracking observed in Grid 164 appears to represent localized surface displacement at the edge of the reaction area rather than a larger slope-stability concern. This interpretation was based on consideration of the geometric, temporal, and site condition indicators summarized below. The intent of this discussion is to provide context for interpreting the cracking patterns shown in Attachment 1 and in Figure 3, which illustrates the size, location, and orientation of the observed cracks relative to site topography and slope geometry.

As shown in Figure 3, the cracks mapped in Grid 164 are located approximately 364 feet from the crest of the south-facing slope and approximately 270 feet from the crest of the west-facing slope. In both cases, the cracks are small relative to the overall slope crest widths, each of which exceeds 1,000 feet. The limited extent and setback distance of these cracks suggest they are not directly associated with active crest deformation.

Cracks that trend parallel to the slope face are more indicative of potential slope movement or tension-related deformation near the crest. In contrast, cracks oriented perpendicular or oblique to the slope may result from localized settlement, shrinkage, or other surface processes unrelated to overall slope stability. The Grid 164 cracks are oriented obliquely to both the south-facing and west-facing slopes, further suggesting the cracks resulted from a localized rather than slope-scale mechanism.

The cracks observed within Grid 164 are small in relation to the adjacent slope crests, obliquely oriented to nearby slope faces, and located several hundred feet from the slope crests. Field documentation indicates minimal (<0.5 inch) vertical offset, no evidence of progressive widening or lengthening, and no recurrence following repair and monitoring. No corroborating signs of instability such as margin cracking, toe bulging, or topographic change were identified. Based on its scale, alignment, and the absence of progressive movement or related signs of distress, the feature appears to represent localized surface strain at the edge of the reaction area rather than a larger slope-stability concern. Continued routine monitoring consistent with existing procedures is considered appropriate, with particular attention given to adjacent grids and evidence of reactivation of cracking in Grid 164. Grid 164 will also be added to the “Previous Monitoring Results and Trends” section of future monthly monitoring summaries.
