CHIQUITA CANYON
A Waste Connections Company

Re: Chiquita Canyon, LLC's Weekly Report on the Documentation and Tracking of Cover Issues

Attachment: October 21, 2025 Weekly Cover Issues Report

4050 - Chiquita Reaction Area Tracking of Fissures and Tension Cracks

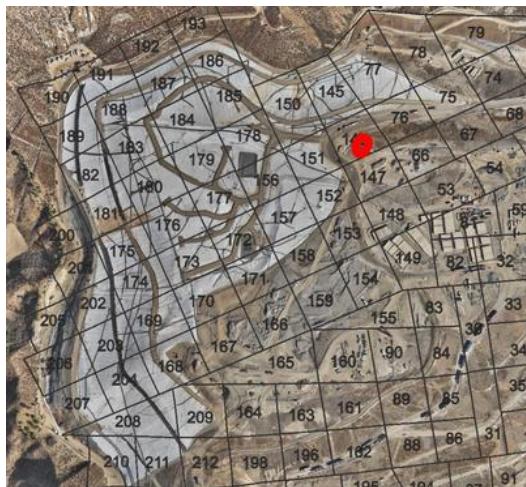
Using the attached image, annotate all areas where inspectors identified a fissure or tension crack.

146

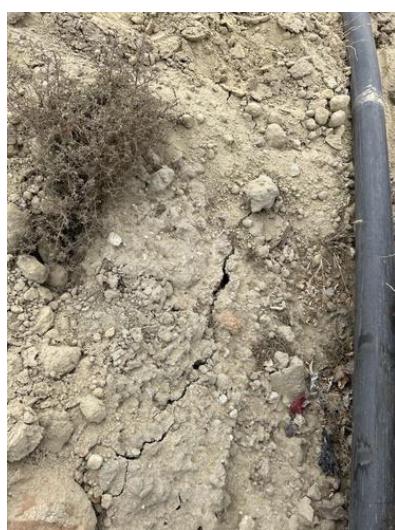
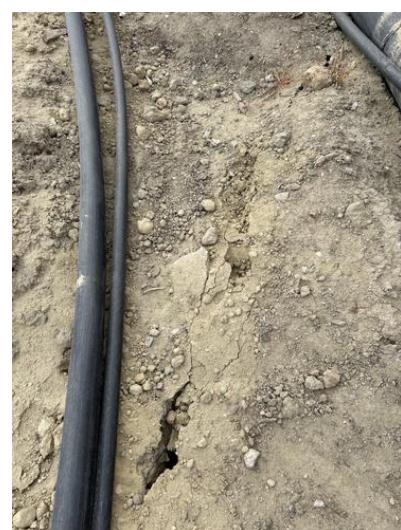
Image of Fissure/Tension Crack

12ft

Horizontal Offset (width)	Large >4" in width
Vertical Offset (height)	Small 0.5-2" in height
Orientation (direction)	NW to SE

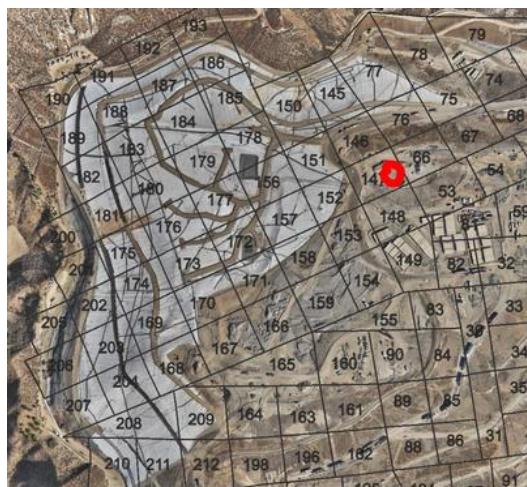
Using the attached image, annotate all areas where inspectors identified a fissure or tension crack.

147

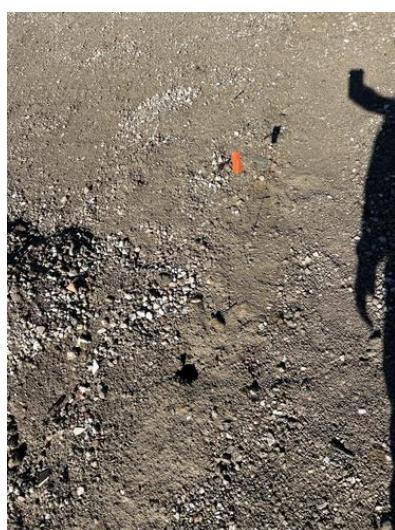
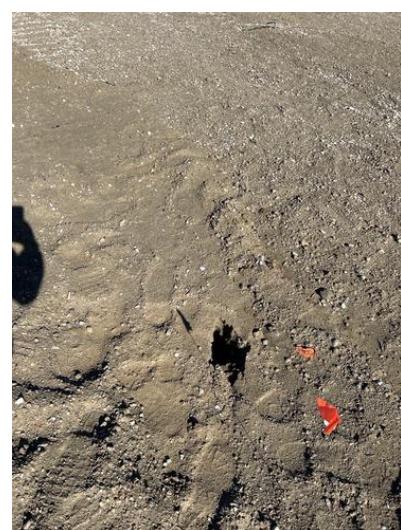
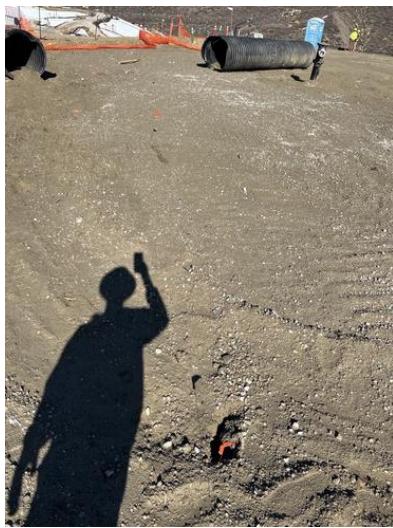
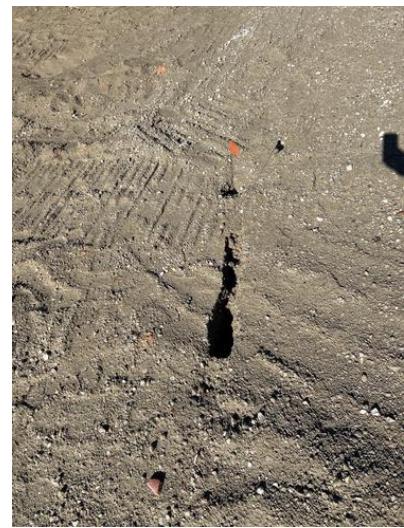
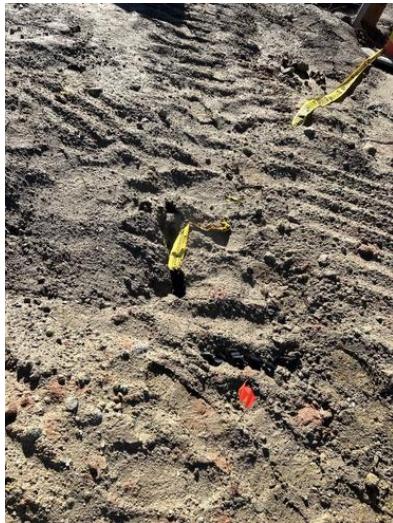
Image of Fissure/Tension Crack

100ft x 70ft

Longest individual crack was 3ft

Large >4" in width

Small 0.5-2" in height

NW to SE

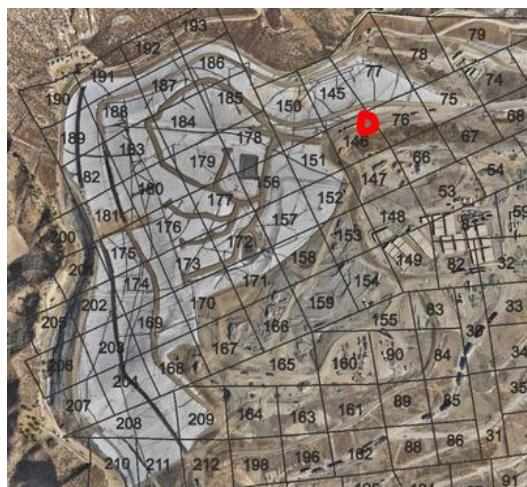
Using the attached image, annotate all areas where inspectors identified a fissure or tension crack.

146

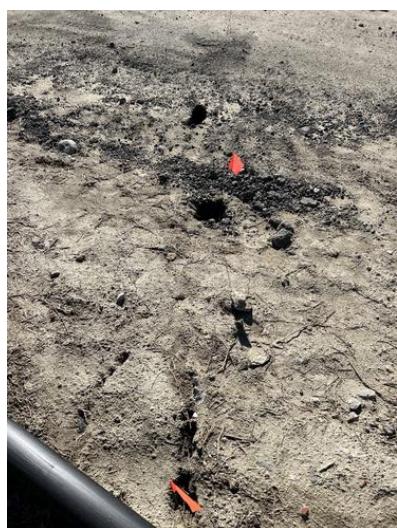
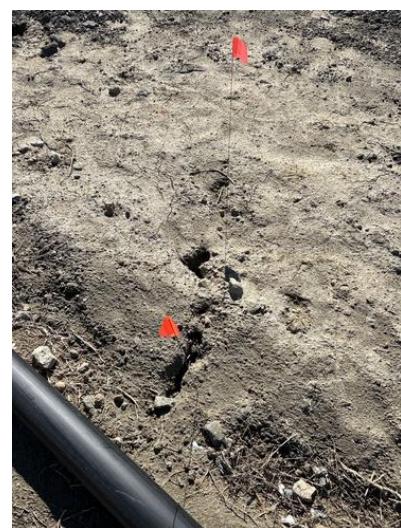
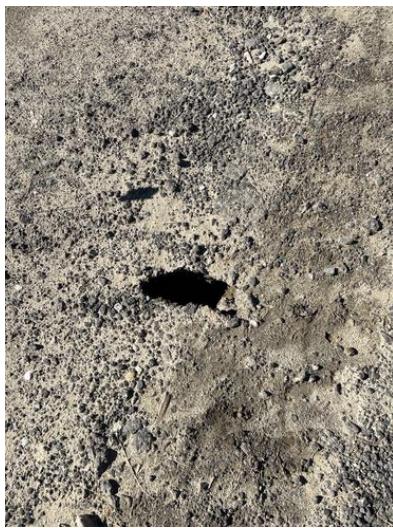
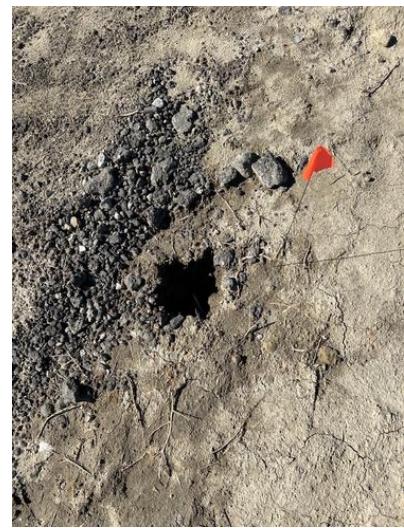
Image of Fissure/Tension Crack

.5ft x 7ft area

One continuous 7ft crack with road covering creating small bridging sections along it

Large >4" in width

Extra small <0.5" in height

NW to SE
