CHIQUITA CANYON
A Waste Connections Company

Re: Chiquita Canyon, LLC's Weekly Report on the Documentation and Tracking of Cover Issues

Attachment: November 4, 2025 Weekly Cover Issues Report

4050 - Chiquita Reaction Area Tracking of Fissures and Tension Cracks

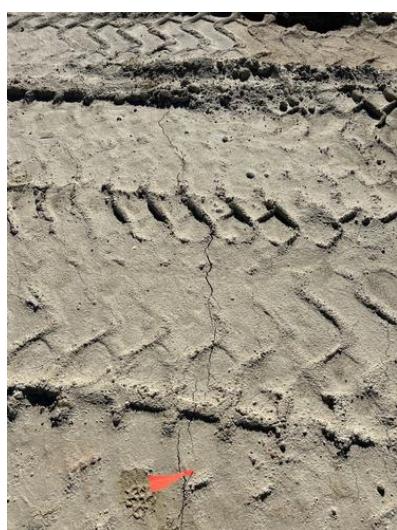
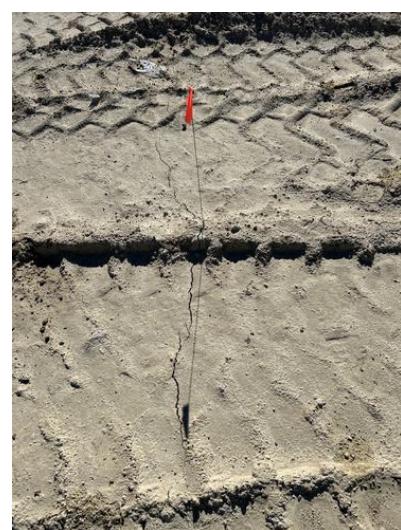
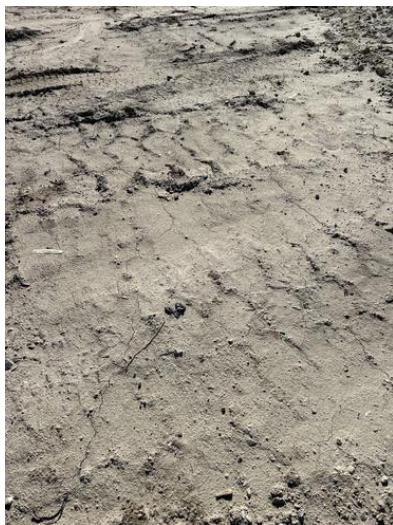
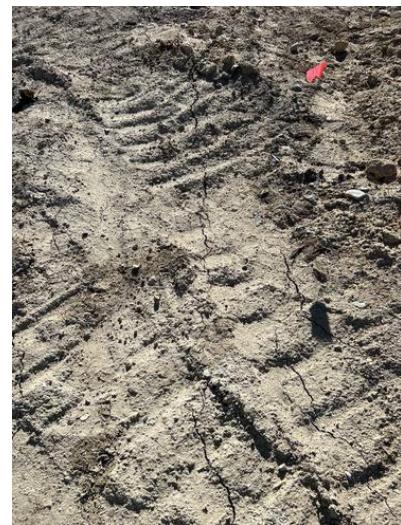
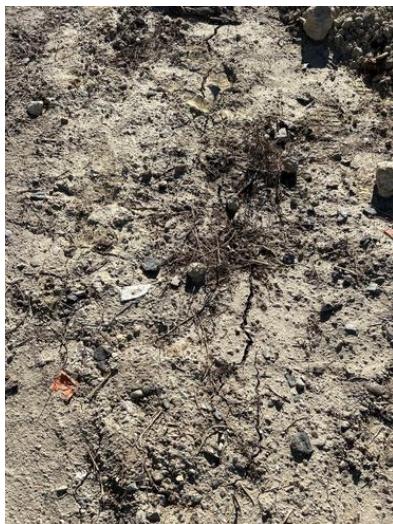
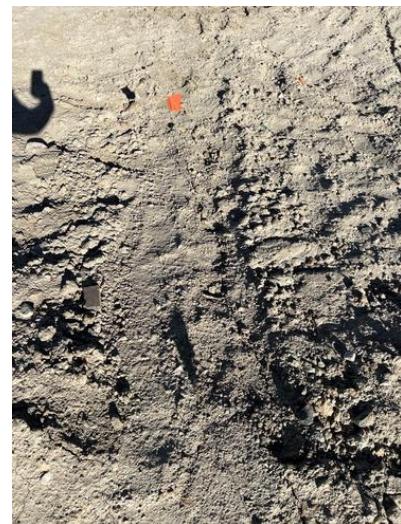
40ft x 95ft

No single crack over 50ft in length.

Small 0.5-2" in width

Extra small <0.5" in height

NW to SE

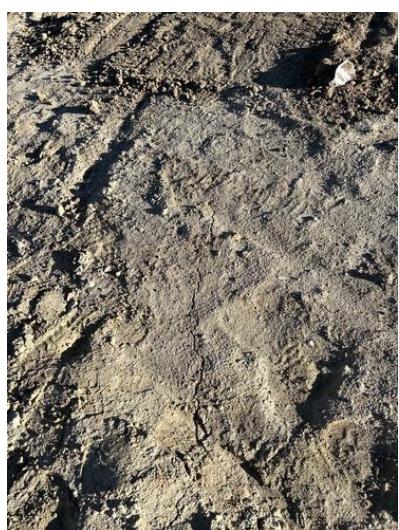
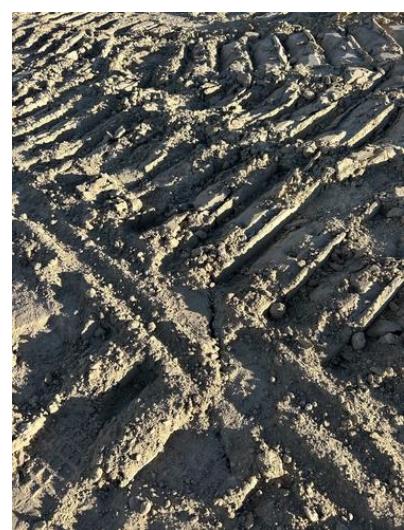
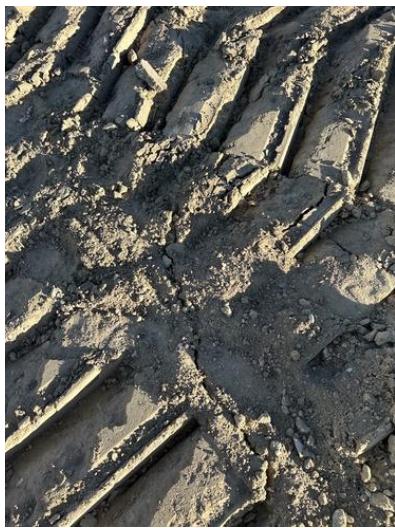
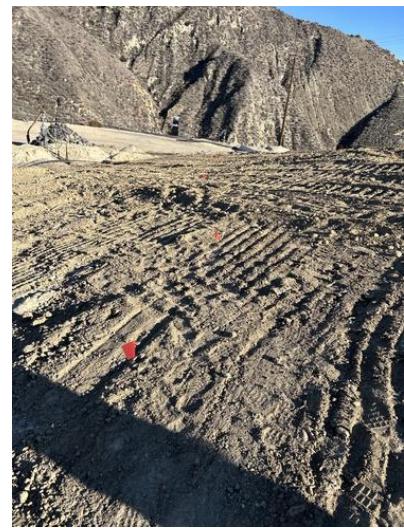
60ft x 5ft

No individual crack longer than 50ft

Small 0.5-2" in width

Extra small <0.5" in height

N to S

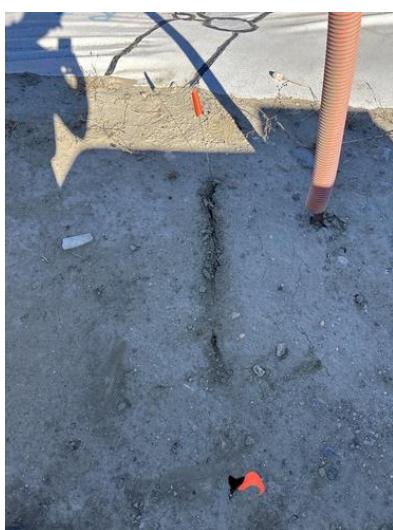
Photo 1

3ft

Horizontal Offset (width)	Small 0.5-2" in width
Vertical Offset (height)	Extra small <0.5" in height
Orientation (direction)	NW to SE

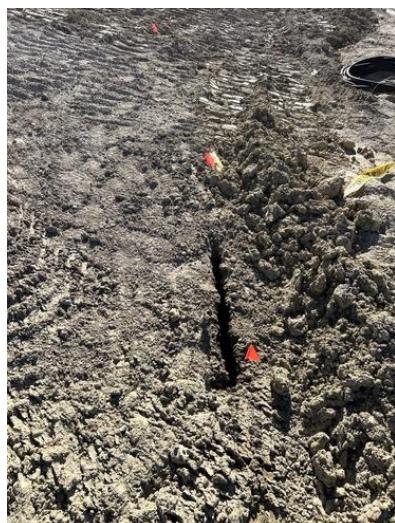
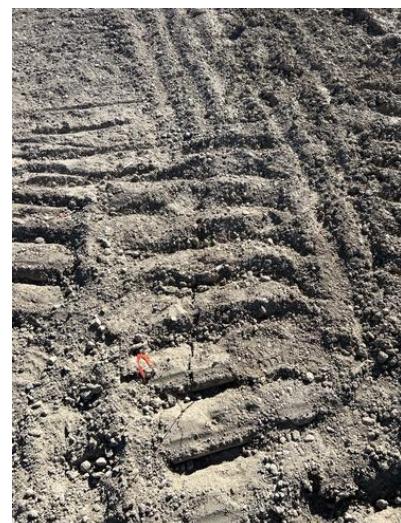
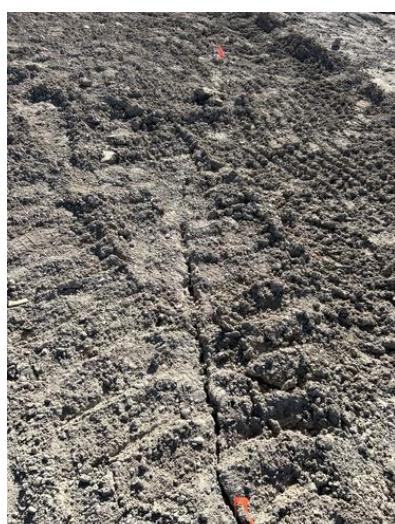
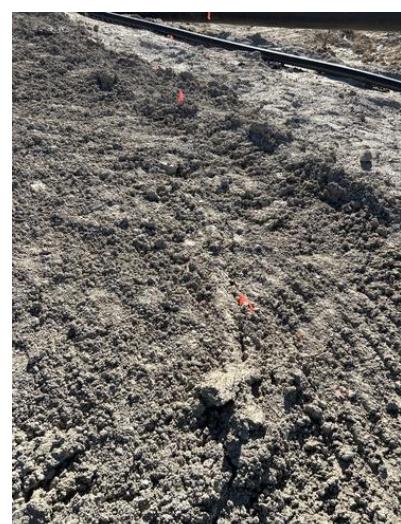
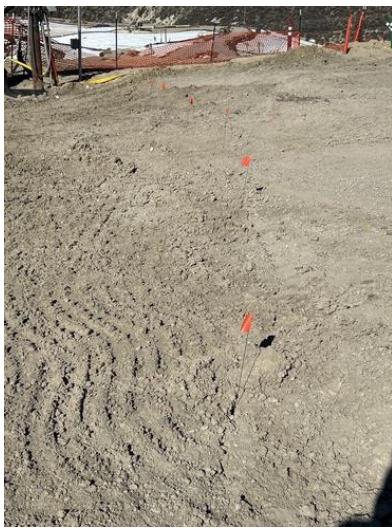
80ft x 10ft

No individual crack longer than 50ft.

Medium 2-4" in width

Extra small <0.5" in height

NW to SE

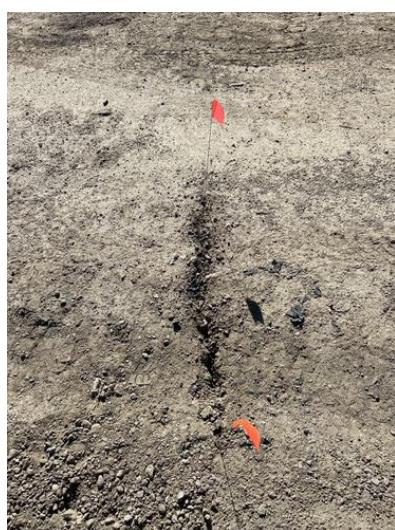
Photo 1

3ft

Horizontal Offset (width)	Small 0.5-2" in width
Vertical Offset (height)	Extra small <0.5" in height
Orientation (direction)	N to S

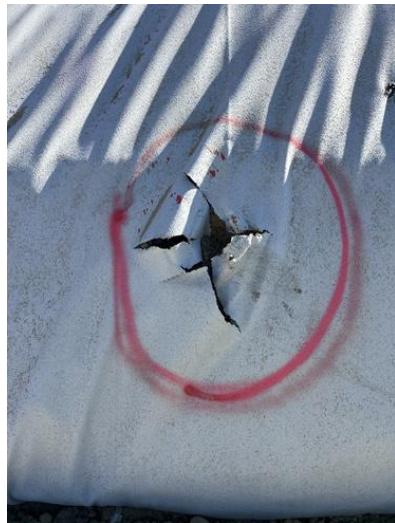
Photo 1

Tear in liner needs to be patched and extrusion welded.
