CHIQUITA CANYON
A Waste Connections Company

Re: Chiquita Canyon, LLC's Weekly Report on the Documentation and Tracking of Cover Issues, Monthly Summary, and Monthly Isopach Map

4050 - Chiquita Reaction Area Tracking of Fissures and Tension Cracks

**OCTOBER 2025 FISSURE AND TENSION CRACK MONITORING SUMMARY
CHIQUITA CANYON LANDFILL
CASTAIC, CALIFORNIA**

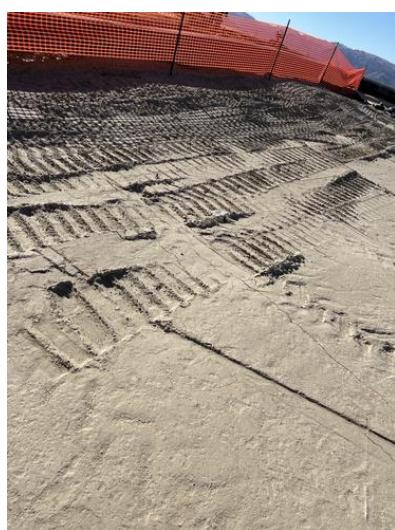
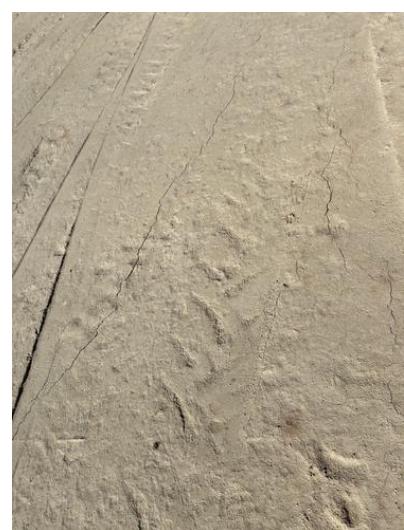
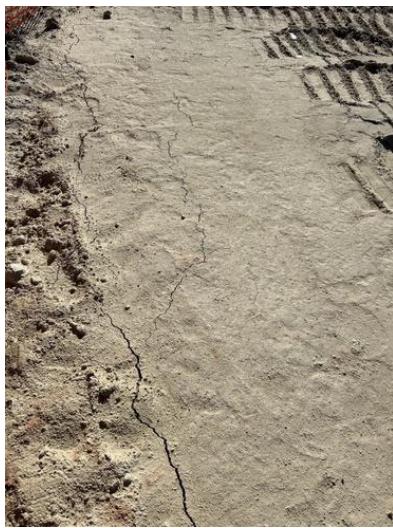
147

Cracks were track walked.

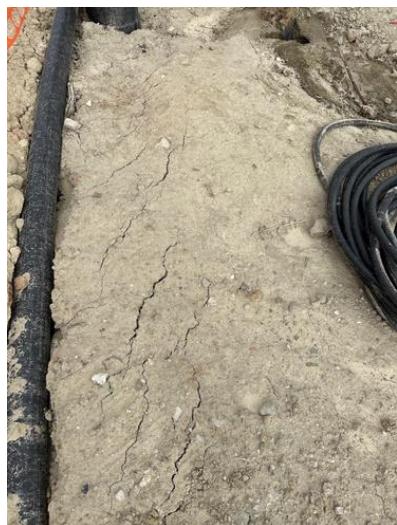
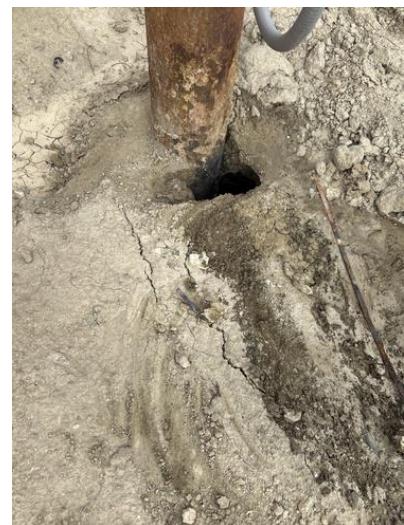
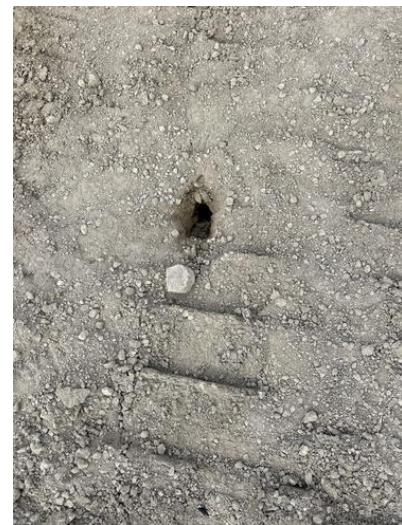
147

Cracks were track walked where accessible and dirt was added and compacted in other locations.

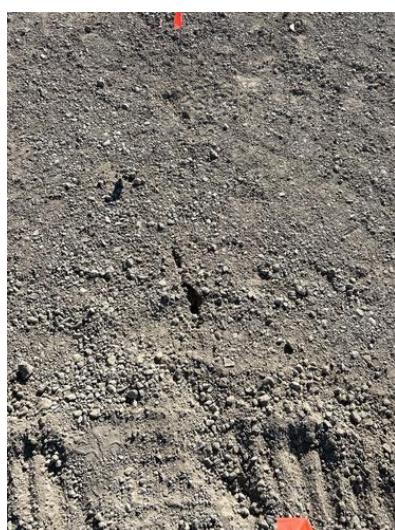
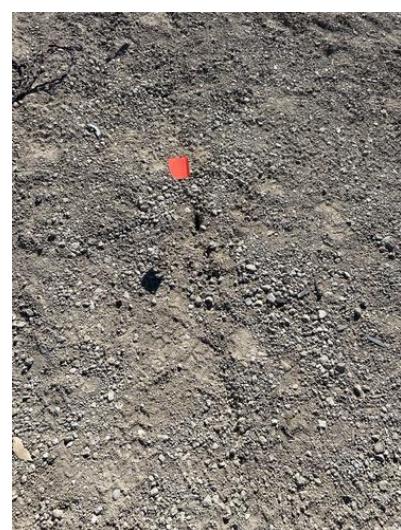
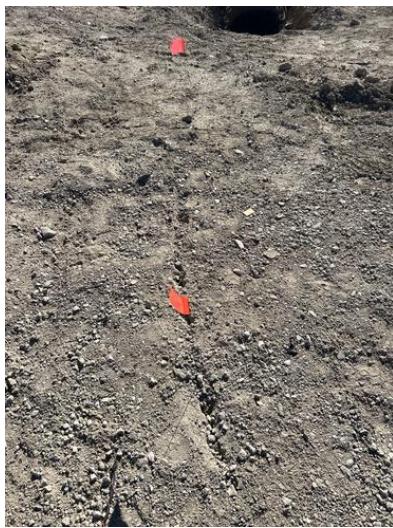
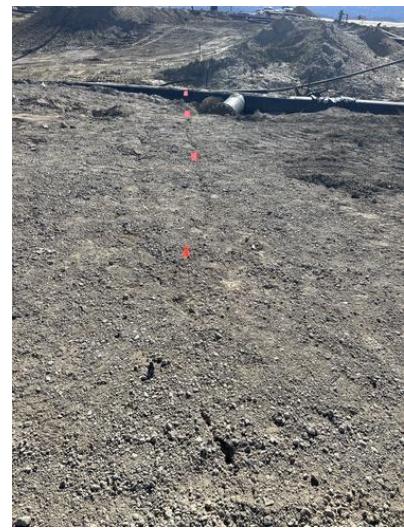
147

Cracks were track walked.

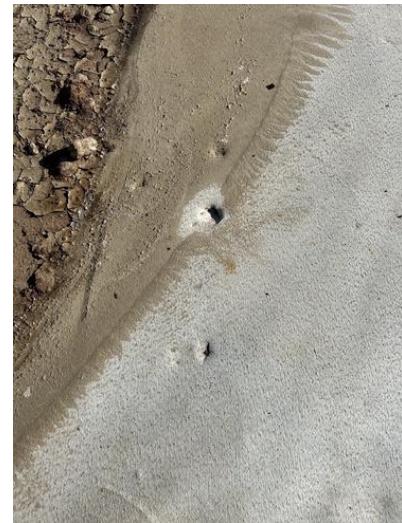
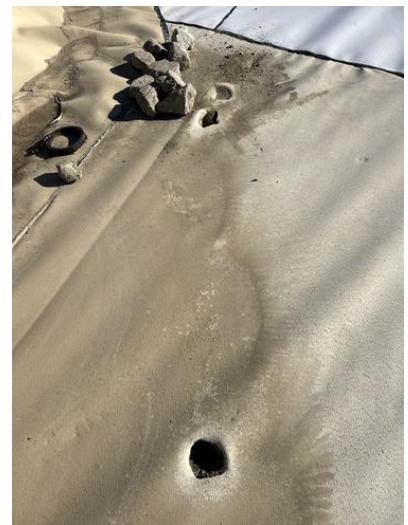
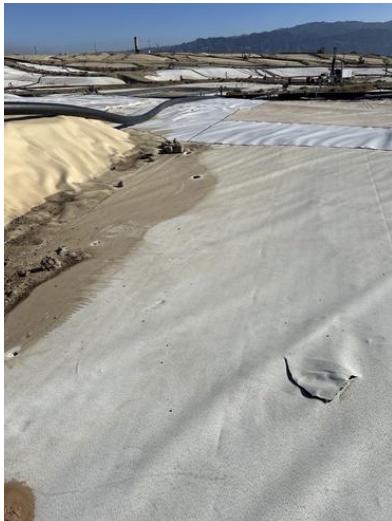
A few tears and holes in liner
need to be patched and extrusion
welded.

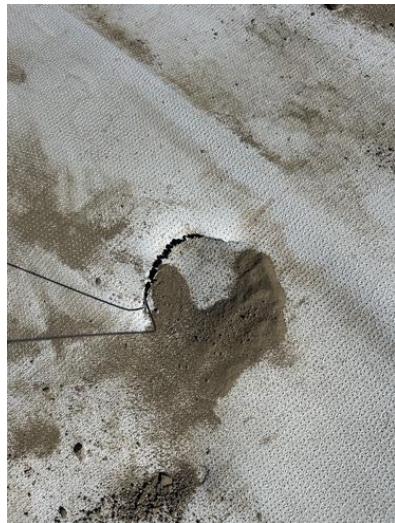
Photo 1

Liner torn. Needs to be patched/extrusion welded.

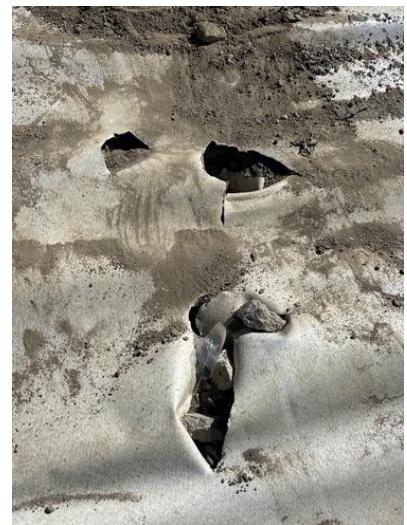
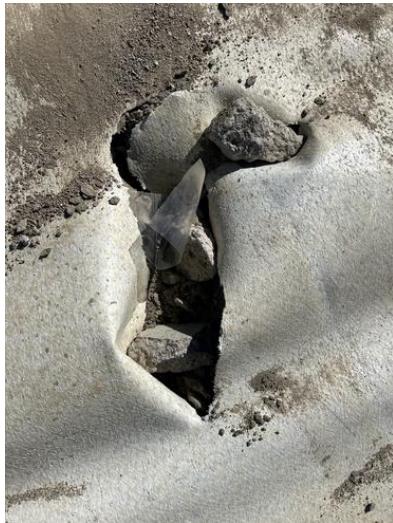
Liner torn, needs to be patched/extrusion welded.

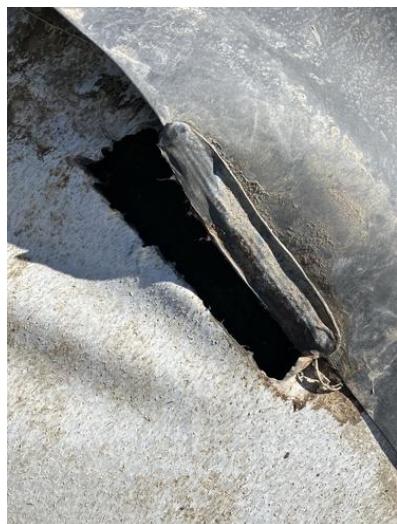
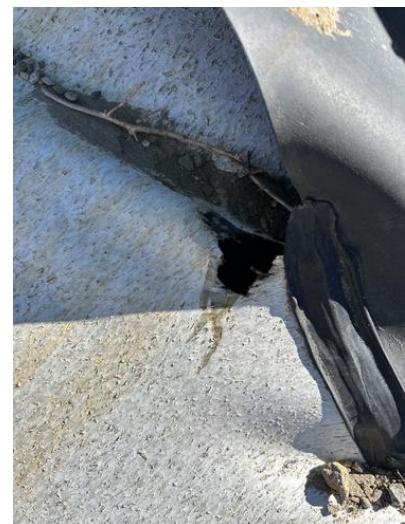
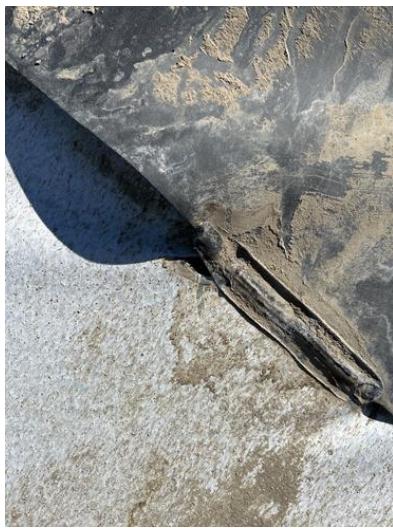
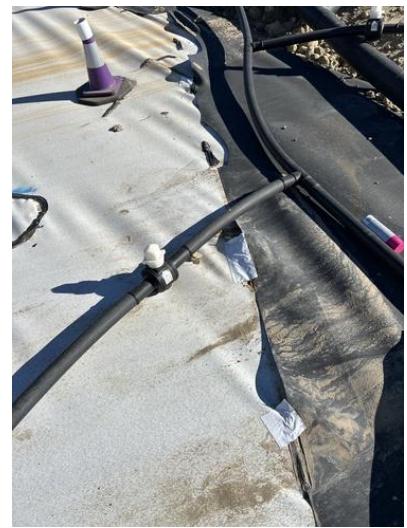
Liner torn. Needs to be patched and extrusion welded.

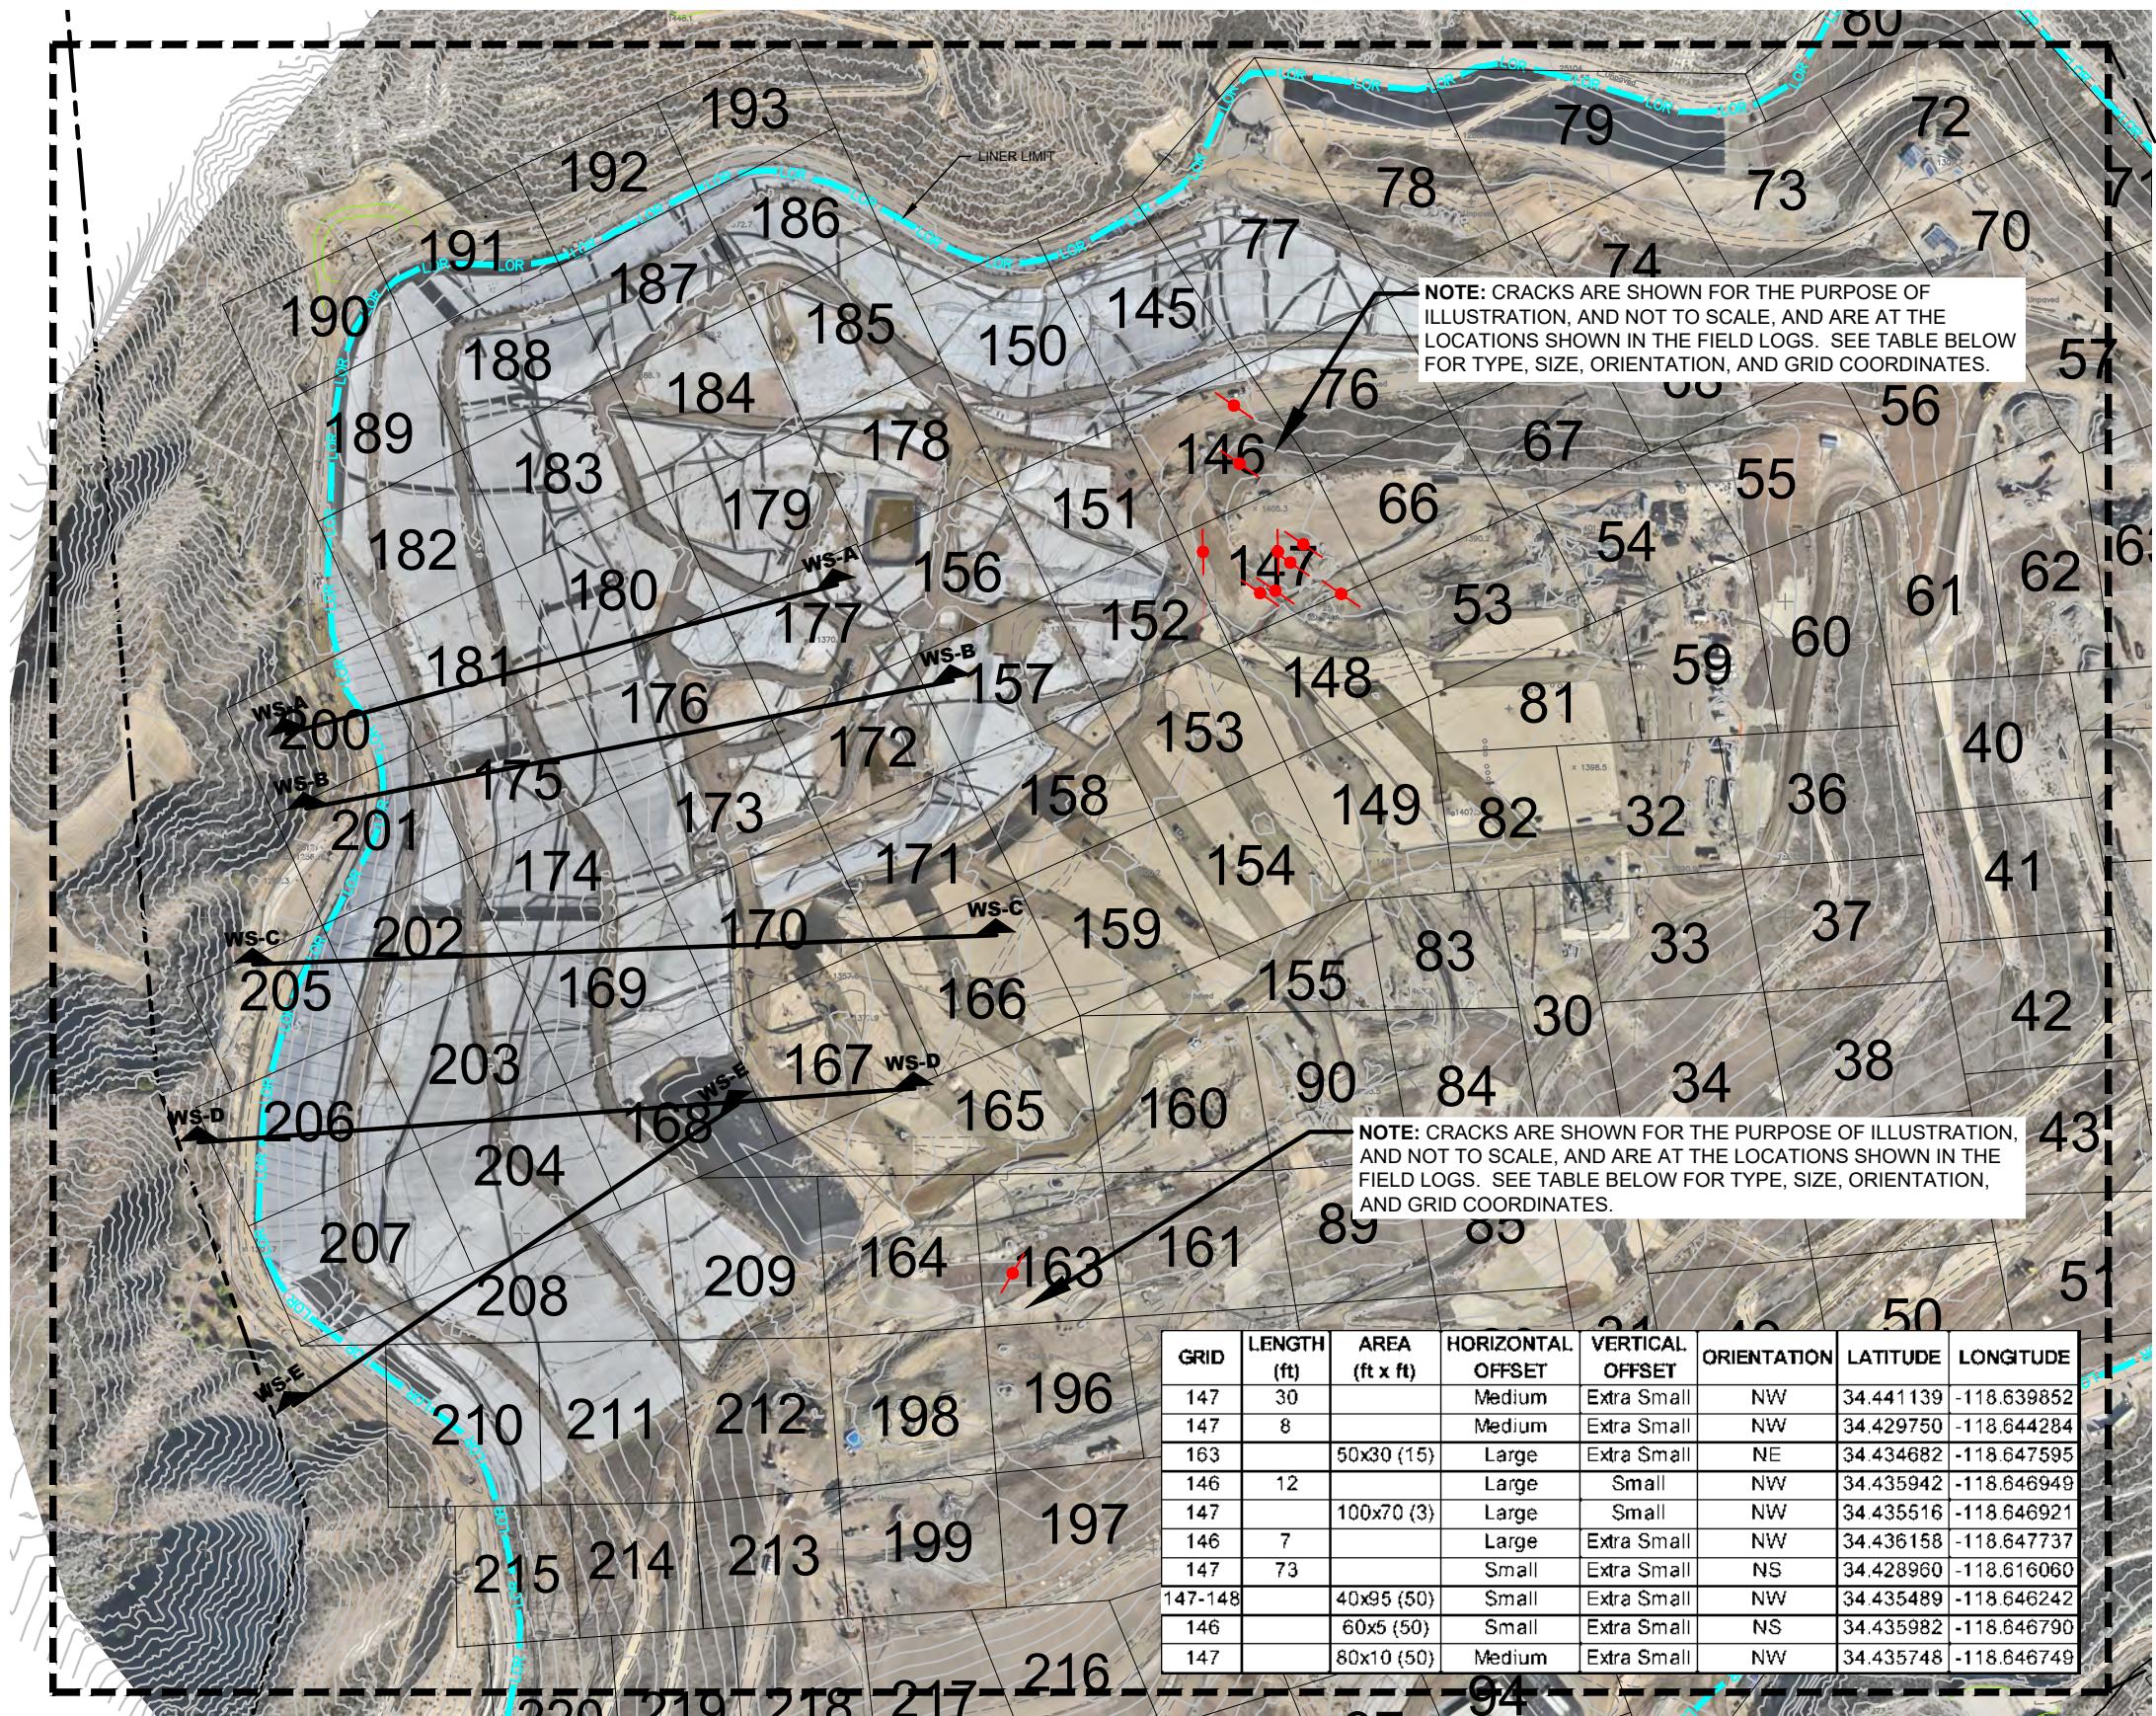
OCTOBER 2025 MONITORING SUMMARY CHIQUITA CANYON LANDFILL COUNTY OF LOS ANGELES, CA		FIG NO. 01
PROJECT NO. RM22.1077

- An approximately 50 ft long crack within a 60 ft x 5 ft area with “small” horizontal offset and “extra small” vertical offset was identified in Grid 146 on October 29, 2025.
- An approximately 73 ft long crack with “small” horizontal offset and “extra small” vertical offset was identified in Grid 147 on October 23, 2025.
- An approximately 50 ft long crack within a 80 ft x 10 ft area with “medium” horizontal offset and “extra small” vertical offset was identified in Grid 147 on October 30, 2025.
- An approximately 50 ft long crack within a 40 ft x 90 ft area with “small” horizontal offset and “extra small” vertical offset was identified across the boundary of Grids 147 and 148 on October 27, 2025.

Figures 1 and 3 show the approximate locations and orientations for these cracks based on the information in the photographs and the daily log. Figure 1 presents a schematic representation of the cracks and areas of cracking identified in September 2025. Figure 3 shows the September and October 2025 cracks and areas of cracking drawn to scale. No slope-stability concerns were noted in these grids at the time of observation, and

Although not “significant,” six other cracks or fissures with “medium” or “large” horizontal offset were observed in October at the approximate locations shown in Figure 1. The observation of these cracks does not indicate slope instability or possible impacts to the landfill’s containment system; rather, they were identified during routine inspection and are reported for consistency with prior documentation of all cracks or fissures with medium or greater horizontal and/or vertical offsets. These cracks and fissures include:

All the cracks identified in Table 1 and above were repaired. Cross sections that compare September 24, 2025 and October 29, 2025 topography are shown in Figures 2A through 2E. The locations of these cross sections are shown in Figure 1. The sections show no significant differences in slope or evidence of instability between the September 2025

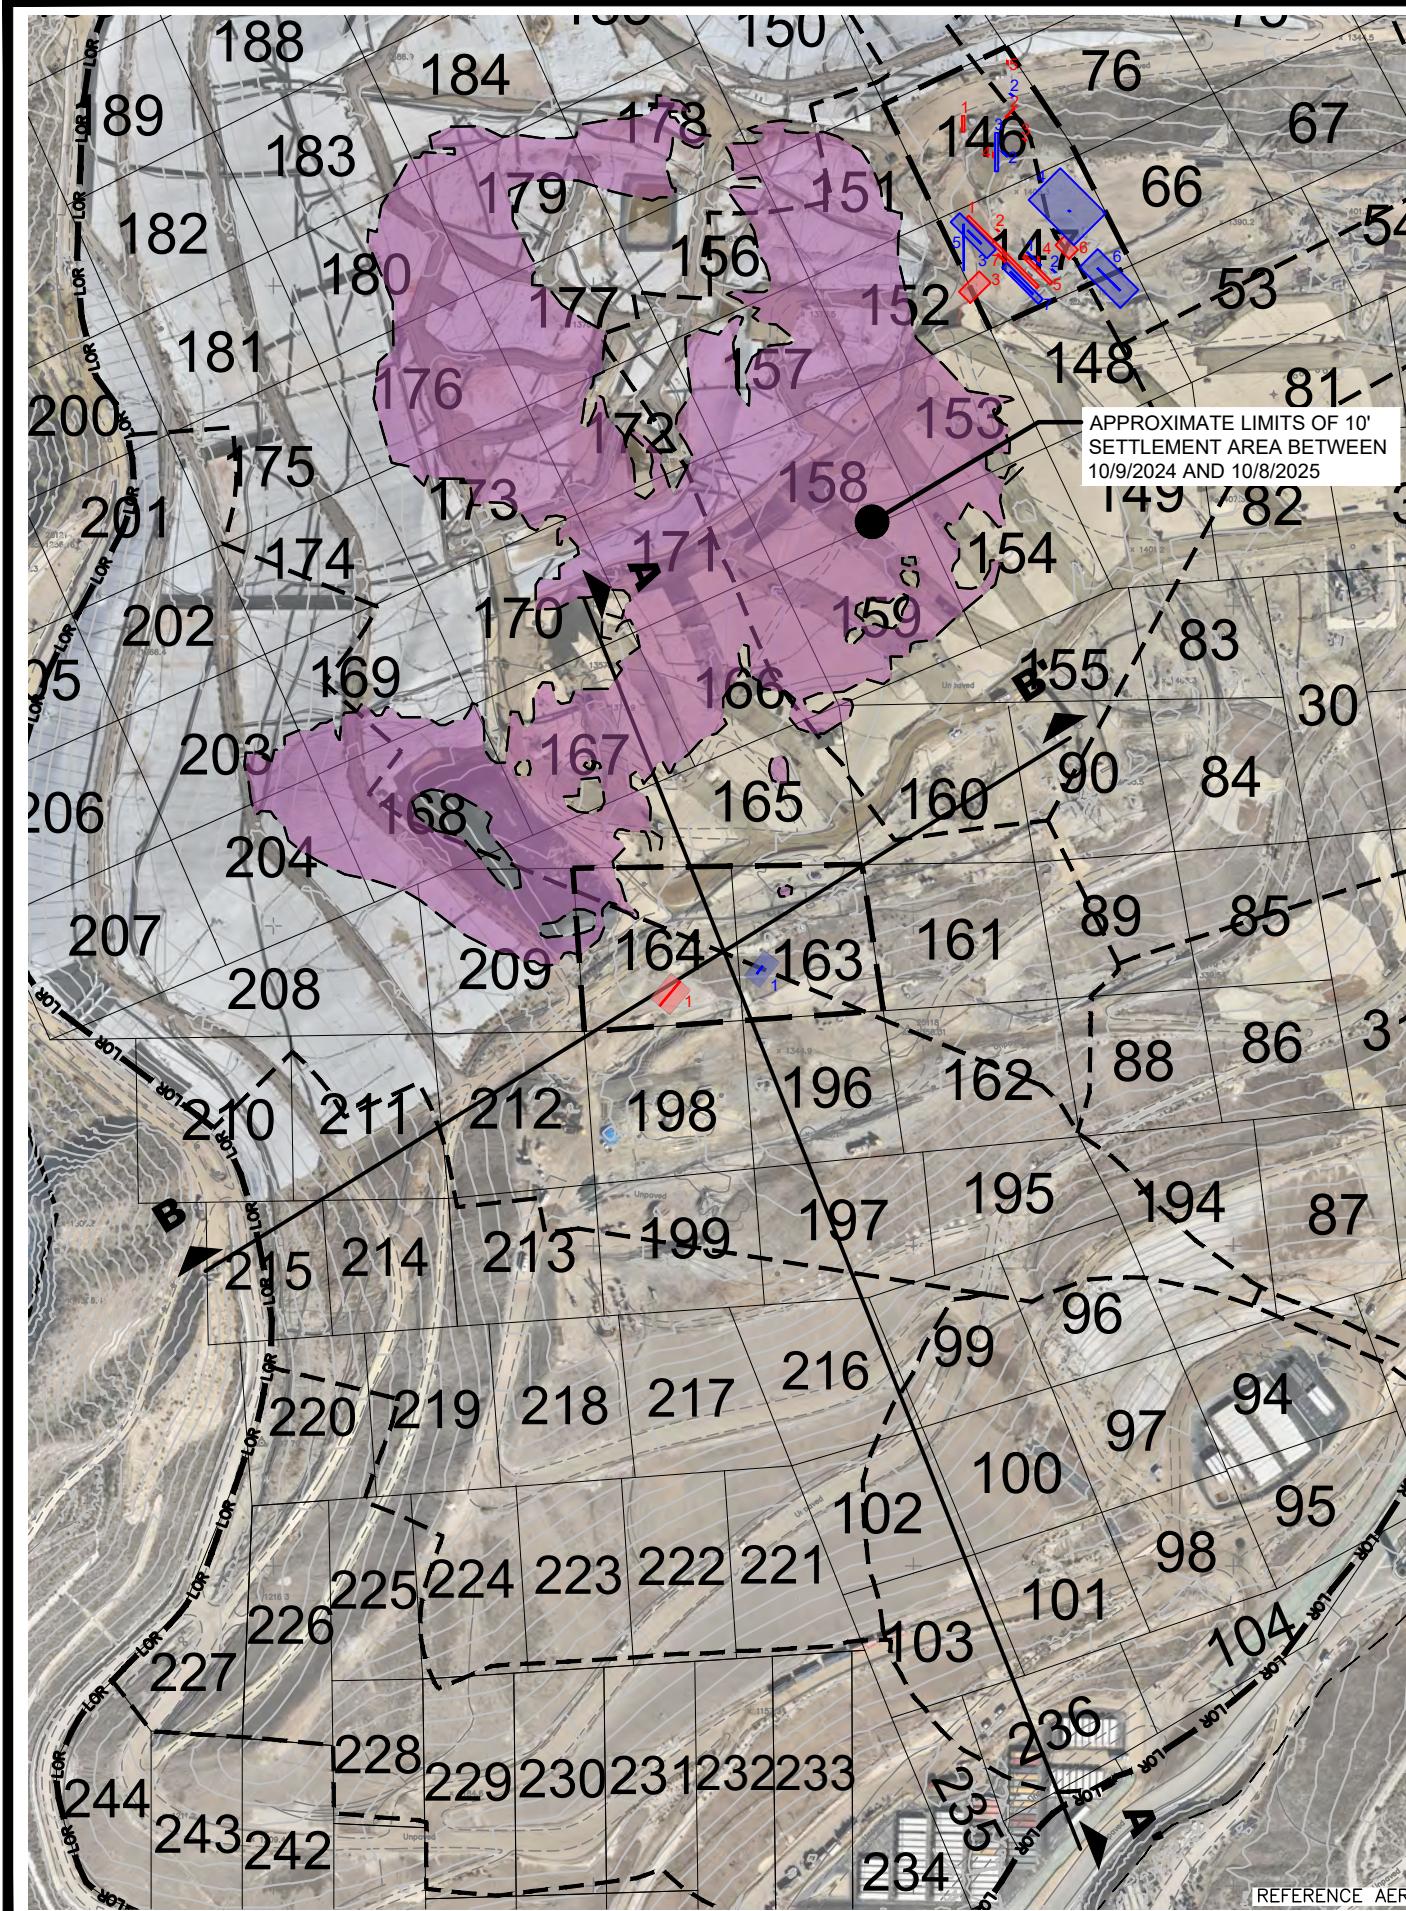
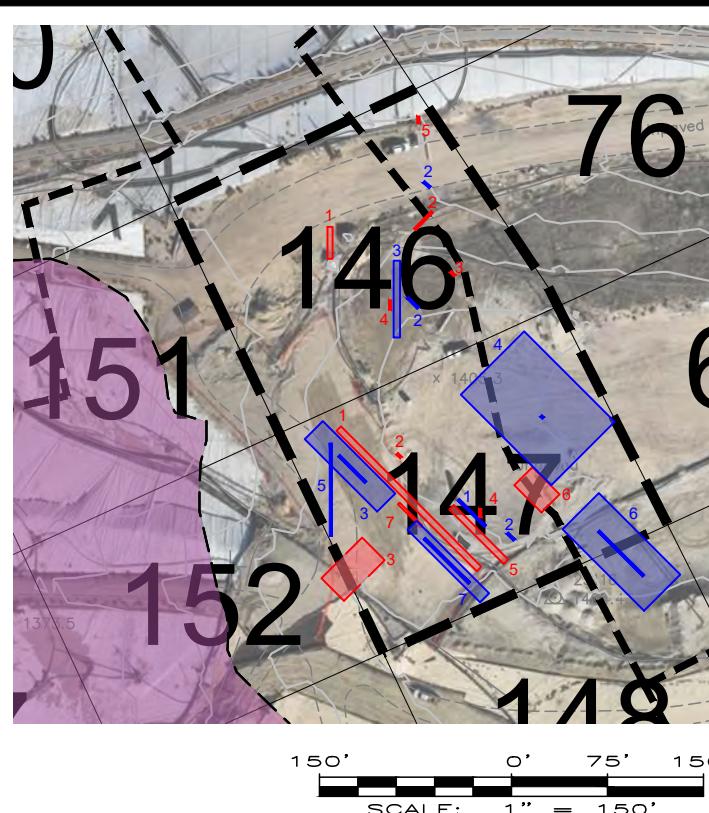
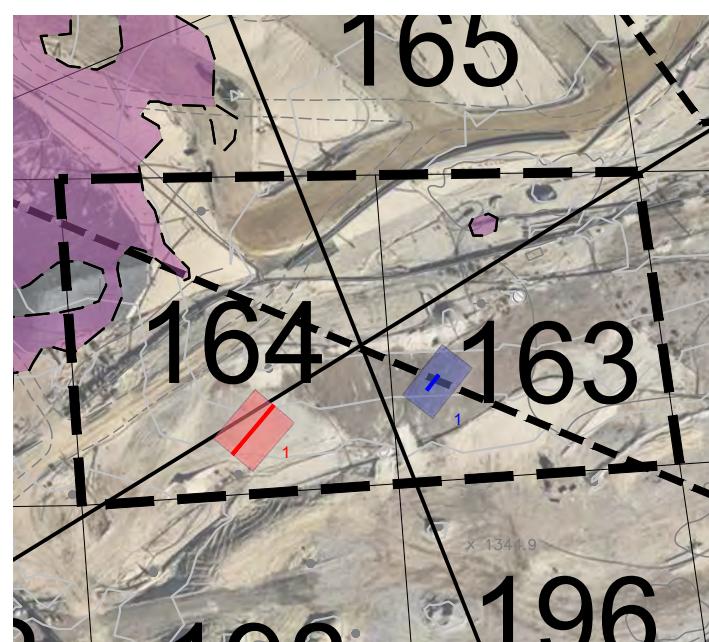
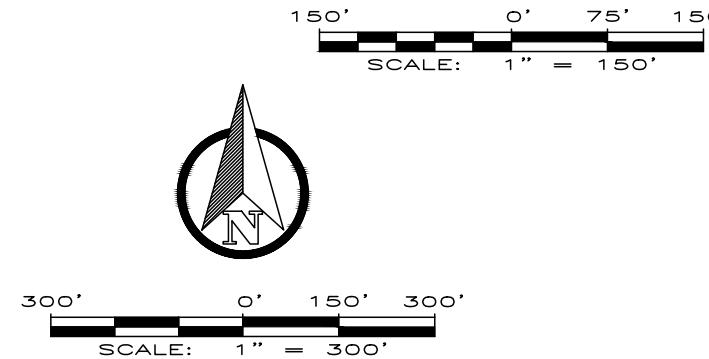
The figures collectively support a finding that the observed cracking most likely reflects localized near-surface tensile strain at the margin of the reaction area rather than slope-scale instability, based on the following observations:

- **Small Scale and Limited Extent.** Cracks extending across a substantial portion of a slope crest or forming connected networks are typically of greater concern than the short, isolated cracks shown in Figure 3. The discrete cracks located well back from the north-facing slope (Grids 146, 147, and 148) and the south-facing slope (Grids 163 and 164) are inconsistent with crest-related tensile cracking from slope movement in those directions, which supports a settlement-related strain feature. As shown in Figures 5A and 5B, the cracks in Grids 163 and 164 occur near the top of the west-facing slope but are oriented perpendicular to the slope contours, which is not consistent with west-facing slope instability.

- **Crack Orientation.** Cracks associated with slope instability would generally be expected to trend approximately parallel to slope contours. In contrast, the cracks in Grids 146, 147, and 148 are perpendicular to the nearby north-facing slope, and those in Grids 163 and 164 are oblique to the south-facing slope and perpendicular to the west-facing slope. As shown in Figure 3, the approximately 10-foot settlement zone associated with the reaction forms a broad, northeasterly-trending trough of depression. The plotted cracks are predominantly subparallel to this trough at its northeastern and southern margins, consistent with tensile cracking that developed as the surface responded to settlement along the reaction boundary.

- **Crack Growth and Vertical Offset Over Time.** Progressive widening, lateral extension, or vertical offset over time may indicate continuing movement or strain accumulation. Conversely, cracks that remain stable suggest localized surface stress-relief or desiccation effects. The Grid 164 cracks were repaired on September 12, 2025, and were not re-observed in daily inspections through October 31, 2025, providing no evidence of continued propagation. The crack observed in Grid 163 on October 10, 2025 is at approximately the same northeasterly orientation as the cracking in Grid 164. However, this crack did not recur after repair, also providing no evidence of crack growth. Cracking on the top deck (Grids 146, 147, and 148) has not expanded into adjacent grids, which is consistent with a localized zone of settlement.

- **Associated Indicators of Slope Distress.** Common secondary indicators of slope instability such as lateral margin cracking, toe bulging, anomalous seepage, or surface grade changes were not observed in the areas surrounding Grids 146, 147, 148, 163, or 164. The topographic cross sections in Figures 4A, 4B, 5A, and 5B show no measurable surface-grade changes between May 28 and October 22, 2025, further supporting the interpretation that the observed cracking is not slope-related.
